1957/17

SECOND PROGRESS REPORT

DAM SITE "C"

UPPER COTTER RIVER, A.C.T.

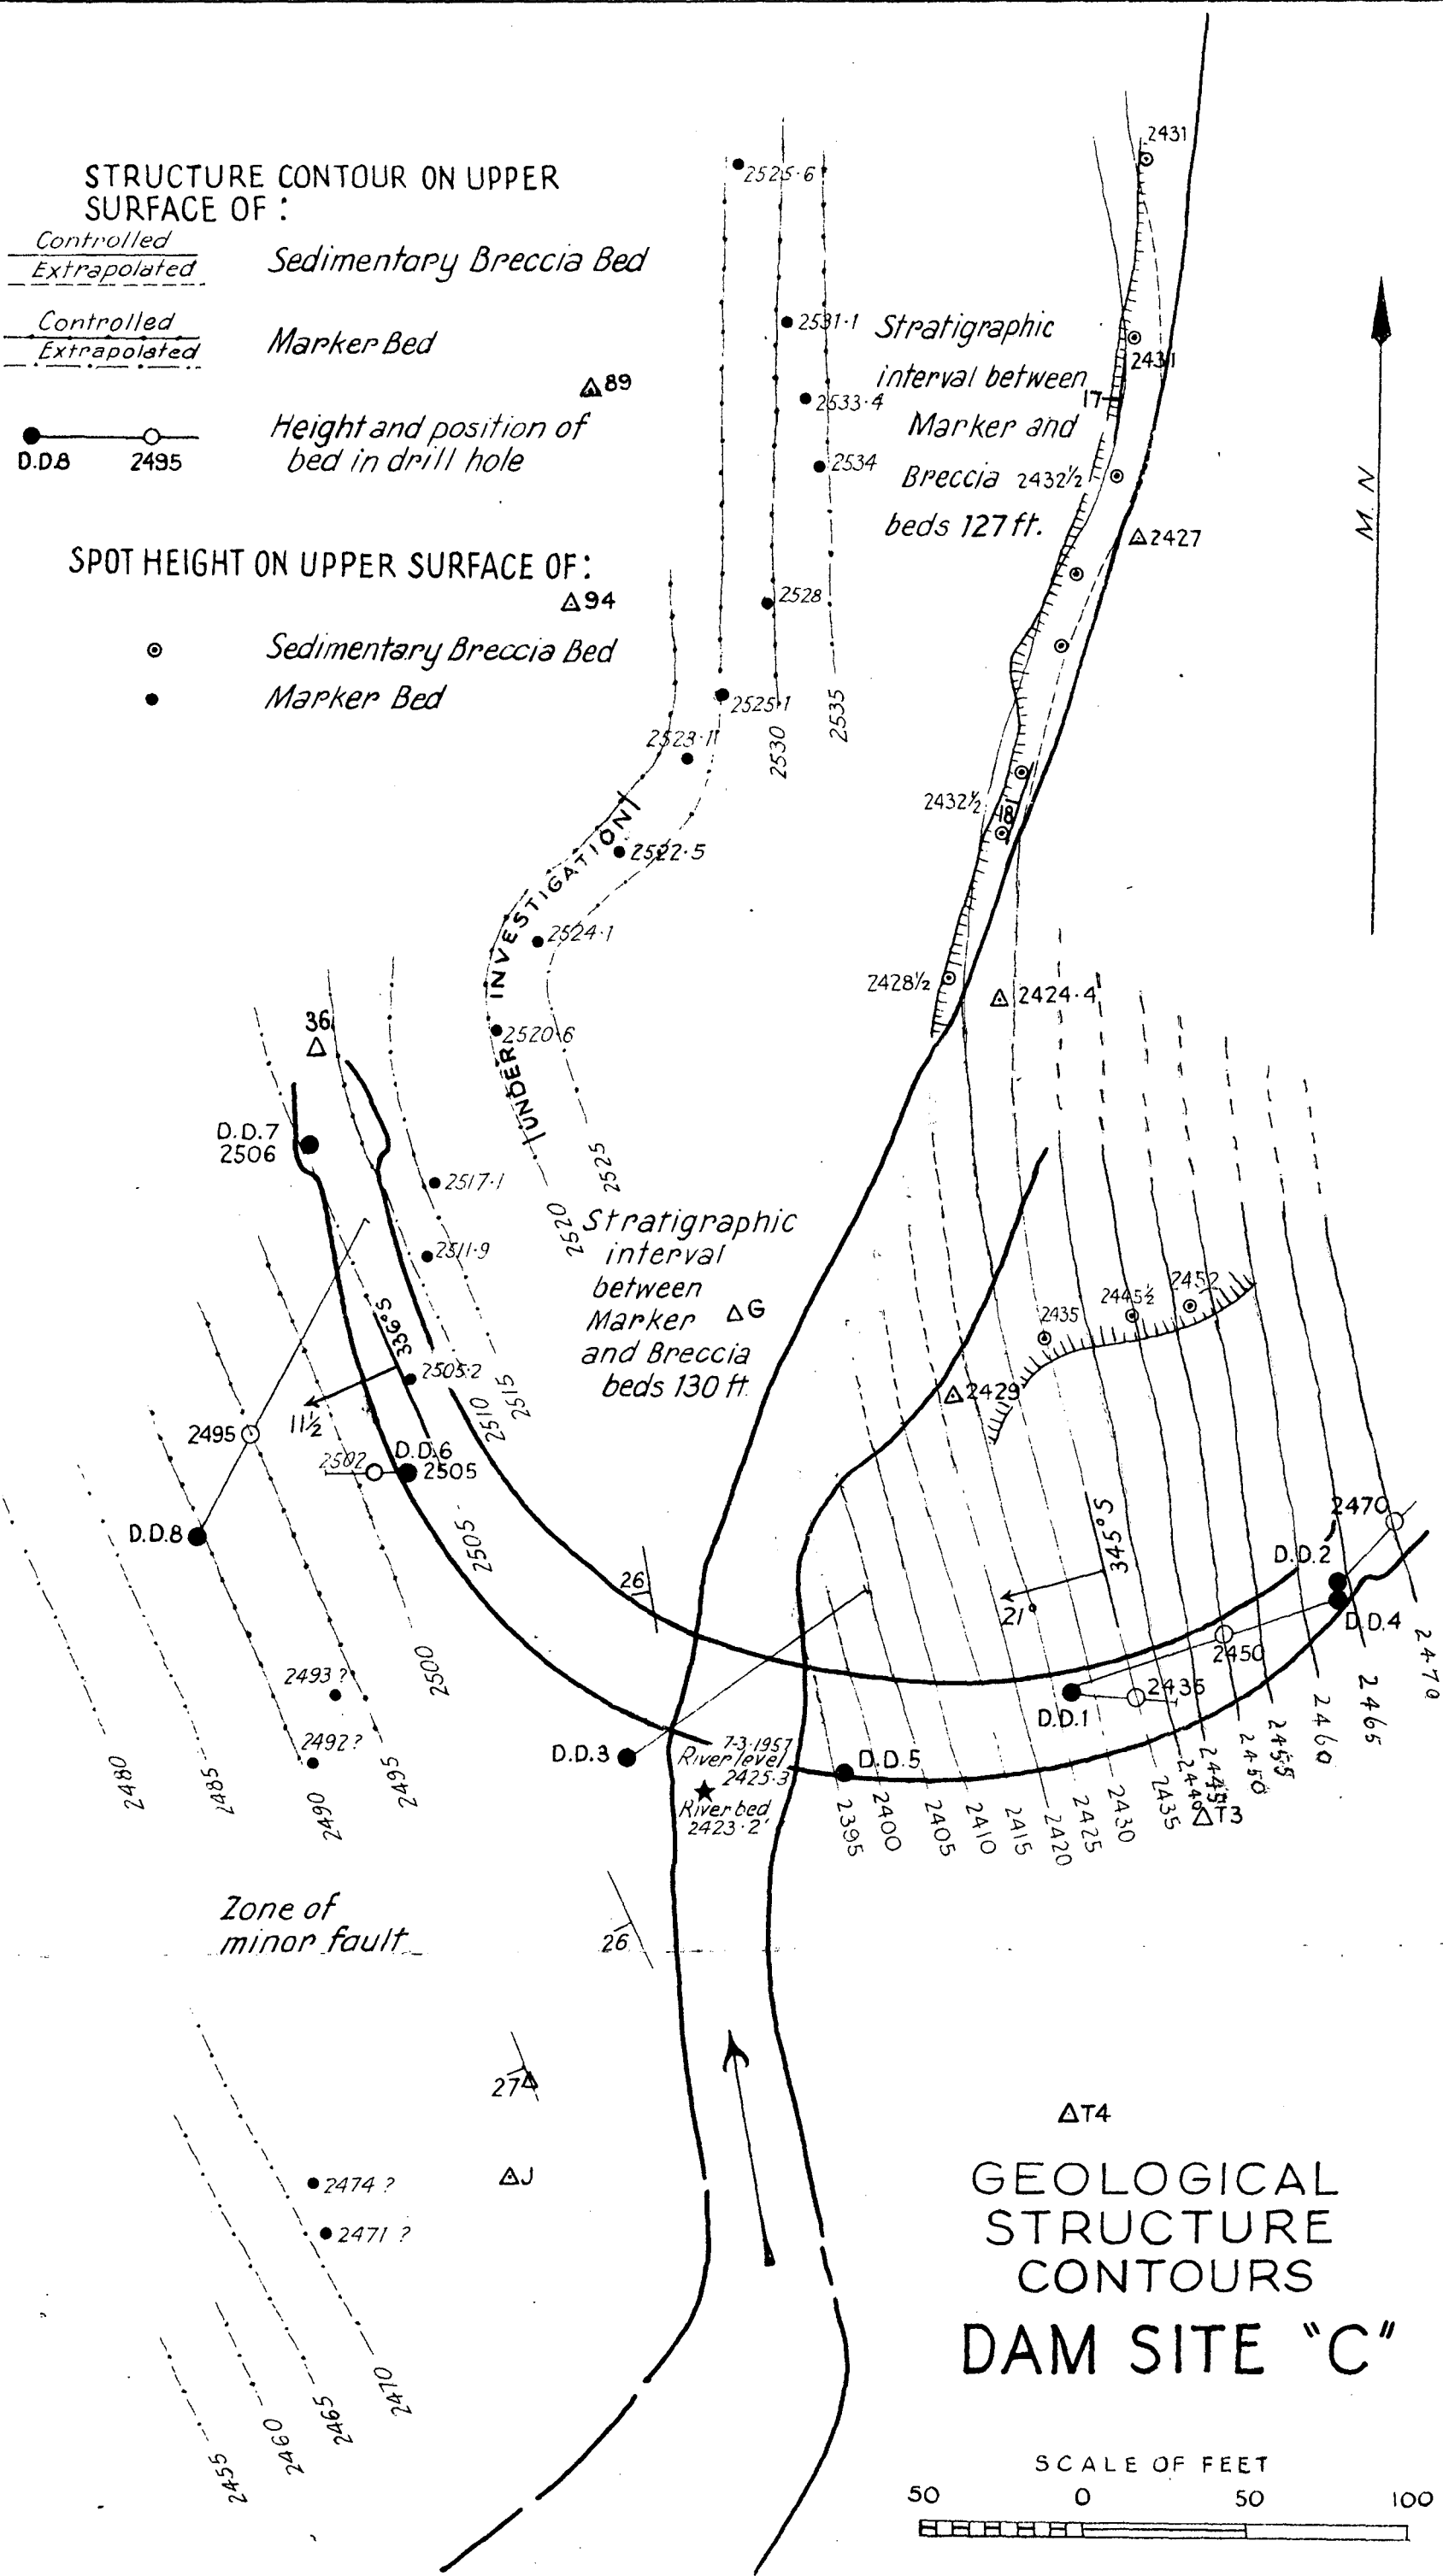
In more detail, the structure of the sediments at the site is shown by the structure contours on the marker and sedimentary breccia beds (Plate 3). There is a swing in the strike of the beds from about 340°\*\* on the upstream side of the wall to about 350° on the downstream side. The structure contours show only an average strike; variations of up to 20° from this general strike have been noted in individual outcrops and these are apparently due to small rolls in the bedding. The dip flattens from about 20° on the eastern abutment to 12° high on the western abutment and, as in the case of the strike, variations occur in outcrop.

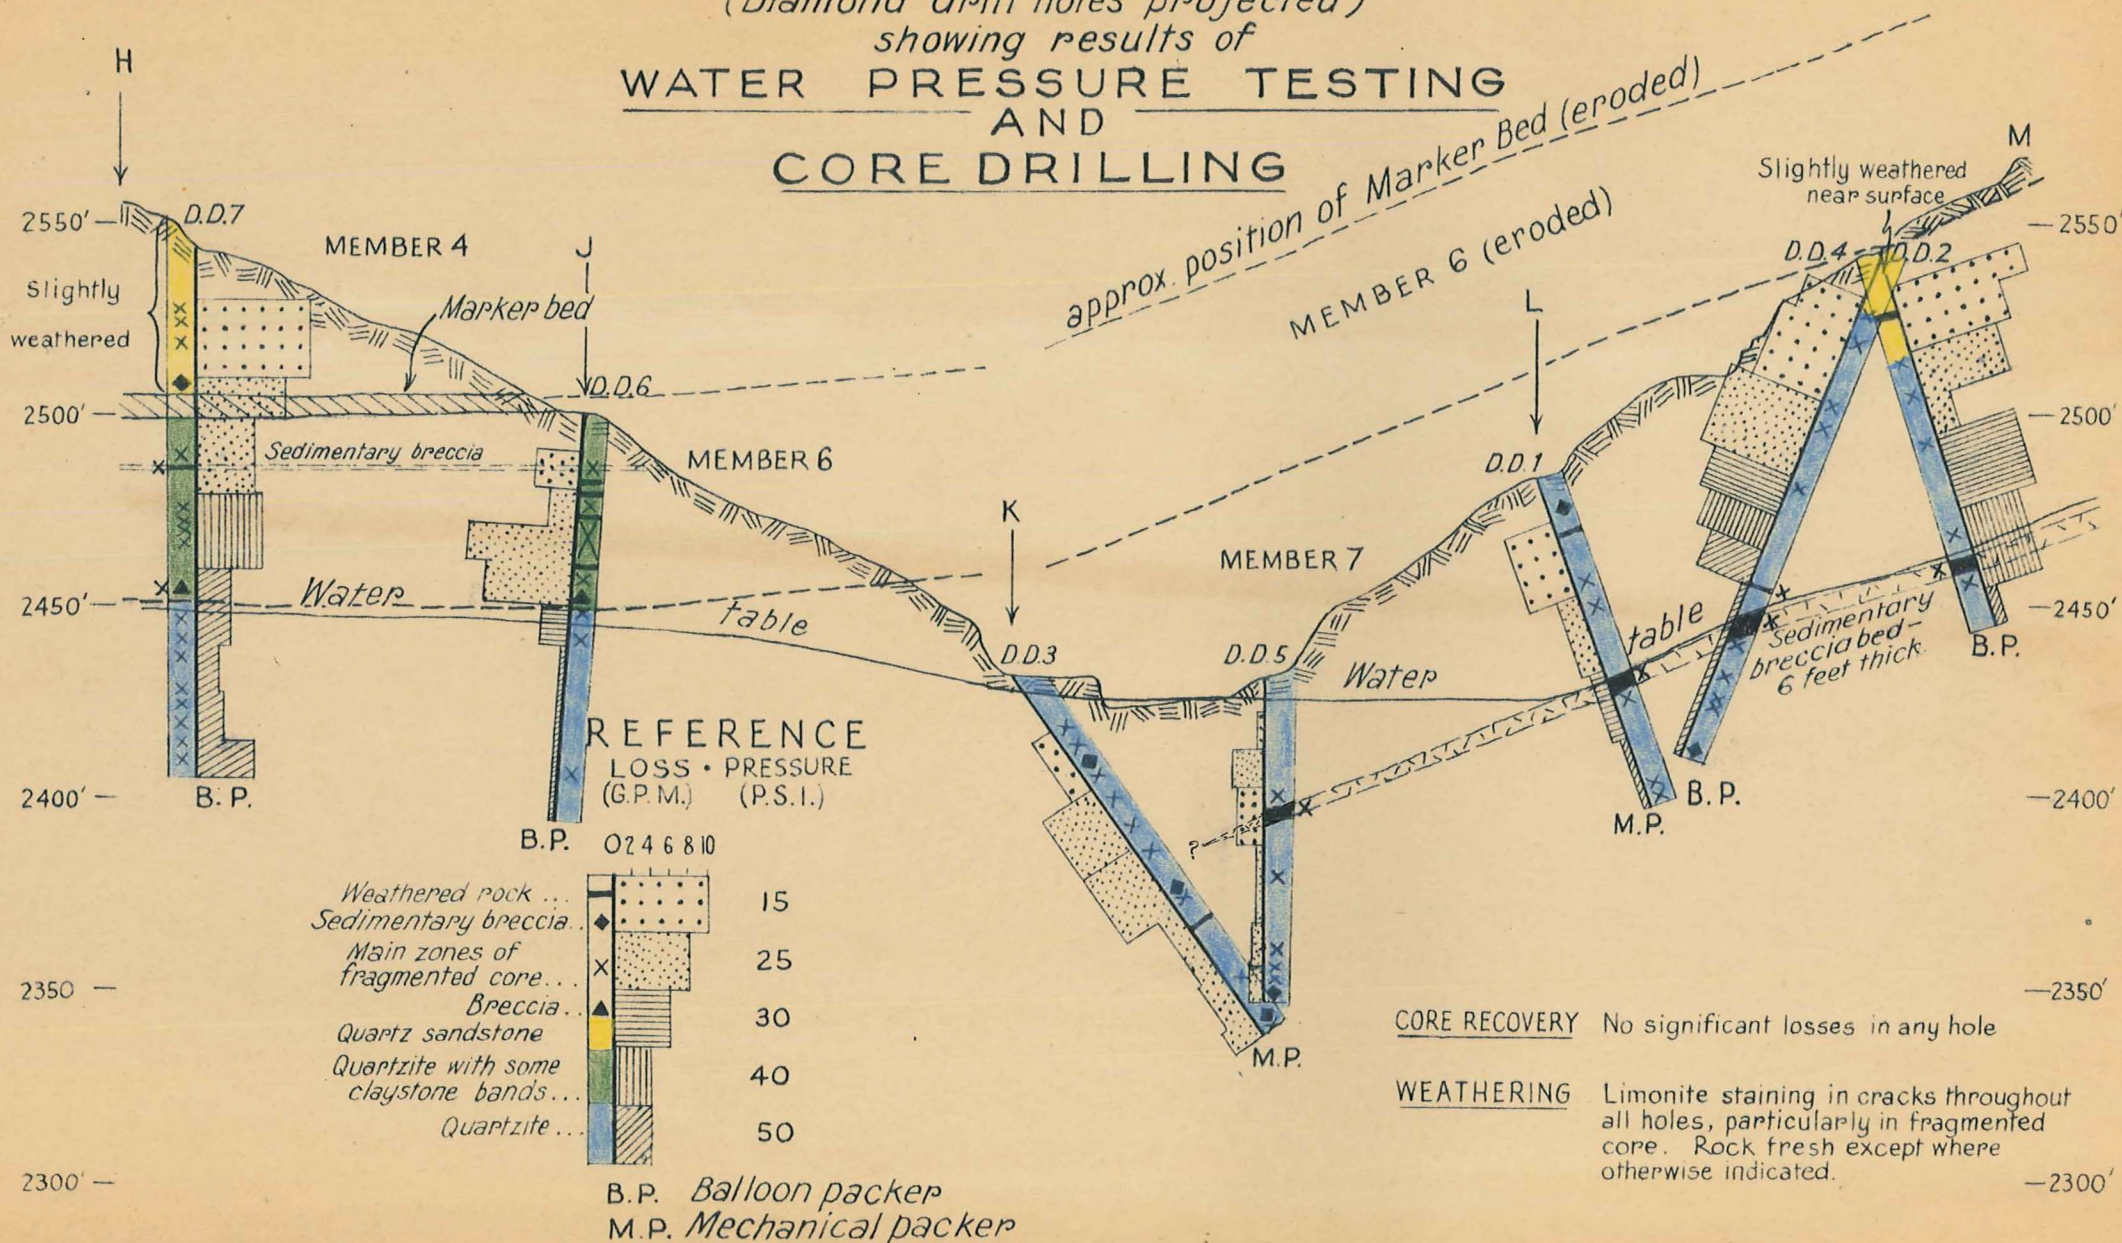
The results of water pressure testing are shown diagrammatically in Plate 4 and their significance is discussed in a later section. One uniform pressure could not be used throughout the water pressure testing because high pressure is avoided in the upper sections of drill holes due to the danger of opening up fractures, and a low pressure was not possible in the lower sections of "dry" holes due to the head of water in the pipes connected to the packer.

The sandstones high on both abutments show medium to slight weathering to a depth of some 20 feet from the surface, but elsewhere surface weathering is much shallower and in general the surface weathering of the rocks themselves will not provide foundation problems. On the other hand, closely spaced and comparatively open joints have allowed oxygenated water to penetrate and circulate well below the present water table, with the result that iron staining and a degree of weathering is found in joints throughout the length of all drill holes. Consequent on this circulation, minor beds in the sequence which are more susceptible to weathering than the general run of sandstone, have been weathered; the sedimentary breccia bed in the eastern abutment is an example of this. The distribution of such weathered bands, main zones of fragmented core and the occurrence of sedimentary breccia are shown on Plate 4.

Thorough grouting to control leakage is the obvious problem where the site lies largely in competent quartzites with a well developed joint system and with a consequent low water table. The results of water pressure testing, shown on Plate 4, give a fairly clear picture of leakage conditions at the site. These results show convincingly that leakage rates cannot be correlated with individual beds or members, but are controlled by fractures, mainly in the zone of weathering above the water table.

Leakage rates decline fairly regularly with depth and except for holes 3 and 7 are low below water level. Significant leakage occurs under the river to a depth of 60 feet, suggesting open joints which have partly controlled the position of the river. Rates of up to 6 gallons per minute, at a pressure of 50 lbs. per square inch, are shown in jointed sandstone below water level in hole 7.

The highest leakage rates, 12-14 gallons per minute at 15 p.s.i. occur high on both abutments where the period of weathering has been the longest and where circulation is least impeded. These sections will have little head of water when the dam is full, but sections of the abutments which will be under pressure of the order of 30 lbs. p.s.i. when the dam is full also show a comparatively high leakage rate of 6-8 gallons per minute under approximately that pressure.

To prevent serious leakage an effective grout curtain will have to extend to the level of the present water table and for 60 feet below the river. Information from which may be determined the necessary extension of this curtain east and west of the wall is being sought in holes 9 and 10, whose positions are shown on Plate 1.
