Records 1957/78

GEOLOGICAL SURVEY OF THE STOKES HILL WHARF PARKING

DARWIN, NORTHERN TERRITORY

W. F. McQueen

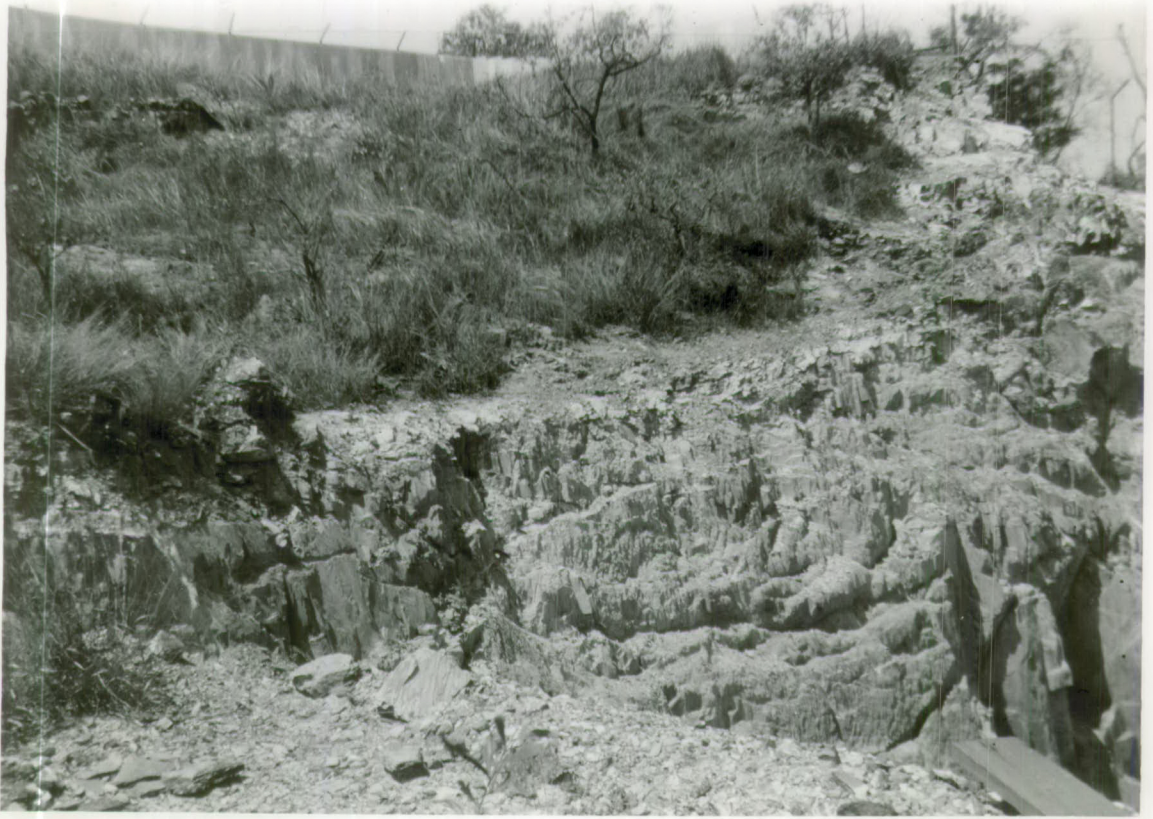
PLATE 3.

Plate 3 shows all units exposed.

The contact between the steeply dipping Noltenius Formation and the flat lying Lower Cretaceous and recent deposits.

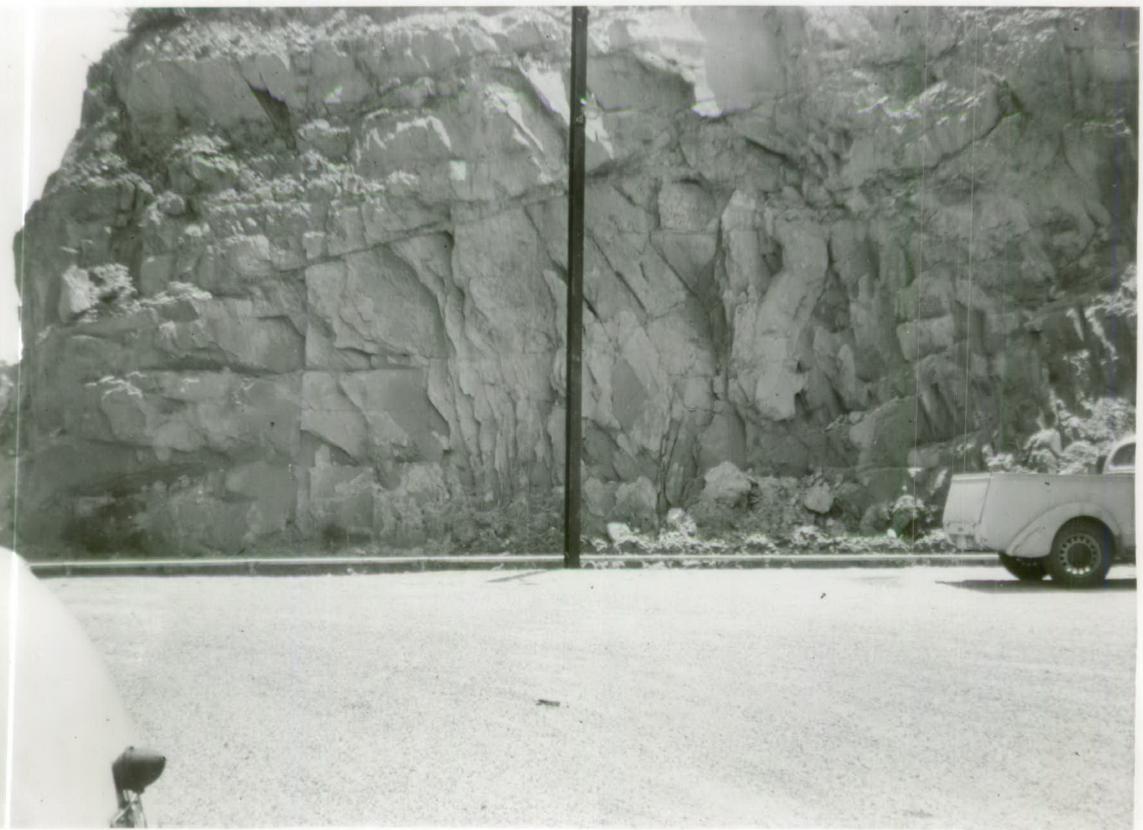
PLATE 4.

Three low angle faults showing movement of three or four inches strike east and dip at 15-20 degrees south. Two of these can be seen in Plate 4, the other in Plate 9. The rock is strongly jointed vertically and horizontally. A third set of joint planes dips about 60 degrees north.

The western face is almost parallel to the strike of the beds and shows details of the faults and joint planes (see Plate 4). As the beds dip very steeply (over 70°) the angle of batter on this face previously $1\frac{1}{2}$ to 1 has by fretting of the rocks now conformed to the angle of dip of the beds. Several bedding planes have opened up and slabs of rock are loose and unstable. This height of the face ranges from 25 feet at the southern end to 50 feet at its junction with the northern face.

The western face showing fault planes, vertical and inclined joint planes and bedding planes.

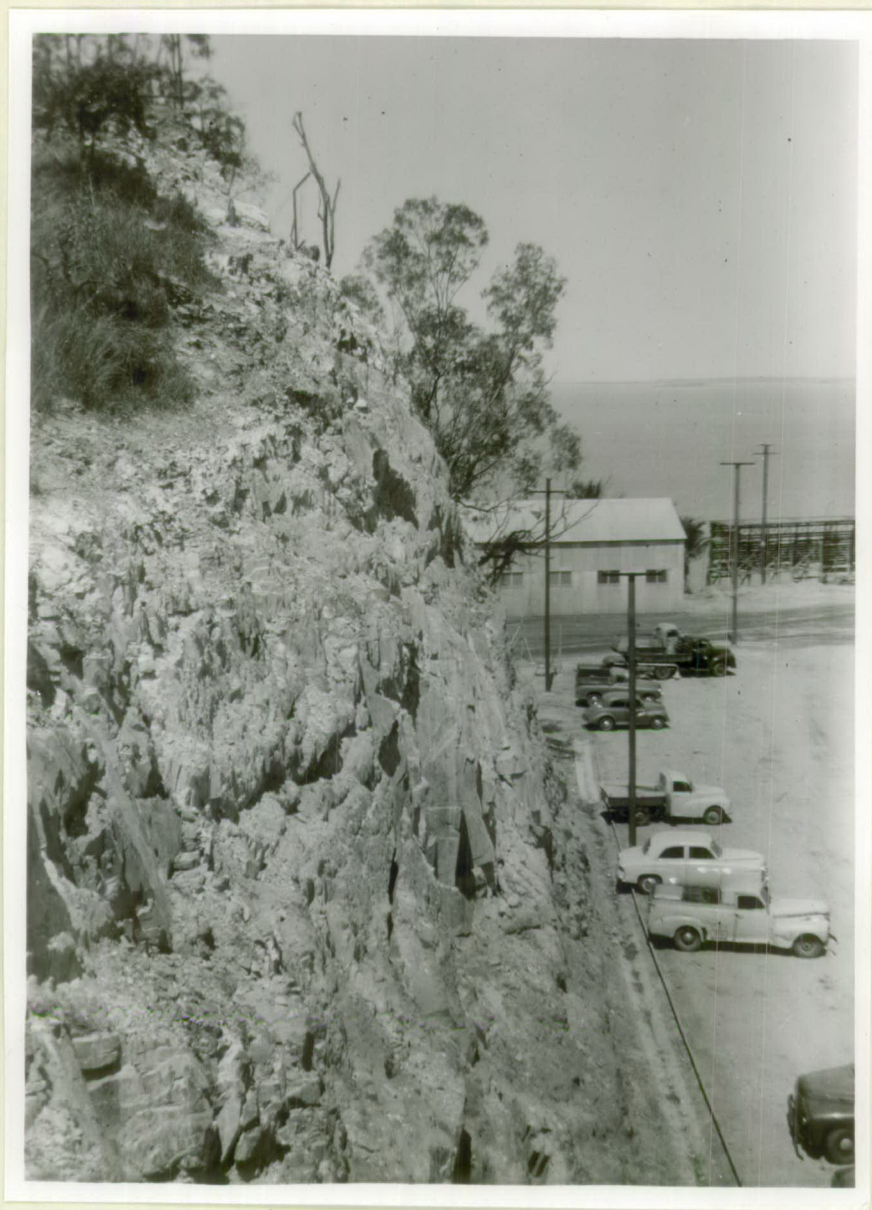
PLATE 5.

The northern face rises to a height of 63 feet about the centre and then slopes down to the level of the parking area. The vertical and inclined joint planes strike almost parallel to the face. These factors together with the angle of dip of the fault planes have resulted

in unstable areas on the face. Joint planes have opened up and several small falls have occurred. The face has changed from a $1\frac{1}{2}$ to 1 slope to vertical in some places. (See Plate 5). One crack has developed along an inclined joint plane and where rock has broken away overhangs are now evident. (See Plates 6 and 7).

General view of the northern face showing present angle of batter and vertical faces.

It is recommended that the unstable rock be barred down (see Plate 8) and that the north face be reduced to a batter not exceeding 1 in 1. Even then further movement may be expected, but this is not likely to endanger life or parked vehicles. Regular cleaning up will be necessary until the slope is considerably reduced. The reduction of the present slope of the northern face of the parking area would require the removal of approximately 3,500 cubic yards of rock.

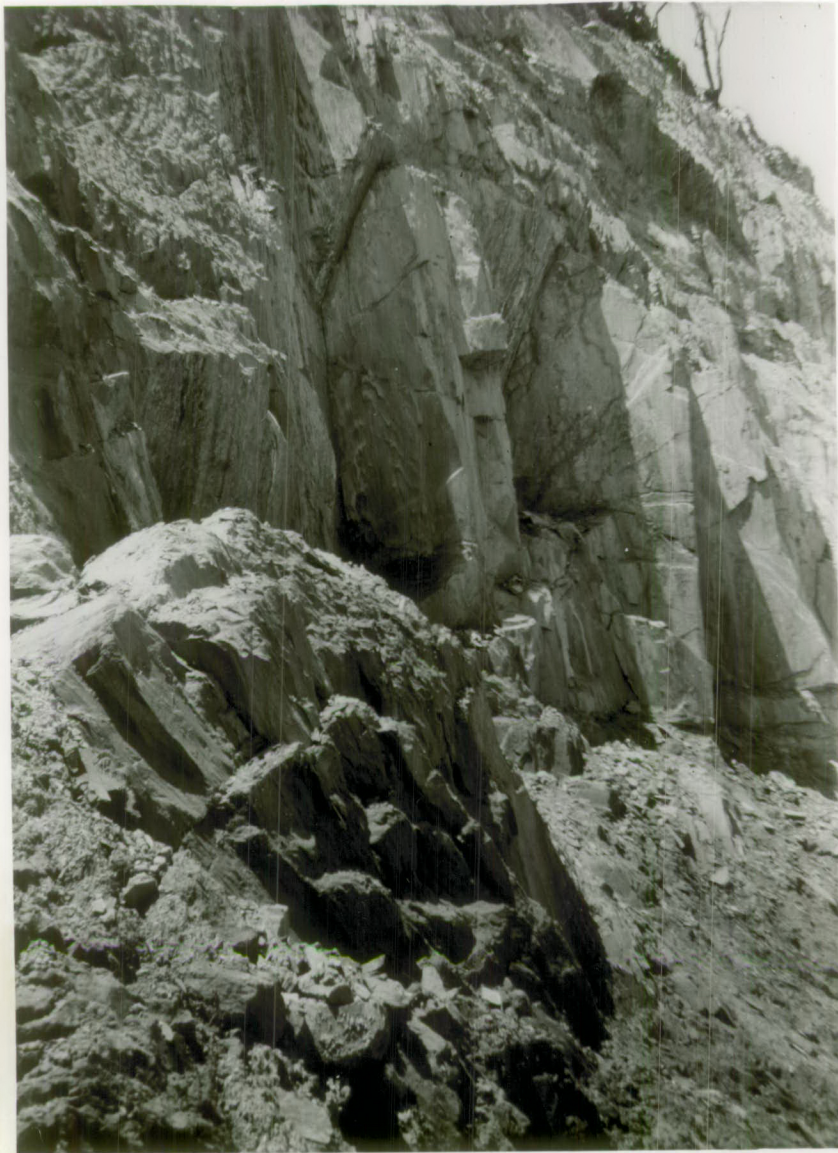
PLATE 6.

Section of northern face showing overhangs and
unstable sections.

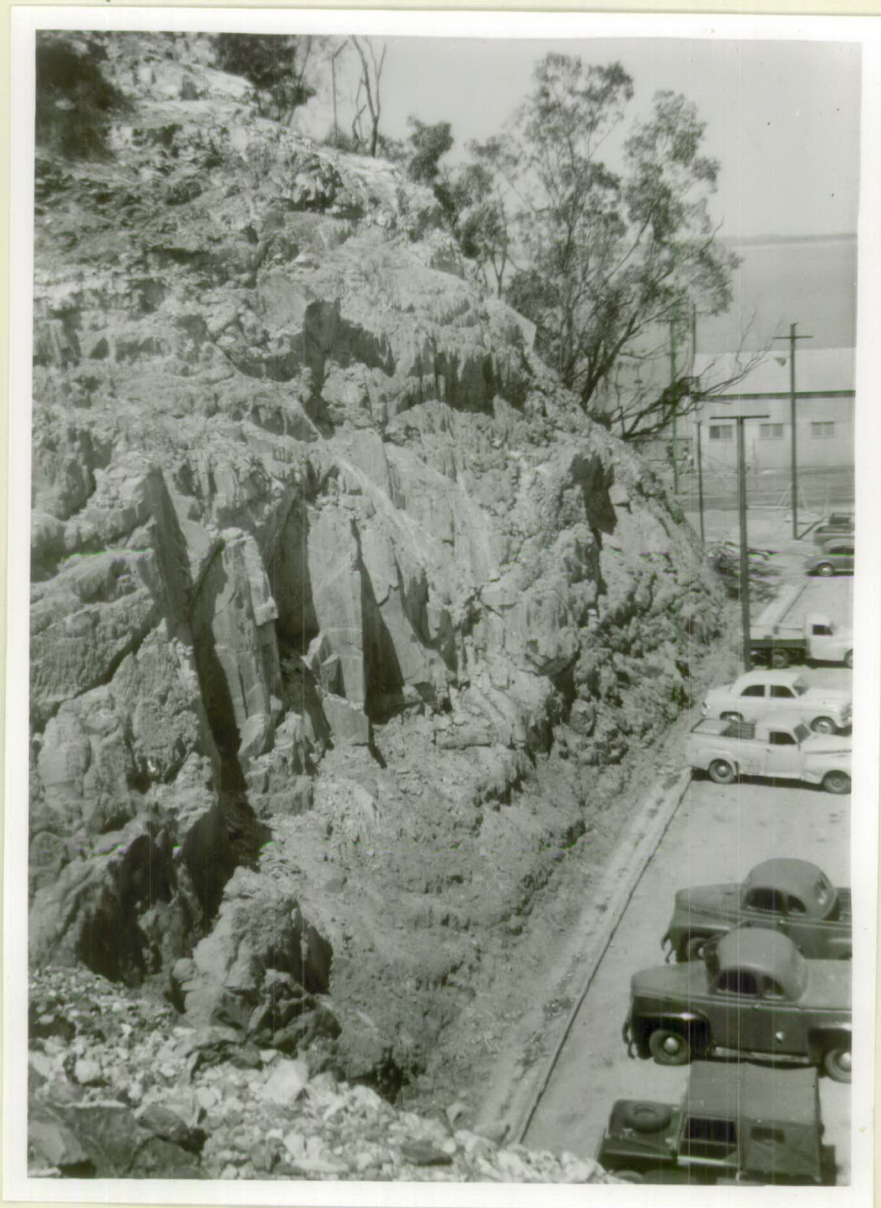
PLATE 7.

Showing relationship of parked vehicles to dangerous section. An open inclined joint plane is visible centre left.

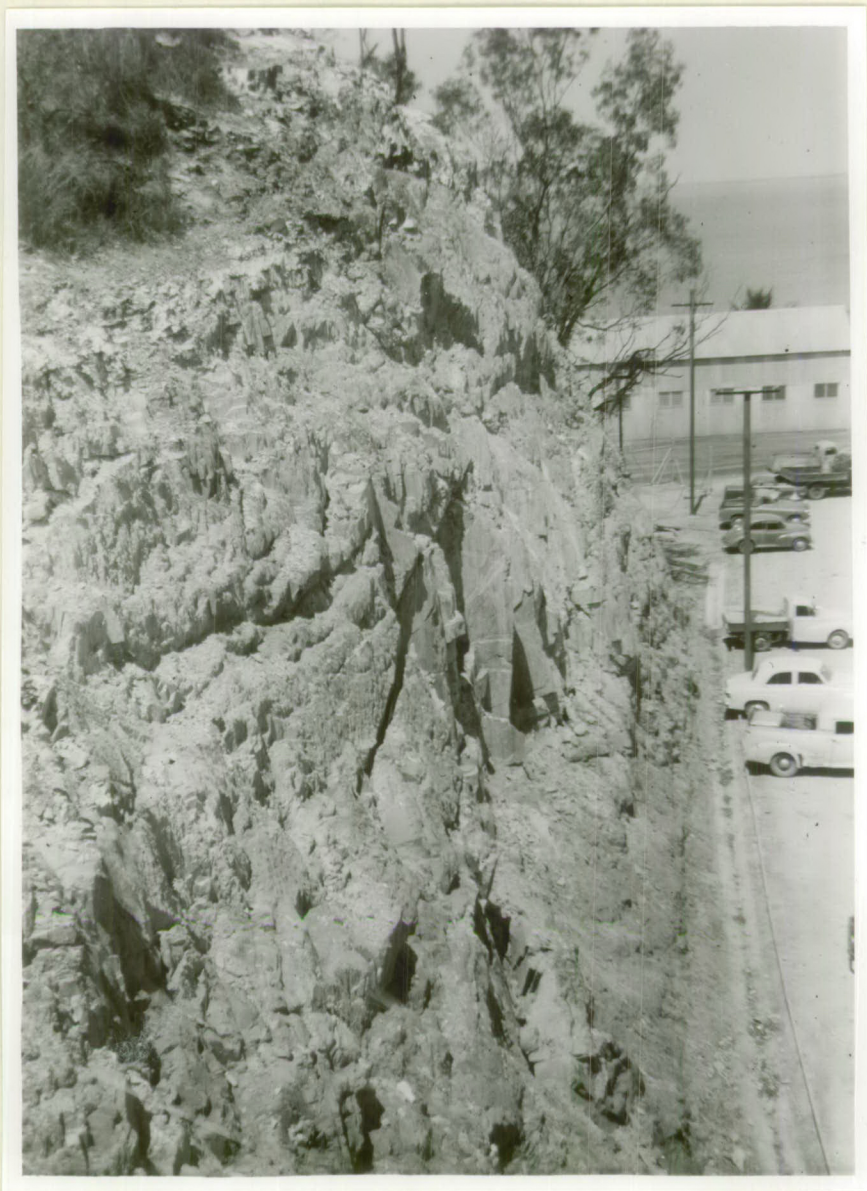
PLATE 8.

General view of north face showing more detail of unstable areas.

The shattering effect of any explosion would cause further opening of joint planes so it is recommended that no blasting be used to reduce the slopes.

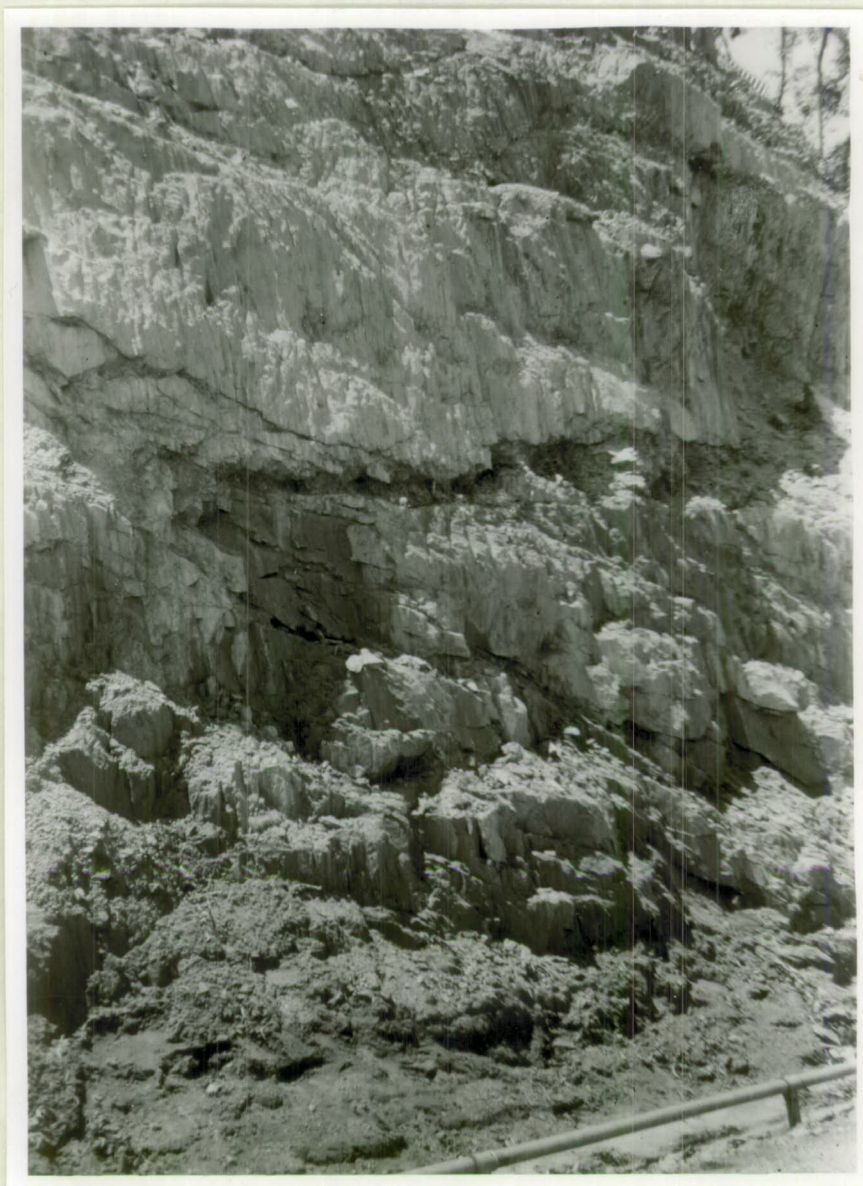
PLATE 9.

North face showing clay breccia filled fault
plane in centre of photograph.

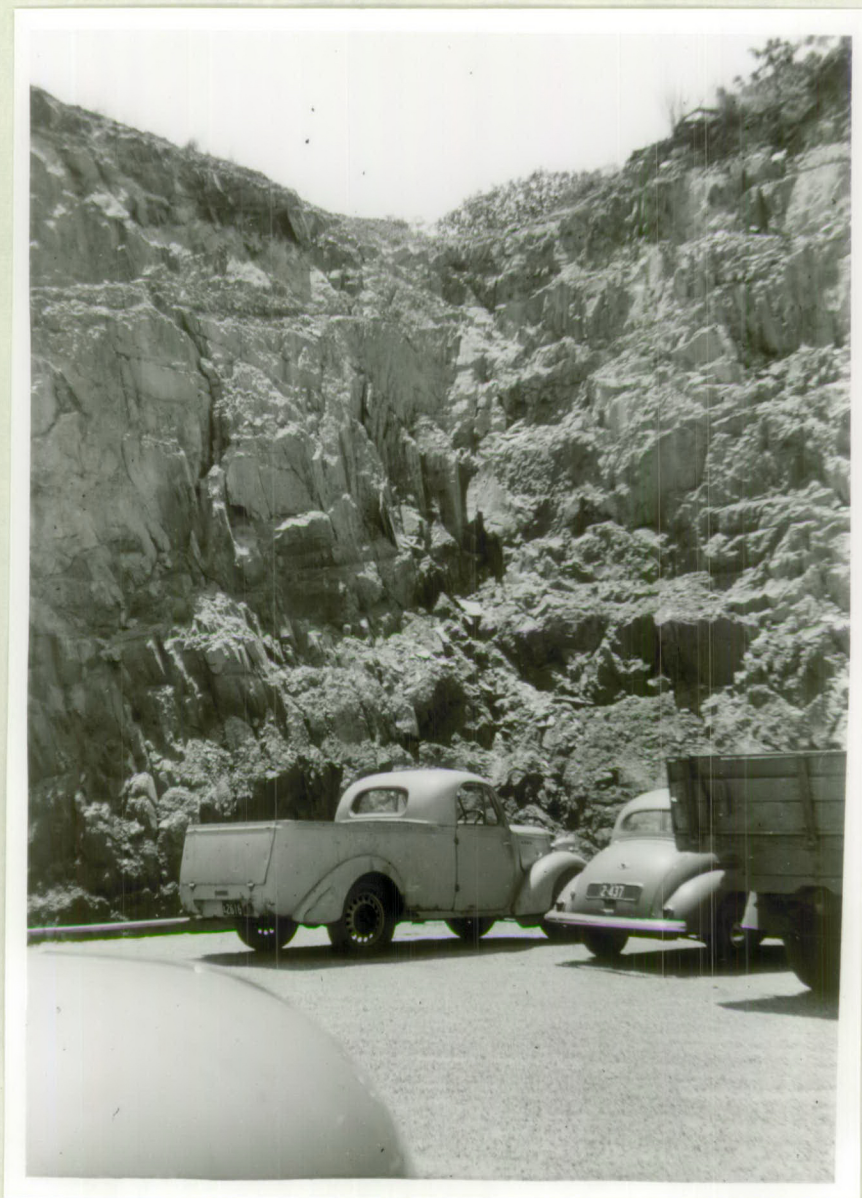
PLATE 10.

Junction of northern and western faces showing
dip of beds and open bedding planes.
