DEPARTMENT OF NATIONAL DEVELOPMENT
BUREAU OF MINERAL RESOURCES
GEOLOGY AND GEOPHYSICS

ROCK FALLS AT CASCADE JETTY, NORFOLK ISLAND.

L.C. NOAKES.

Records 1957/92

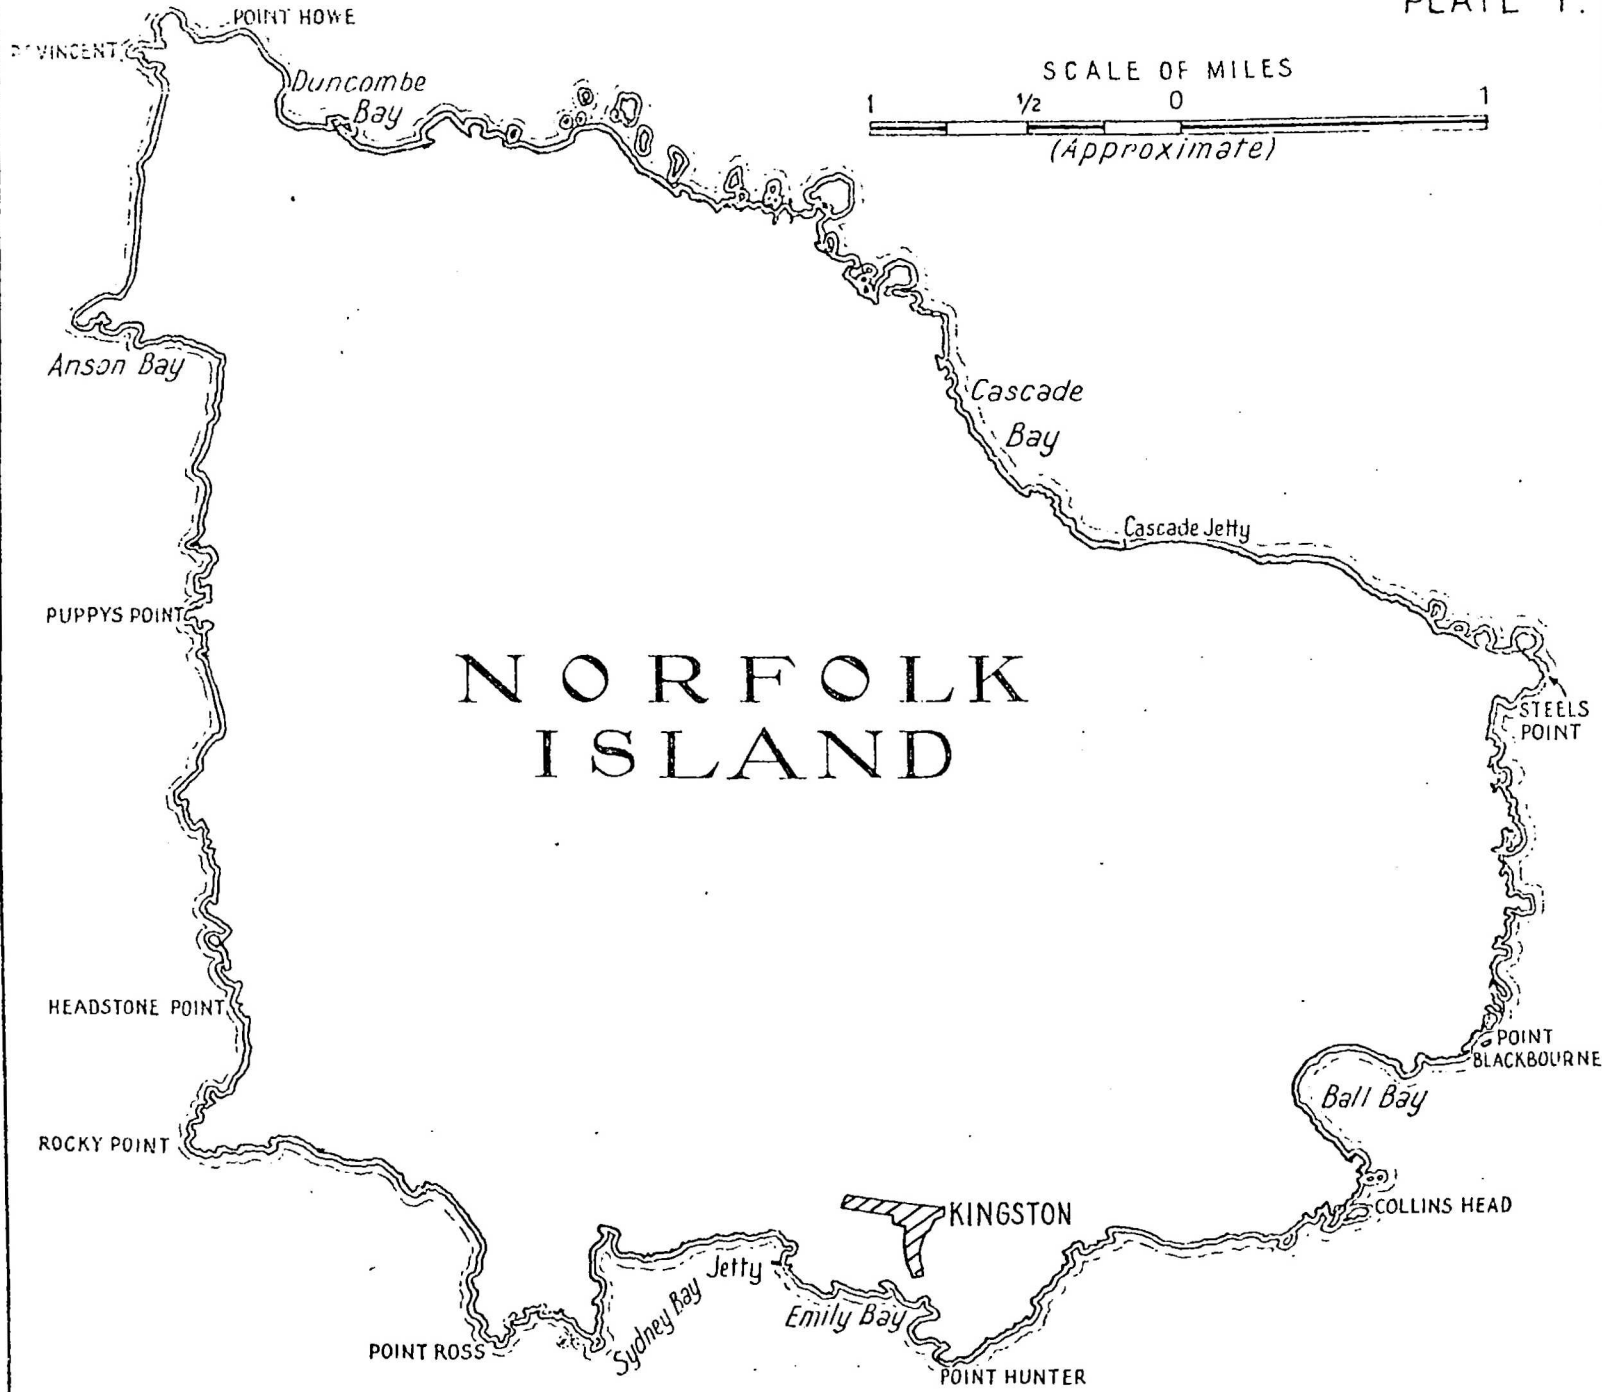
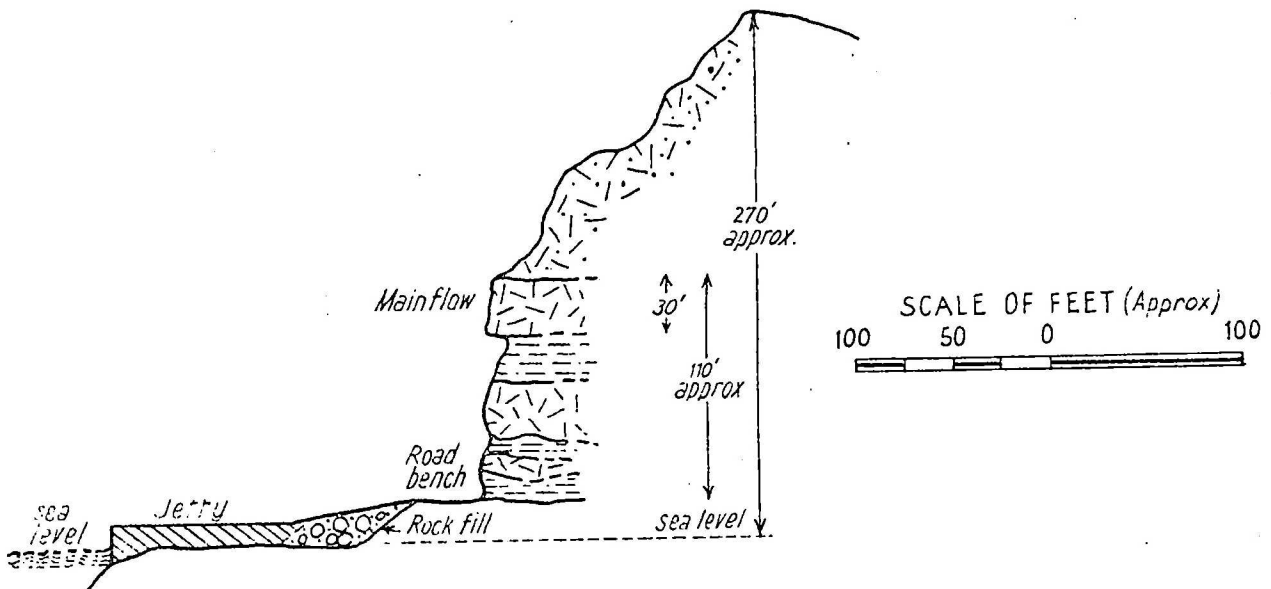
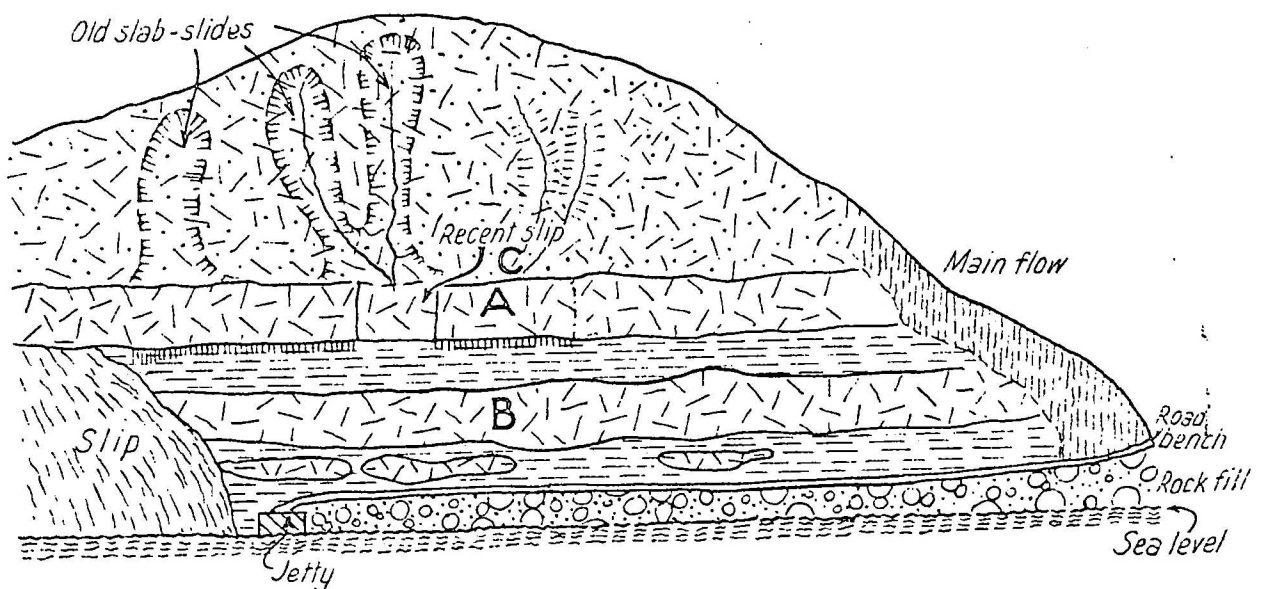
SKETCH SECTIONS CLIFF AT CASCADE JETTY NORFOLK ISLAND

The cliff is composed of interbedded basaltic flows and tuffs and shows evidence of numbers of slab-slides and rock falls in the past. A recent rock fall came from an undercut section of a 30' basalt flow and was apparently triggered by water penetration during heavy rain.

Sketch sections of the cliff and of the volcanic succession are shown in Plate 2; more accurate illustrations will be available when coloured photographs have been developed. The cliff is divided into two sections. The lower part, extending for some 110' above the road, is near-vertical and consists of a succession of weathered tuffs and comparatively unweathered basalt flows; the top of the vertical section consists of a 30' flow, which for convenience will be termed the main flow; it overlies a tuff bed and, in places, is undercut to an average of 2 - 3 feet.

The upper section of the cliff, some 140' in height was not accessible; it has an average slope of 45° and consists of weathered and leached rock which may include tuff as well as basalt. Dark-coloured, less weathered outcrops are probably basalt.
