1958/5.

DIAMOND DRILLING AT SITE OF WEETANGERA RESERVOIR

D.E. Gardner.

DIAMOND DRILLING AT RESERVOIR SITE, WEETANCERA.
LOGS OF DRILL HOLES.

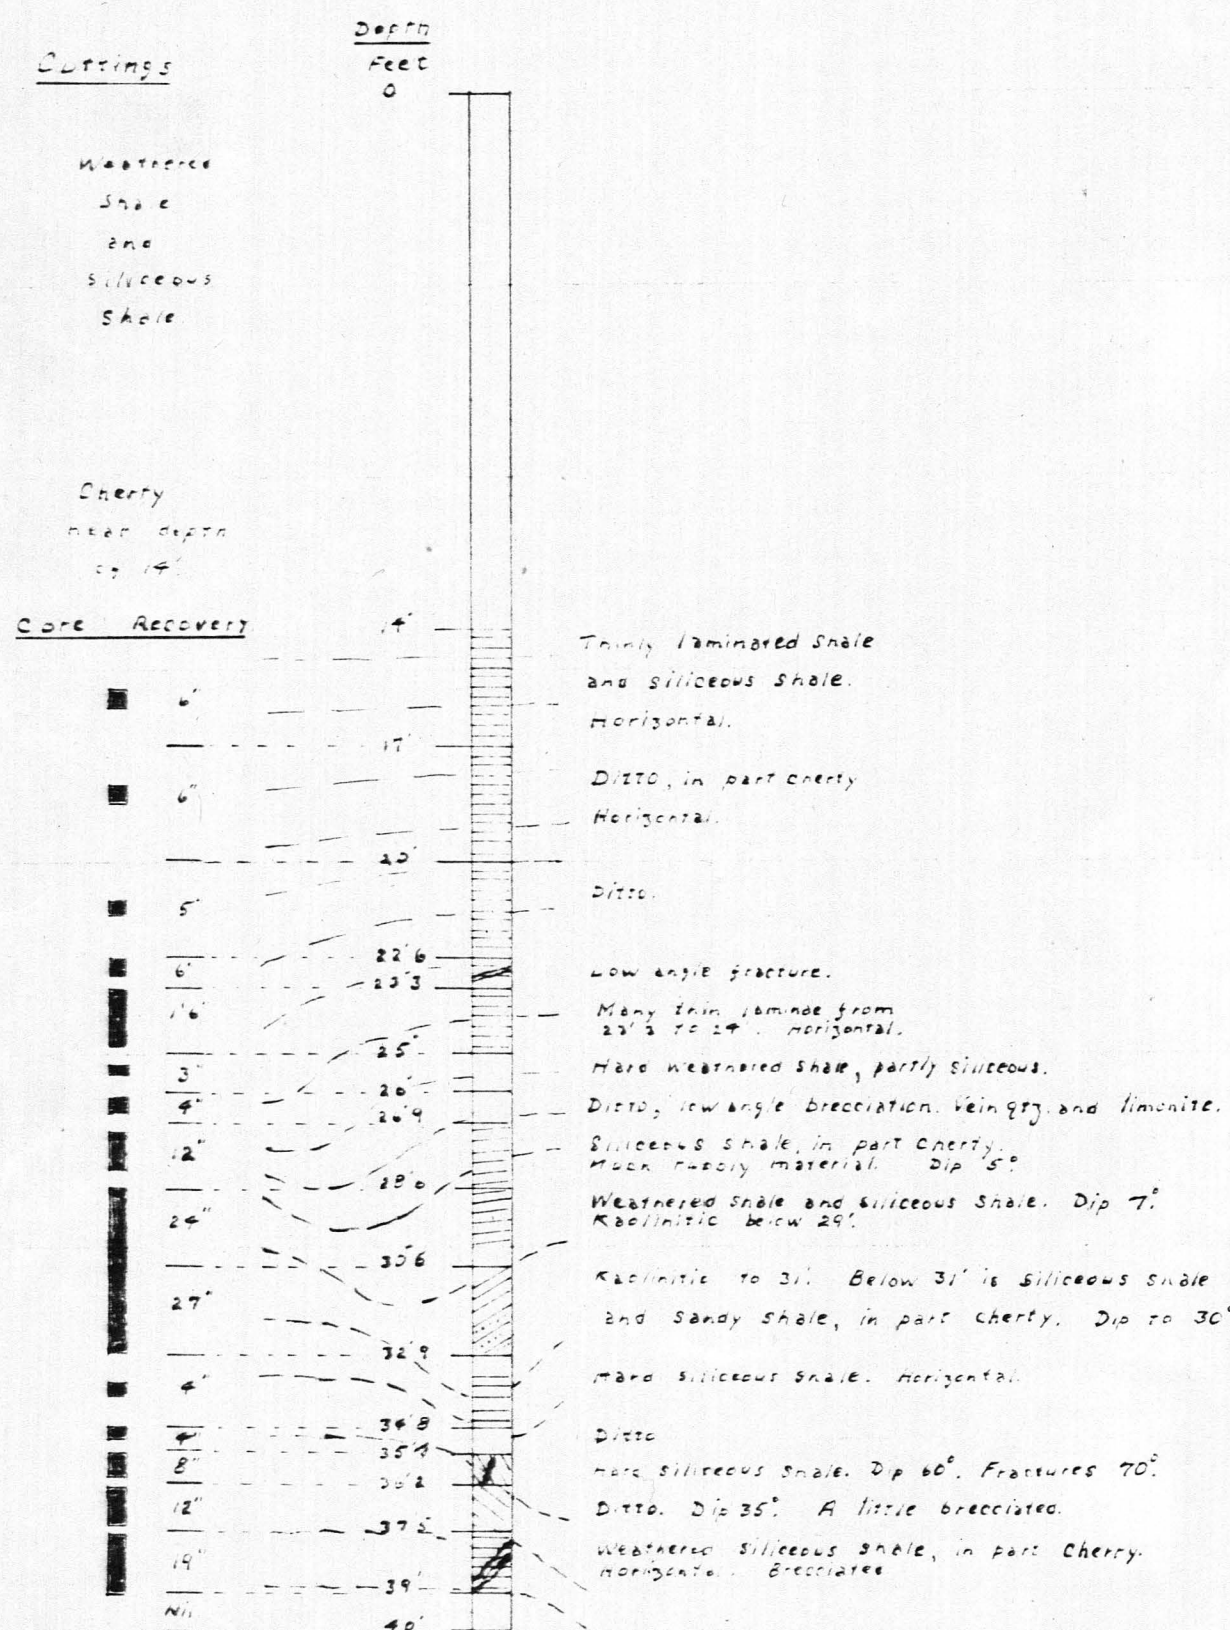
HOLE N° 1

The drill holes were sited by the Works Department for construction purposes and are not suitably placed to elucidate the structure of the area. The thin beds appear to be folded into a sharp syncline puckered by minor (? drag) folds. The axis of folding is approximately parallel to the crest of the ridge. A possible interpretation of the dips seen in core from holes Nos. 1 and 4 is given in the drawings at the end of this report.

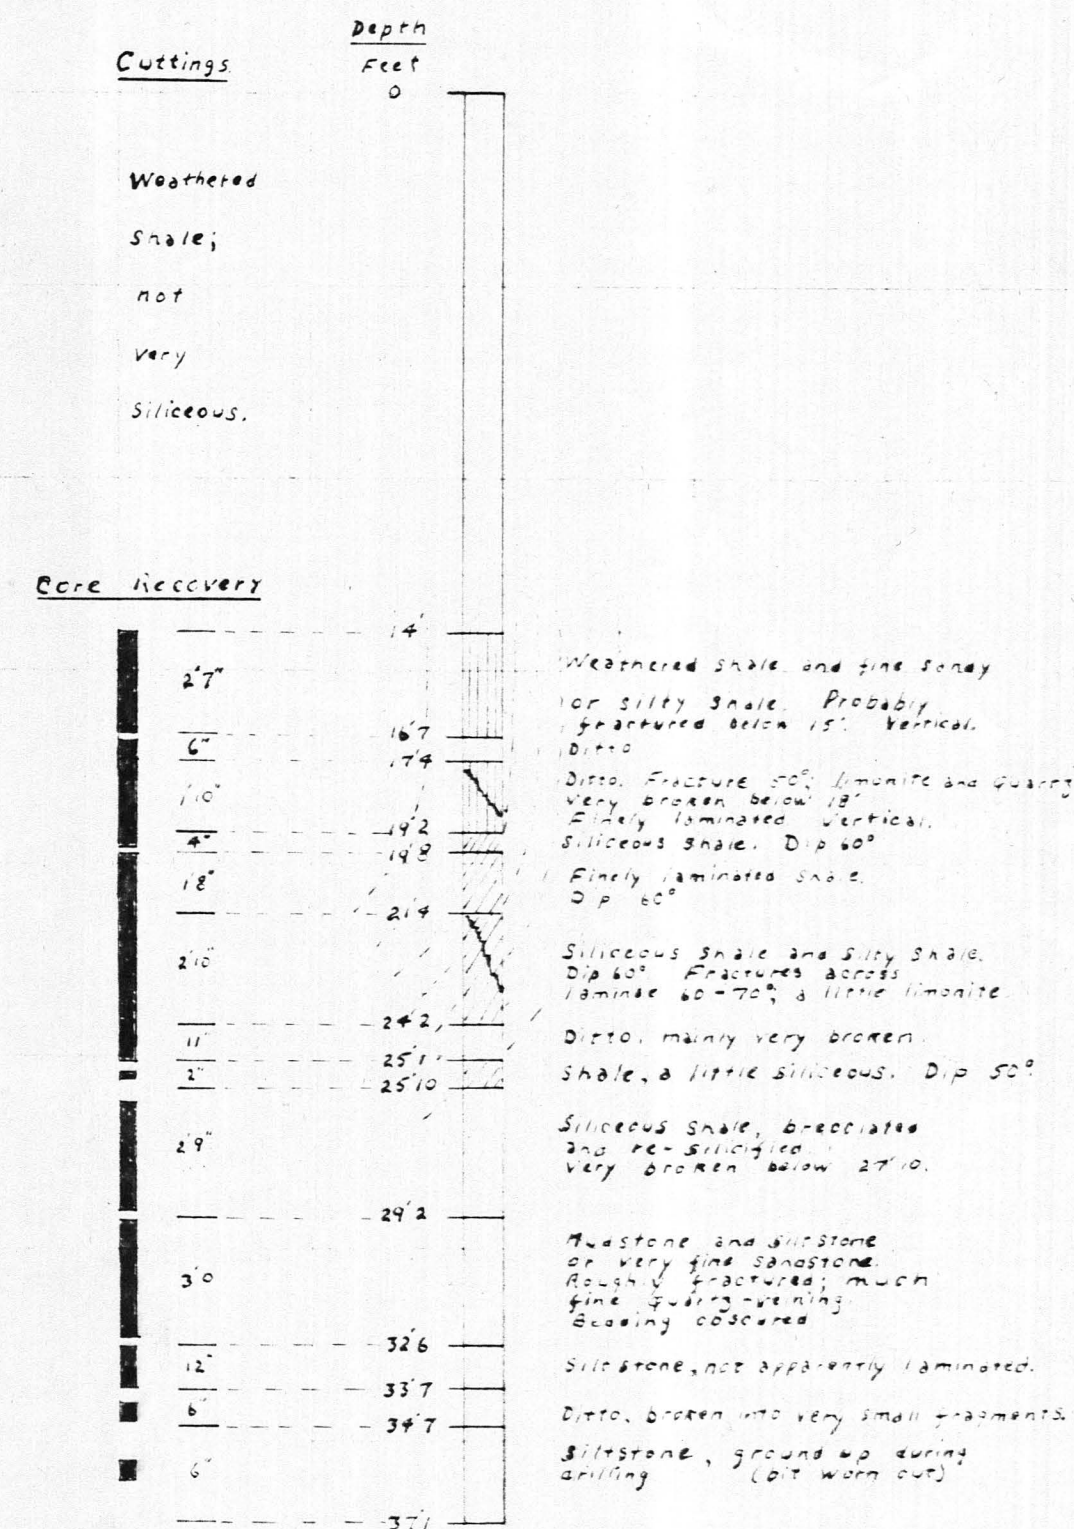
HOLE N° 4

While drilling was in progress the bit frequently became blocked. Core recovery was very poor except in hole No. 4 (see drawing that accompanies this report). In an effort to improve core recovery, core was lifted every two feet. It is unfortunate that the split-inner-tube H.M. core barrel, available at the Works Department could not be used with the contractor's equipment, as this barrel would have given good core recovery.
