DEPARTMENT OF NATIONAL DEVELOPMENT.  
BUREAU OF MINERAL RESOURCES  
GEOLOGY AND GEOPHYSICS.

Records 1958/11

THE DRAINAGE PROBLEM AT TORRES STREET, RED HILL.

L.C. Noakes

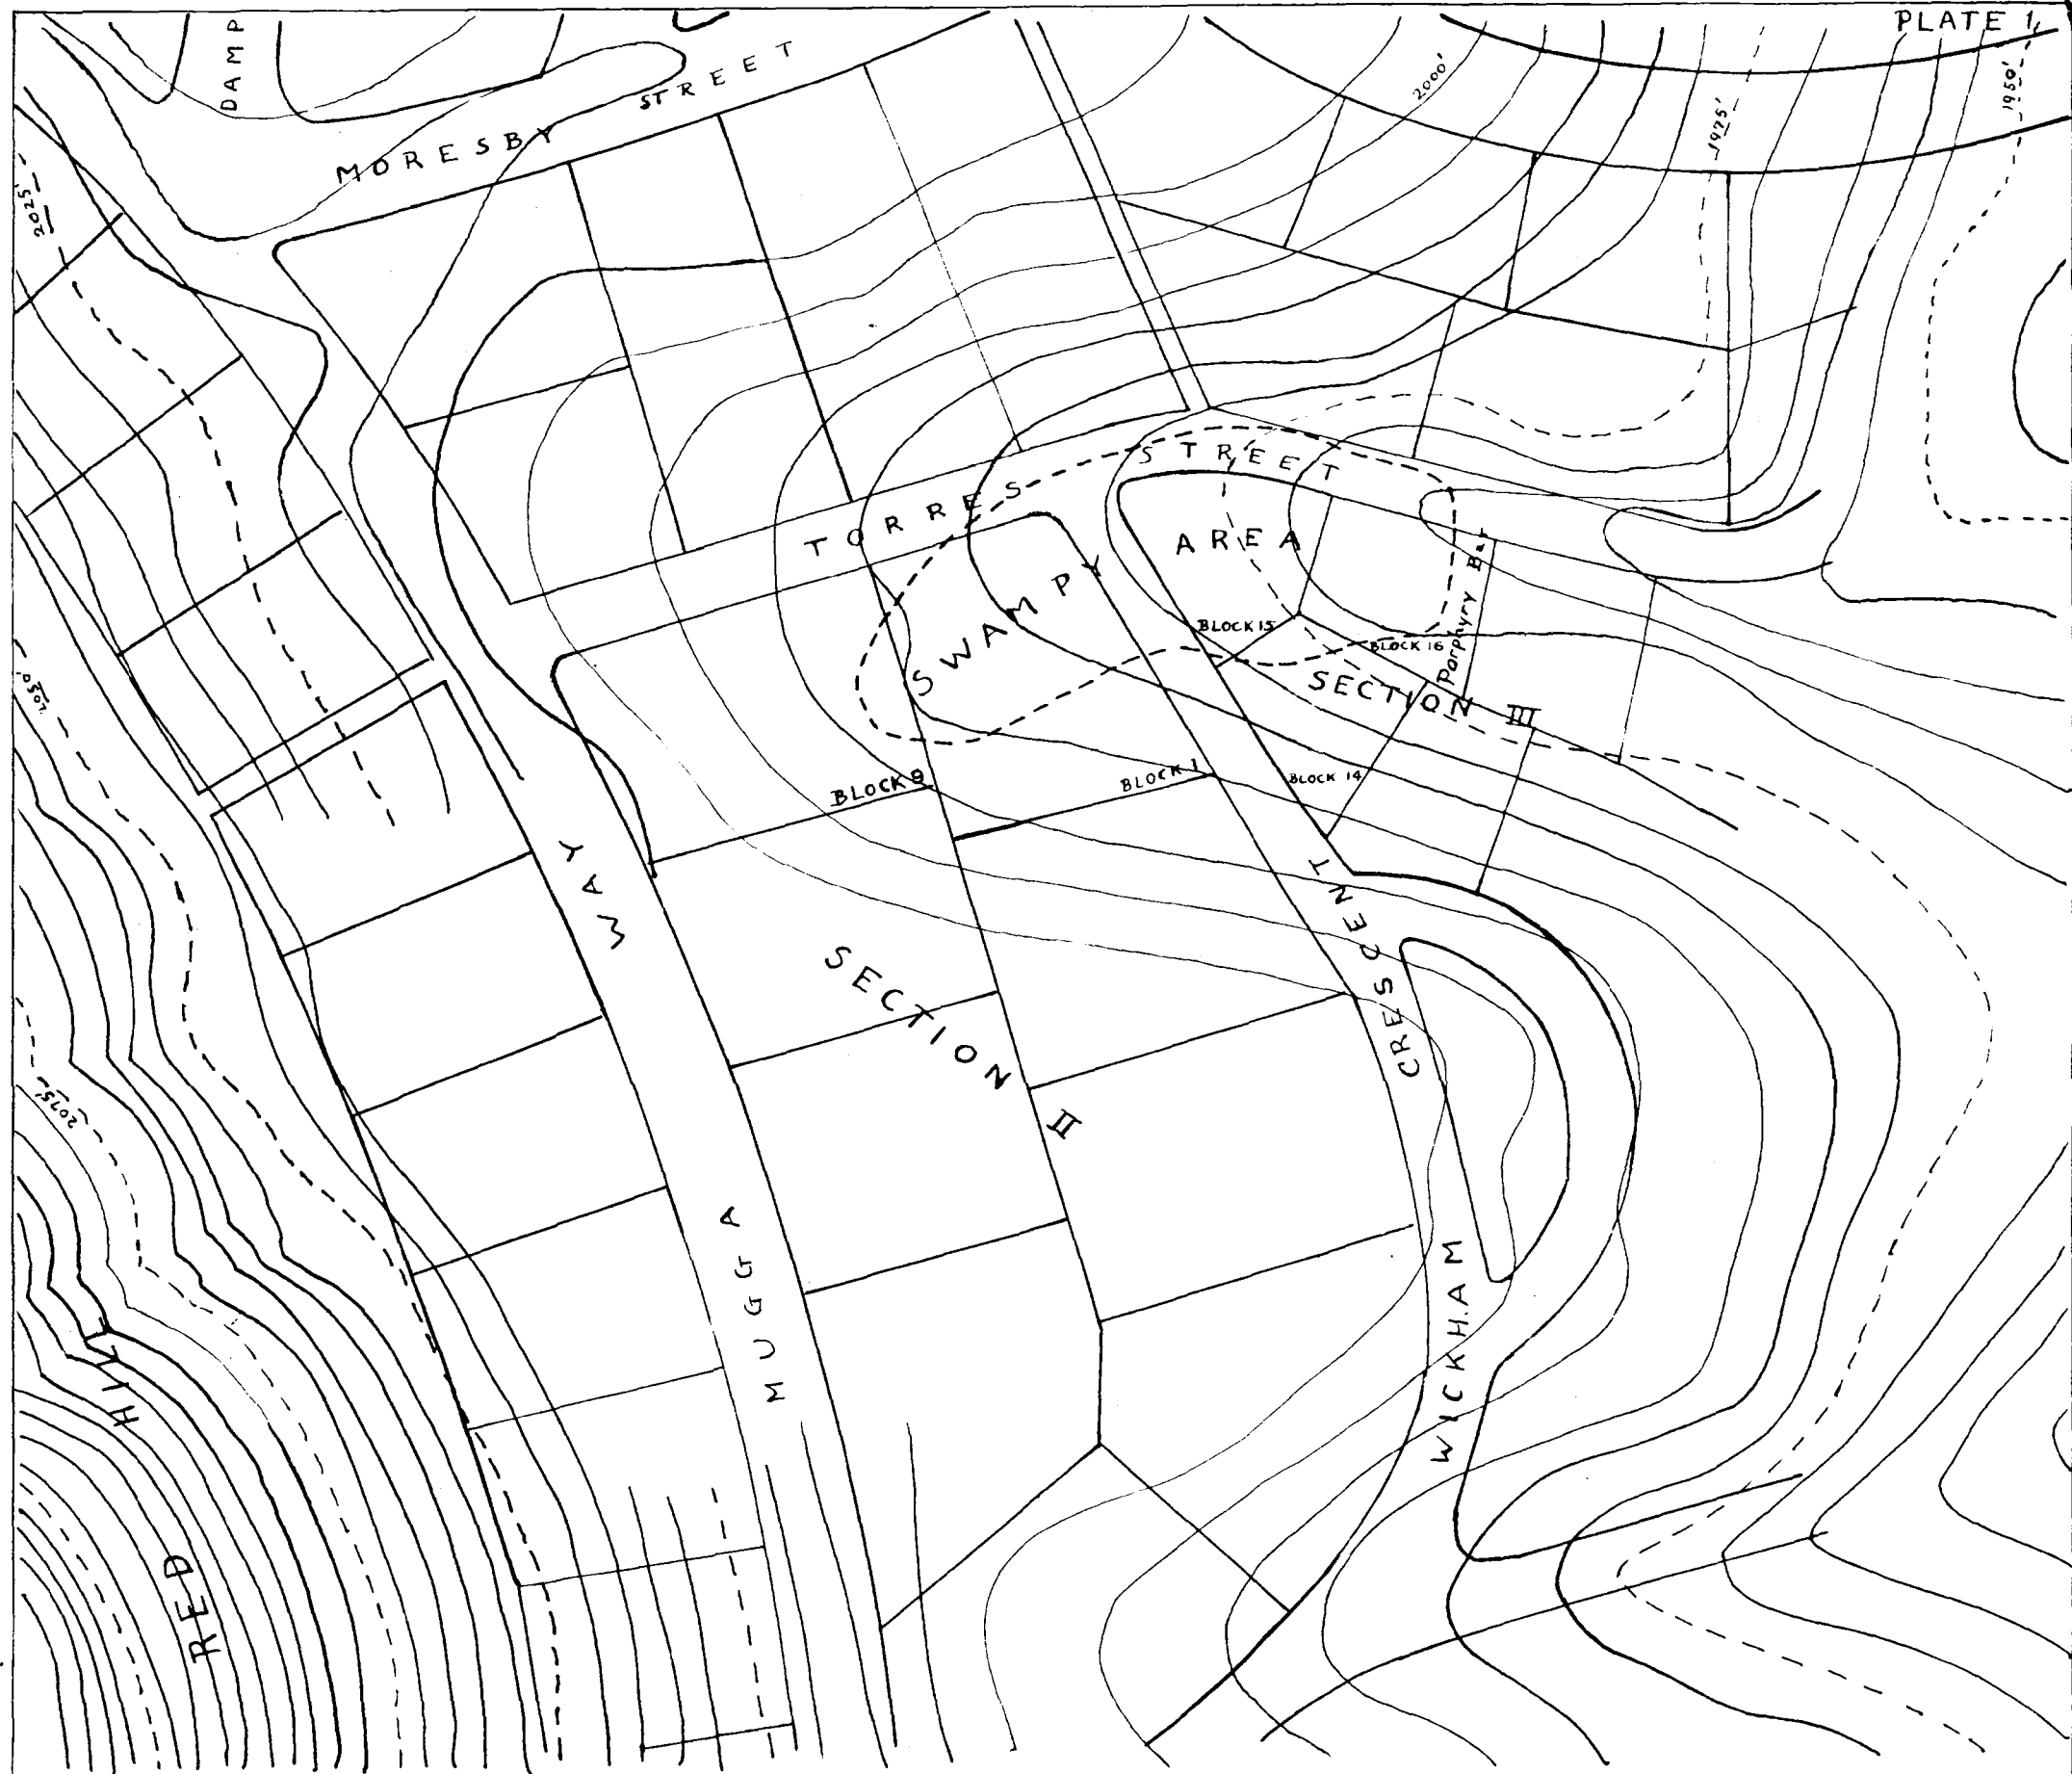
DEPRESSION and SWAMPY AREA,  
TORRES ST., RED HILL.

Blocks 15 and 16 are situated in a shallow depression which heads on the slopes of Red Hill and falls eastward toward Manuka (see Plate 1). The underlying rock in the depression and on the slopes shedding into it is a quartz-porphyry which weathers readily, producing scattered low outcrops and dominantly sandy soils. Blocks 15 and 16, in the depression, are covered with a deep mantle of soil except at the eastern boundary of block 16 where boulders and outcrops of porphyry are evidence of a narrow meridional bar.

The importance of this bar was emphasised by N.H. Fisher in 1953; the rock bar has apparently a lower permeability than the deeply weathered porphyry up-gradient from it, under blocks 15 and 16, and tends to act as a dam against sub-surface drainage eastwards.

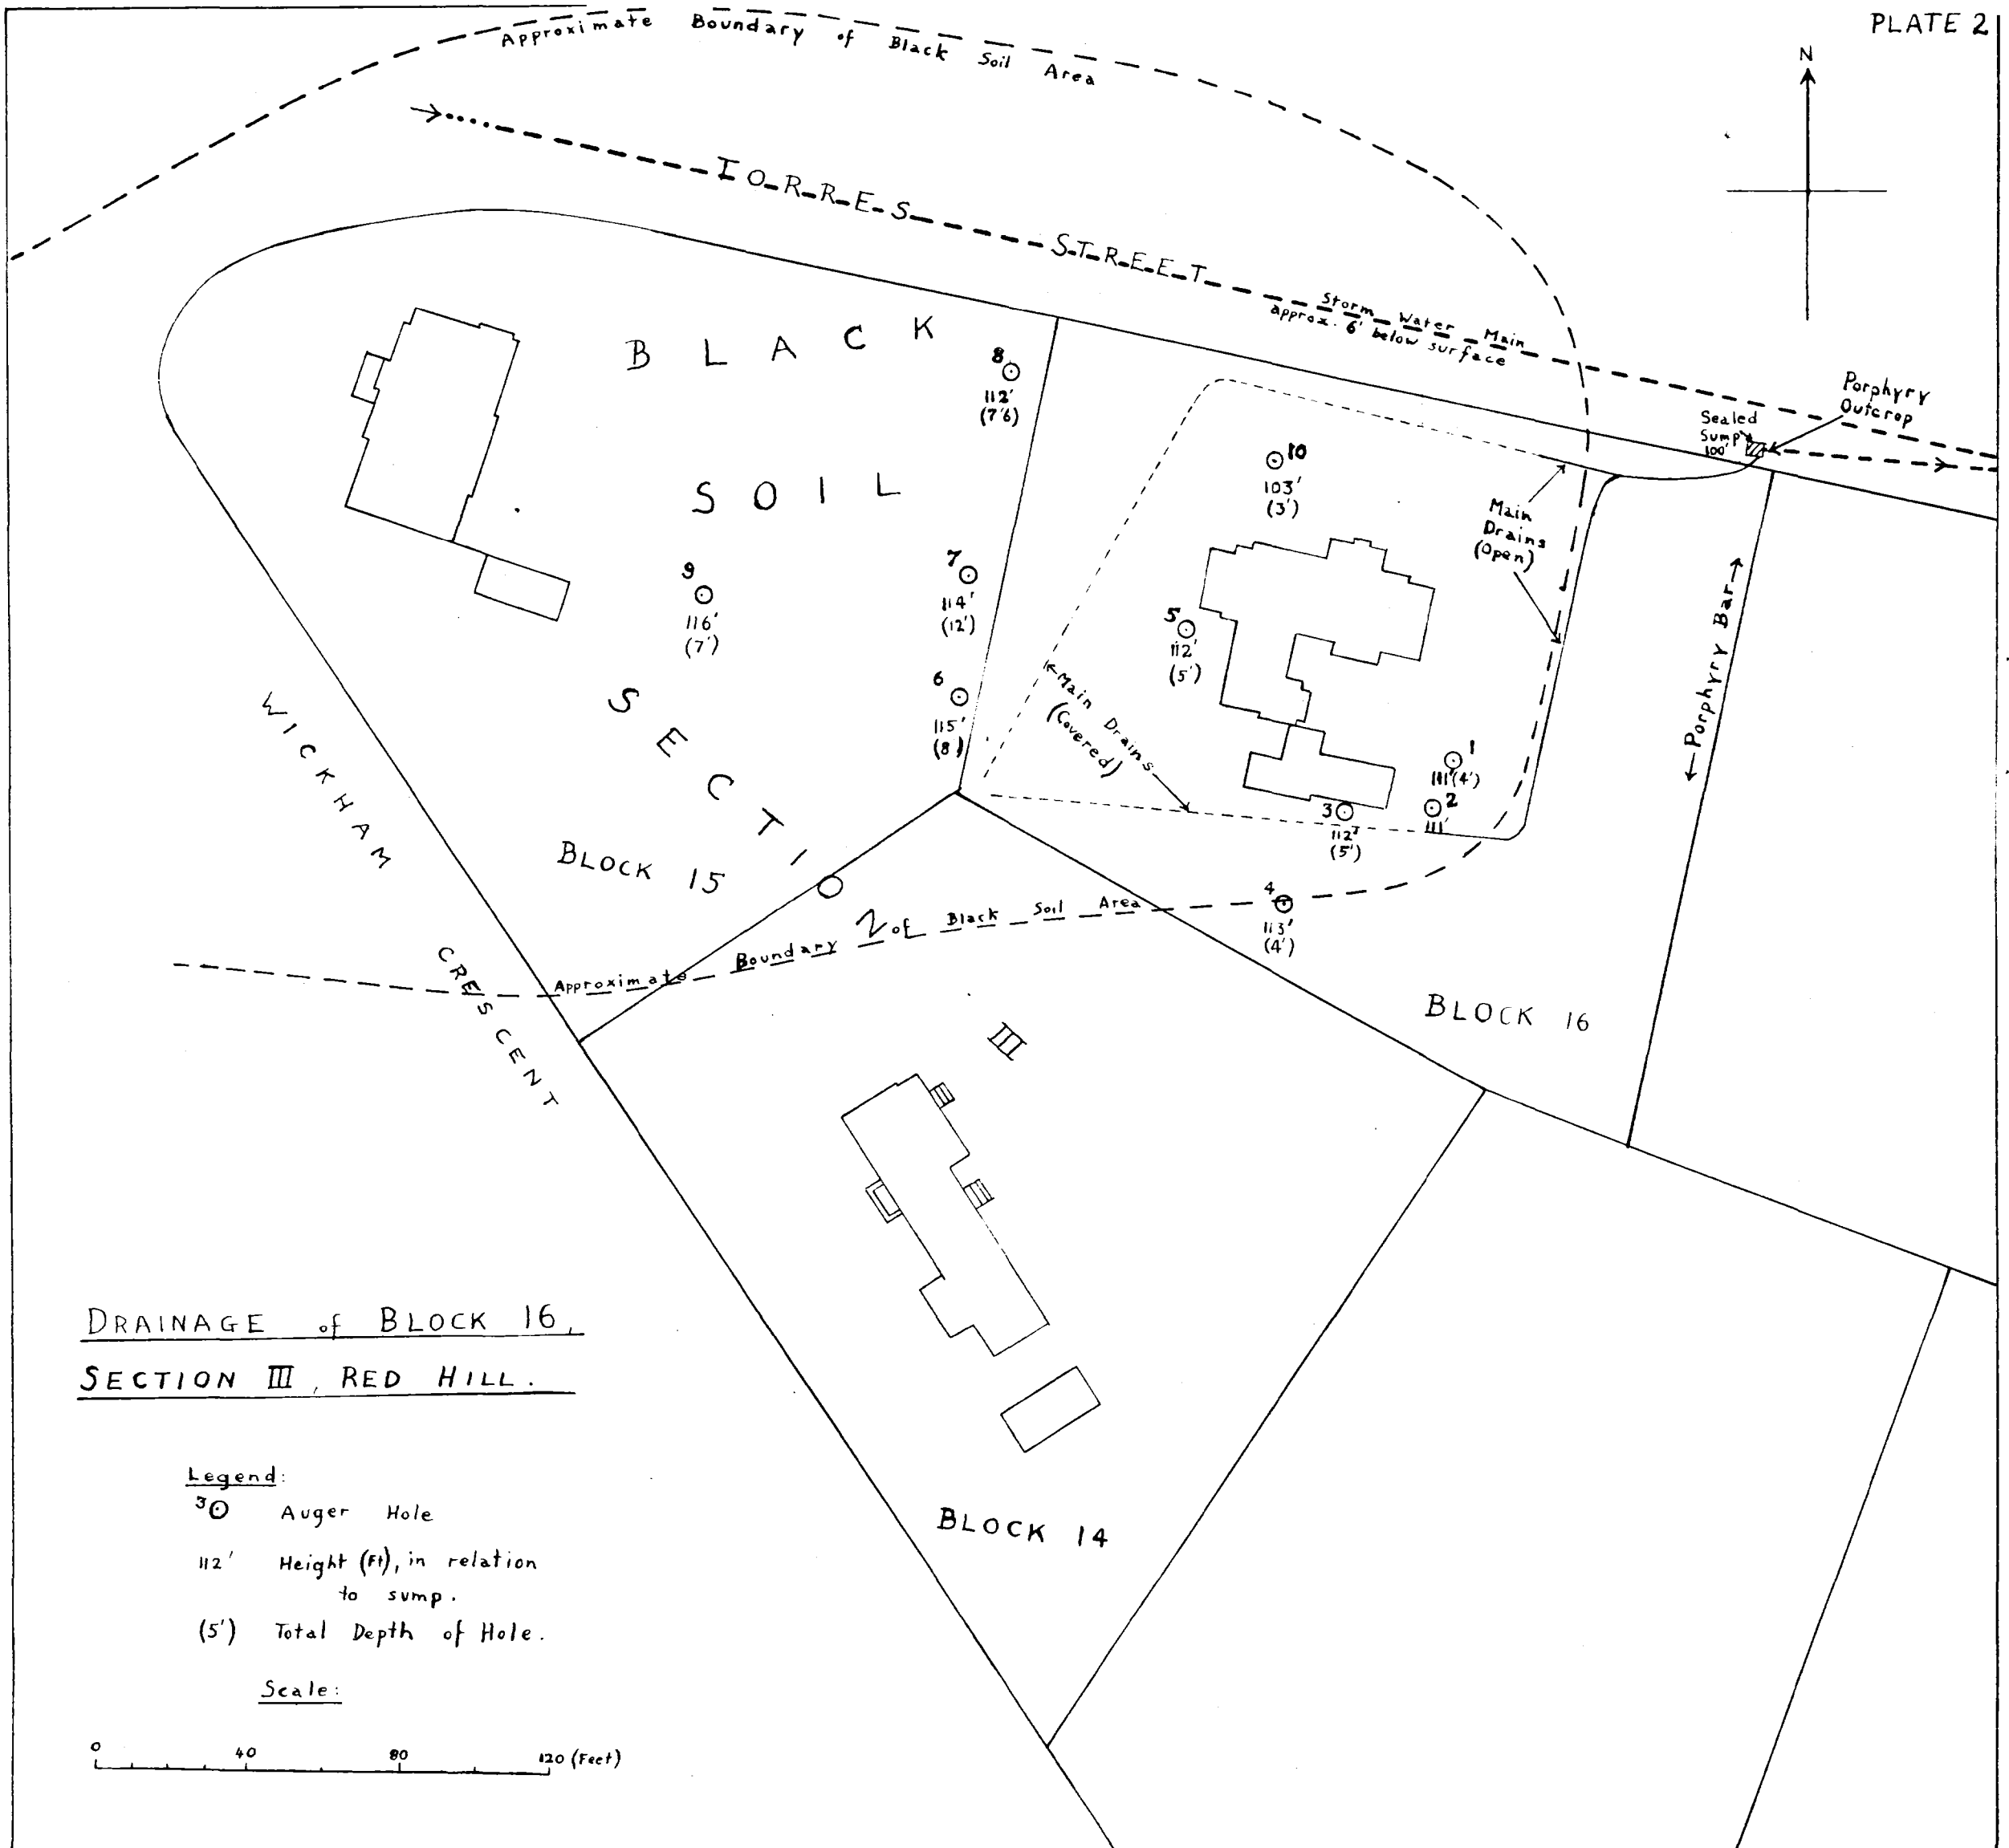
Initially it was thought that this more sandy layer had sufficient permeability to allow adequate drainage but bailing and recovery tests particularly in holes Nos. 6, 7, 8 and 9 (see Plate 2) indicated that the permeability of the material was in fact, low. This was eventually confirmed by Dr.Talsma

(C.S.I.R.O. Griffith) and Mr. Chapman (Land Research, C.S.I.R.O.) in separate permeability measurements. In particular, Mr. Chapman, using the fluorescence dispersion technique measured the movement down-gradient from hole 7 to hole 5 and calculated an apparent velocity of about 8" per day. Dr. Talsma found evidence of strong vertical pressure in piezometers sunk to a depth of 6 feet.

Prior to 1953 there was no drainage system designed to counter water logging in this area because the problem was not apparent. Remedial measures in block 16 suggested in 1953 and carried out in 1954, were put in by the leaseholder but the Department of Works provided a drain to the north-east corner of the block on the lowest possible elevation; however, the drains in block 16 could not be dug to the maximum <sup>depth</sup> set by the elevation of the sump in the north-east corner because a rib of porphyry immediately west of the sump, and 3.5' higher, proved too hard for manual excavation. The system was designed to drain weathered porphyry beneath the surface clay soil and the main drains shown on plate 2 exposed an average of some 2' of this layer.

1. A bore should be sunk to fresh rock near auger hole No.7 on the boundary between blocks 15 and 16 (see plate 2). This should be cored if possible and cased. The bore is required for:
