PRELIMINARY GEOLOGICAL REPORT ON YARRALUMLA WEIR SITE

WITH RECOMMENDATIONS FOR TESTING

D. E. Gardner.

RECORDS 1958/20

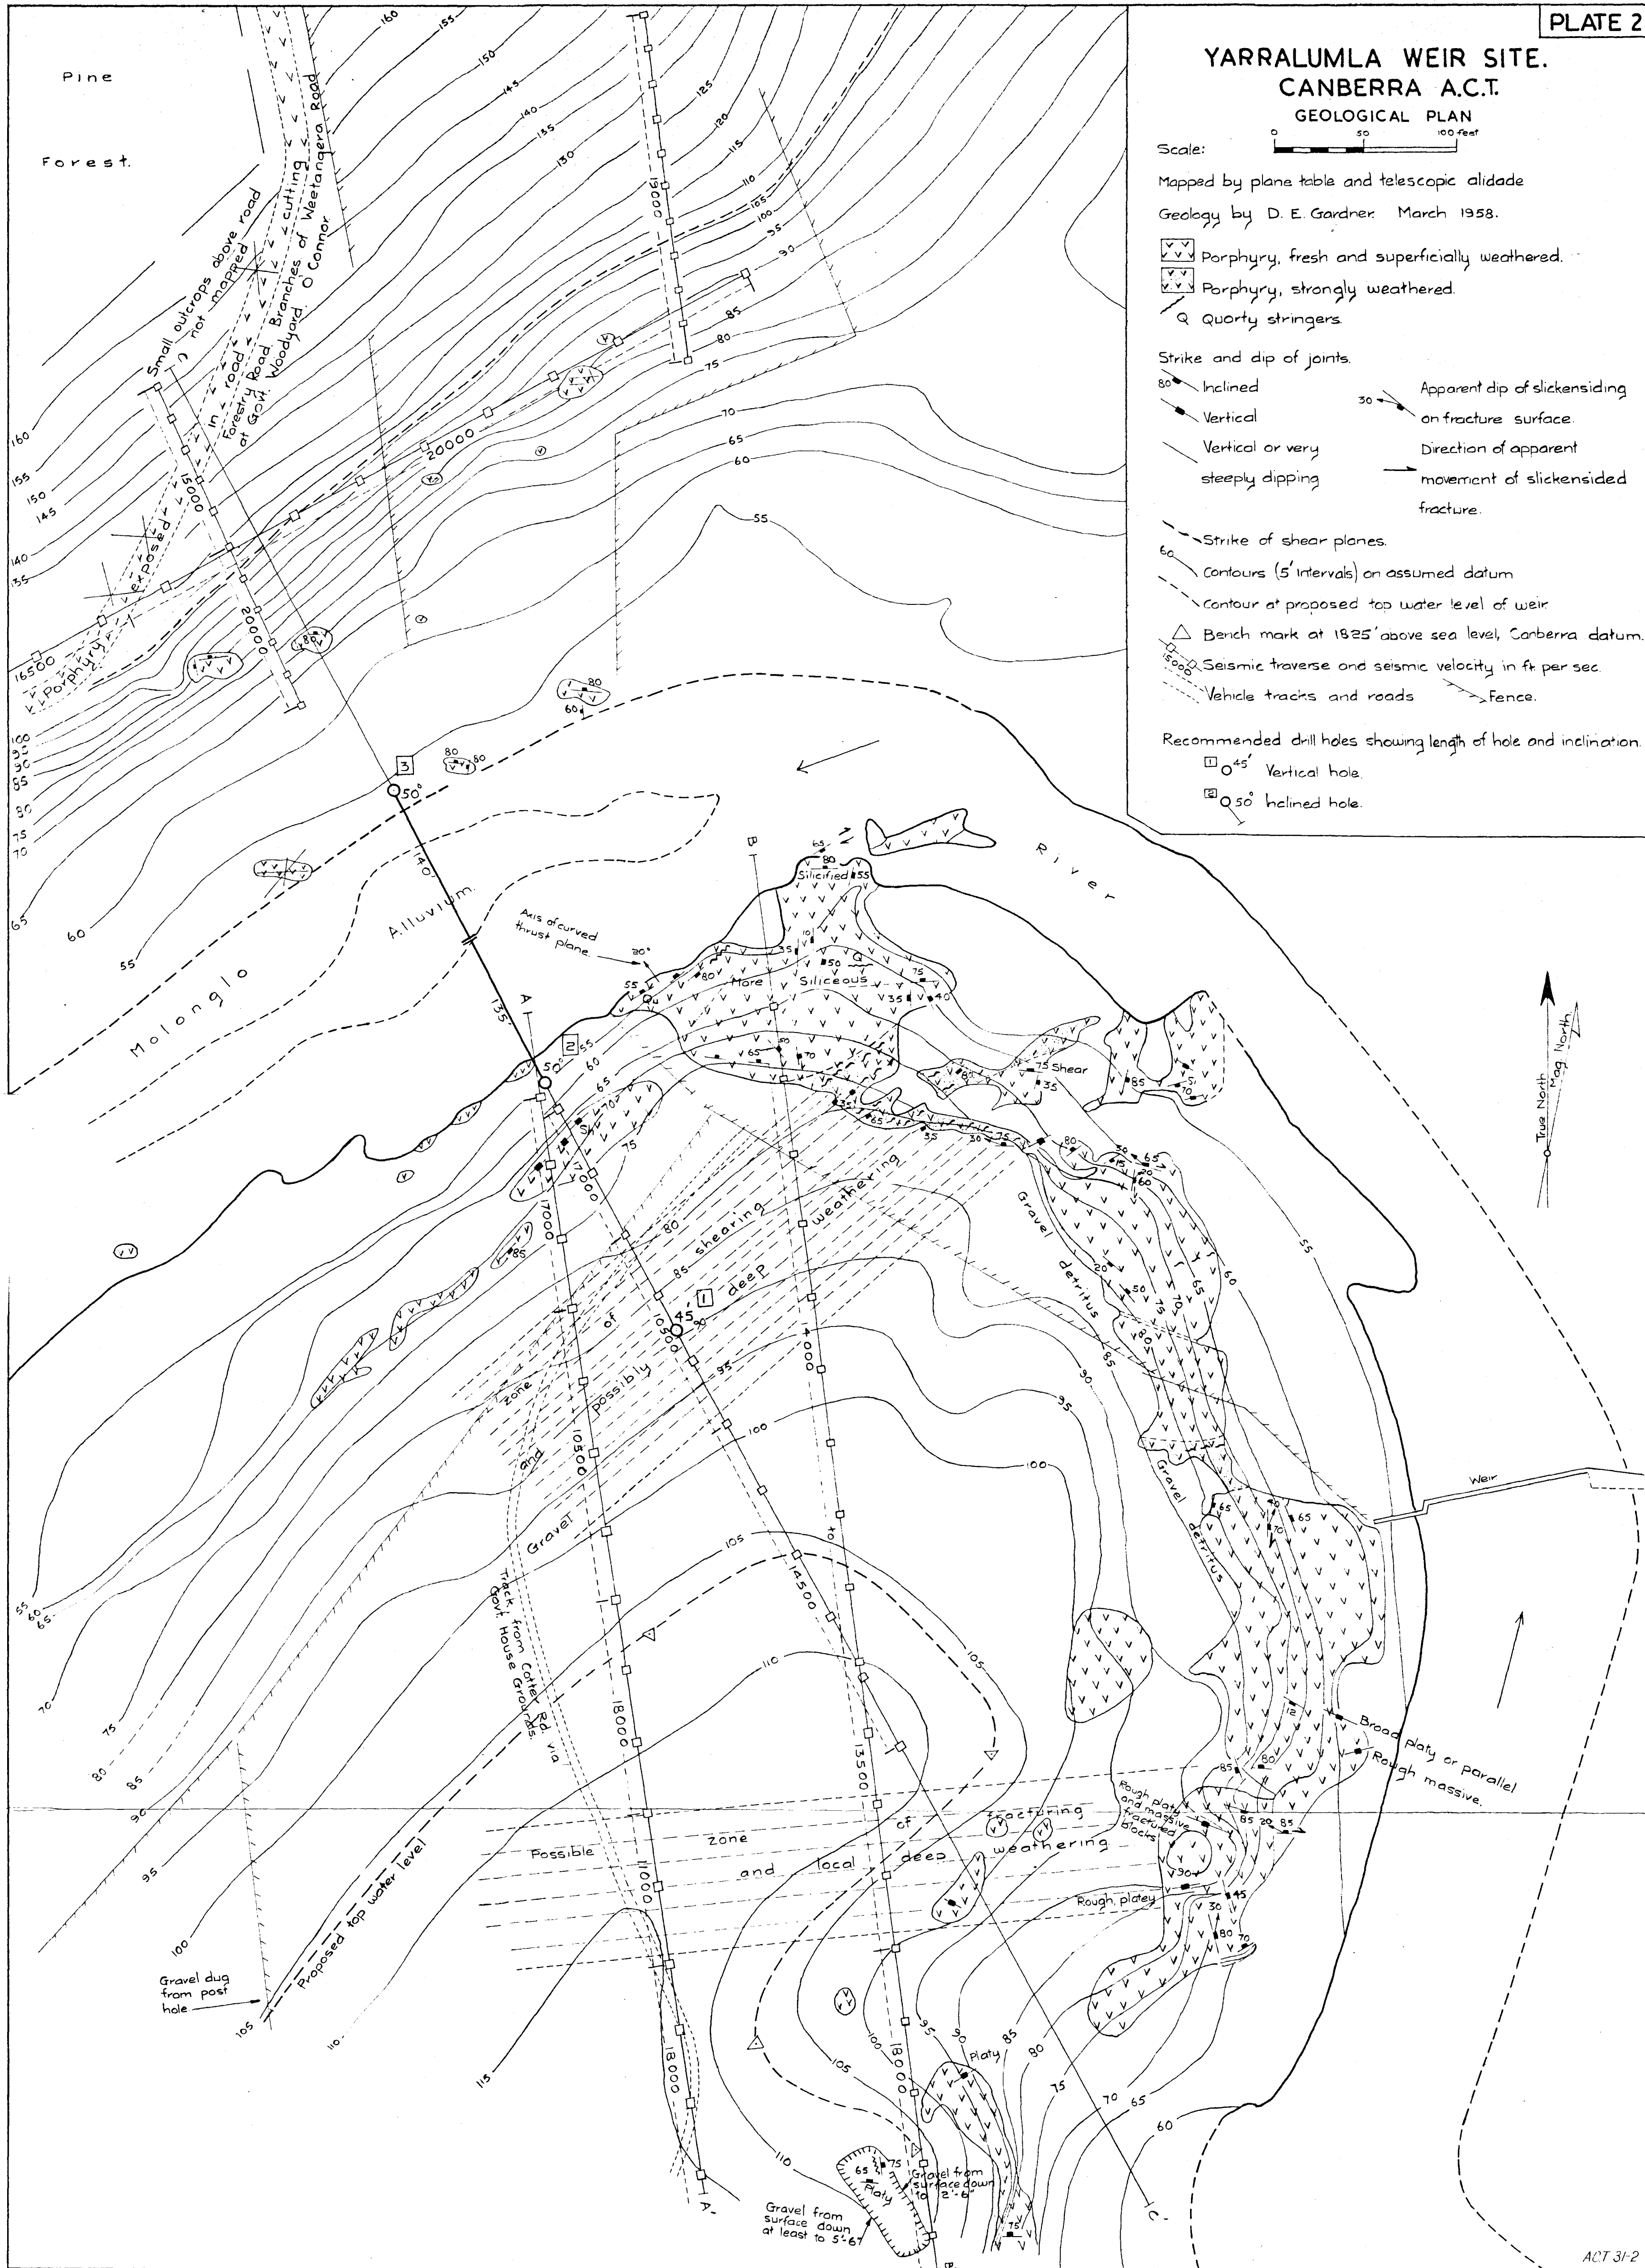
## GEOLOGICAL PLAN

In the road cutting shown in the north-western part of Plate 2 fresh porphyry is exposed in rounded masses a few feet across and in angular masses bounded by joint surfaces. It is surrounded by partly-weathered porphyry. The seismic investigation of the area revealed relatively low velocities from the surface down to about 20 to 40 feet, presumably the depth to unweathered porphyry, (see Plate 3 of this report). Hence it seems likely that the unweathered outcrops in the area are mainly residuals that are surrounded and underlain by weathered rock.

Immediately east of the resistant rock that forms the northern end of the spur is a zone of slight shearing 100 ft. wide. The porphyry here is noticeably more weathered in the outcrop than it is in the adjacent areas. In addition, this porphyry appears to be slightly more basic. The relatively low velocity sections encountered in traverses A and C of the seismic survey lie almost exactly on the projection of the sheared zone along its strike; suggesting that the low velocities are a result of the shearing and possibly of partial weathering. The velocity along traverse B where intersected by the shear zone, though lower than the usual velocities in massive porphyry, is appreciably higher than in the other two traverses. This does not invalidate the supposition that the shear zone continues south-westwards beyond the traverse lines. Where crossed by traverse B, the shearing could be restricted to movement in a relatively narrow zone.

Near the south-eastern end of the outcrop the porphyry is cut by easterly-trending fractures of which some are vertical and others dip steeply both to north and to south. No noticeable weathering is associated with this fracturing. The fracturing extends over a width of about 70 feet. Its extension westerly along its strike coincides with the section in traverse B where the seismic velocity decreases from 18,000 to 13,500 and in traverse A with the low velocity of 11,000 f.p.s. Probably the reduction in velocity is due to fracturing.

Some minor very narrow shears that trend approximately westerly were mapped on the eastern side of the spur. In them the porphyry has weathered fairly deeply resulting in steep or vertical breaks in the outcrops.

It is considered that for the purpose of preliminary testing a vertical diamond drill hole should be put down at the locality where the bedrock is apparently weakest, viz., in the section of Traverse C where the seismic velocity is 10,500 f.p.s. The drill hole should penetrate 15 ft. below the top of the unweathered porphyry, that is, assuming that the geophysical estimate of its depth is correct, to about 45 ft. below the surface. Purposes of the hole will be to determine the nature and thickness of the alluvial capping, to core both weathered and fresh porphyry, to carry out water pressure testing in foundation rock, and to check the accuracy of the estimated depth to unweathered bedrock.

Three diamond drill holes are recommended as specified in the following table.

Hole No. Position and bearing are shown on Plate 2.	Attitude of hole.	Length of hole Ft.	Required.
No. 1	Vertical	45'	Nature of alluvial capping and thickness. Core of weathered bedrock and of fresh bedrock. Water pressure testing of possible foundations.
No. 2	Depressed $50^{\circ}$	135'	Continuous coring and water pressure testing.
No. 3		140'

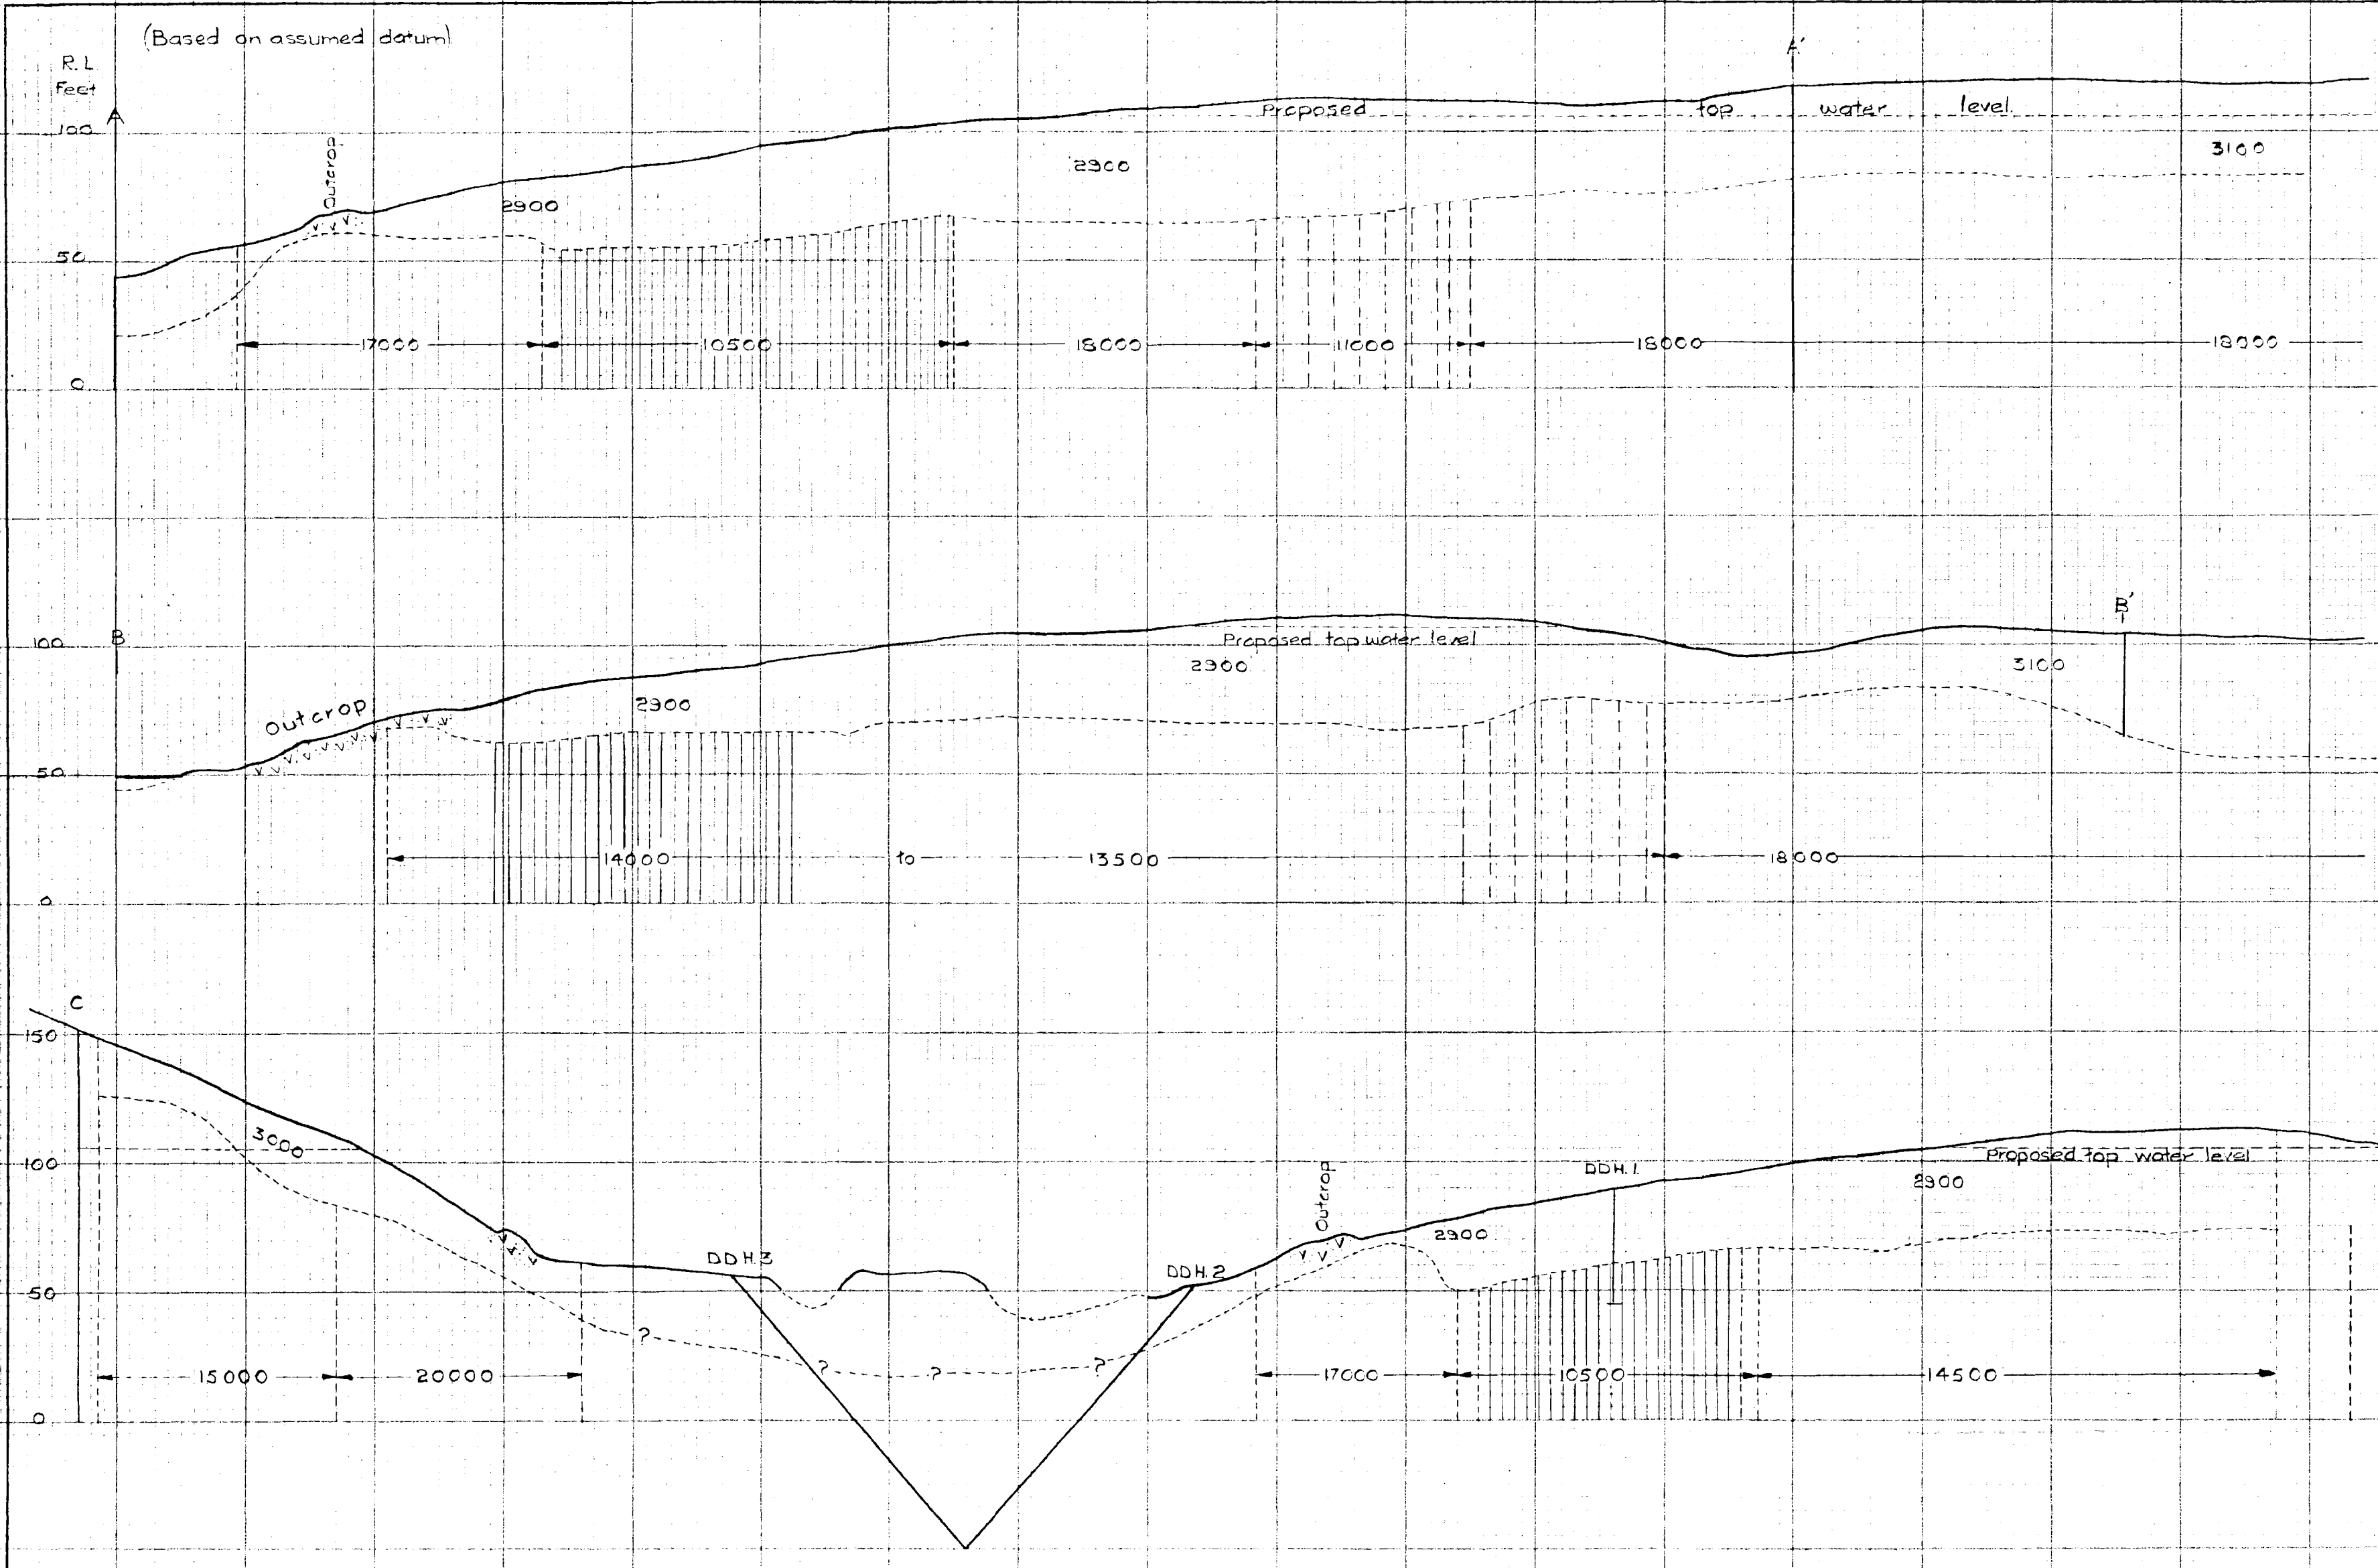
CROSS SECTION.

end of the weir would not appreciably increase its length. (The additional length to unweathered bedrock at the 1825' contour is approximately 50 ft. See Plate 3) On the south-eastern side of the river at the point where the crest height of the spur is at top water level, the width of the spur is only 180 ft. The spur maintains this width for 200 ft. south-westwards, where the crest height is 9 ft. above top water level. It is very unlikely that this low, narrow spur probably capped by old stream gravels would retain water without giving rise to considerable leakage. To overcome the trouble two alternatives can be examined. Firstly, the retaining wall could be constructed across the valley to terminate at the spur, and thence a cut off wall could be constructed in an excavation along the crest of the spur to a point where width and crest height are adequate to ensure safe retention of water. It can be seen by reference to Plate 2 that the spur width at top water level near the southern end of the area shown is 400 feet and crest elevation is 10 ft. above top water level. Plate 1 shows that at 300 ft. farther south the crest elevation is 14 ft. above top water level and the width is 1200 ft. Secondly, the weir could be sited downstream from the spur, where the steep valley sides both rise well above the 1825' contour. Plate 1 shows that it would be necessary to move about 1200 ft. downstream. Such a site would necessitate a separate investigation and will not be considered here.

Soil. The true soils in the area, excluding alluvium and weathered porphyry, are quite shallow, probably of the order of 1 foot in thickness. Weathered porphyry may, to some depth, have the mechanical characteristics of soils, and will have to be excavated probably down to the unweathered porphyry shown in Plate 3.
