BUREAU OF MINERAL RESOURCES

THE DRAINAGE PROBLEM AT No.16 MUGGA WAY, RED HILL

E.G. Wilson

RECORDS 1959/55

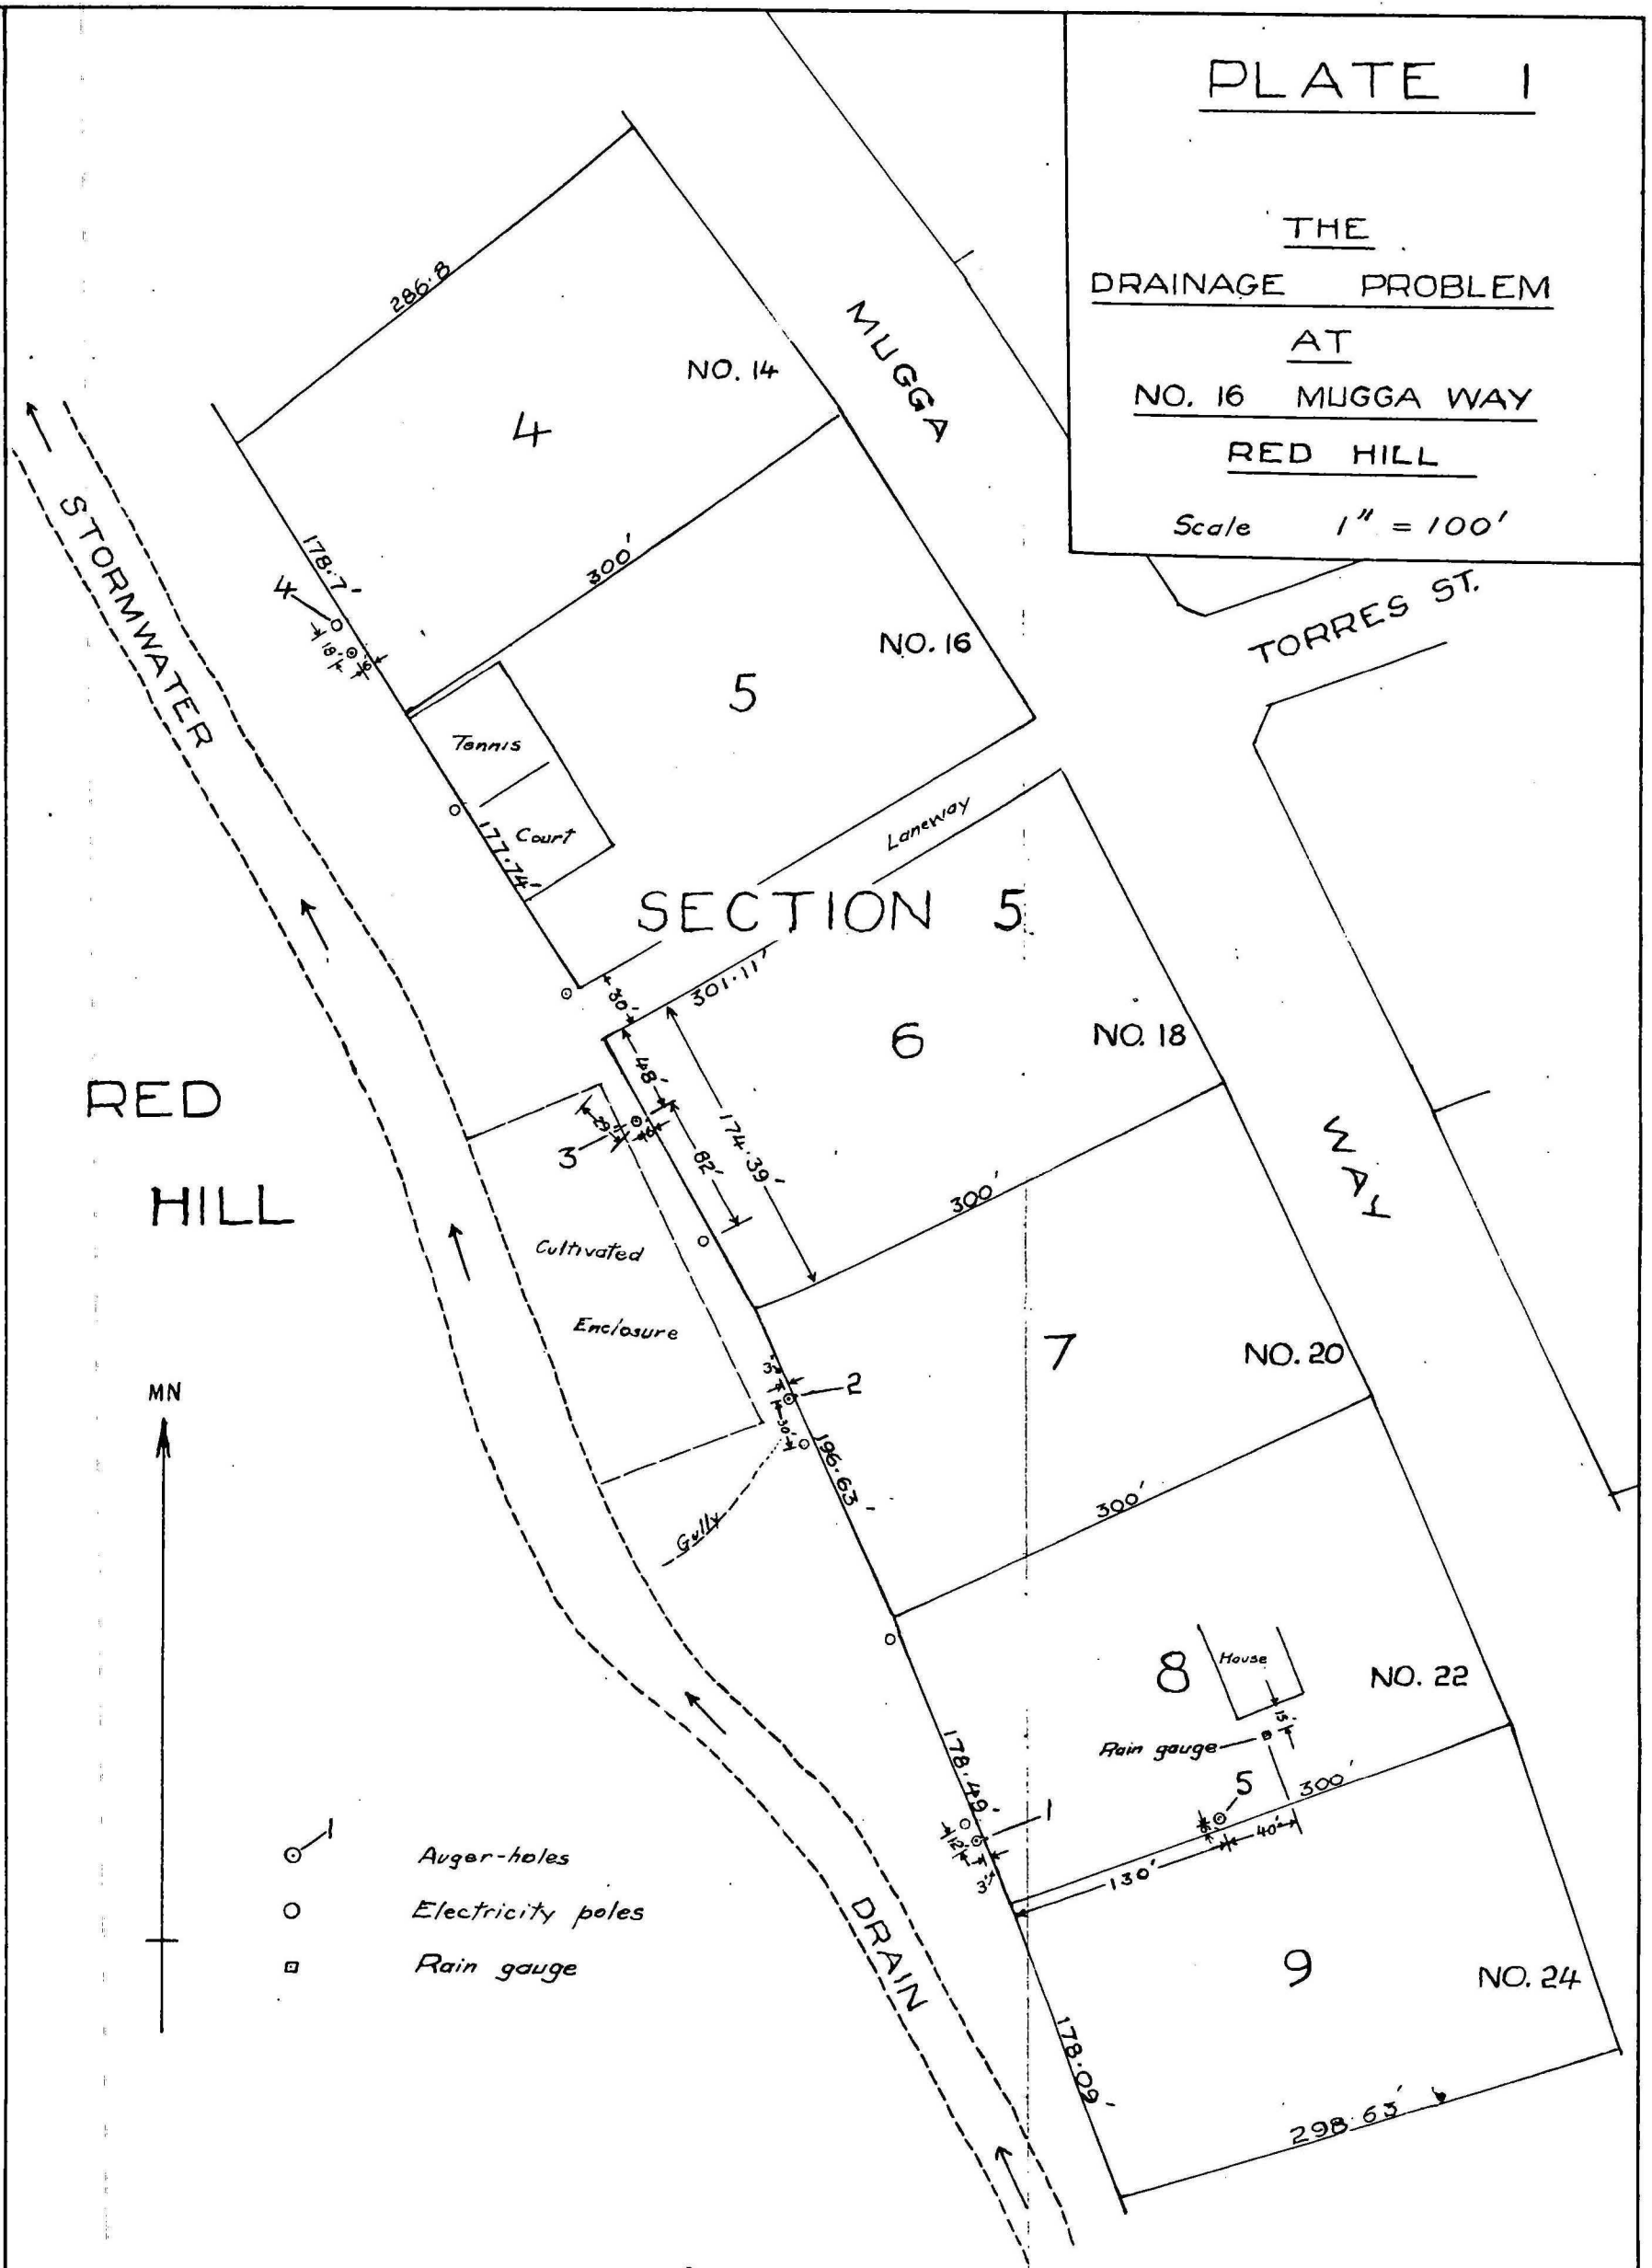
# PLATE I

There is no doubt that leakage from the drain takes place at this point. Investigation to detect leakage from other points of the drain in the same area is proposed. Five hand auger-holes have been put down preparatory to tracing the movement of dyes from the stormwater drain to these points during the next wet period. Details of the holes are given in the Appendix and their positions are shown on Plate I.

Plate I marks the positions of a number of auger-holes. These holes are part of a plan to discover leakage from other parts of the stormwater drain in the same catchment.

<u>Auger-hole 1</u>	<u>(rear No.22)</u>
0 - 2'6"	Red-brown soil.
2'6" - 3'0"	Red-brown soil with rock fragments.
<u>Auger-hole 2</u>	<u>(rear No.20)</u>
0 - 3'0"	Red-brown soil.
3'0" - 3'3"	Red-brown soil and rock fragments.
<u>Auger-hole 3</u>	<u>(rear No.18)</u>
0 - 2'9"	Red-brown soil.
2'9" - 3'3"	Red-brown soil and fragments of weathered porphyry.
<u>Auger-hole 4</u>	<u>(rear No.14)</u>
0 - 3'0"	Red-brown soil.
3'0" - 3'10"	Red-brown soil with rock fragments.
<u>Auger-hole 5</u>	<u>(in No.22)</u>
0 - 2'3"	Red-brown soil.
2'3" - 2'6"	Red-brown soil with rock fragments of weathered porphyry.

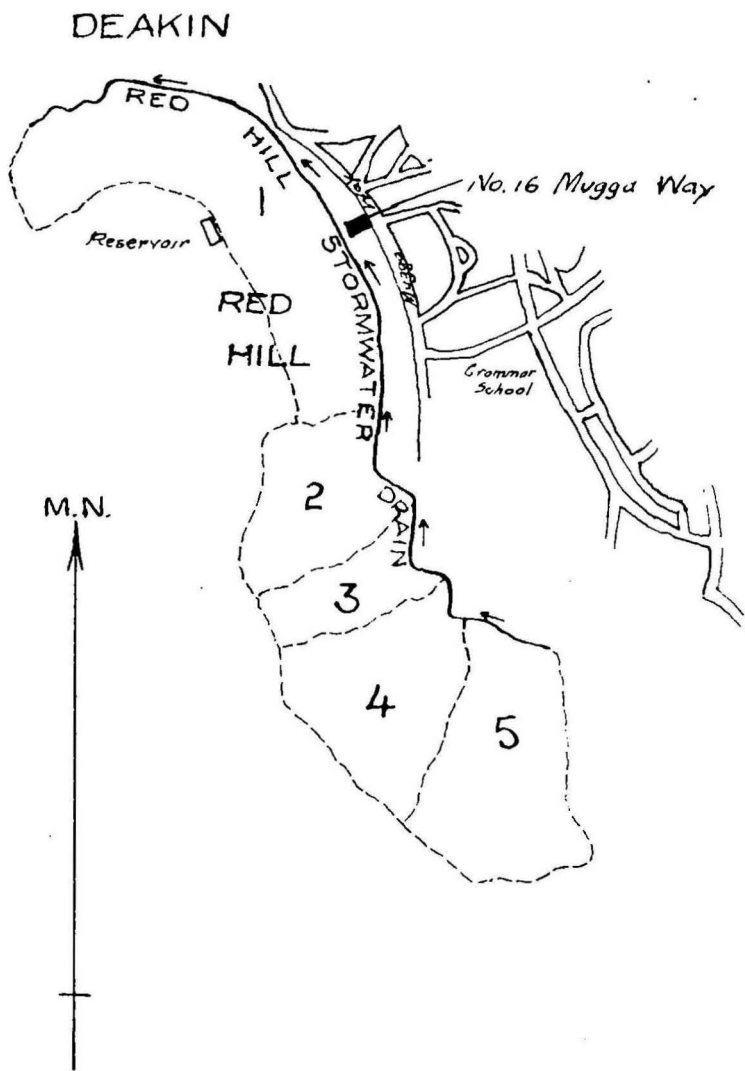
CATCHMENT AREA  
OF THE  
RED HILL STORMWATER DRAIN

Plate II defines the catchments flowing into the Red Hill drain. The gully catchments of Red Hill proper in the north are shown grouped together (No.1). The combined area of the other four catchments, south of the Grammar School, more than doubles the area of No.1. Run-off from No.1 area by means of a number of steep gullies clears the area quickly. Catchments 2, 3, 4 and 5 are spread over large areas with gentle slopes; run-off from them is much slower and keeps the drain flowing after rain has ceased.
