DEPARTMENT OF NATIONAL DEVELOPMENT.
BUREAU OF MINERAL RESOURCES
GEOLOGY AND GEOPHYSICS.

1959/56

THE DRAINAGE PROBLEM AT DUFFY ST. AINSLIE

E. G. Wilson

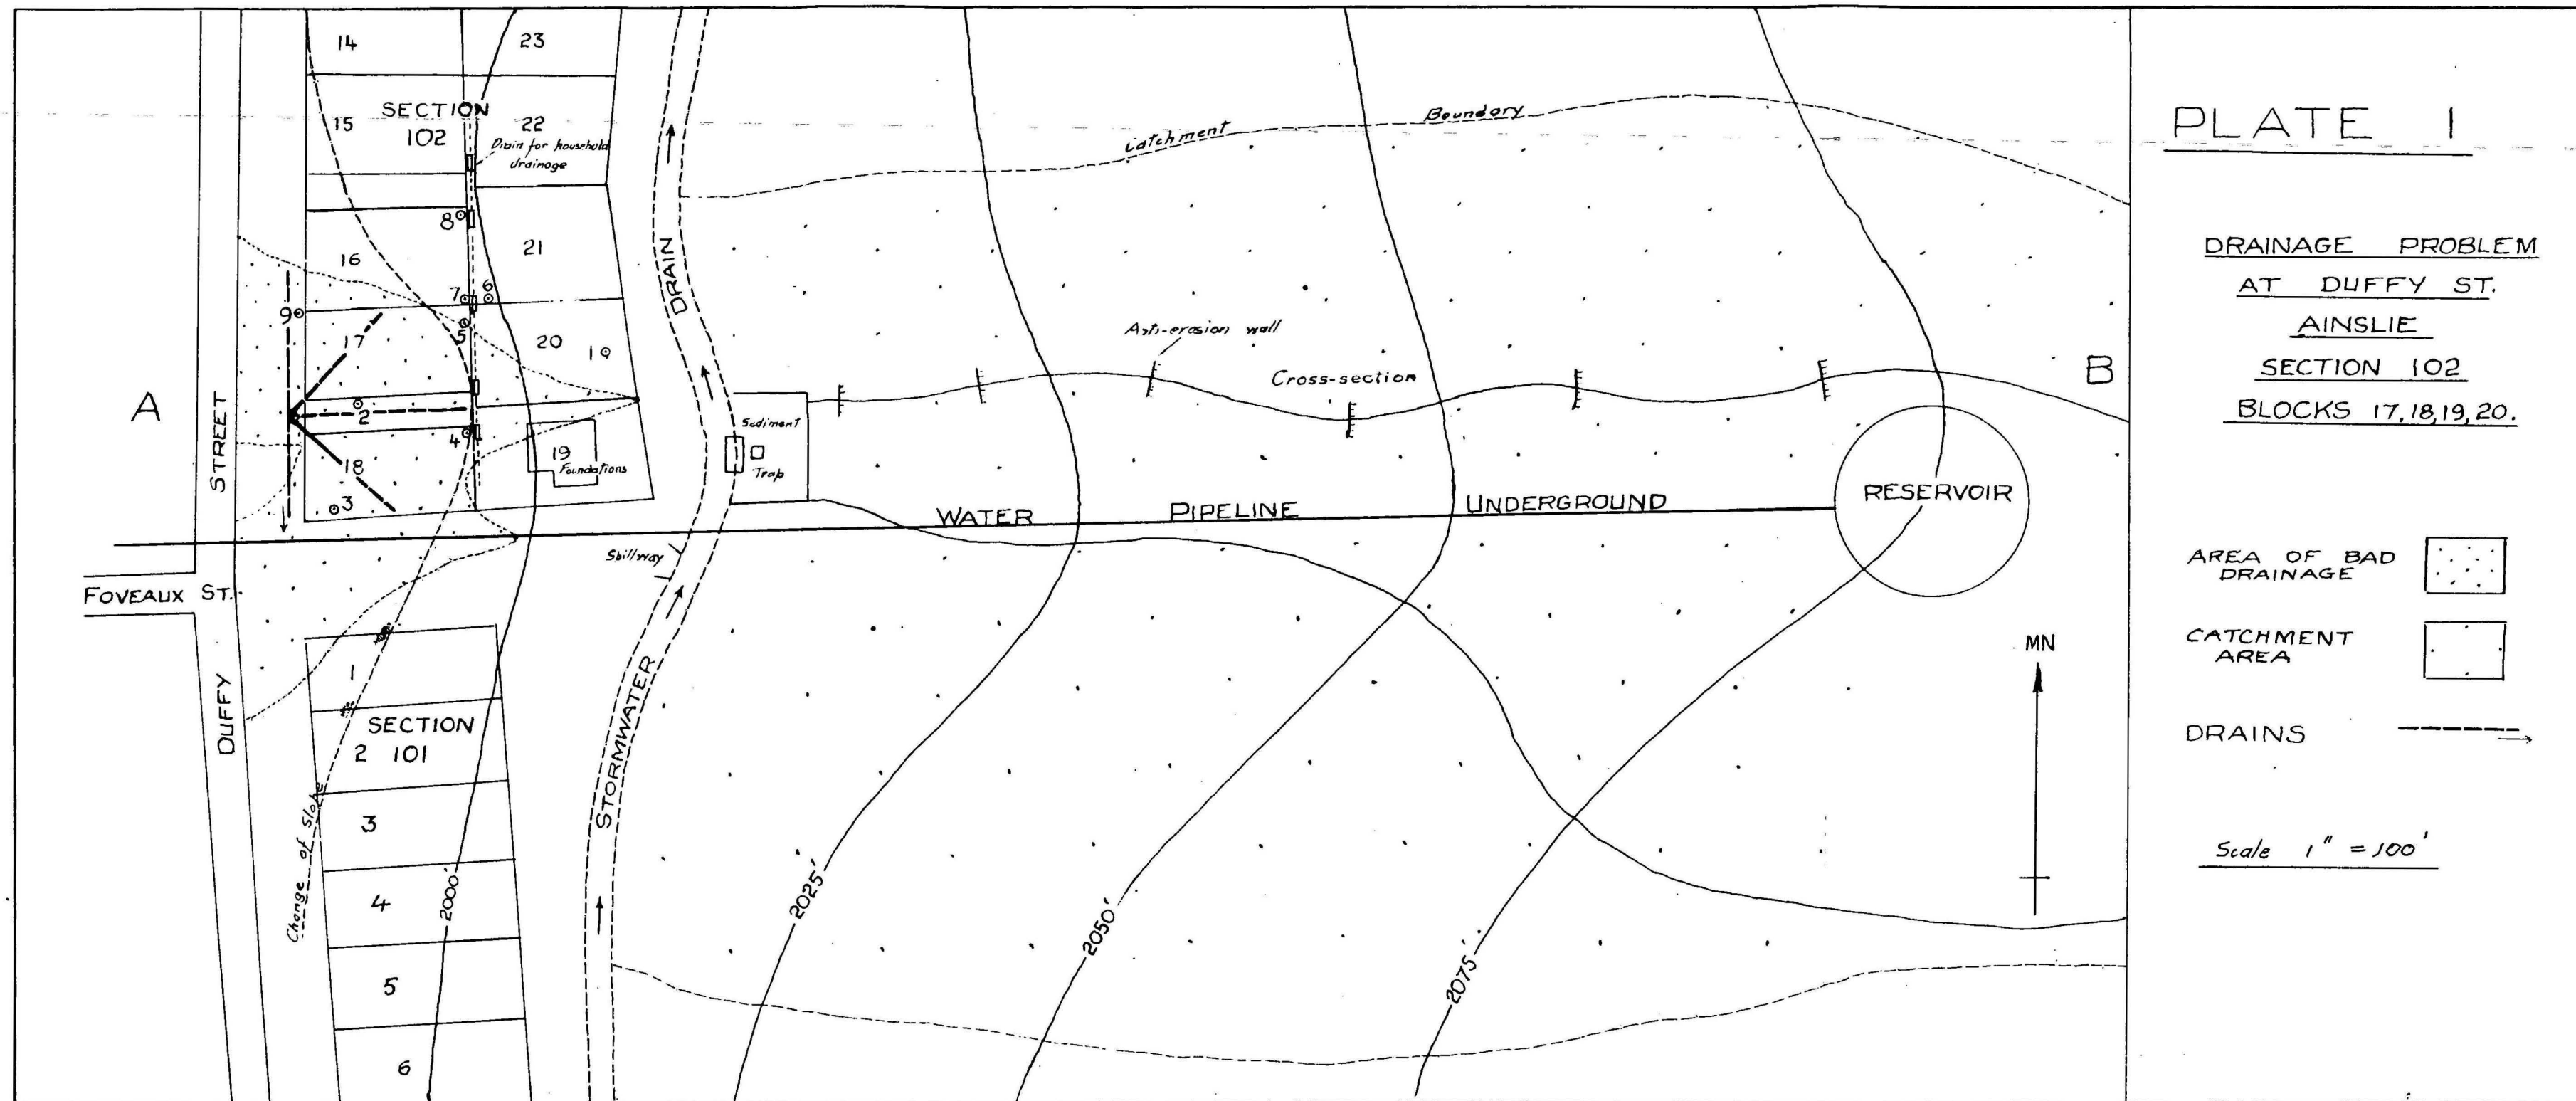
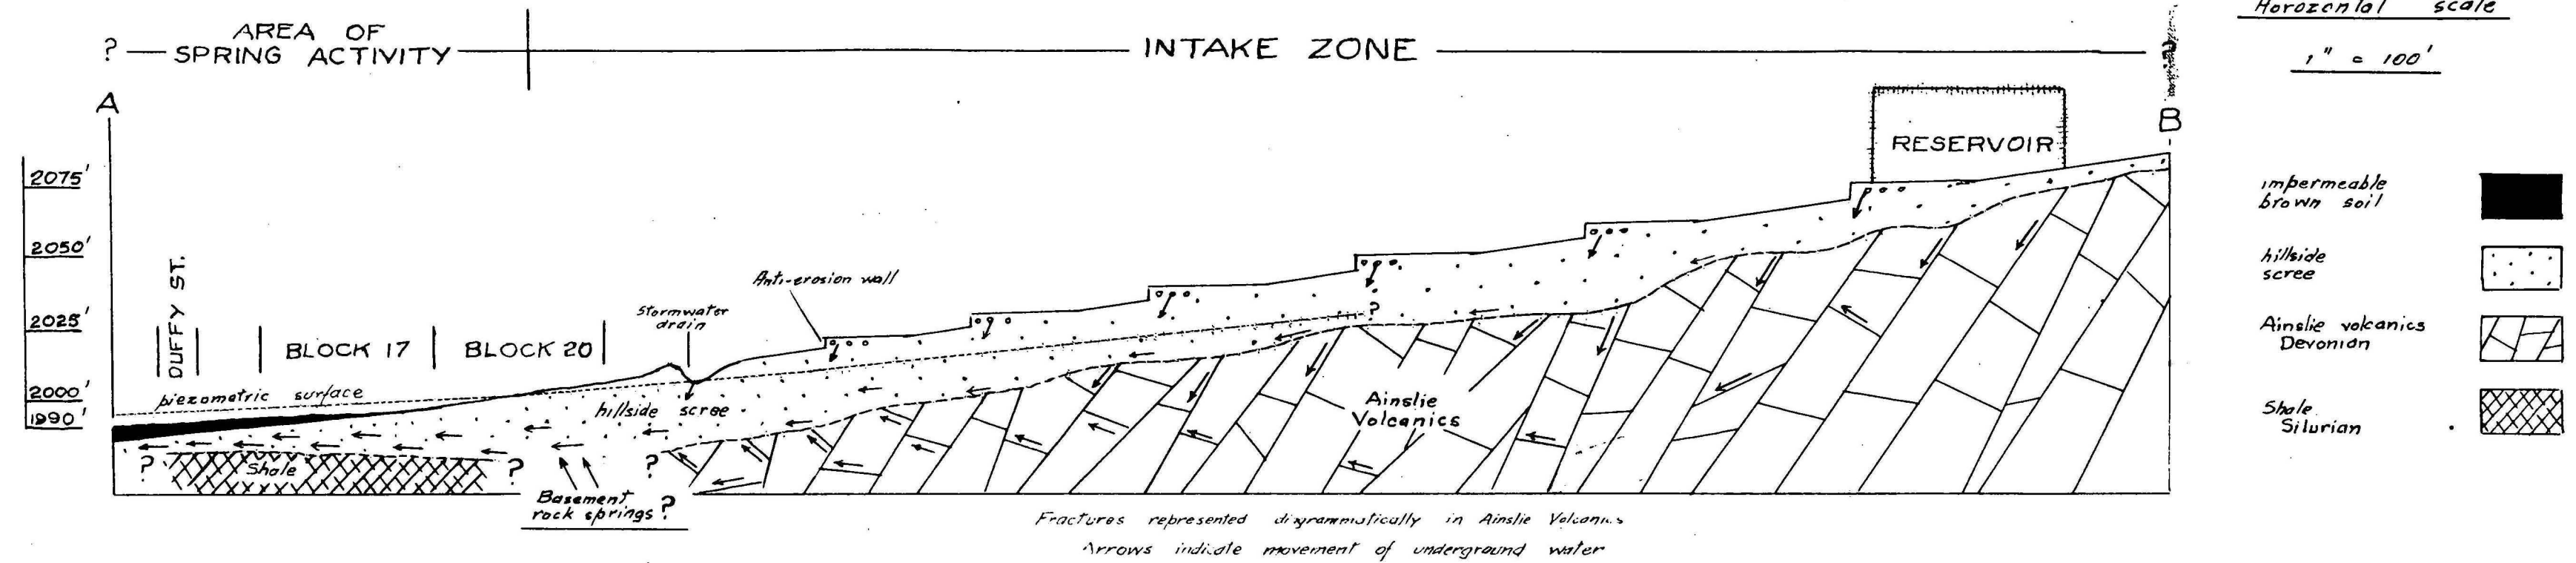
PLATE II

Silurian age. It is very likely that the Ainslie Volcanics rest unconformably on the shale; waterlogging is probably brought about by the shale acting as a bar to the movement down slope of underground water. Faulting has taken place along the western slopes of Mt. Ainslie; quartz veins found in the shale may indicate a fault in this area, perhaps an offshoot of the Oakes Fault. Faulting could also be postulated as a means of placing the shale in a position to block the movement of underground water.

Plate II is a cross-section of the area. Water entering the catchment on the slopes passes through the hillside scree into fractures in the Ainslie volcanics. These fractures are diagrammatically represented in the cross-section with possible movement of water along fractures indicated by small arrows. The water slowly moves down-hill through scree on top of the volcanics and by following fractures until shale is encountered. The shale is relatively impermeable, and the water must flow above it. Development of brown soil of low permeability at the foot of the slope and vertically above the probable position of the shale, means that the path of underground water is constricted. Backing up takes place causing a rise in the water table and pressure is exerted by the weight of underground water further up the slope. With sufficient influx of sub-surface water, the piezometric surface (the surface to which water tends to rise) rises above ground level in the lower part of the hill slope and springs and seepages develop.
