GEOPHYSICAL WORK AT

MACQUARIE ISLAND 1958.

A. TURPIE.

RECORDS 1959 NO.123

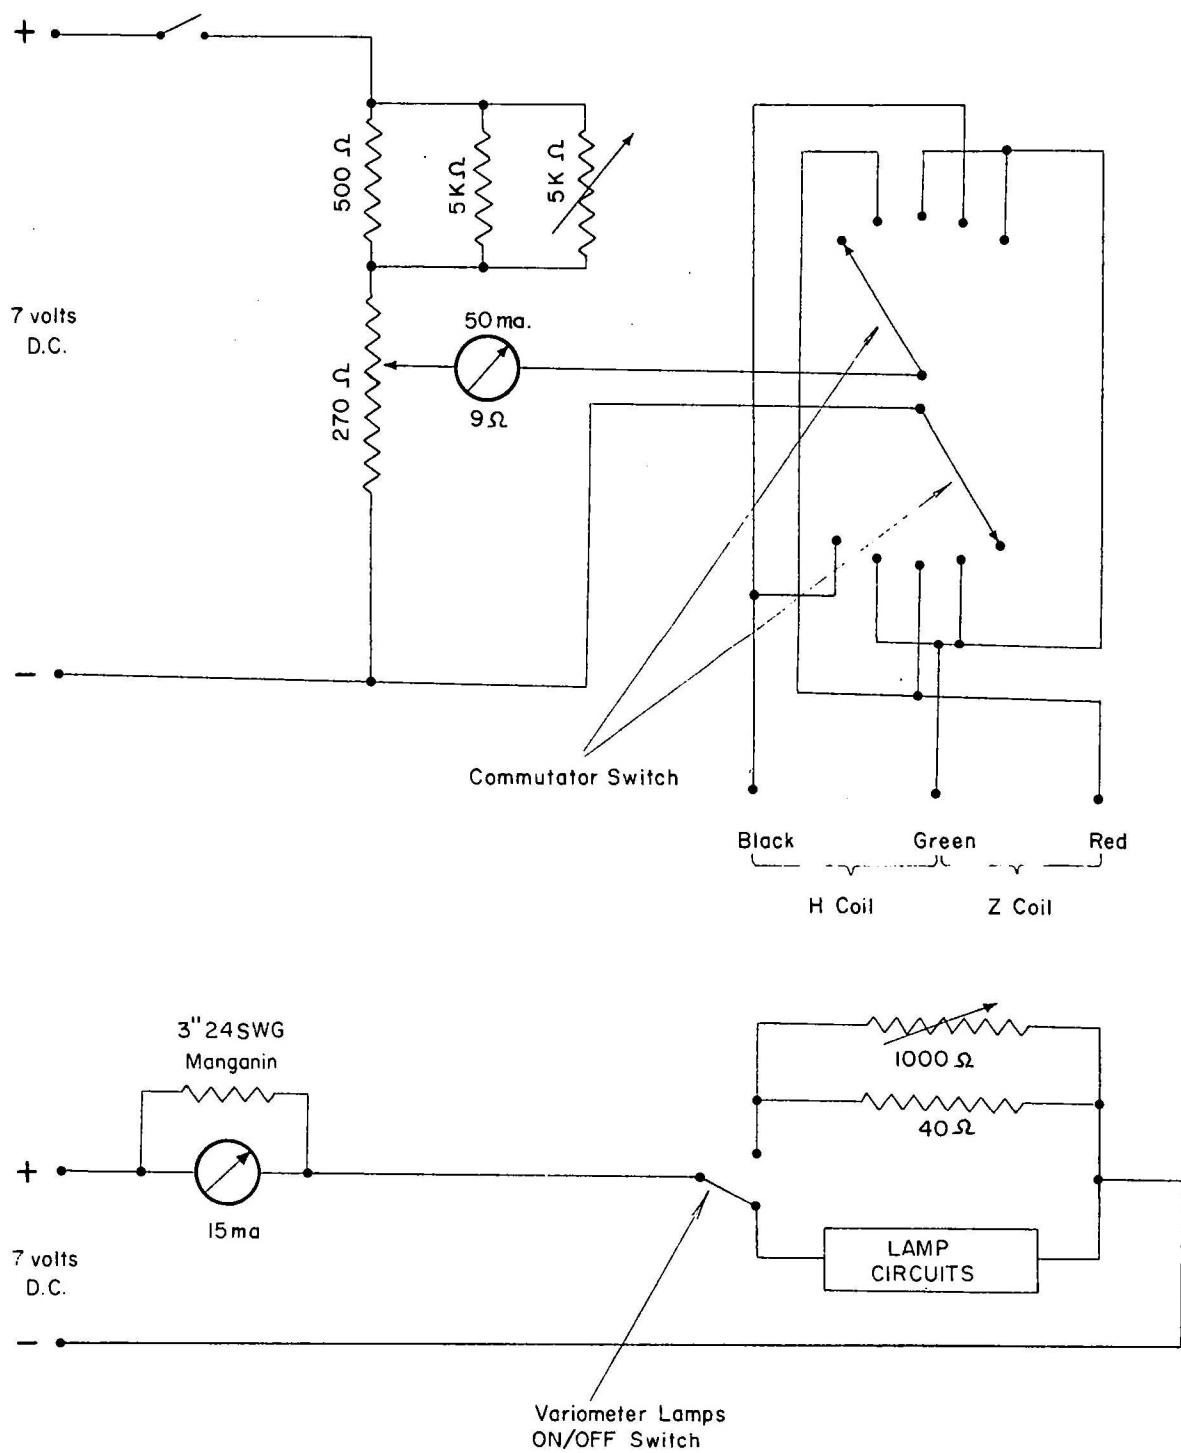
FIGURE 1

From previous reports it appears that trouble has always been experienced with the scale value circuit due to corrosion of the switch contacts and potentiometer tracks. An attempt was made to get a steady current by cleaning these contacts and tracks before every measurement.

The scale value circuit was modified, early in the year, using the existing components. It gave a fine control and reduced the effect of corroded tracks. With this new circuit, the current could be reduced to zero before reversal. This circuit proved very successful and is shown in Fig. 1.

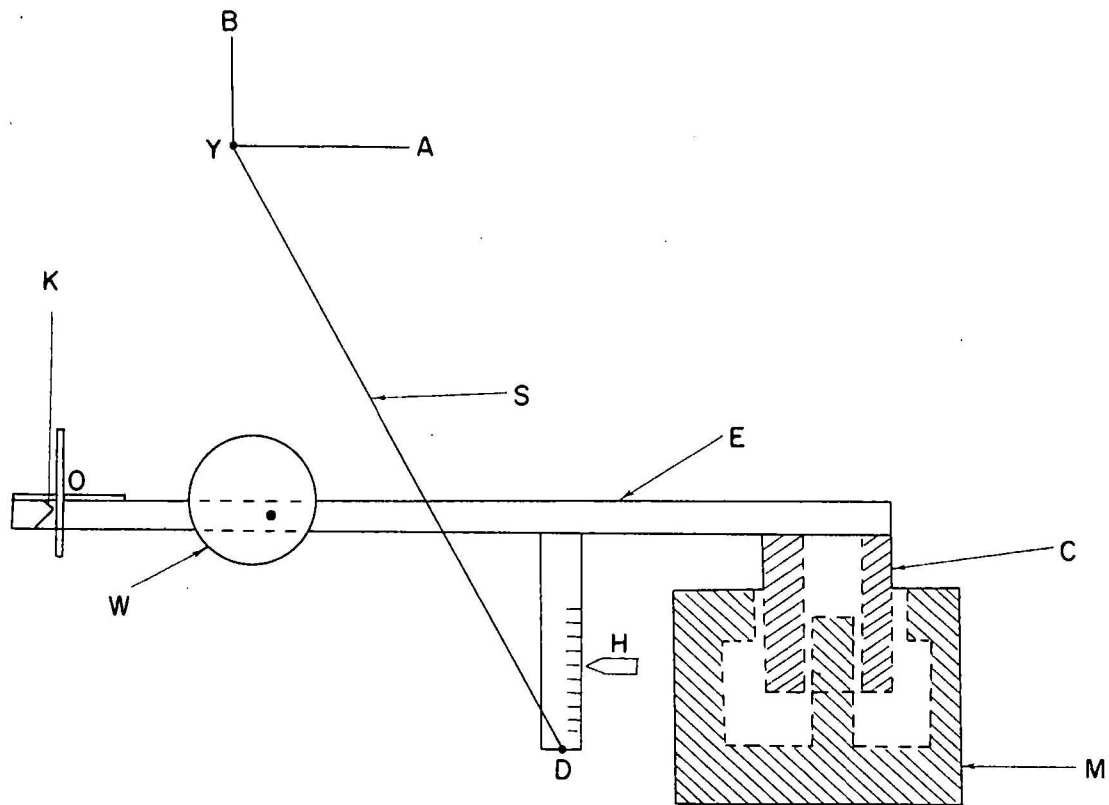
FIGURE 2

During December 1957 and January 1958, the record from the Grenet Seismograph occasionally became completely smooth. It was found that the boom was resting on the toroidal magnet. An operational diagram of the seismometer is shown in Fig. 2.
