RECORD No. 1962/58

GOOGONG DAM SITE SEISMIC REFRACTION SURVEY, NSW 1961

W.A. Wiebenga and M. Kirton

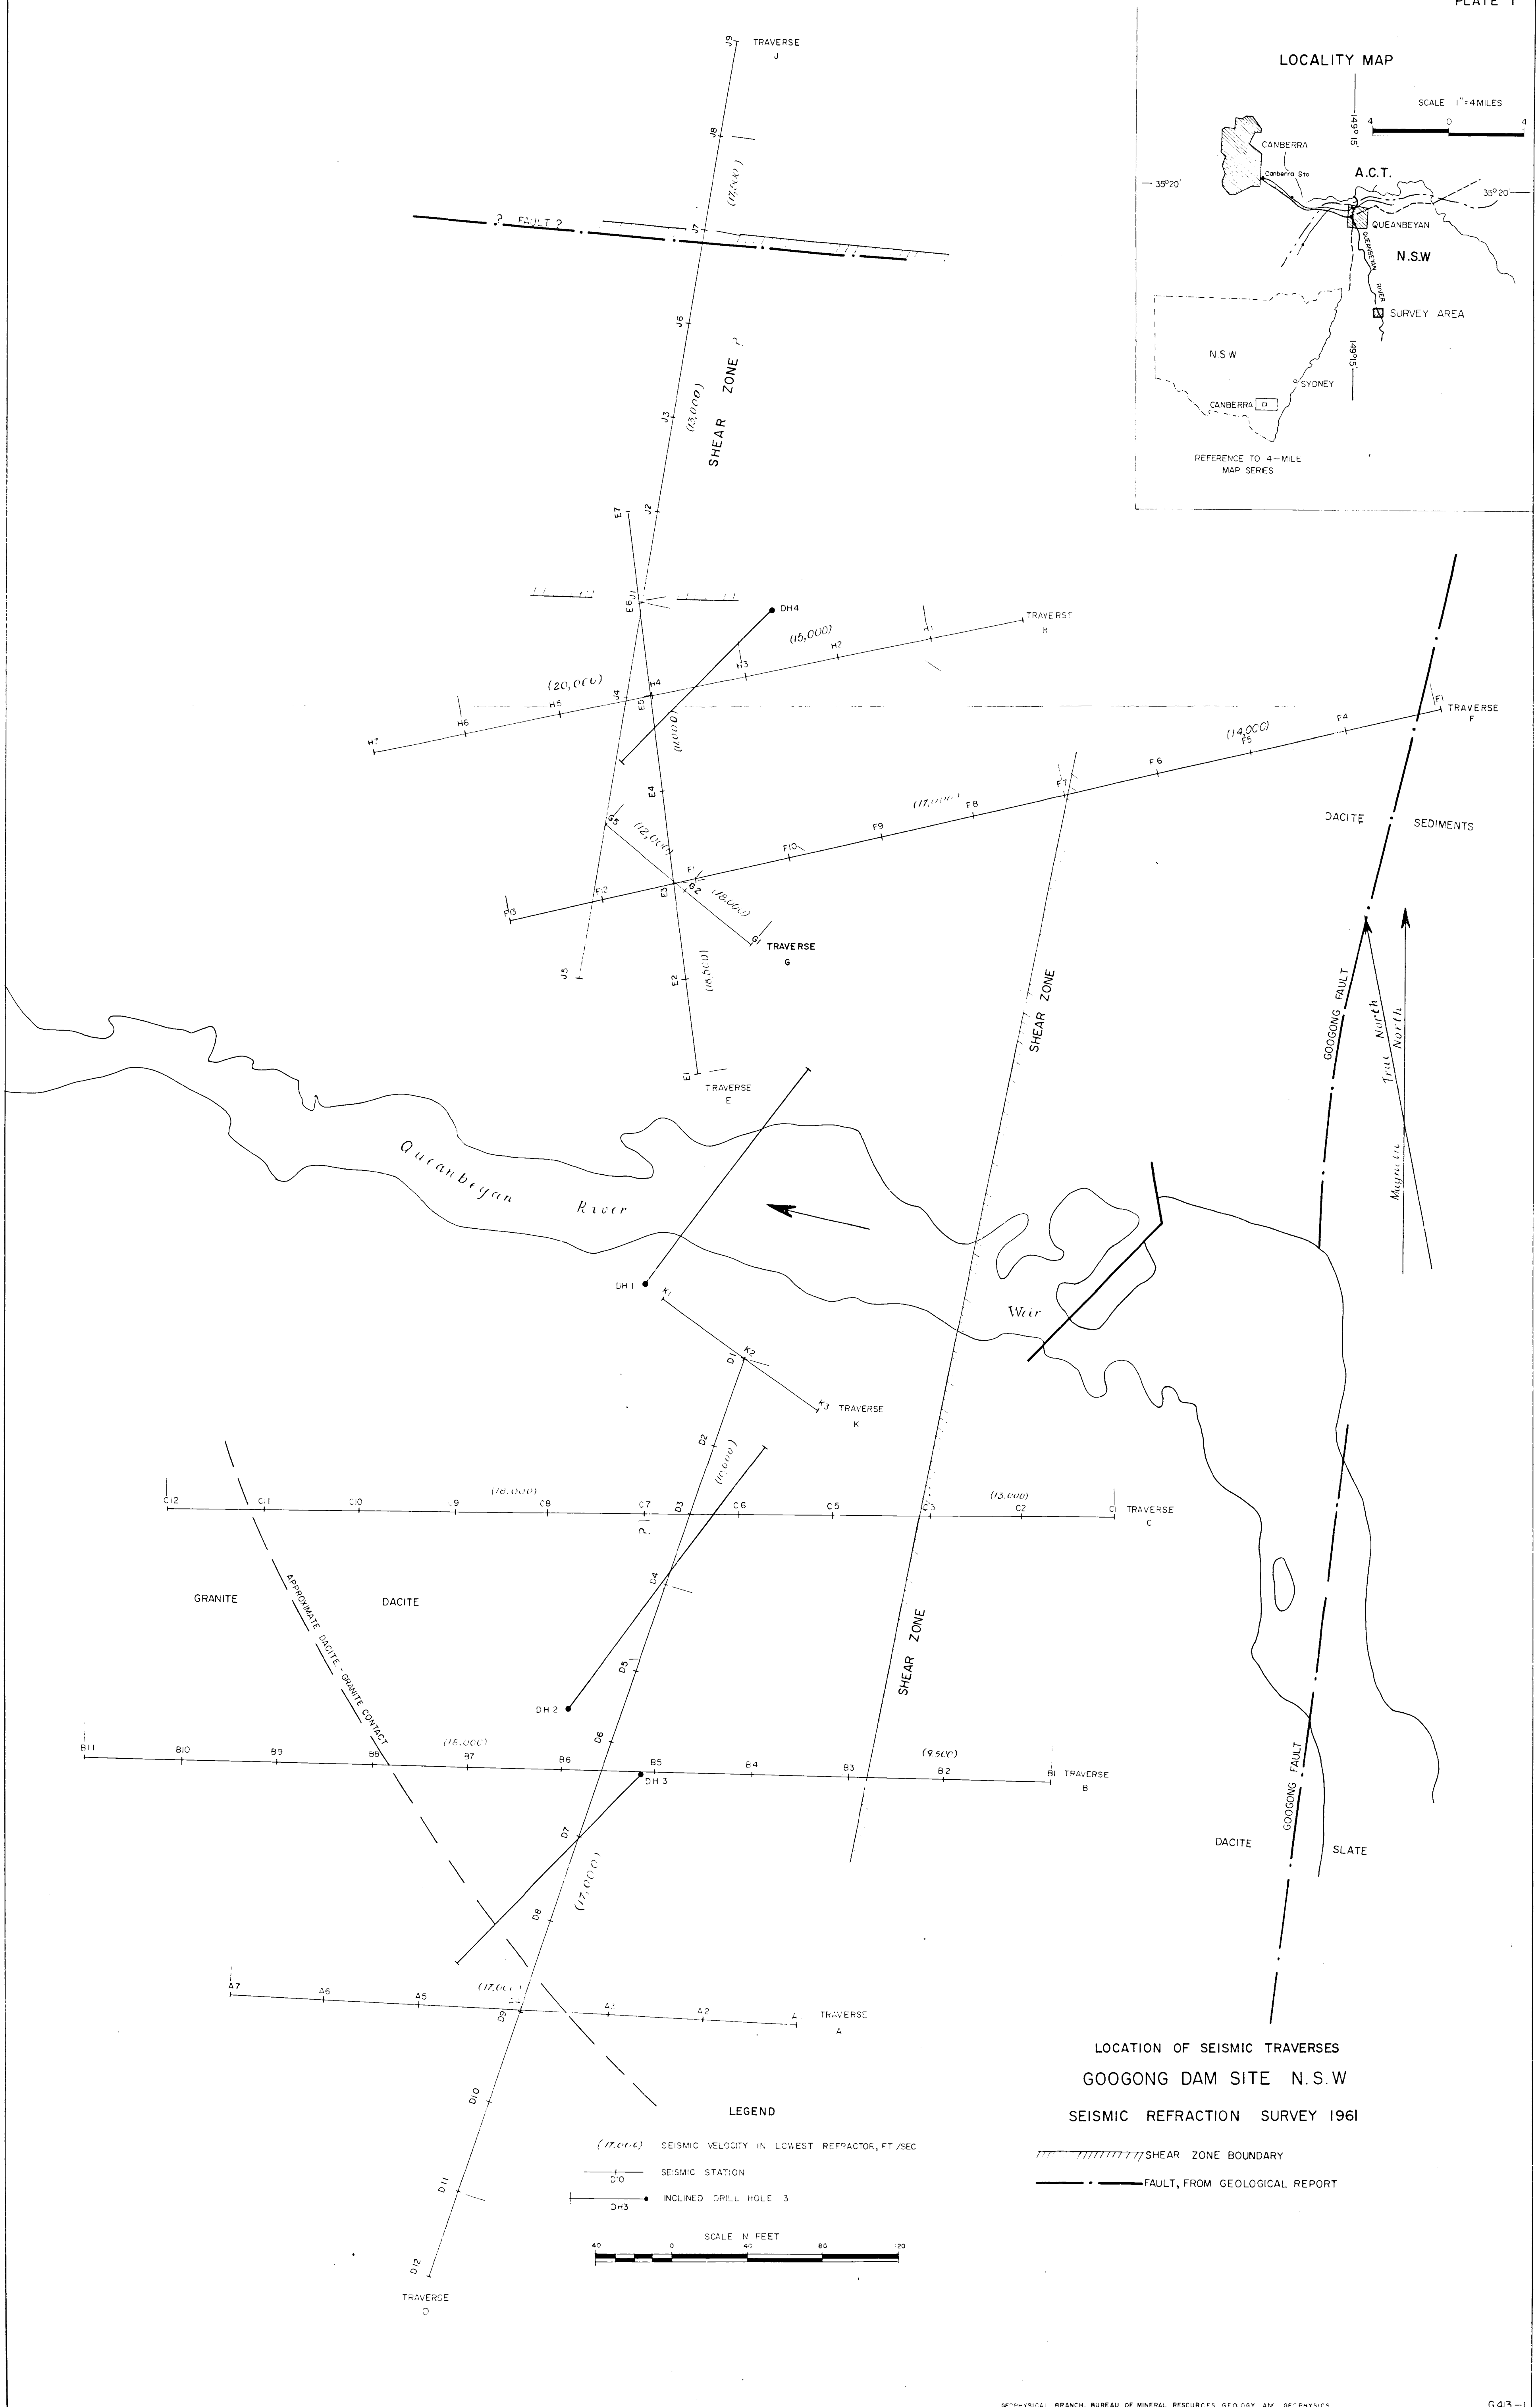
LOCATION OF SEISMIC TRAVERSES
GOOGONG DAM SITE N.S.W
SEISMIC REFRACTION SURVEY 1961

The site is on thick bedded Silurian dacite tuff and flows which dip west at 40° to 60° . It is believed that thin layers of tuff may be interbedded with the lava flows. On the eastern side of the site, according to the geological map about 300 ft east of Traverse D (Plate 1), the dacite is separated by the Googong Fault from slightly older tuff, sediments, slate etc. The strike of the Googong Fault is about 010° magnetic. The geological map shows another possible fault with a strike of about 090° magnetic 200 ft north of drill hole No. 4. On the western side the dacite is intruded by younger granite.

Plate 1 shows the traverse plan with some geological information and the location of the four drill holes.

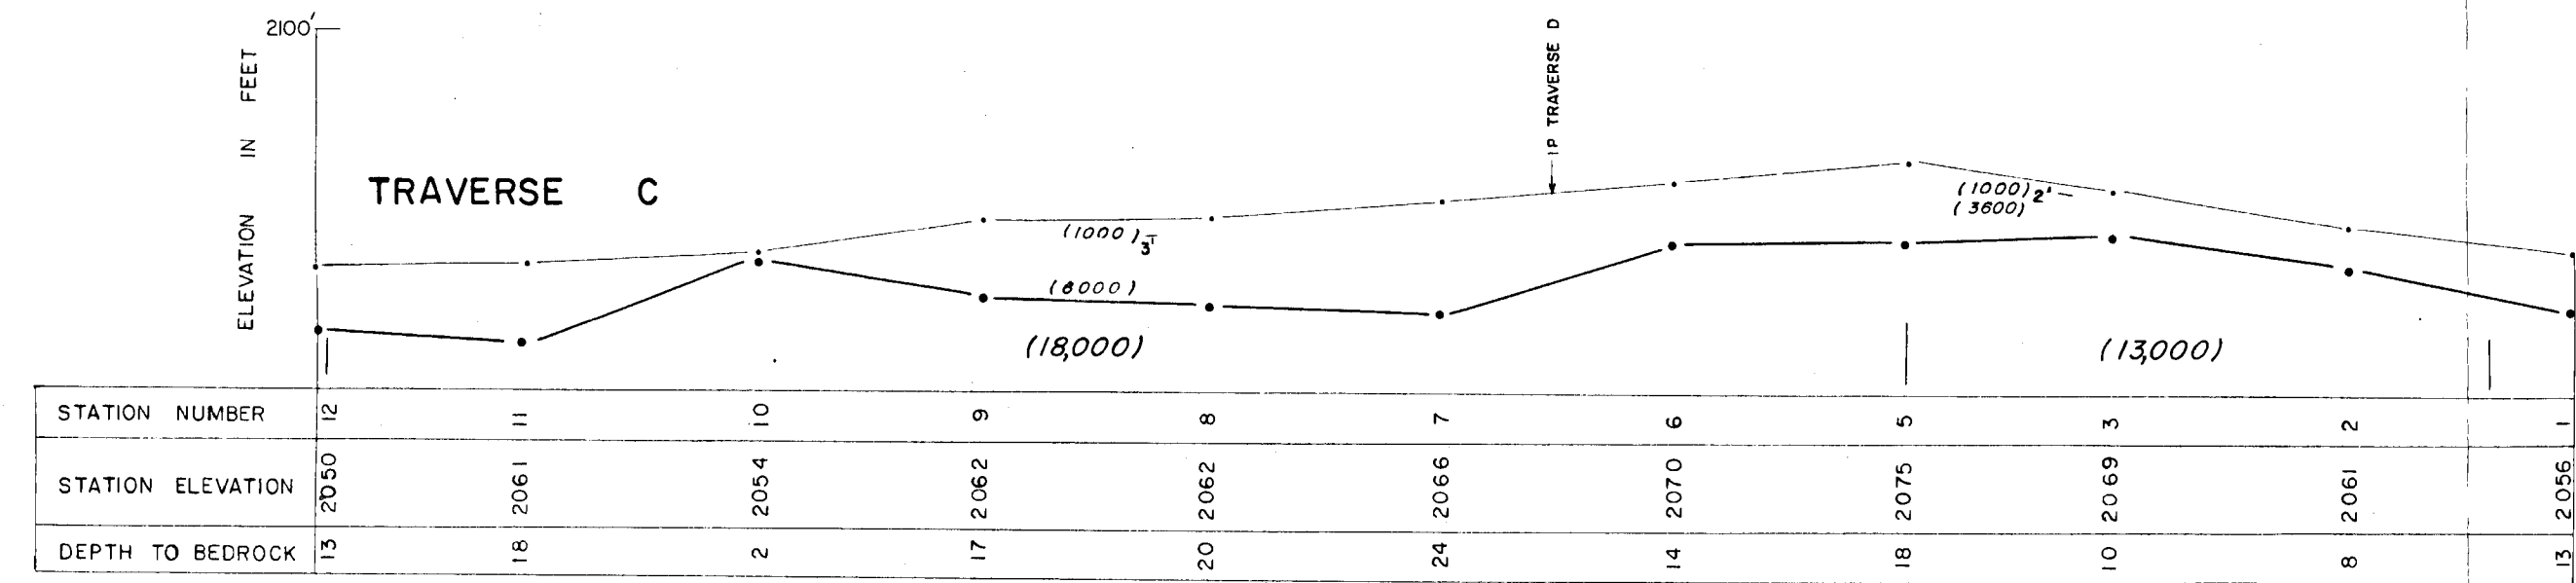
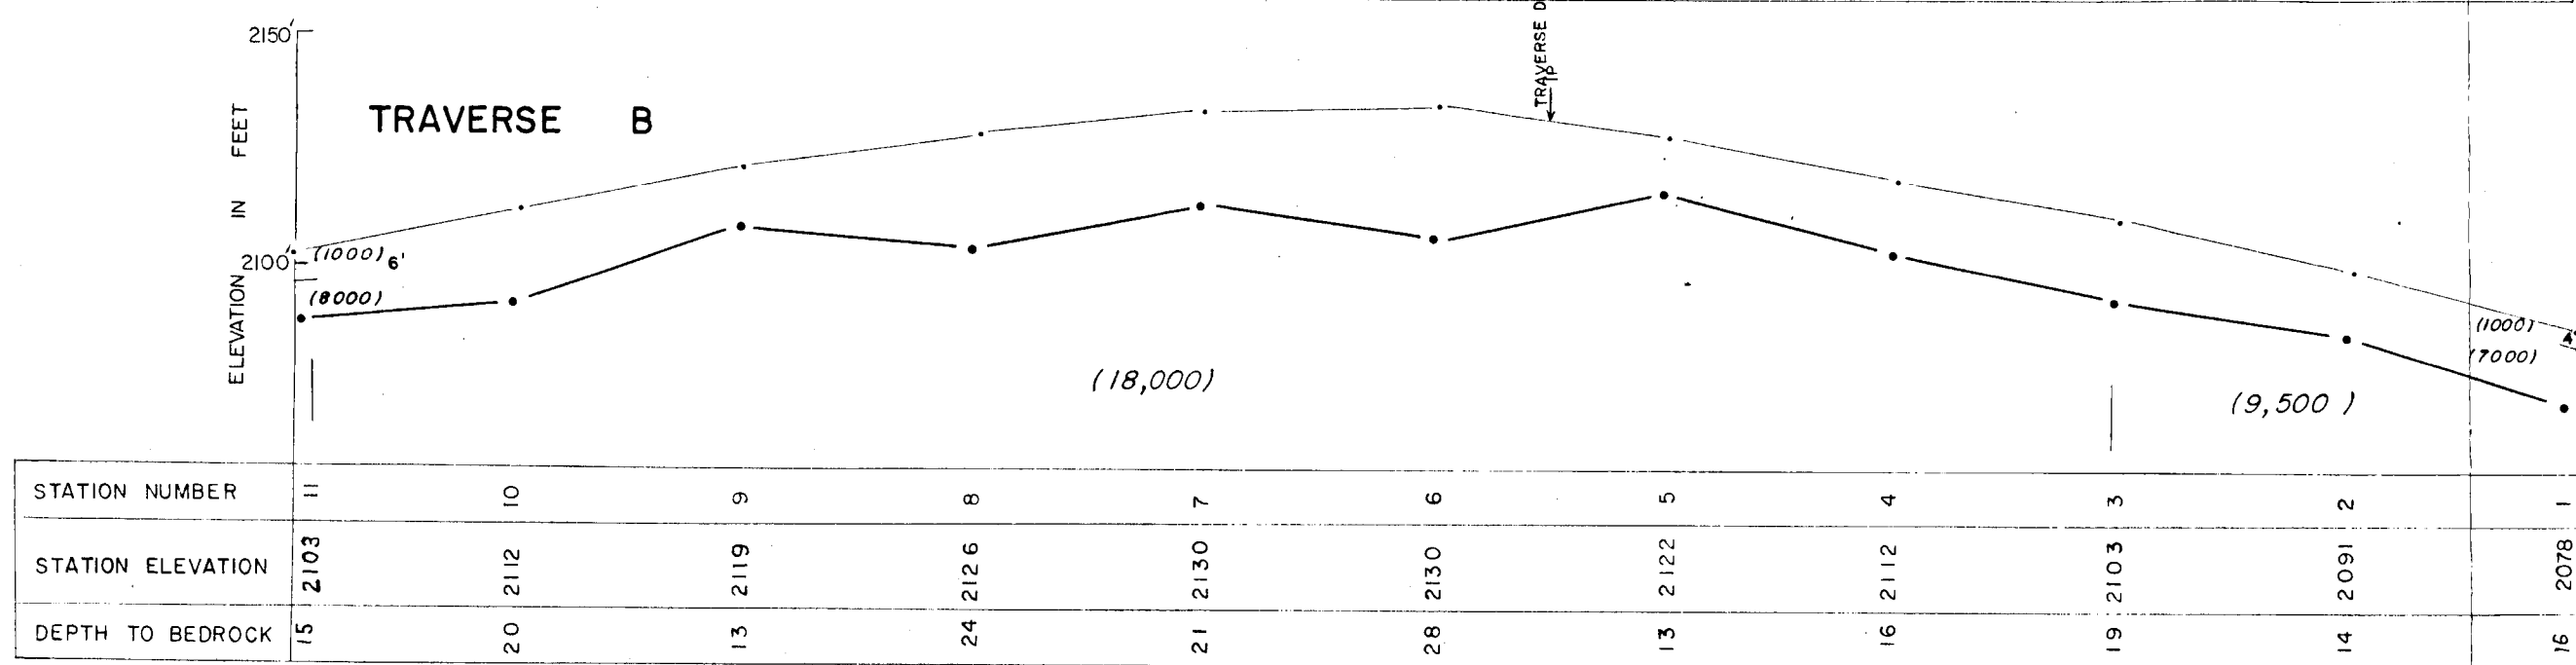
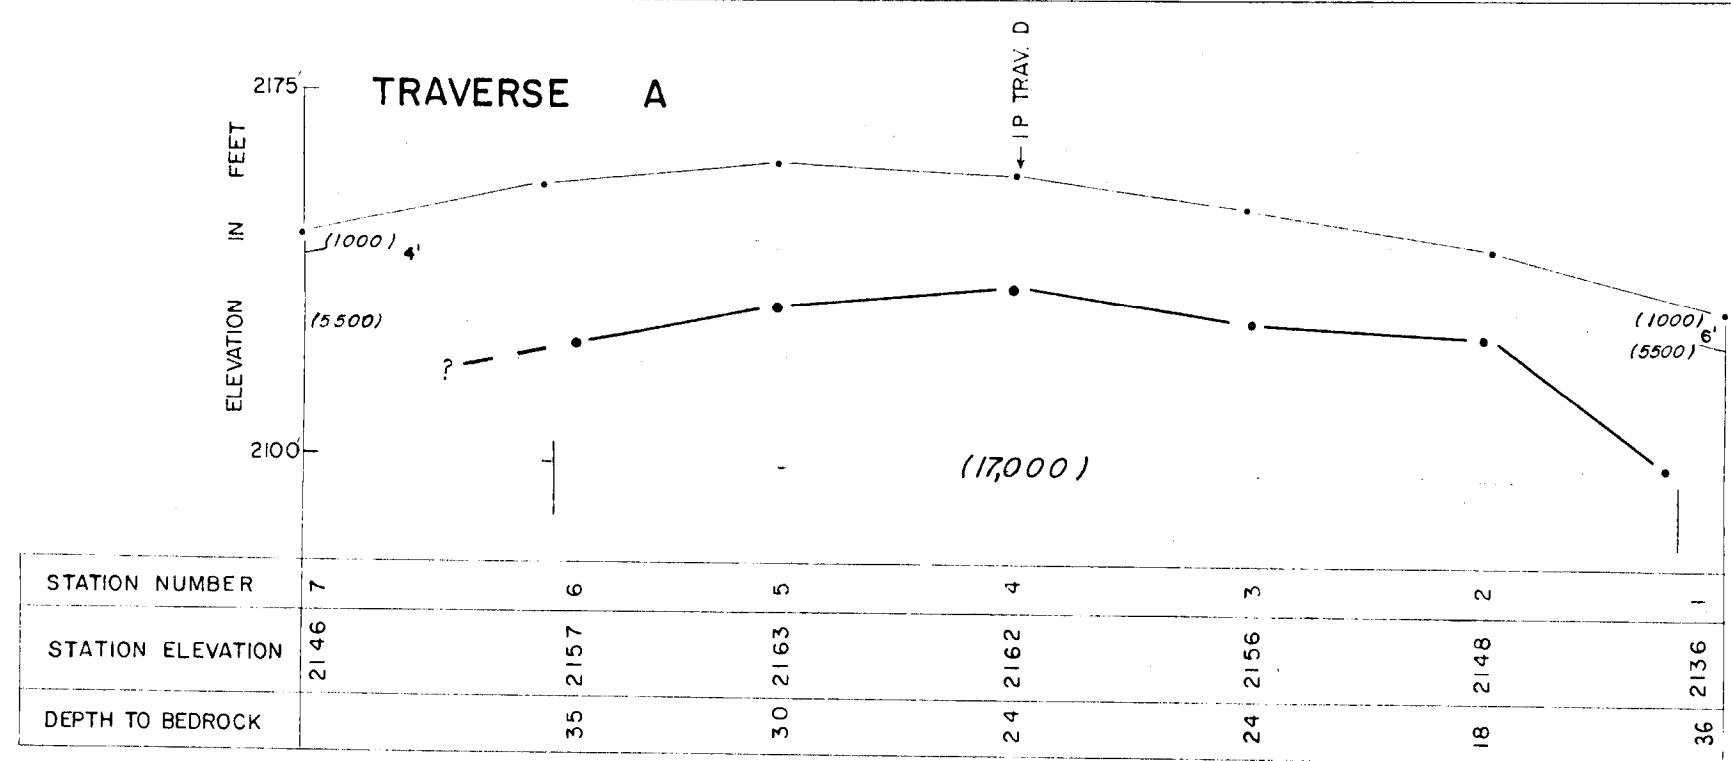
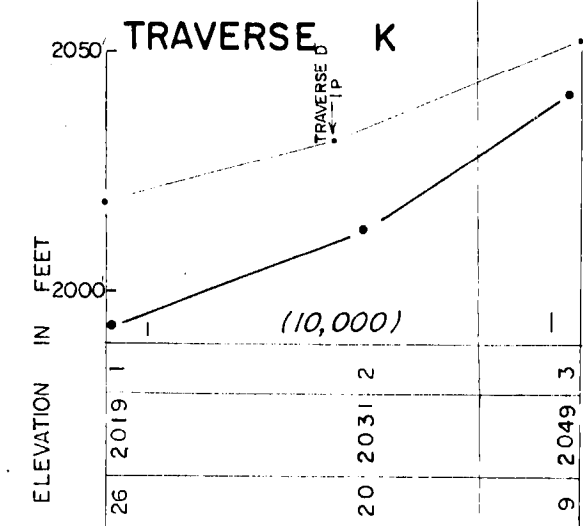
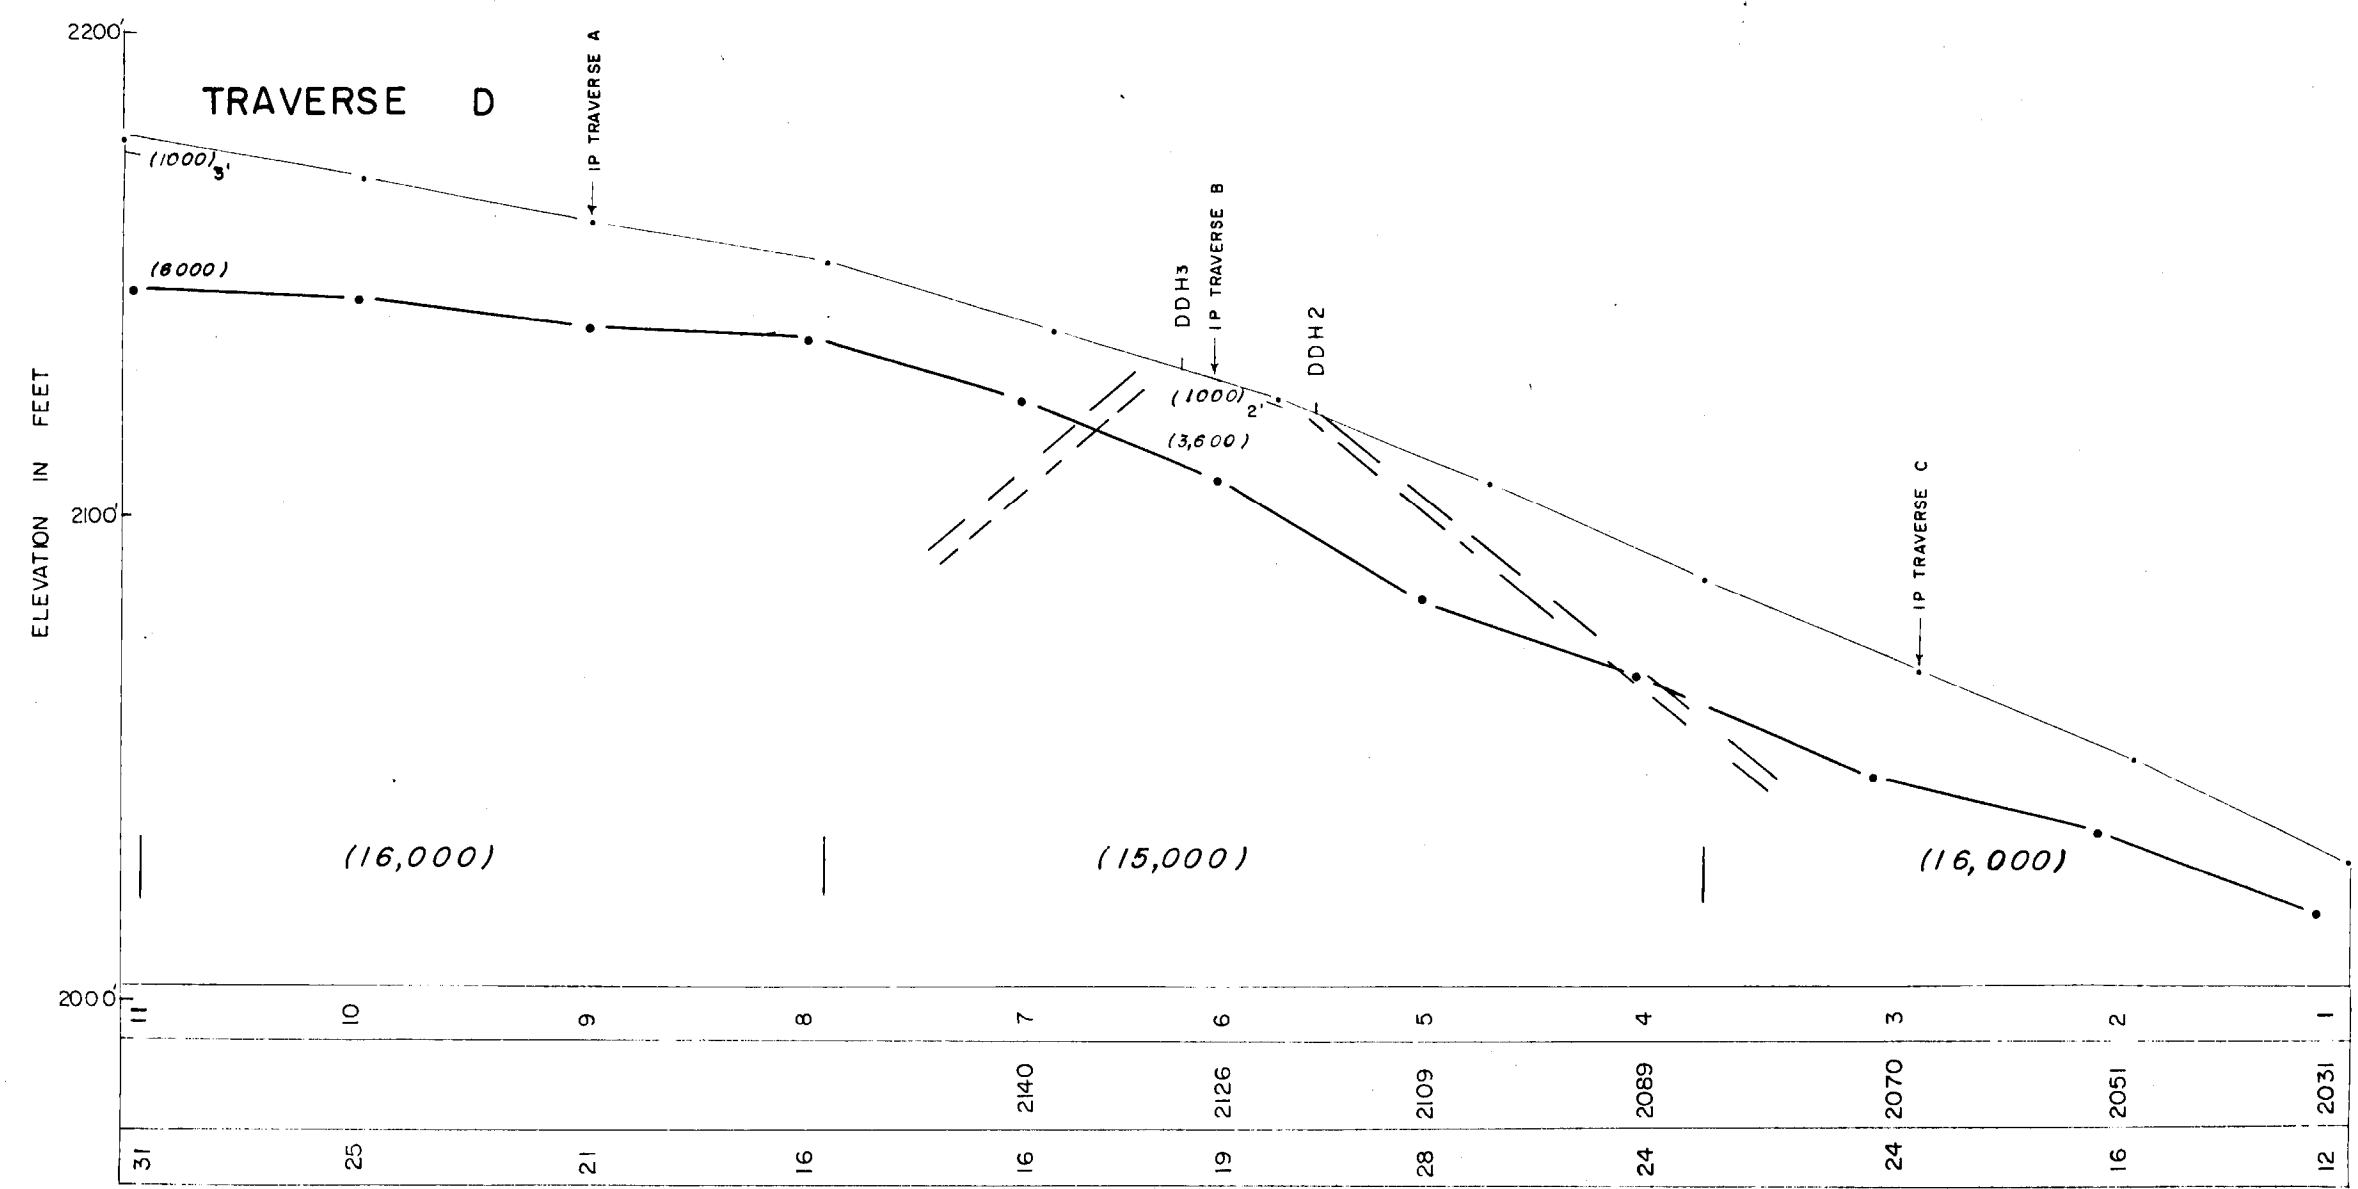
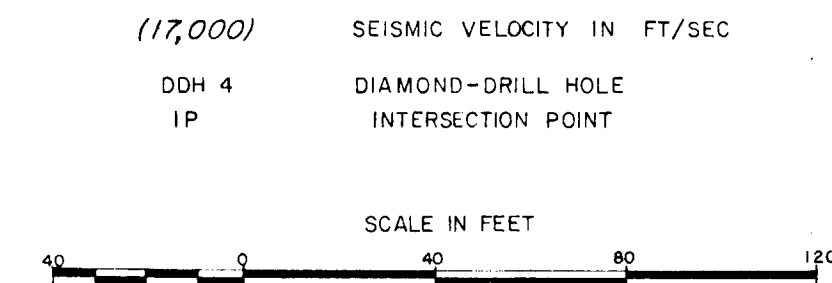
SEISMIC TRAVERSES A,B,C,D, and K
CROSS - SECTIONS

Plates 2 and 3 show the depths to bedrock in seismic cross-sections.

Rocks with velocities ranging between 9000 and 14,000 ft/sec are classified as bedrock because they are the deepest seismic refractors recorded in some parts of the area. East from B3, C3, and F7 the lower velocity of the bedrock is possibly due to shearing associated with the Googong Fault. Another zone of lower bedrock velocity between J1 and J7 coincides approximately with a fault marked with question marks on the geological plan, with a strike of about 090°. The direction of strike of this zone cannot be inferred from the seismic work, as it is crossed by only a single traverse.

Any dam on the site should preferably be located west of the zone of lower-velocity bedrock whose western edge is marked by a line through B3, C3, and F7. Although the drill holes do not exactly coincide with the seismic stations, the depths to unweathered bedrock from the drill hole logs are roughly the same as the depths found by seismic work; that is for drill hole Nos. 2, 3, and 4 the depths from logs are about 20, 20, and 8 ft respectively, and from seismic work about 24, 18, and 10 ft.
