RECORD N^o. 1962/140

GEOLOGICAL INVESTIGATION OF
DAMSITE E,
UPPER COTTER RIVER,
A.C.T. 1961

E. J. BEST and J. K. HILL

GEOLOGICAL INVESTIGATION OF DAMSITE E, UPPER COTTER RIVER,
AUSTRALIAN CAPITAL TERRITORY

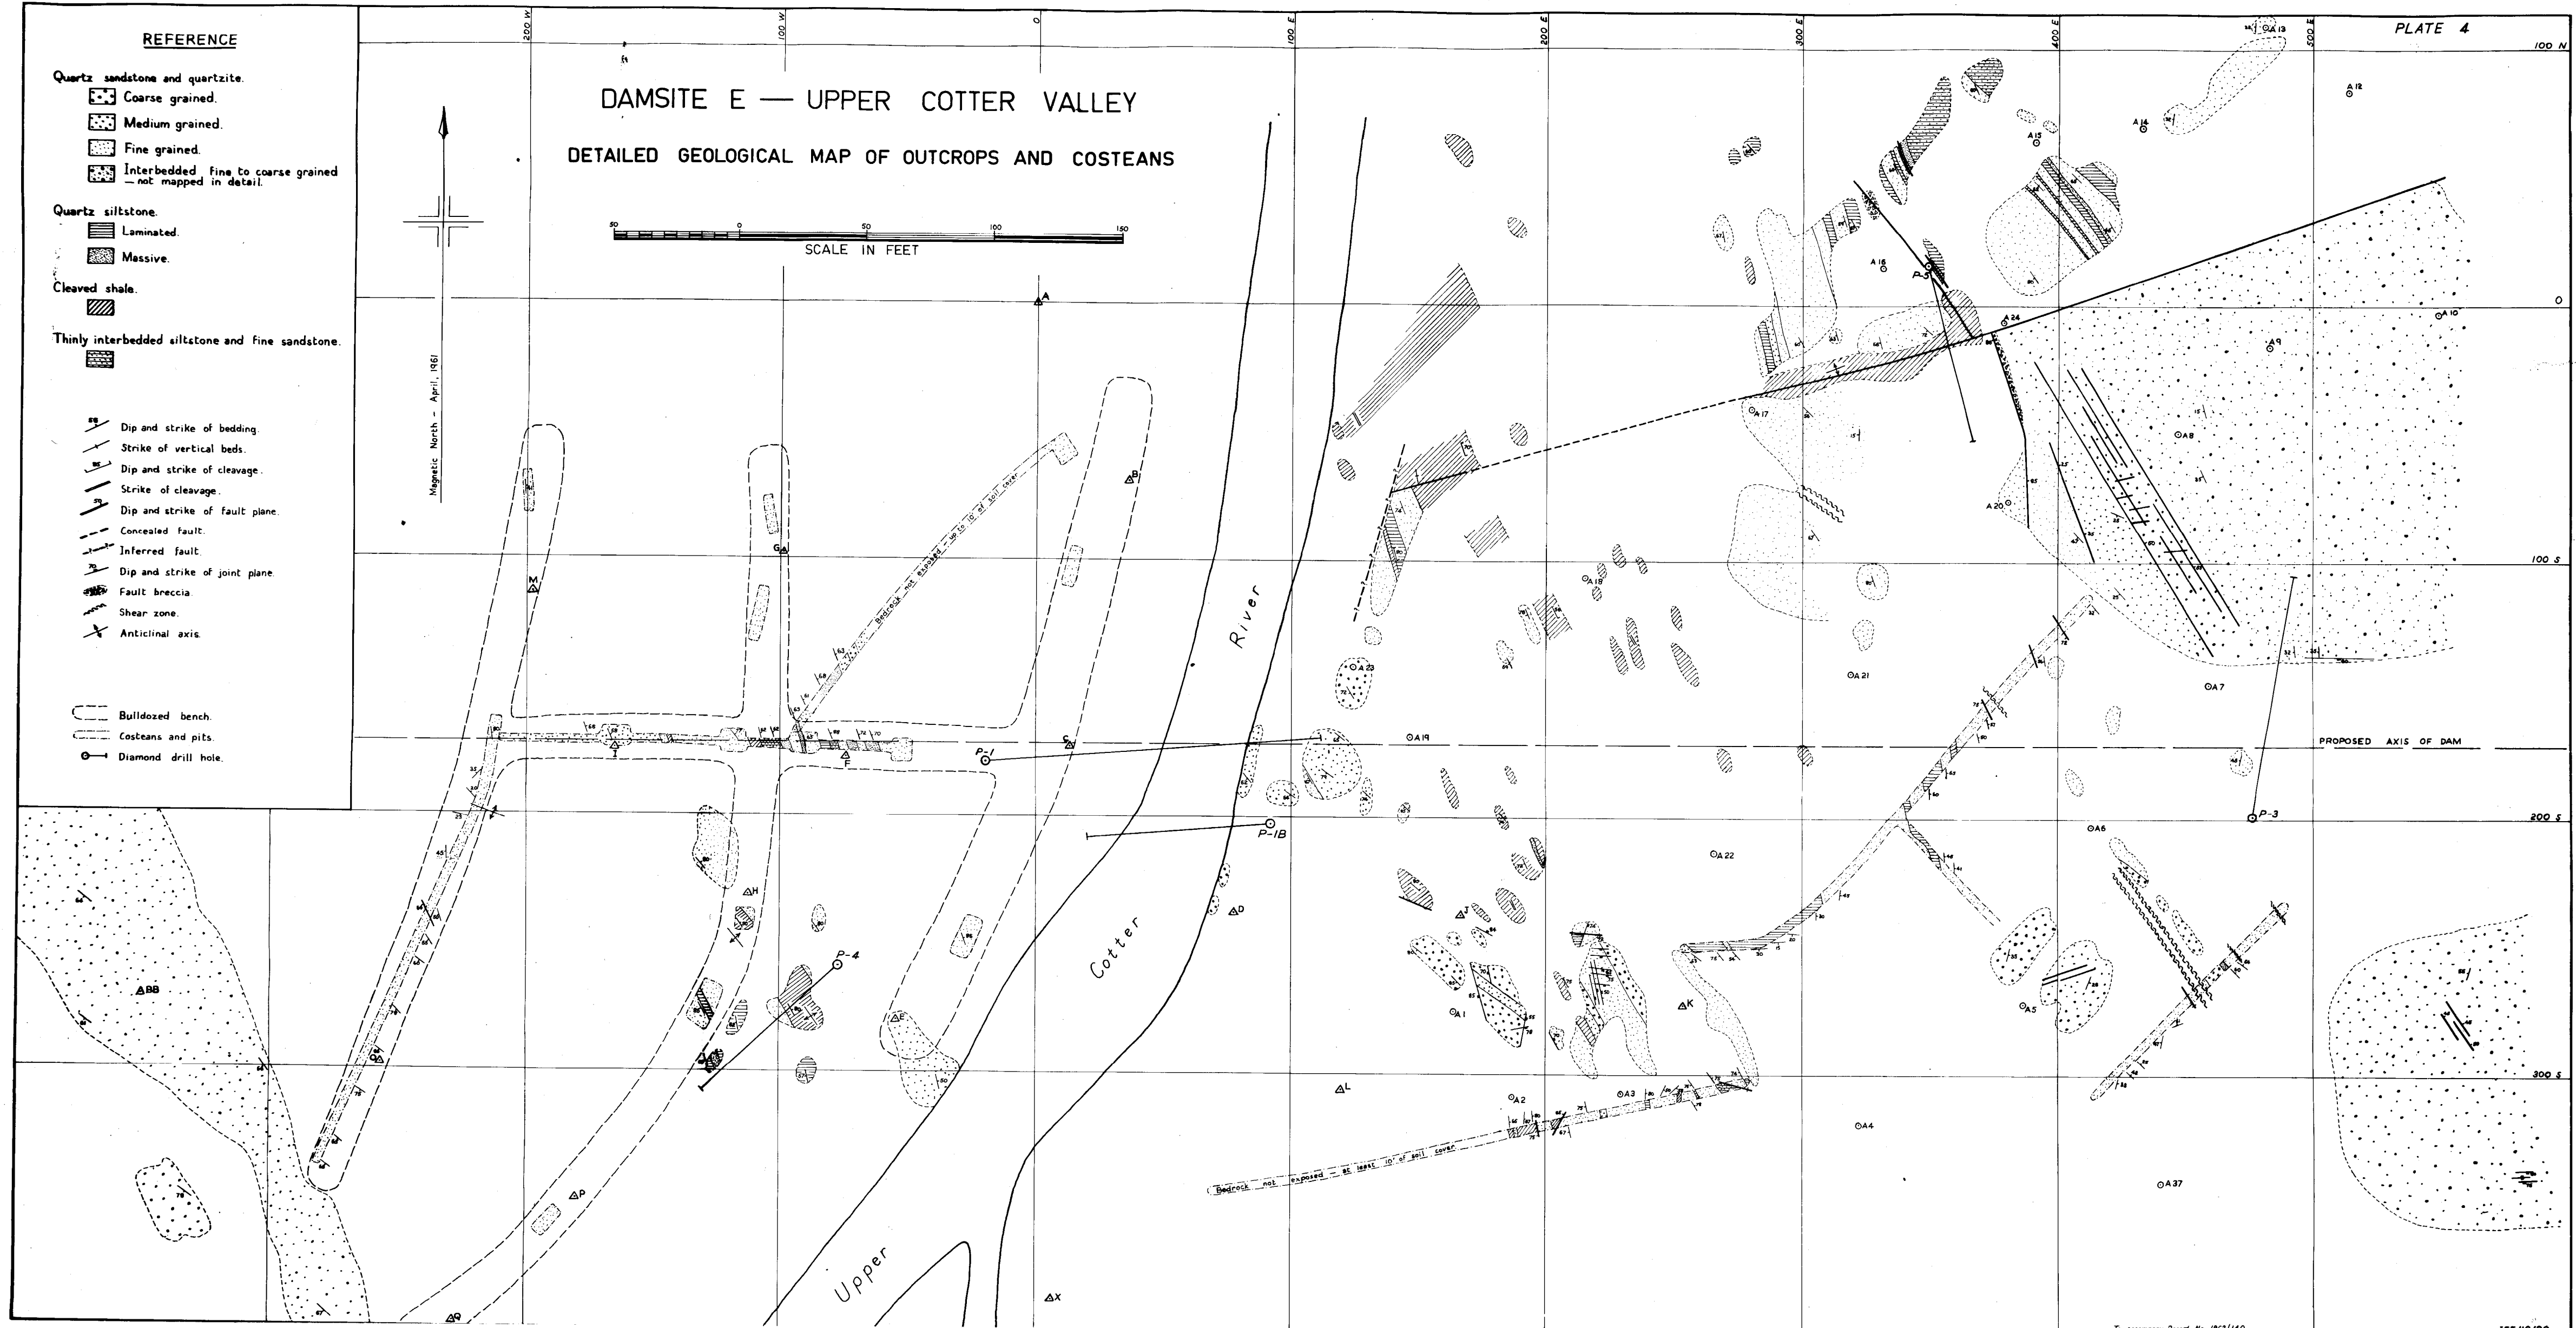
DETAILED GEOLOGICAL MAP OF OUTCROPS AND COSTEANS

Costeans on the east bank have exposed several faults and shear zones, as shown on the detailed map (Plate 4). The faults exposed in the T-shaped costean may be correlated with those in the short parallel costean, and are seen to form part of the north-north-west system of faulting; they dip very steeply. The most prominent of these fractures is the shear zone which has been traced towards station A17 and which coincides approximately with a synclinal axis. The shear zone is 8 feet wide in the short costean, and is shown up well in a seismic profile along the proposed axis of the dam.

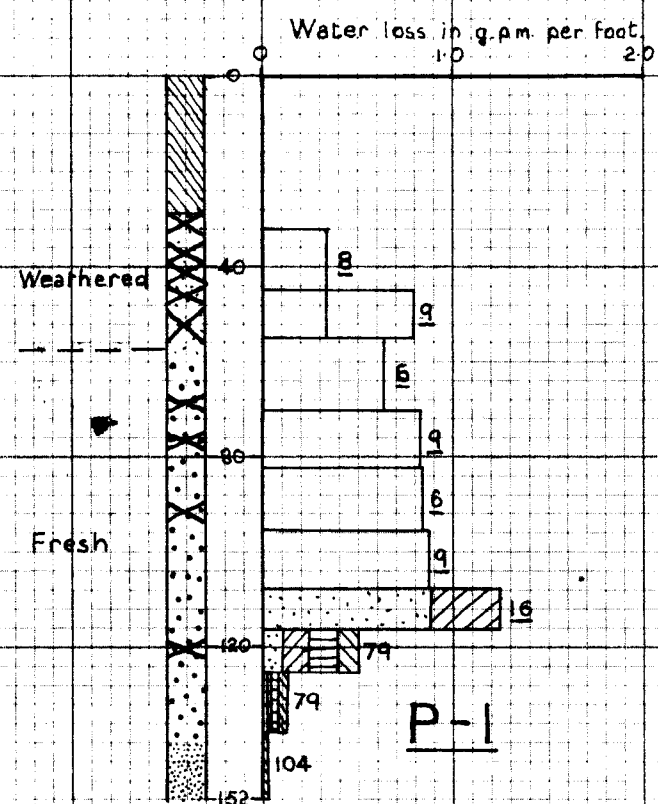
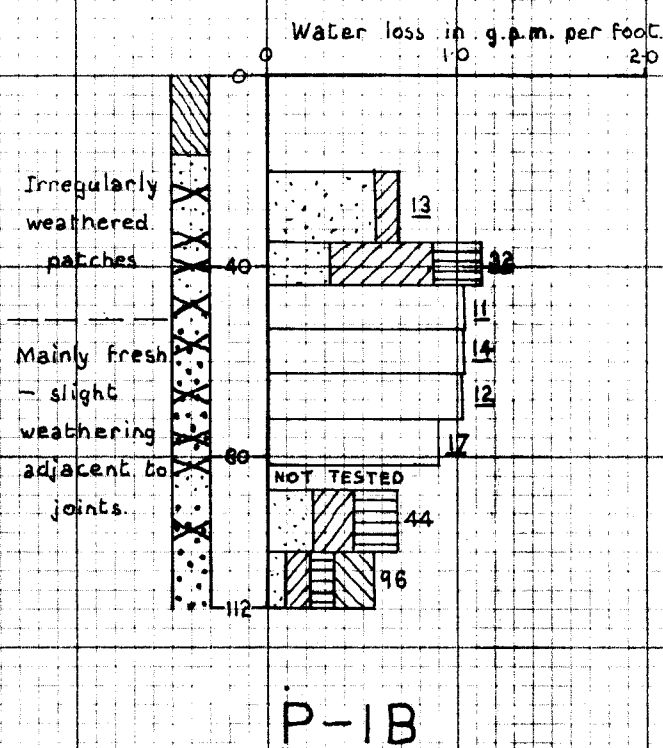
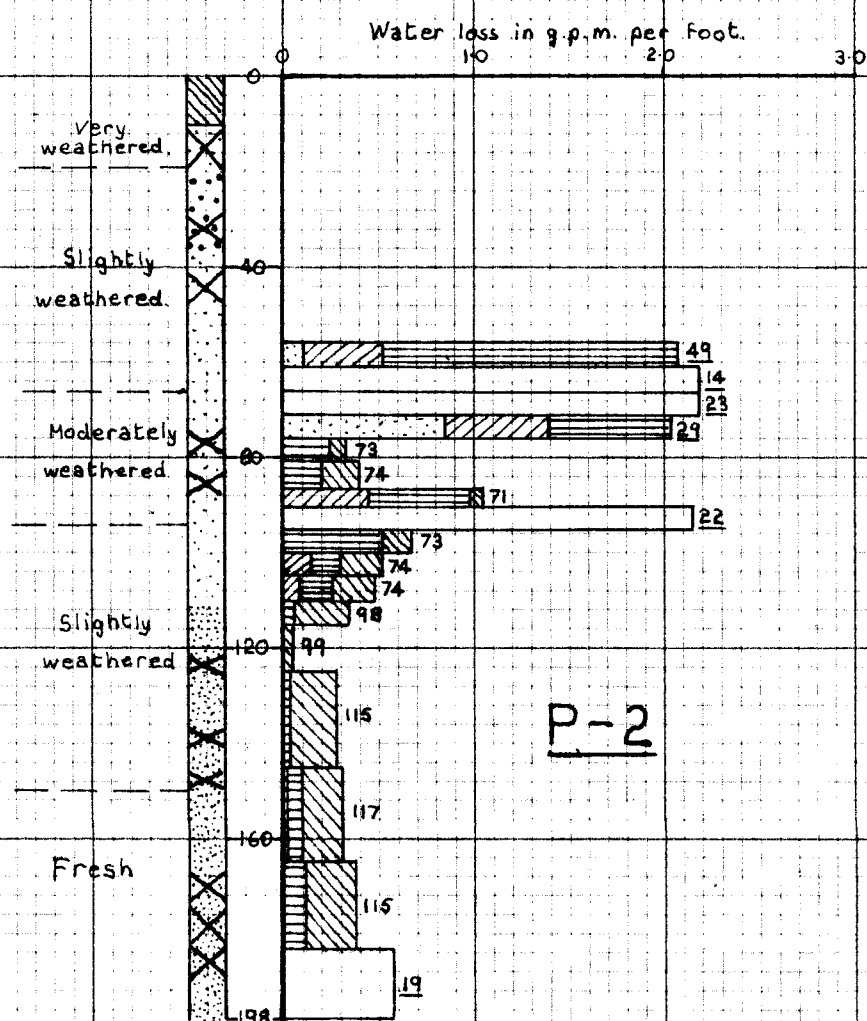
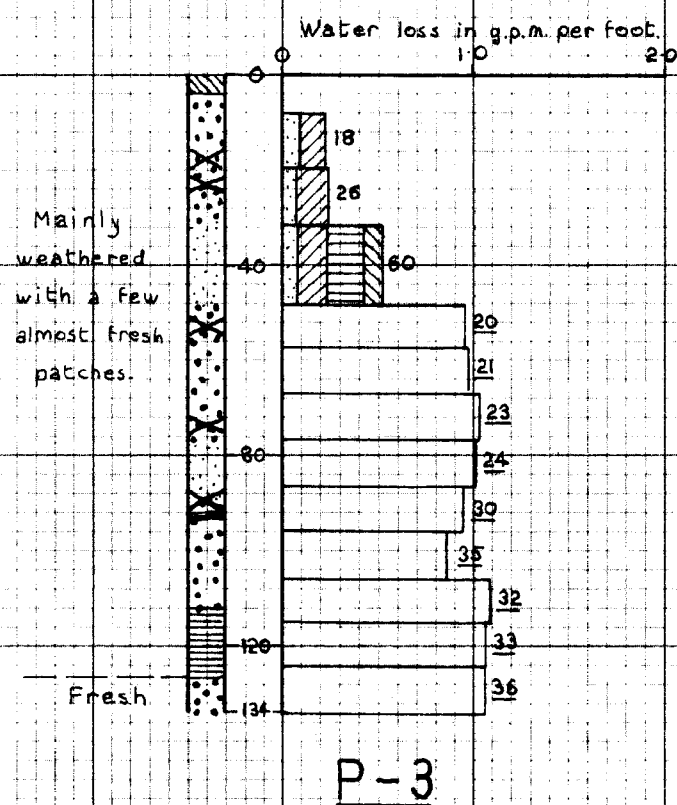
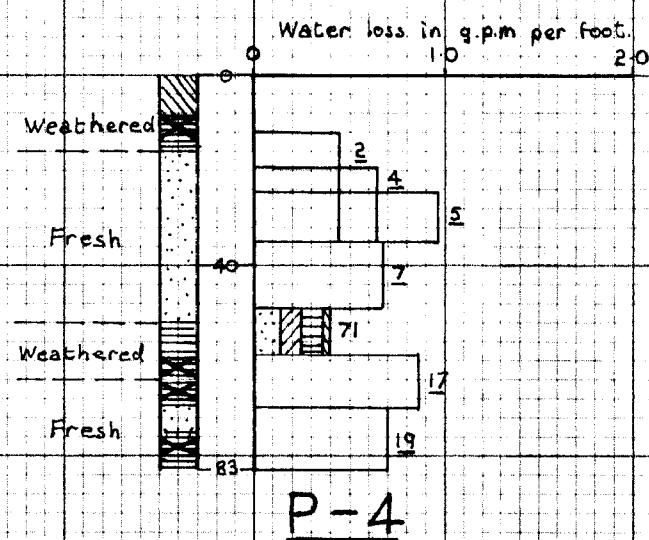
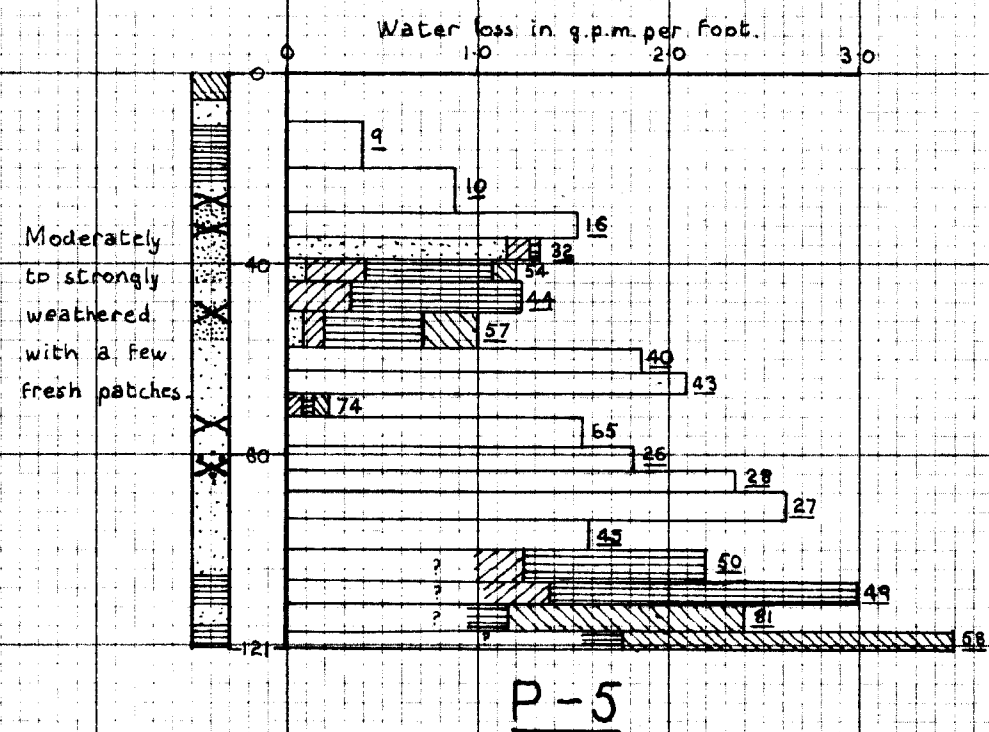
DRILL CORE LOGS AND WATER PRESSURE TEST RESULTS

The core from drill hole P-1 shows many broken zones, particularly between 30 and 60 feet (inclined) from the surface, and several thin zones of crushed, weathered and decomposed bedrock were found. This, together with the poor water pressure test results down to 110 feet, suggested a fault zone below the river, and P-1B was drilled in an attempt to verify this possibility. Again, several broken and crushed zones were disclosed, and poor water pressure test results were obtained between 40 feet and 90 feet. The zone of faulting has not been traced on the river banks, and so its exact location is not known; it is probably parallel to the river at the proposed axis. Silicification of the outcrops low on the east bank presumably is associated with this fault zone.

In an area where competent sandstones and quartzites with a well developed joint system (and consequently a low water table) form the main foundation rocks, leakage is one of the main engineering problems, and can only be controlled by thorough grouting. The water pressure test results shown in Plate 5 indicate that leakage rates are high and are controlled by fractures in the competent rock. Water losses are particularly high in the downfaulted block north of the proposed axis (see results from P-3) and are moderate in the adjacent areas.

The highest recorded leakage rates, $2\frac{1}{2}$ to $3\frac{1}{2}$ gallons per minute (g.p.m.) per foot of NX hole, occur adjacent to the main east-west fault on the east bank. These results were obtained using 5 foot test sections, however, and comparable results would probably have been obtained if 5-foot sections instead of 20-foot sections were used in other holes, particularly P-3. The recorded leakage through the downfaulted block was 1 g.p.m. per foot at pressures ranging from 20 to 36 pounds per square inch (p.s.i.). These pressures were due only to the weight of the water column in the drill rods, however, and in these tests no back pressures were developed, even with the water pump running at full capacity. Tests in the same drill hole gave much higher pressures in the rocks outside the downfaulted block, and water losses were only moderate ($\frac{1}{2}$ g.p.m. per foot at 30-50 p.s.i.).

Below the river, water losses were high, even though little pressure could be built up by the pump during the tests. These high losses tend to confirm the presence of a fault zone along the river, and are particularly serious as the assumed leakage path is normal to the proposed wall.

Summarising, to prevent serious leakage beneath a dam structure at Site E, an effective grout curtain will be necessary and will have to extend at least down to the present water table in the abutments. From the water pressure tests in P-1 and P-1B, grouting will be necessary to at least 50 feet below the river, and possibly deeper, depending upon the extent of the fault zone below the river. Grout takes can be expected to be high in most of the foundations, particularly in the downfaulted block at the eastern end of the wall. Depending upon the exact location and width of the grout curtain, however, it may be possible to avoid grouting this particularly bad area. Compared with the Bendora Dam, grout takes will be much greater, as the highest water loss recorded during water pressure testing at Site C was $1\frac{1}{2}$ g.p.m. per foot at 50 p.s.i., compared with $3\frac{1}{2}$ g.p.m. per foot at 58 p.s.i. at Site E. At least half of the water pressure tests at Site E recorded a loss greater than 1 g.p.m. per foot, and most of these were at low pressures.

1. The probable fault zone beneath the river should be further examined by drilling and water pressure testing, using a pump of sufficient capacity to develop in the rock at depth a pressure differential equivalent to the pressure which will be exerted when the reservoir is full; the pump must also have the capacity to maintain this pressure, in spite of high water losses, for the duration of the test. (The United States Bureau of Reclamation strongly recommends the use of a centrifugal pump of 250 to 350 gallons per minute capacity against a total dynamic head of 140 to 160 feet. The Bureau of Reclamation does not consider multiple cylinder drill circulation pumps to be satisfactory for water pressure tests because of their low capacity and fluctuating pressures.) Reliable water pressure test results for the zone under the river would materially assist in determining its true nature and importance, likely grout and excavation requirements, and the required depth of the group curtain. Probably one inclined hole 150 feet long would be sufficient for this investigation.

2. Further diamond drilling and water pressure testing should be undertaken between the river and the 3,200-foot contour on the east bank to provide a complete section of the foundation rock sequence. Three inclined or vertical holes, total length 600 to 700 feet, would be required to cover this section. The holes would provide valuable information on the degree of weathering in the core of the anticline, and water pressure testing would show the amount of leakage along the faults already located.

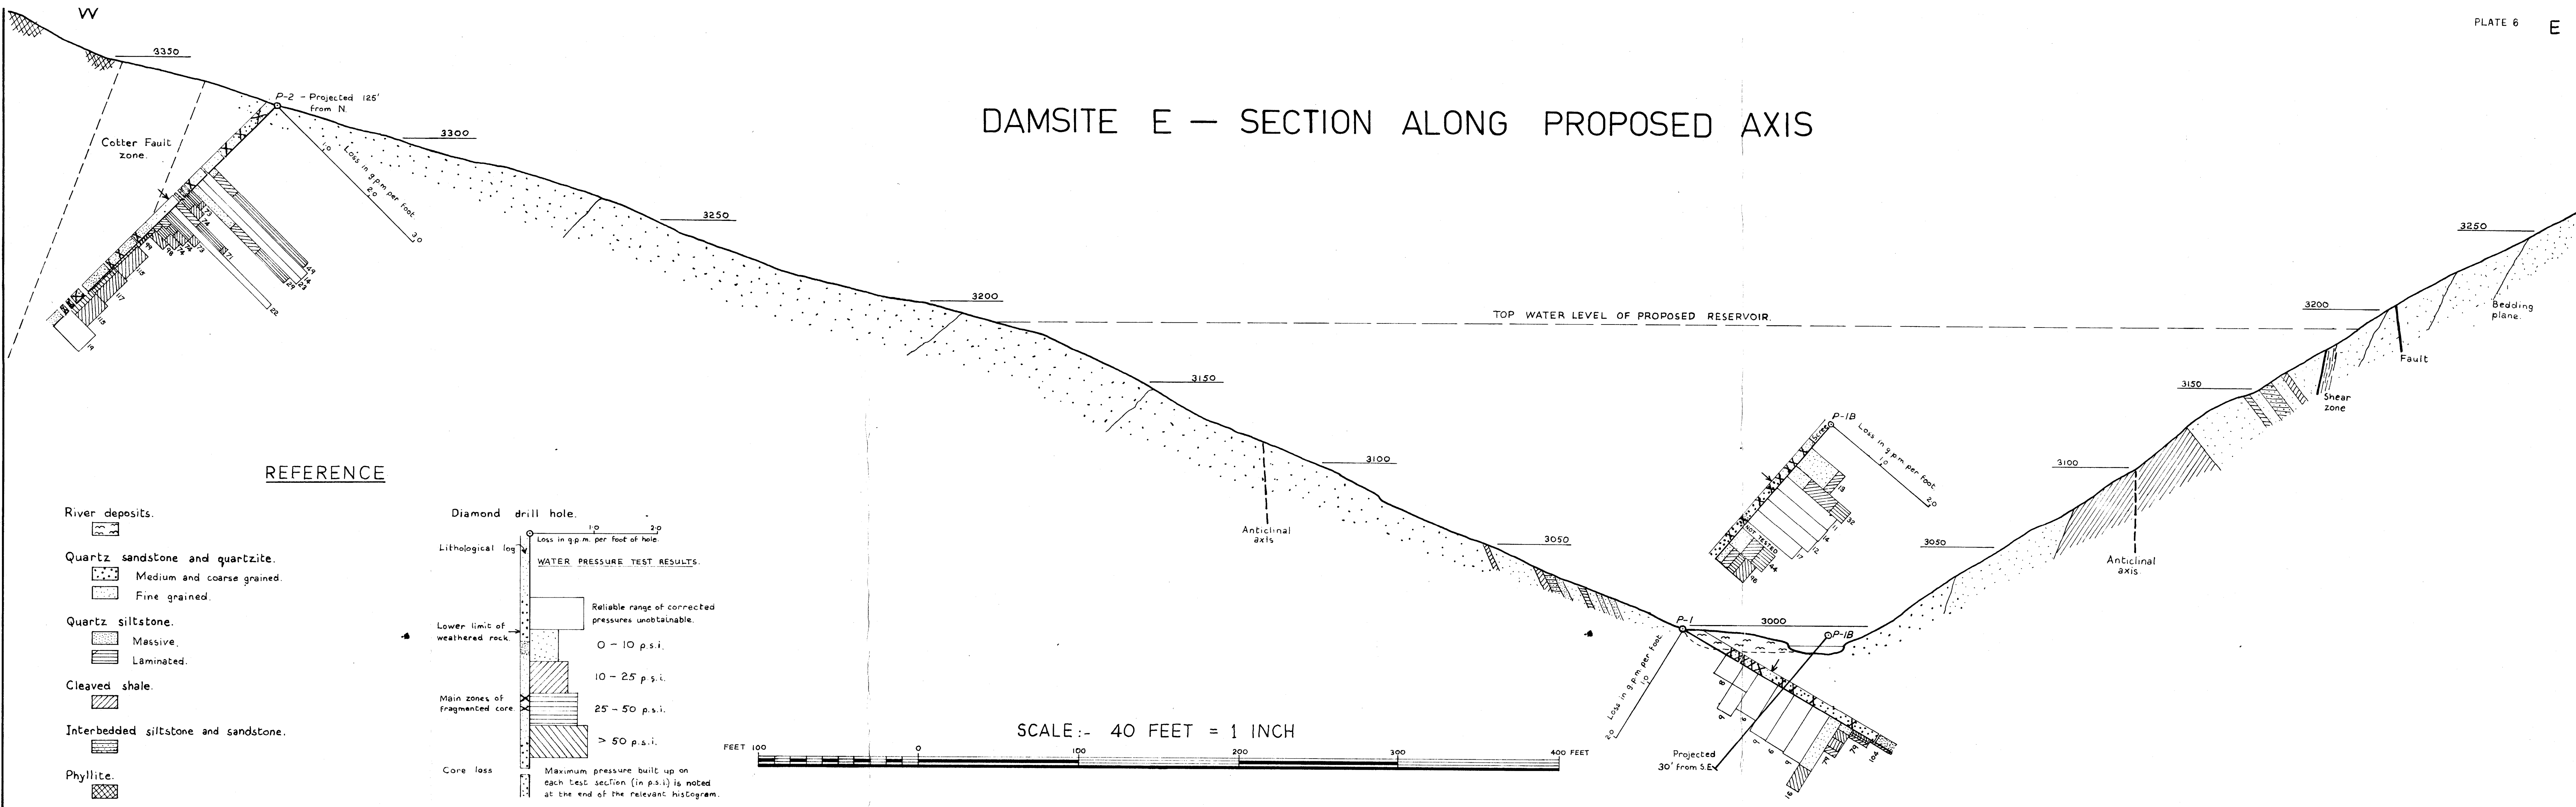
DAMSITE E — SECTION ALONG PROPOSED AXIS

The main seismic traverse was run across the damsite along the proposed dam axis. Four longitudinal seismic velocity ranges were distinguished, namely 1,000 feet per second (ft/sec.), 2,200 to 2,300 ft/sec., 6,000 to 9,000 ft/sec.^{and} 10,000 to 11,500 ft/sec.; these were correlated respectively with soil, scree and eluvium, very weathered and fractured bedrock, and slightly weathered and fractured bedrock. However, the lack of drill hole data at the time of interpretation - hole P-2 had not been drilled - resulted in emphasis being placed upon the degree of weathering rather than upon the open jointing. Hence, according to the seismic profile, the very weathered zone extends to a constant depth of 60 feet over the west bank, and the layer below this is denoted as slightly weathered. Drill hole P-2 shows, on the other hand, that below 15 feet from the surface, the bedrock is only slightly weathered, except for a 30-foot wide fracture zone where weathering is moderate. It seems quite likely therefore, that the comparatively low seismic velocities obtained are due to fracturing and jointing rather than weathering.

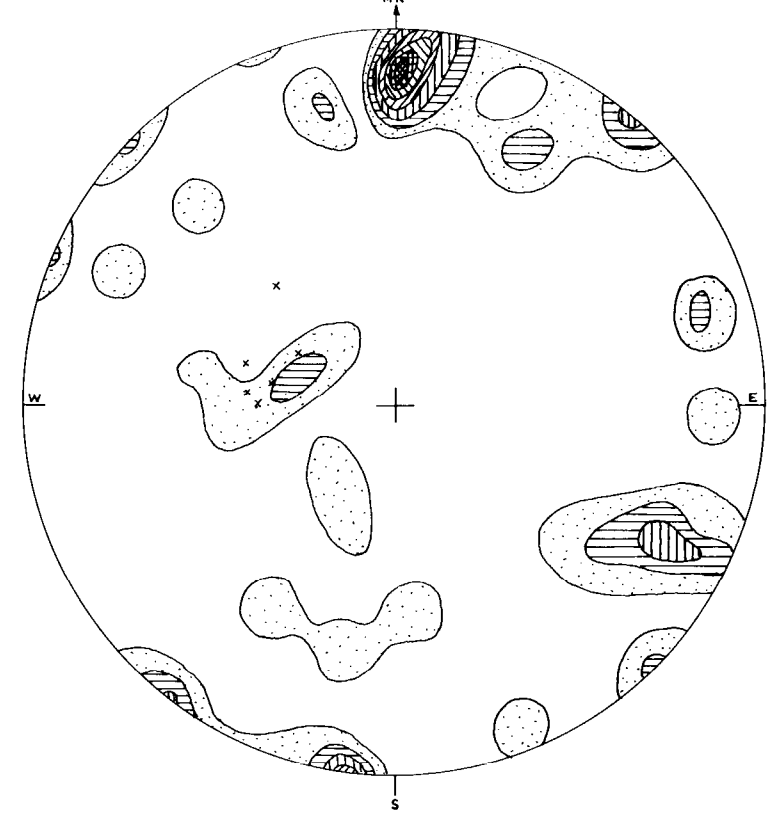
5. 46 MEASUREMENTS FROM COARSE QUARTZ SANDSTONE OUTCROPS NEAR A 5.

The first feature to be noted from these results is the dissimilarity of stereogram no. 5 compared with the others. This refers to the two prominent outcrops near station A5 which could not be fitted into the geology of the surrounding area very well, being very coarse blocks of sandstone surrounded by fine grained sandstones and siltstones. It was thought that they may possibly be large blocks of Tidbinbilla Quartzite which have fallen downhill, and to test this theory the stereogram was superimposed on that of the Tidbinbilla Quartzite and rotated about a vertical axis until the groups of bedding poles coincided. In this position, the strike and dip of bedding in the isolated outcrops were identical with those of the Tidbinbilla Quartzite, and the areas of concentration of the joint poles coincided almost exactly; this proved that the outcrops are, in fact, fallen blocks of Tidbinbilla Quartzite. It should be noted that, in a general case, rotation of the poles on the stereogram about a horizontal axis parallel to the strike is necessary before the rotation of the direction of strike; in this way the dips of bedding on the two stereograms are made equal first. In the case described above, this was unnecessary as the dip of bedding of the isolated outcrops is the same as that of the Tidbinbilla Quartzite.
