FOUNDATION CONDITIONS,  
CANBERRA LAKE DAM, A.C.T.

INTERIM REPORT

AUGUST 1962

E. K. CARTER and E. J. BEST

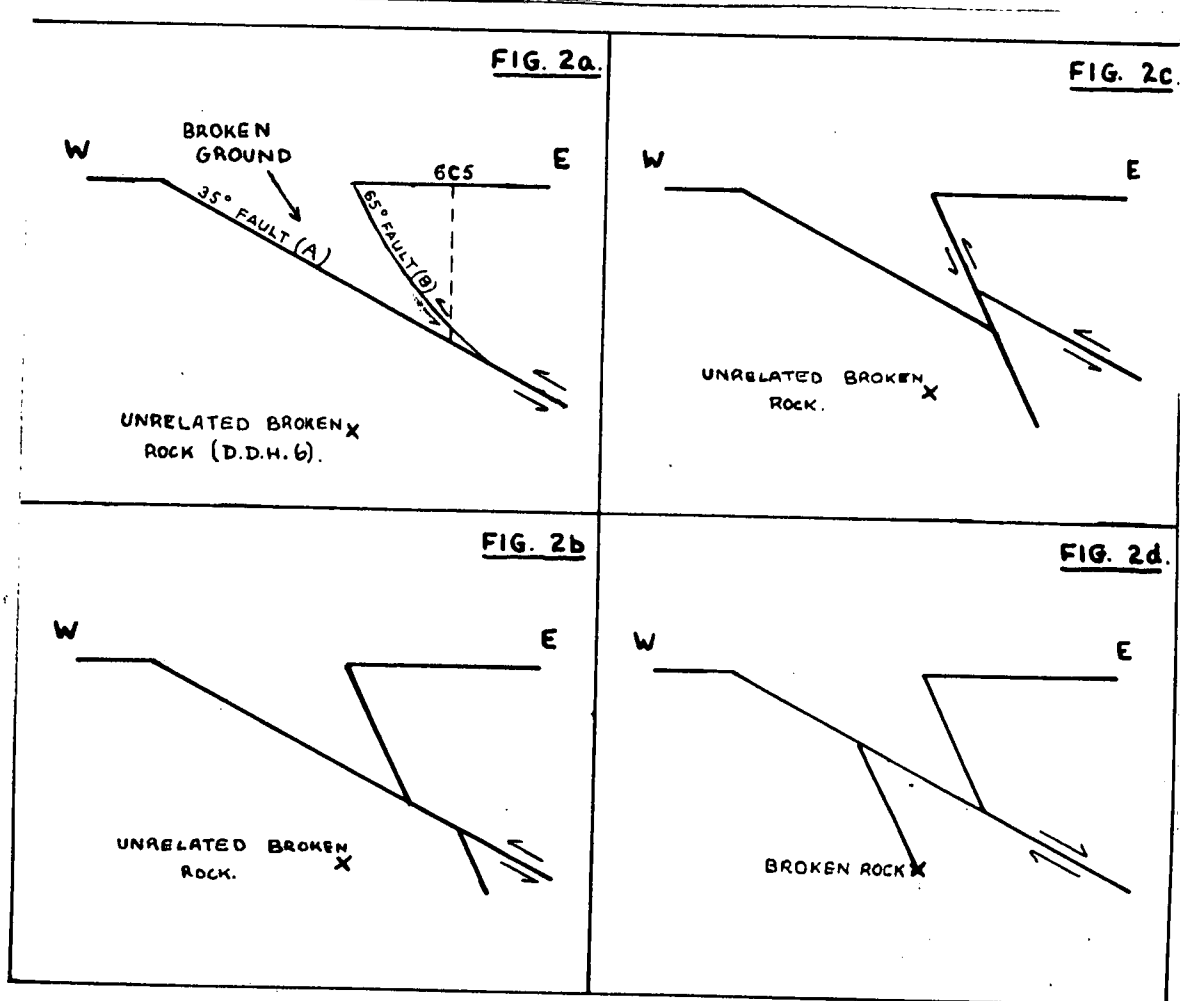
FIGURE 2 : SECTIONS SHOWING POSSIBLE EXPLANATIONS OF THE 35° AND 65° FAULTS AND ADJACENT BROKEN GROUND.

Until the extent and attitude of the known zones of fracturing below Fault A have been established, the relationship between Faults A and B cannot be conclusively determined. Possibilities are shown in Fig.2.

1. The two faults are part of the same thrust fault system, Fault B being a thrust plane extending into the hanging wall of Fault A (Fig. 2a). This explanation was offered by Mr. D.G. Moye (S.M.H.E.A.). This structure would explain the weathered and broken rock above the projected position of Fault A in drill hole 6C5 and of the clay and broken rock at 42½ feet in 6AC6<sup>2</sup>; however, the intersection in 6C1 is in the predicted position. It is also considered that deformation along Fault A could be sufficiently irregular to account for the apparent misfit in 6C5; further, the base of the weathered rock has not been reached in the drill hole.

2. If this possibility (see Fig. 2b) is correct broken (but not necessarily badly weathered) rock is to be expected at the junction of the two faults below Fault A. No opinion can be expressed about the likely displacement of Fault B by Fault A.

3. Fault B is a younger reverse fault on which the plane of Fault A has been displaced a few feet (Fig. 2c) to produce the apparently high position of the broken and weathered rock in hole 6C5 (but see 1. above; further, the intersections of Fault A in 6C1 and 6AC6 are in the predicted positions). If this is so, bad ground probably extends along Fault B below Fault A.

4. If movement on Fault A were hanging-wall-block down, the broken rock intersected in drill hole 6 could be the expression of Fault B in the footwall block (Fig. 2d). Fault A appears to be a typical thrust fault; however, it is not unusual for reciprocal movement to take place on a fault, once established. On the other hand the trace of Fault B has not been observed in the footwall of Fault A. If the fourth explanation is correct, weathered and broken ground can be expected below the present excavation down to at least RL.1660.

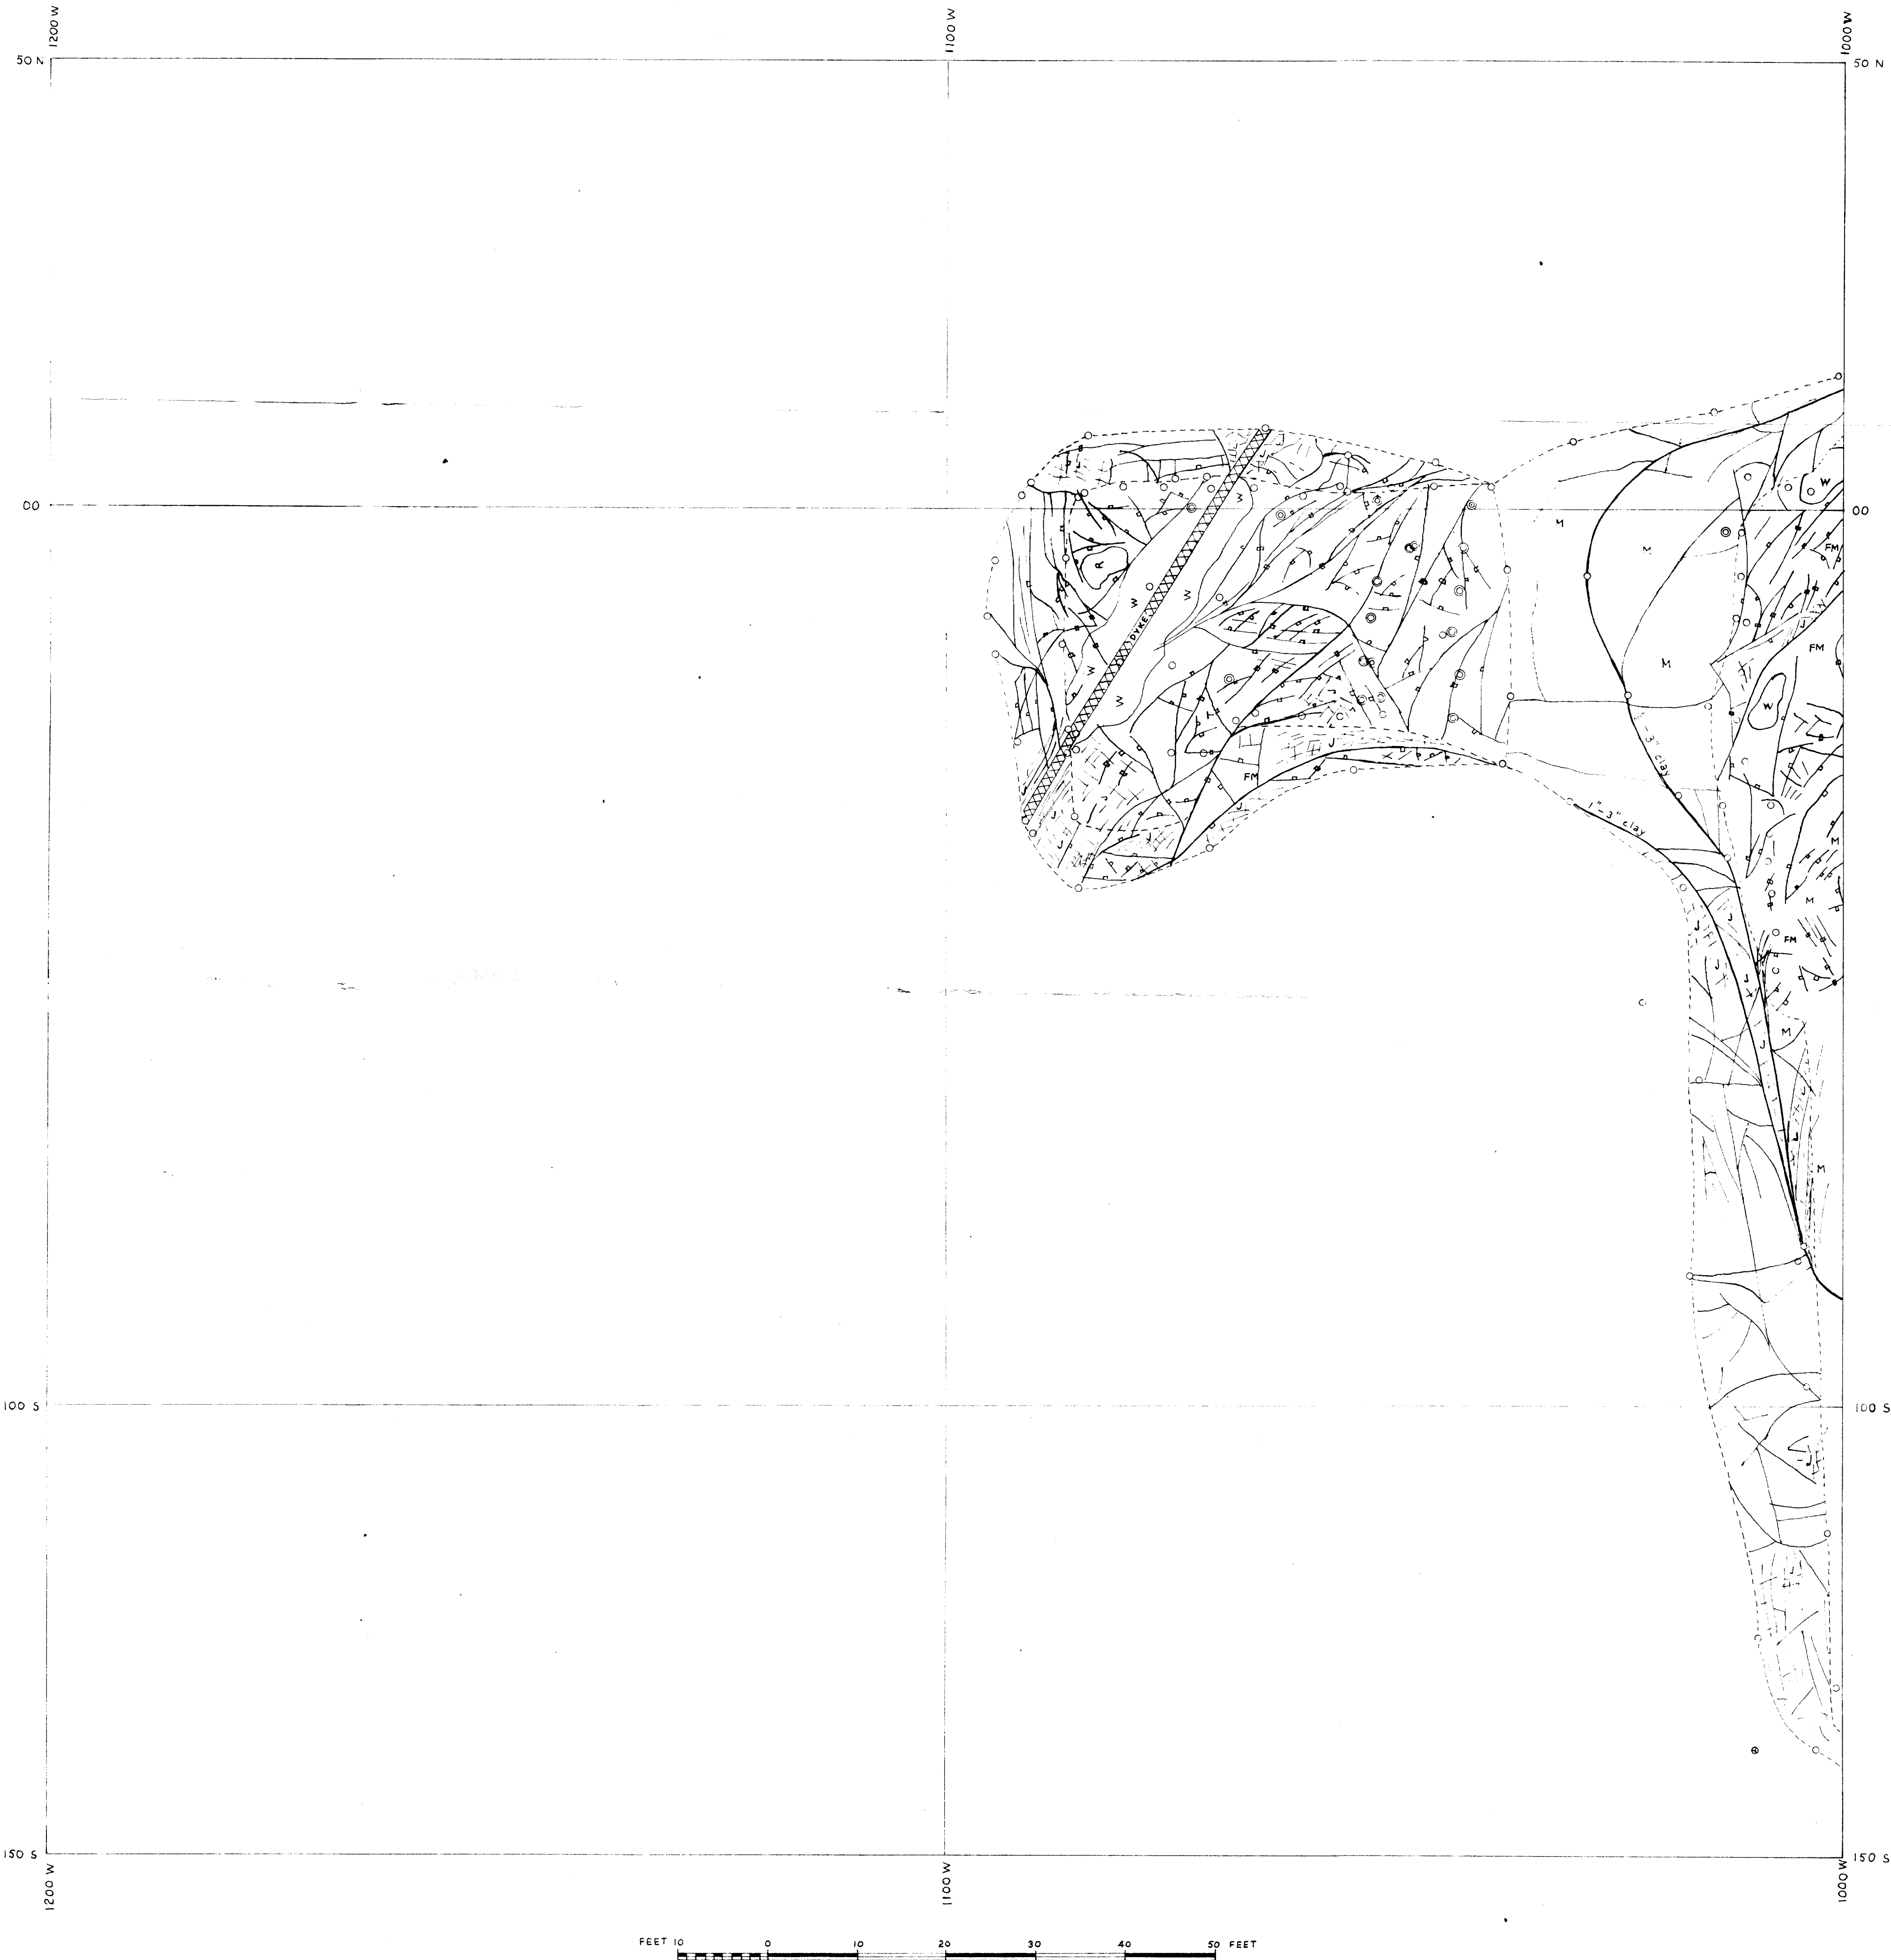
PLATE 2

Several persistent joints, some of them with strongly weathered bounding rocks and clay, were exposed in the foundations of Blocks 2 and 3 (Plates 2 and 3). Most of these were cleaned out as far as practicable and replaced by concrete so that a strong foundation of generally fresh rock was provided for the block. In detail, as a result of the cleaning out of the weathered joints, the block foundation is very irregular. However, a block, covering an area of about 600 square feet, in the eastern corner (upstream adjoining Block 4), which is underlain by clay (along joints) up to 2 inches thick remains in place; it was subsequently found to be part of a larger block, formed by two joints, which has been largely removed from Block 4 (see below).

Many of the persistent, but irregular, joints in the foundations of Blocks 2 and 3 strike between  $055^{\circ}$  and  $070^{\circ}$ , and dip steeply south or vertically. Grout takes, even in the most jointed areas, were negligible.

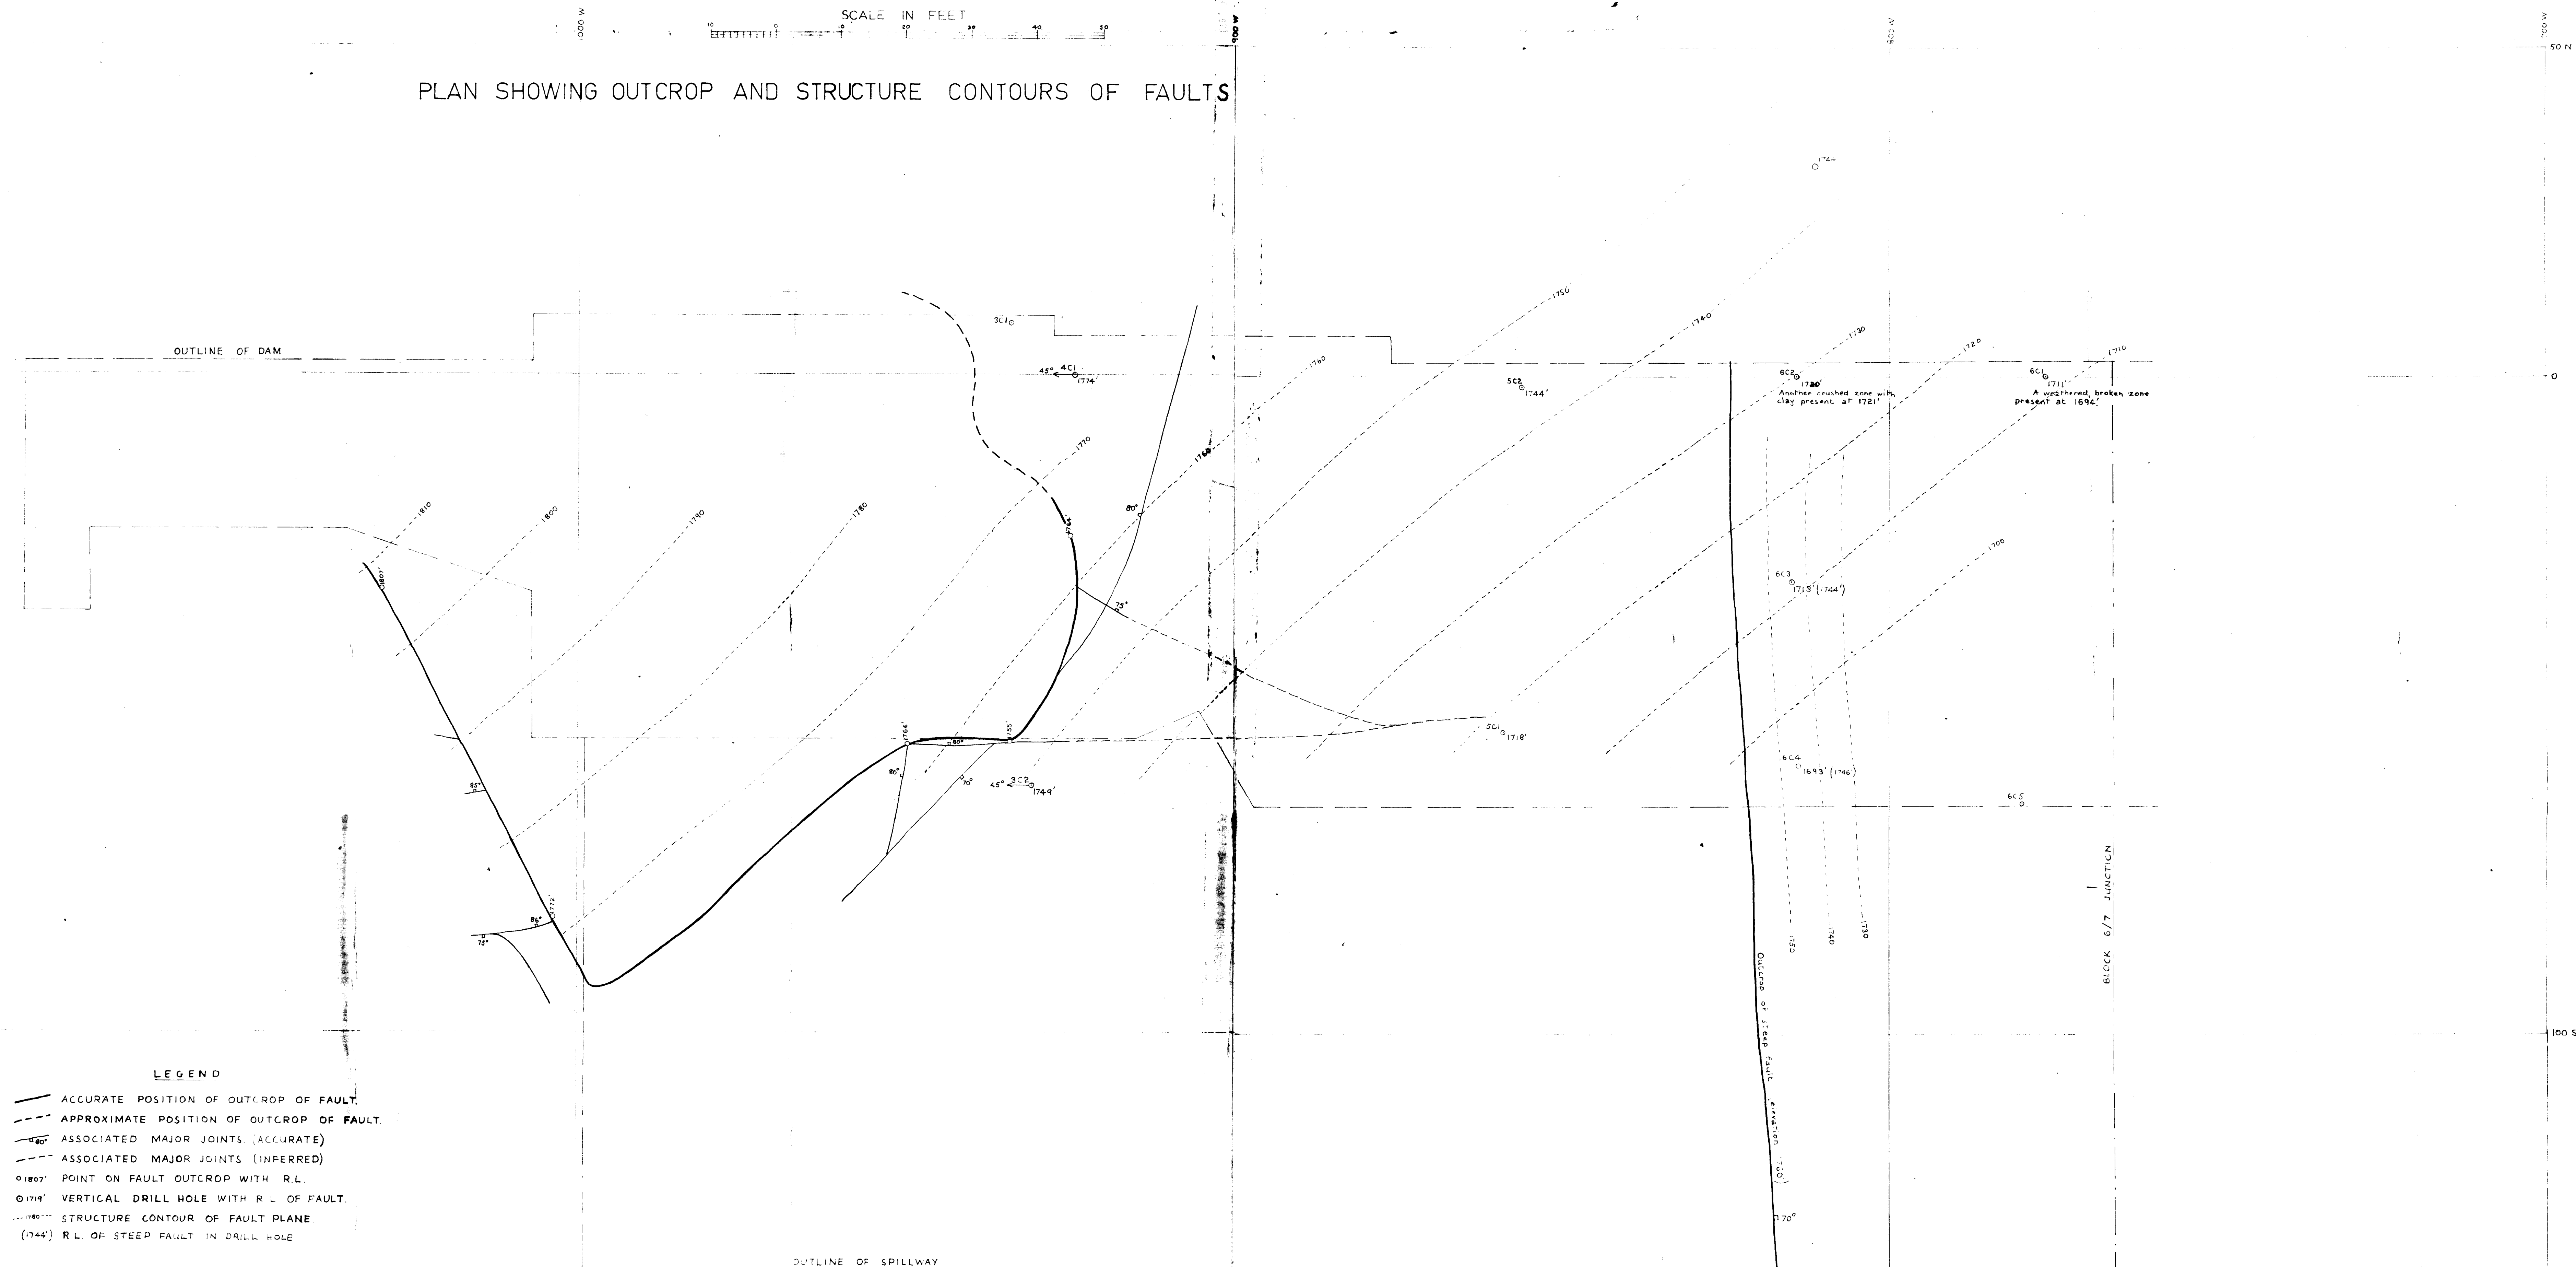
PLAN SHOWING OUTCROP AND STRUCTURE CONTOURS OF FAULTS

The two major faults which have given rise to unsound foundation conditions intersect or meet in this section. The distribution of unsound rock, as known, is shown in Figure 2 and Plate 10. The bad ground, consisting of profoundly to moderately weathered rock (some of which was extensively sheared before weathering) and clay has formed in the acute angle between the  $35^{\circ}$  dipping thrust fault, which strikes at  $065^{\circ}$ , and a fault which strikes at  $020^{\circ}$ , normal to the axis of the dam, and dips  $65^{\circ}$  E below Block 6\*. The volume of unsound material has been increased by weathering along joints in the footwall of the thrust fault.
