RECORD No. 1962/151

MACQUARIE ISLAND GEOPHYSICAL OBSERVATORY WORK, 1961

P.J. Milne

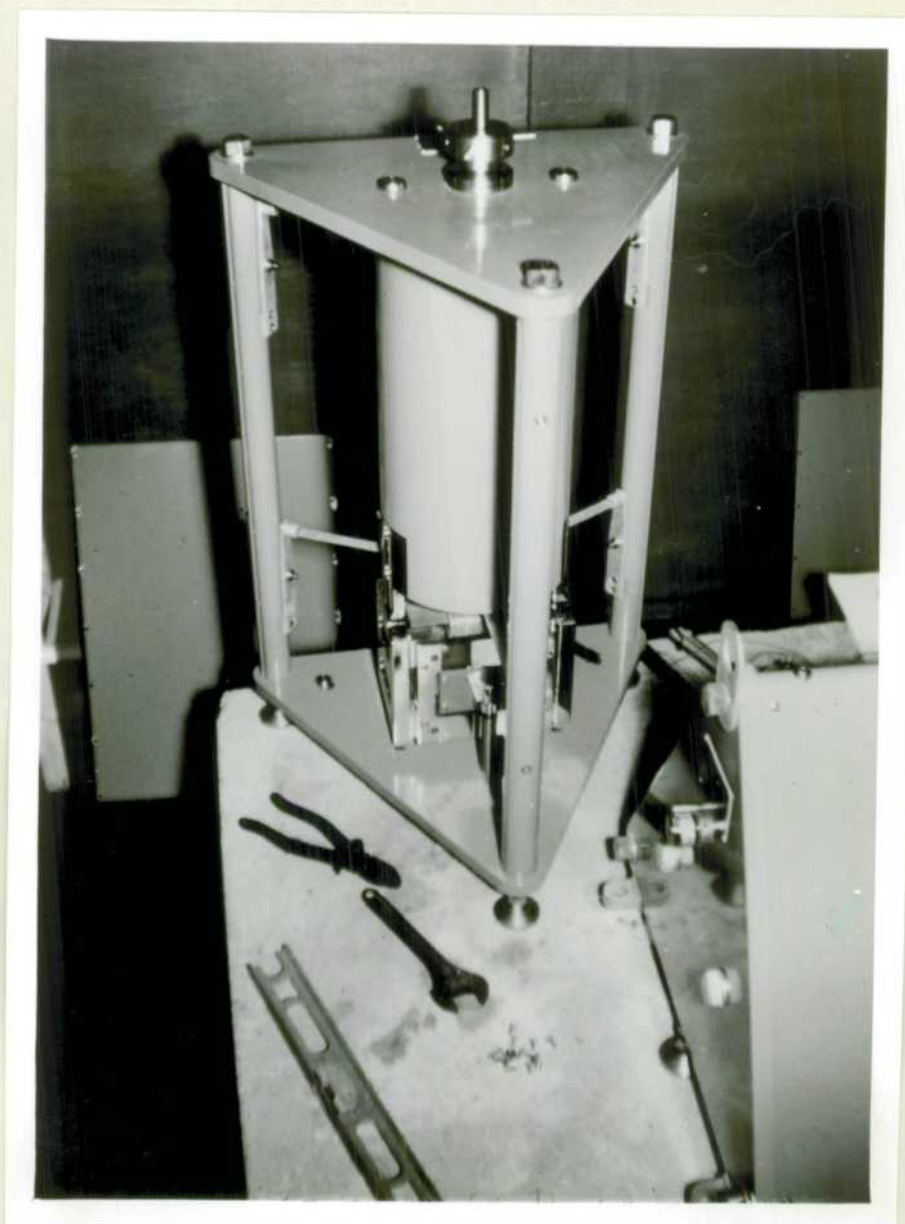
VERTICAL SEISMOMETER
DURING INSTALLATION

Installation. The setting up of the seismometers and recording unit was carried out as instructed in the manuals provided by the manufacturing company. All instruments were accommodated on the existing pier (see Plate 1). A part of the shelf above the pier had to be cut to allow room for the recorder.

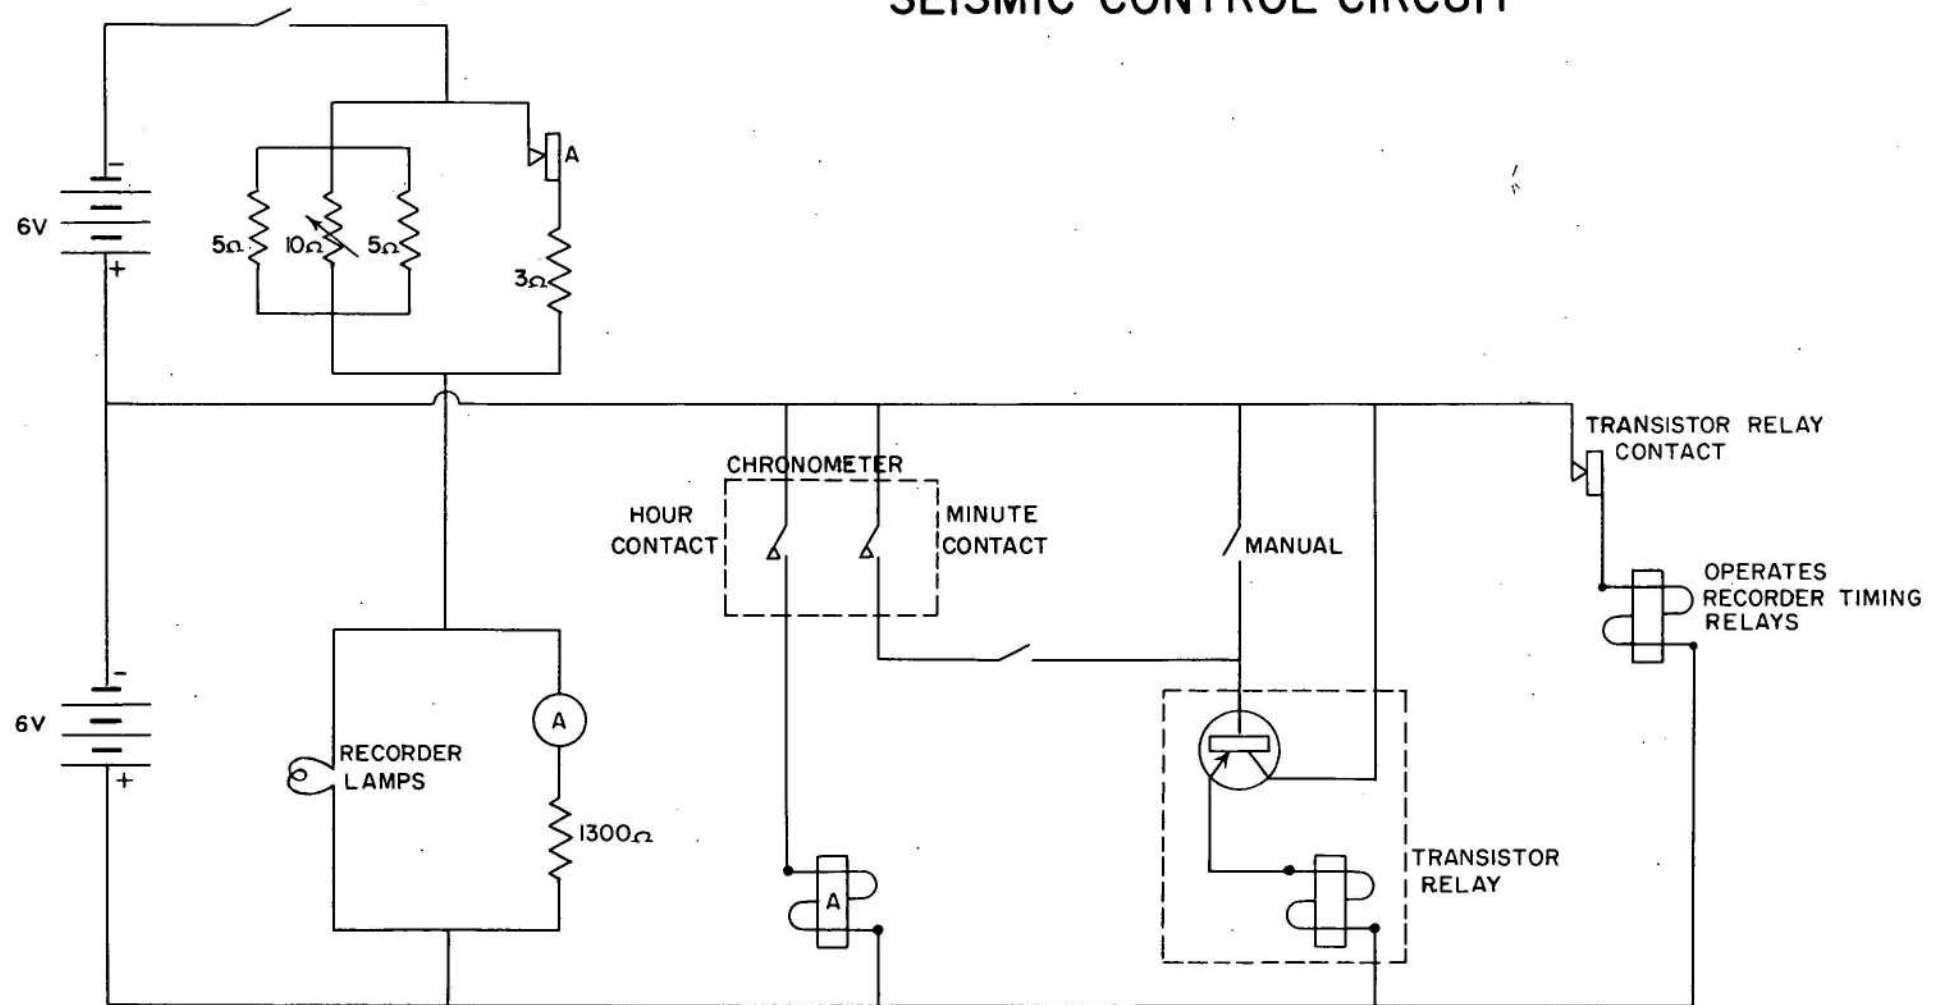
SEISMIC CONTROL CIRCUIT

Seismic control circuit (see Plate 2)

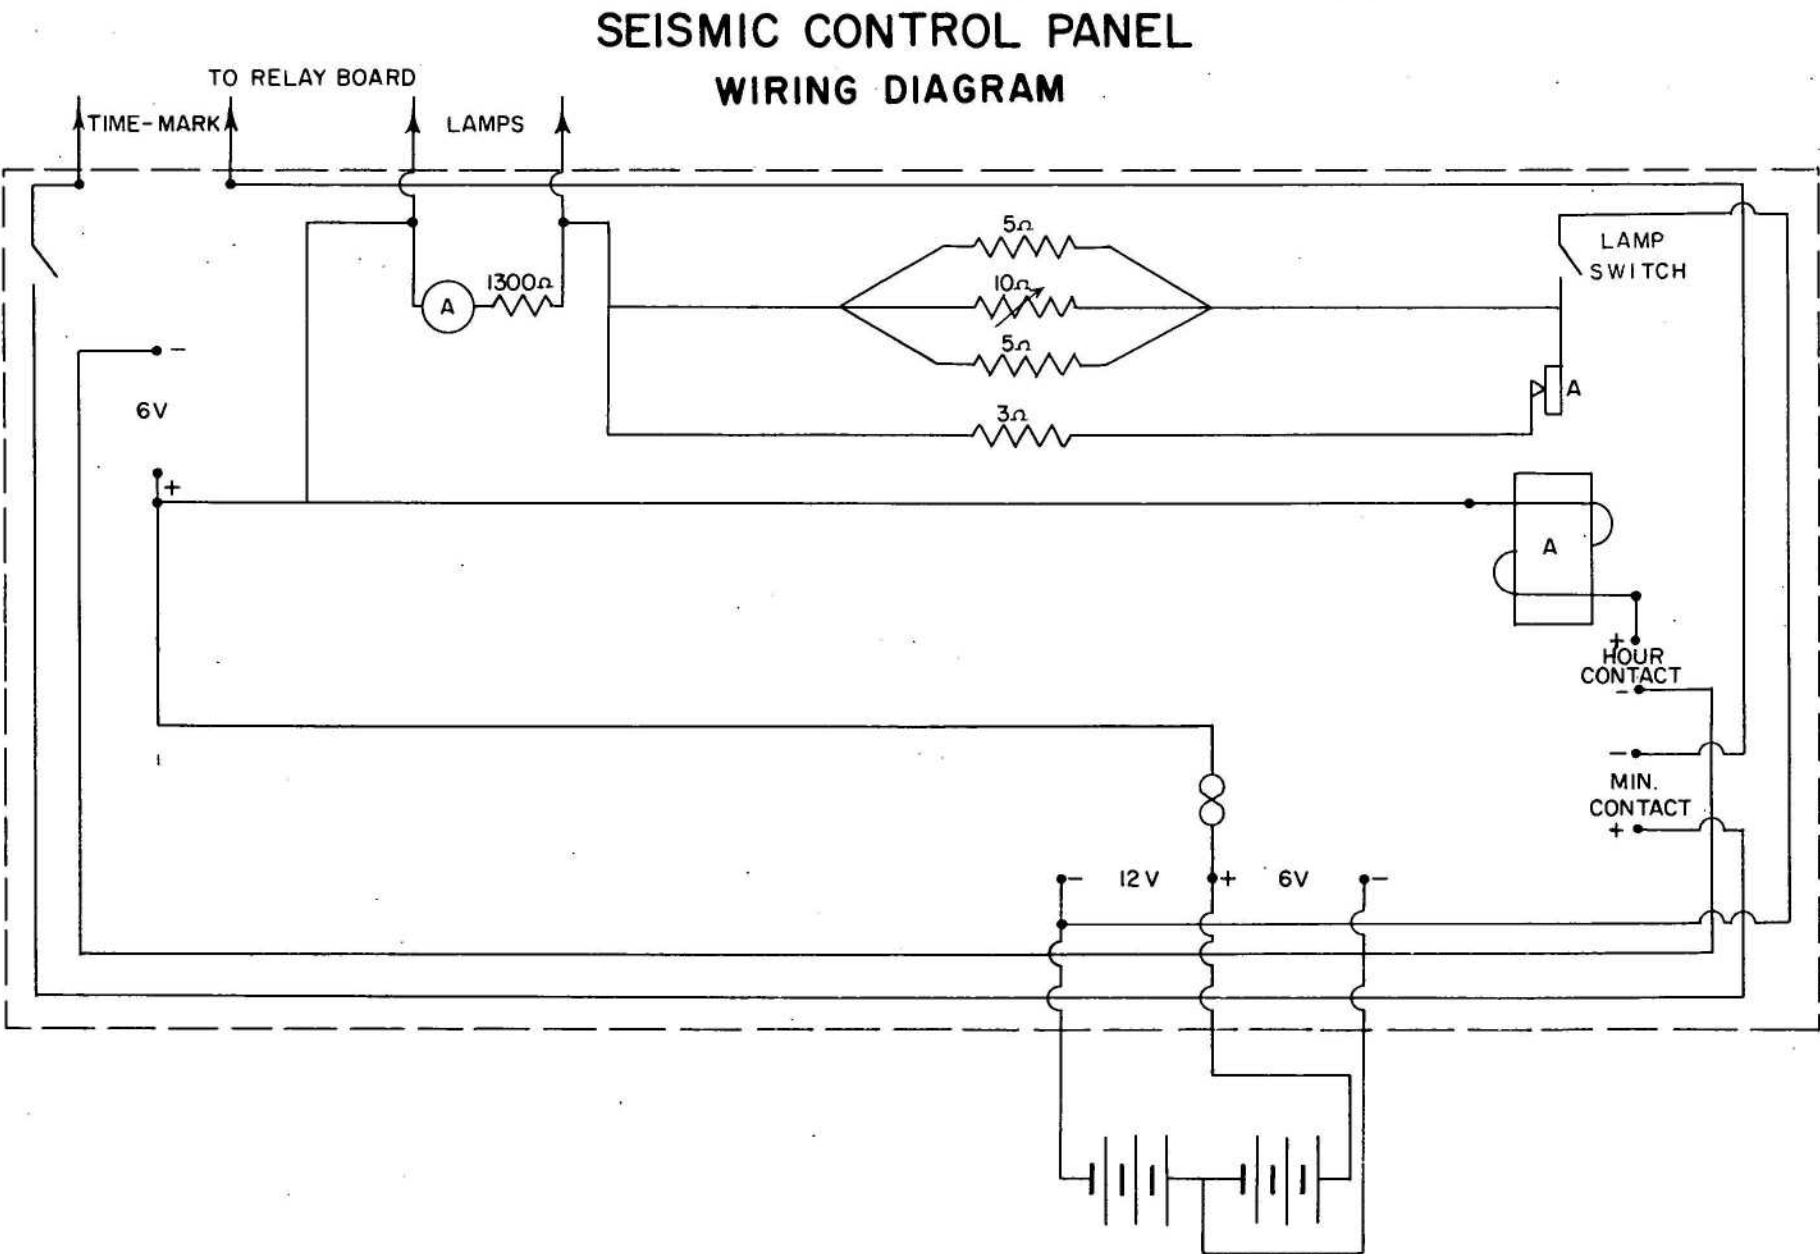
Geophysical Branch, Bureau of Mineral Resources, Geology & Geophysics G54-61

Control Panel. With some modifications to accommodate the new installation, the existing office control panel was used (see wiring diagram Plate 3). The indicator meter was retained in parallel with the recording lamps, and proved a useful guide to the condition of the lamps and batteries. The ceramic-base potentiometer was retained for intensity control, but fine control of each lamp was obtained by means of the potentiometer in each branch of the recorder-lamp circuit. Extra resistance was required to reduce the voltage from 12 to 8 volts for lamp operation. The lamp switch was used as a master for all lamps during record change. Separate 6-volt terminals were available for the time-mark relays and the relays of the thermostatically controlled strip heaters.

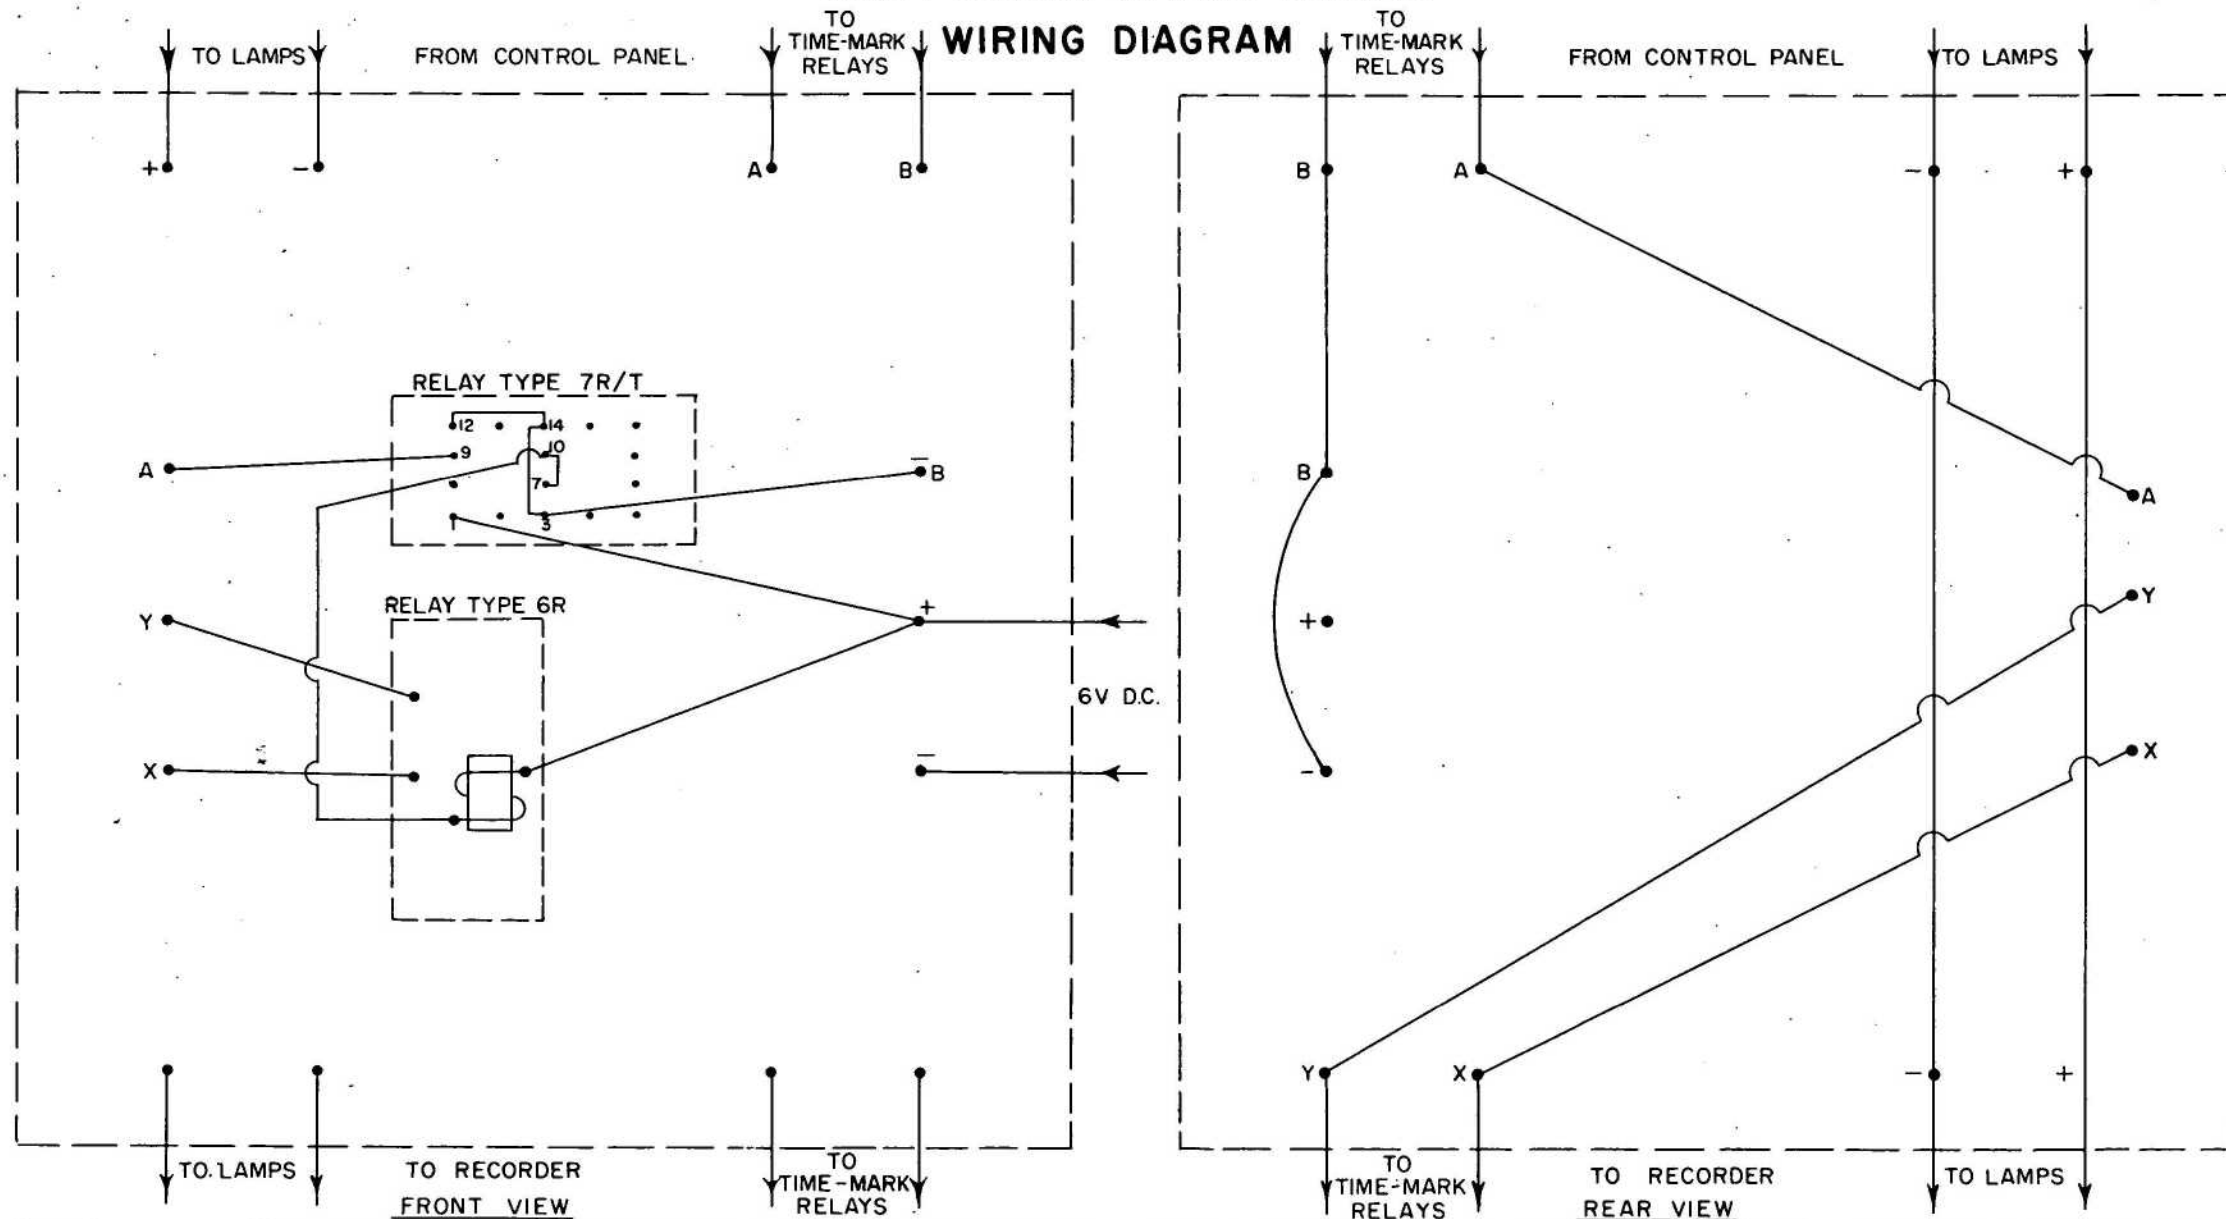
TIME-MARK RELAY BOARD

Time-mark relay board. The terminal board, which previously sat loosely on the pier, was screwed to the northern wall of the vault. It was also used as a time-mark relay board (see wiring diagram, Plate 4).
