RECORD N<sup>o</sup>. 1963/76

GEOLOGICAL INVESTIGATION.  
PORT MORESBY N<sup>o</sup>. 2  
UNDERGROUND HYDRO-ELECTRIC  
POWER GENERATION SCHEME,  
LALOKI RIVER, T.P.N.G. 1962

*E.K. CARTER and G.H. BROUXHON*

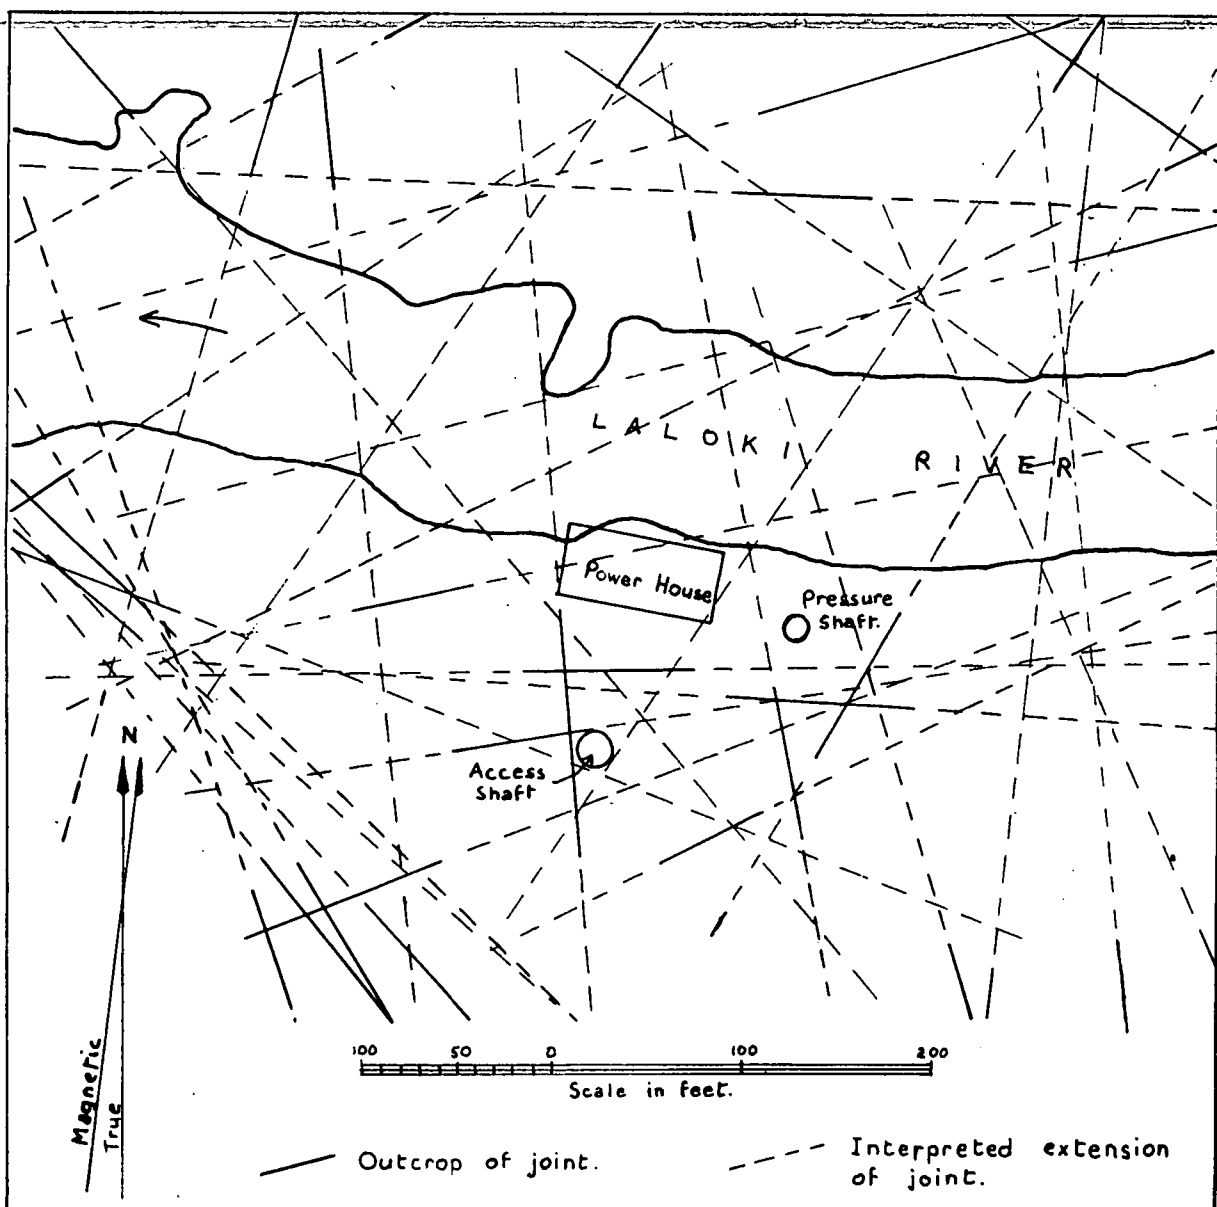
Fig 4 :- Location of underground power station in relation to joints at the surface.

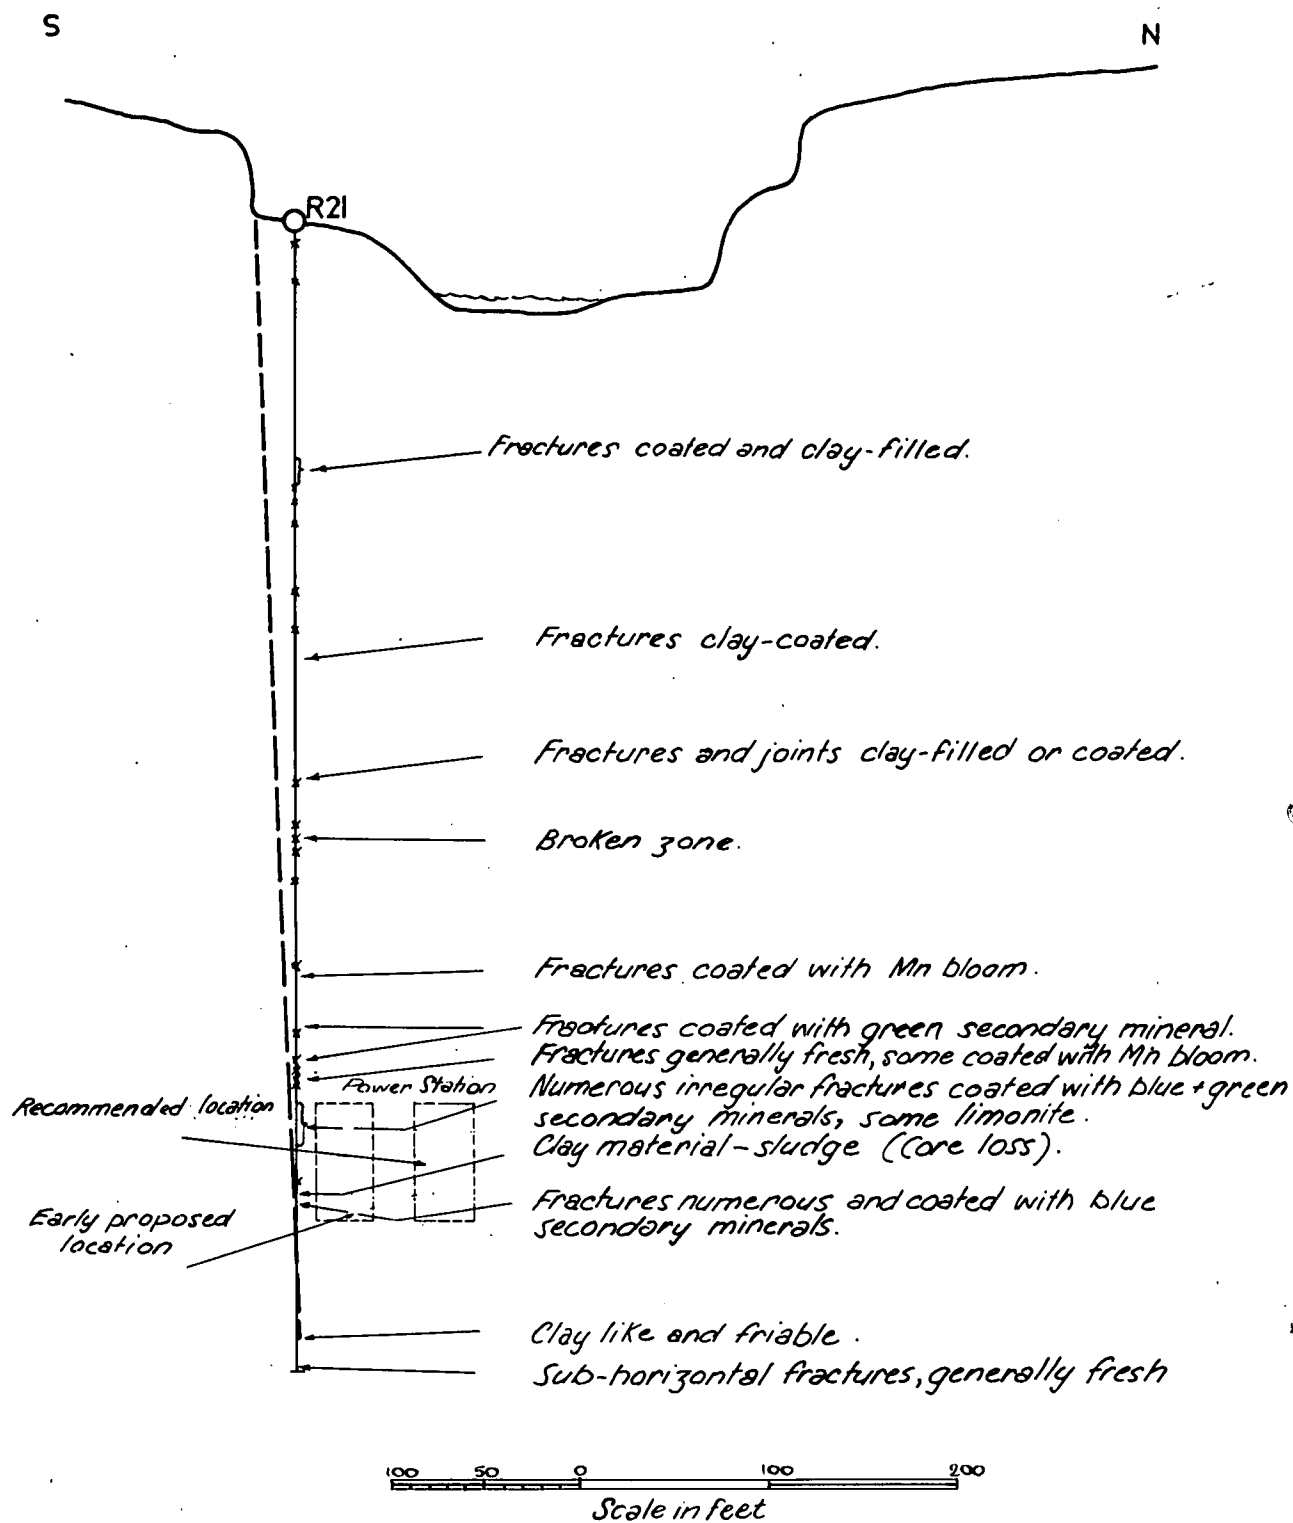
*Figure 5.*

Vertical drill hole R21 is believed to have passed for about 200 feet through a zone of weathered and broken rock associated with a fault that strikes  $074^{\circ}$  magnetic and dips  $88^{\circ}$  N. A cliff face of this orientation stands only 18 feet south of the collar of R21 (see Plate 1 and Fig.4). The persistence of the fracturing in R21 suggests a weathered and broken zone up to 5 feet wide, provided the hole did not deflect along the structure; such a wide zone is more likely to be due to a fault than a joint. However R23 did not reveal any significant shear or fault zone along strike, so possibly R21 intersected the junction of two joints.

*Intersection of 88° dipping fault  
on joint by drill hole R21*

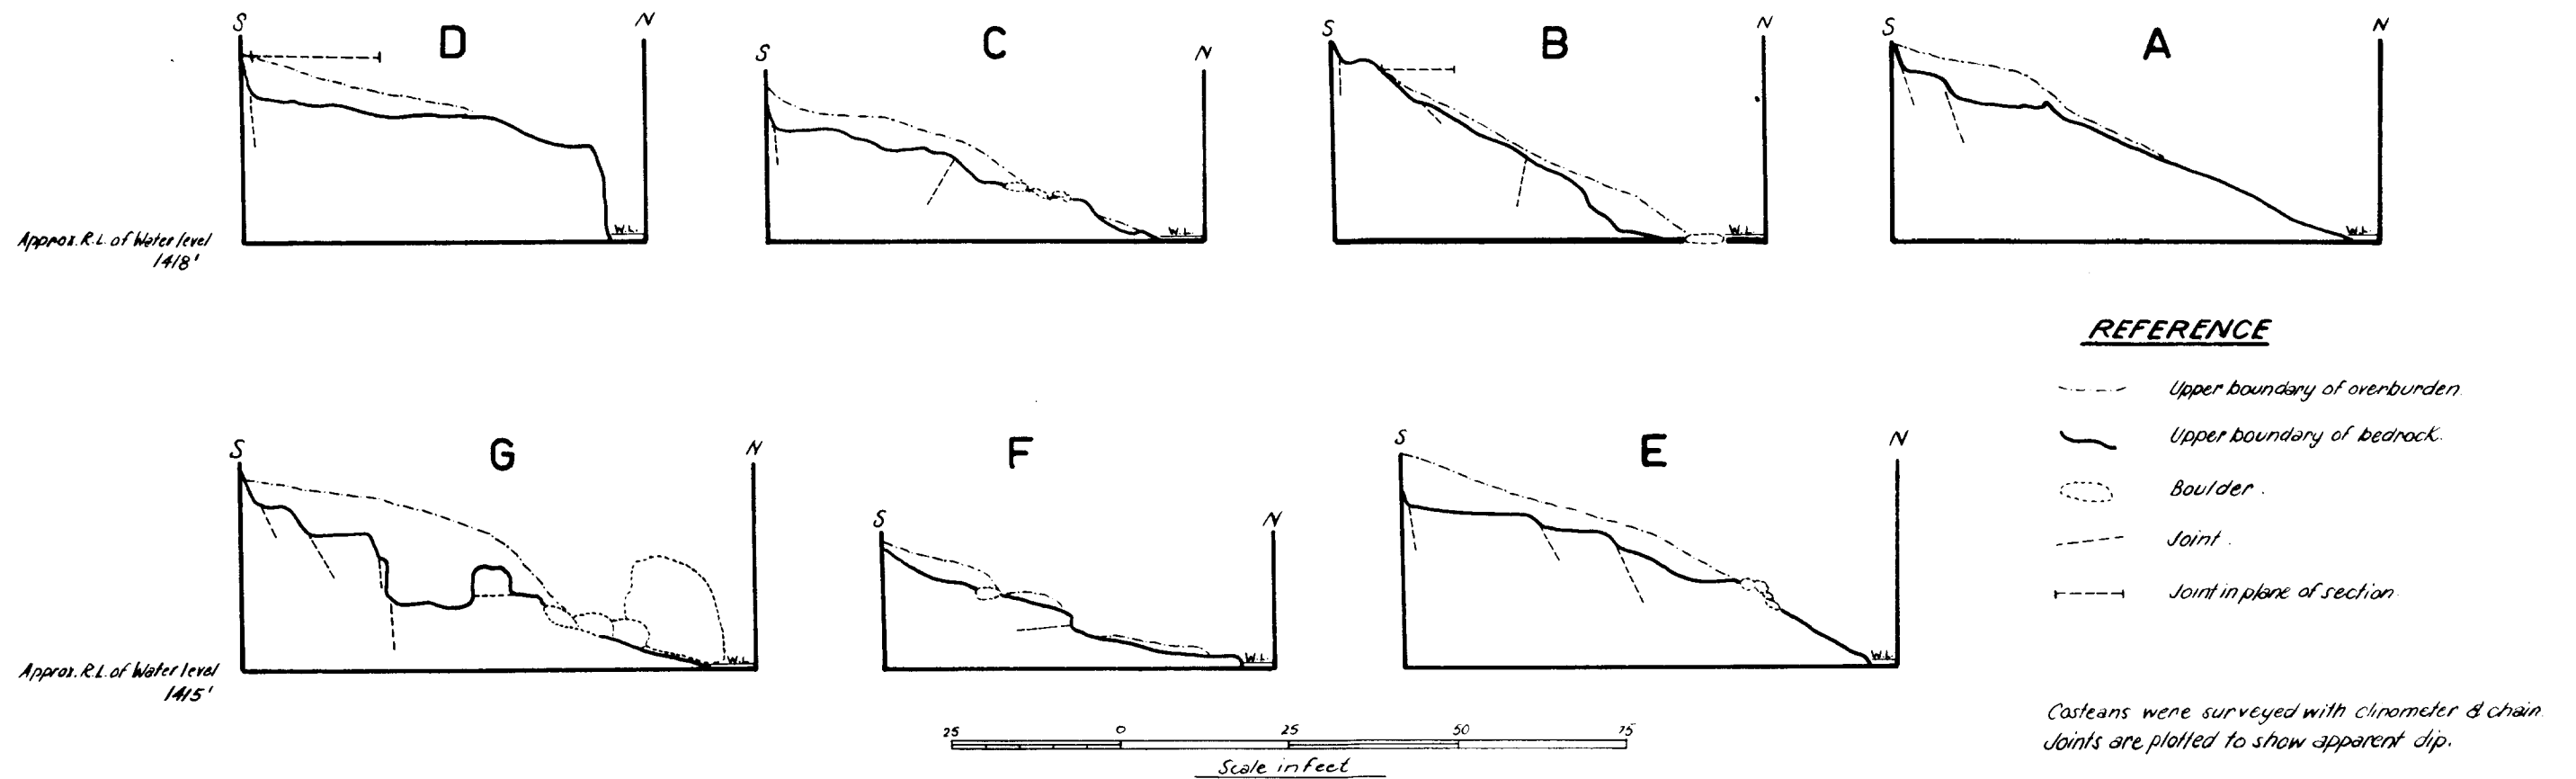
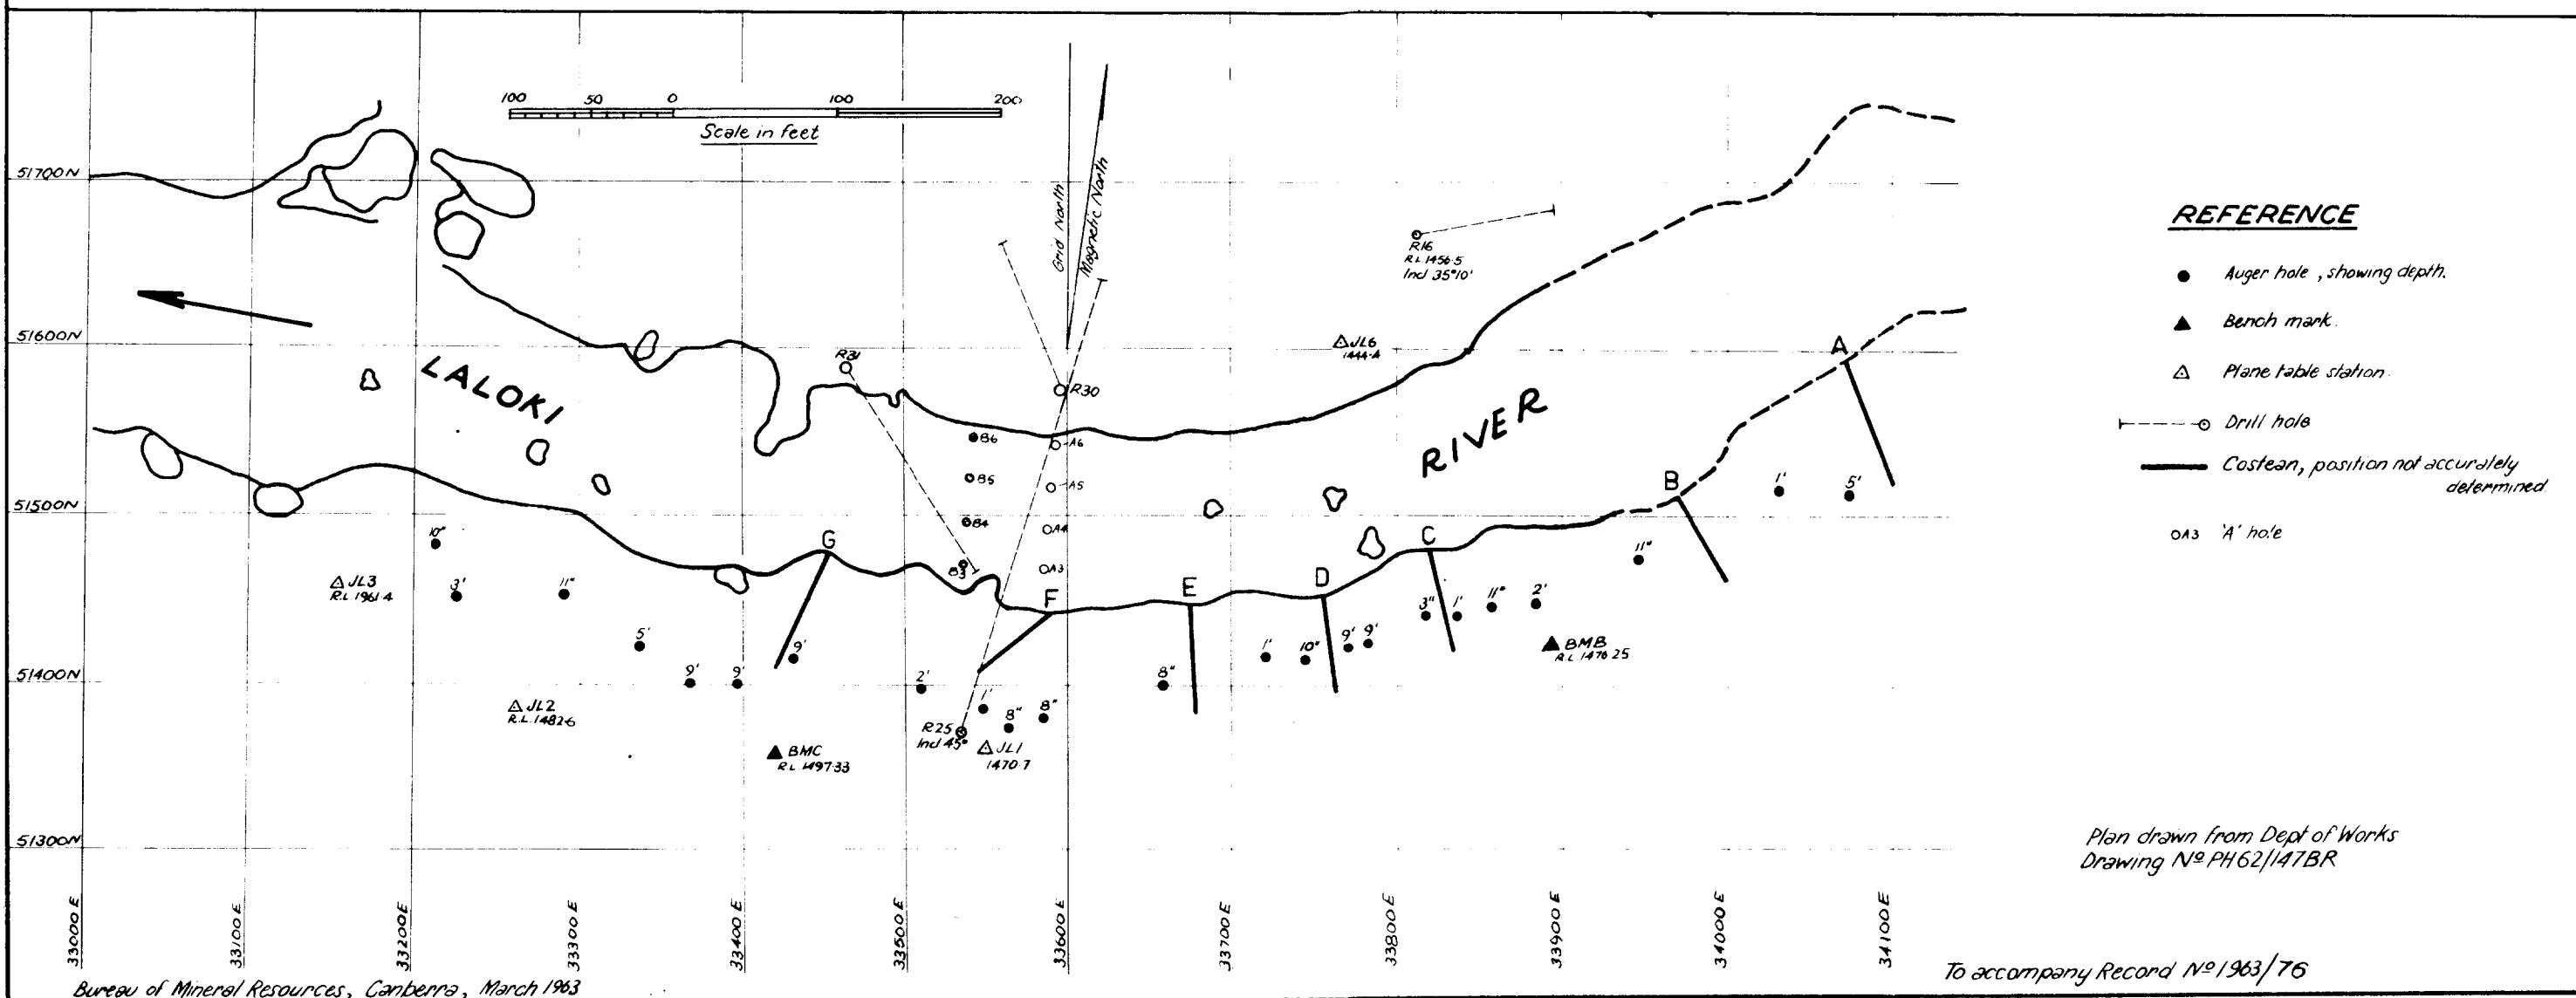
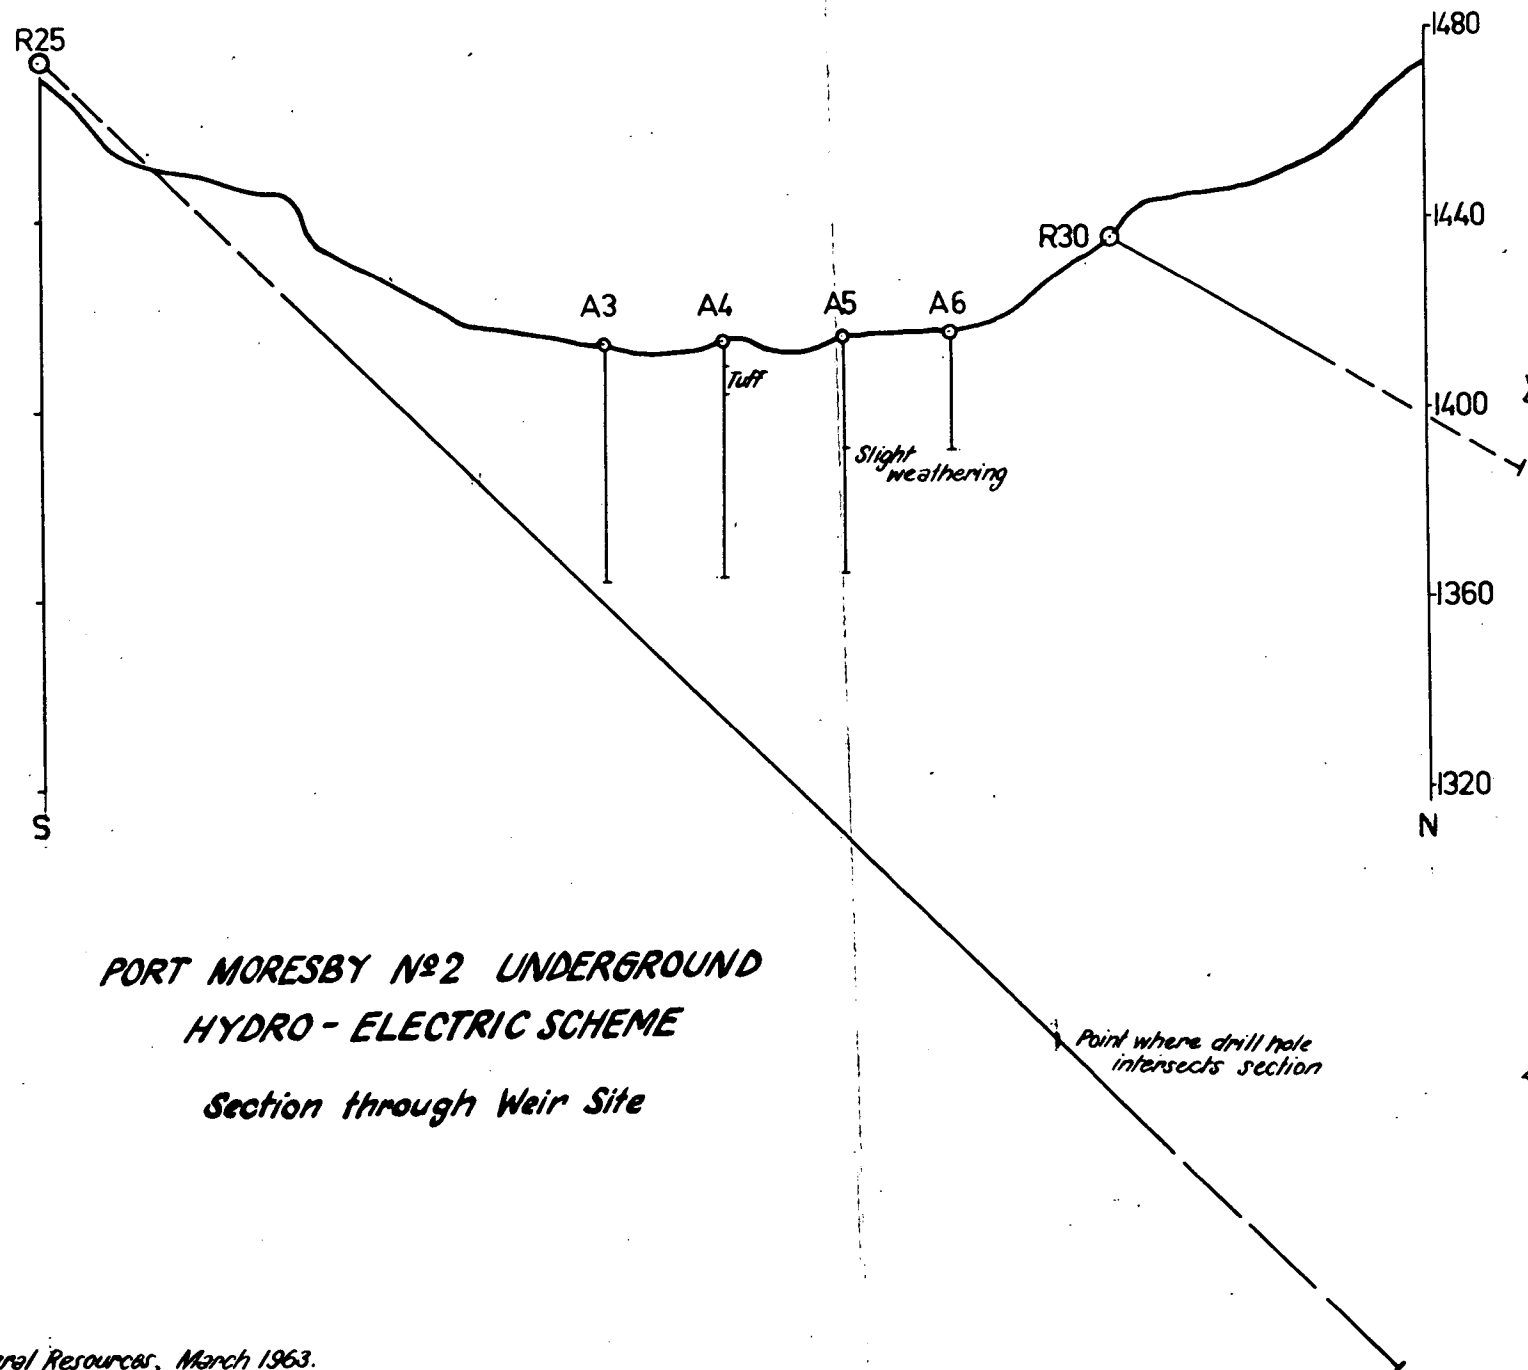
## COSTEANS, DRILL HOLES & AUGER HOLES TO TEST DIVERSION WEIR FOUNDATIONS

B3- 4'-5' Cavity, slight weathering below cavity.

B4- 2'-3'-36" Cavity, broken below cavity.

B5- Broken, but fresh.
