RECORD No. 1964/140

FOUNDATION GROUTING AND JOINT
PERMEABILITY MEASUREMENTS AT
BENDORA DAM, A.C.T.

J.K. HILL

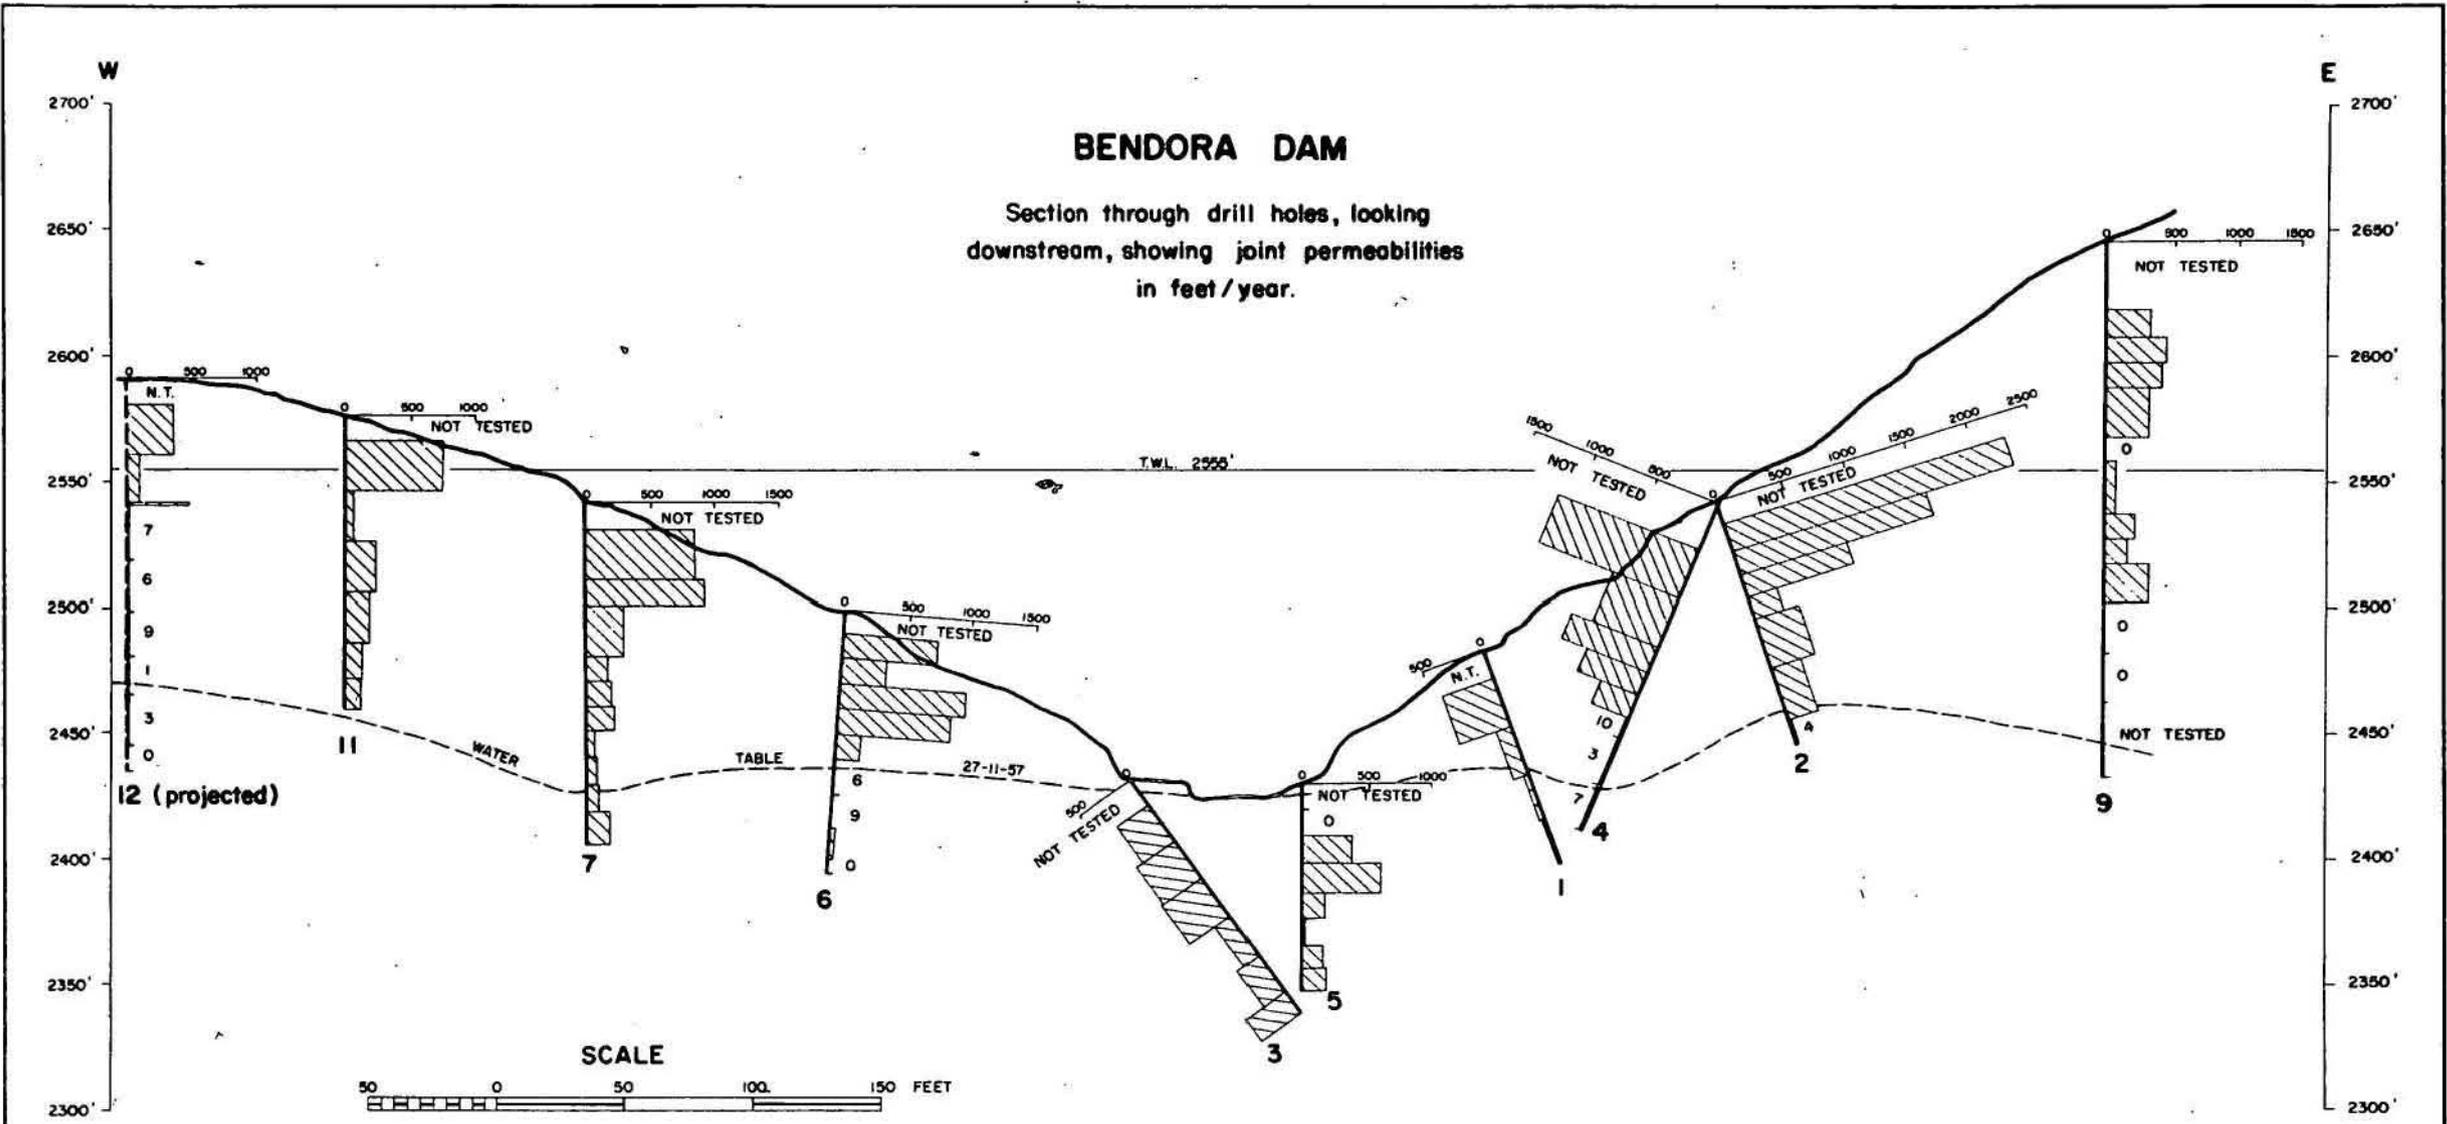
FIG 4

In the histograms shown in Fig. 4, all pressure corrections, except the packer correction, have been made before the joint permeabilities were calculated. Unfortunately packers used in the tests were not calibrated for pressure loss at various flow rates as it was not realized at the time that significant pressure losses might occur. As an illustration of the effect a packer can have on pressure lost between gauge and test section, two packer calibration curves from recent work at the Corin Dam site, on the Cotter River, are given in Fig. 3. Highest flows at Bendora were about 15 gallons per minute (g.p.m.) so the packer correction would be fairly small, and the fully corrected joint permeability values a little higher than those shown in Fig. 4, whereas flows up to 50 g.p.m. have occurred in several holes at Corin Dam site with pressure losses of the order of 40 p.s.i., which may almost double the joint permeability value when finally calculated.

Results from joint permeability testing helped to determine the optimum depth for curtain grouting and located the more permeable sections where extra treatment was required. The joint permeability varied from an average of 30 feet/year near or below the water table in the abutments to a maximum of 2270 feet/year in the openly jointed zone near top water level on the eastern bank. Joint permeability in the river bed rock was somewhat higher than for rock below the water table elsewhere, being about 250 feet/year.

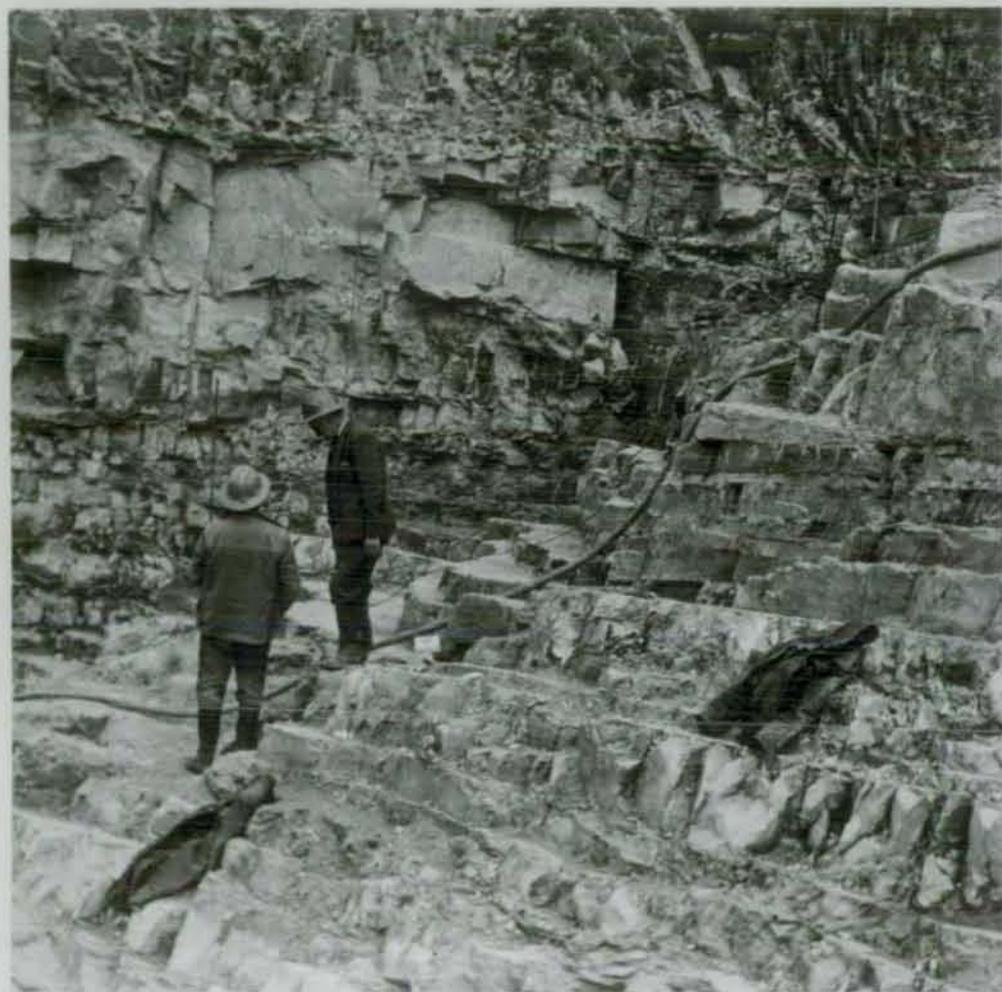
Fig. 6a:- Western abutment foundations showing thinly to thickly bedded quartzite, quartz sandstone, quartz siltstone and ashstone, dipping into the hillside. The different intensity of jointing in thin and thick beds is evident. This rock, in the vicinity of Blocks 3 and 4, had a joint permeability of 550 to 700 feet/year and a cement consumption of 16 to 20 cu.ft/100 sq.ft of rock surface during consolidation grouting.
 Department of Works photograph.

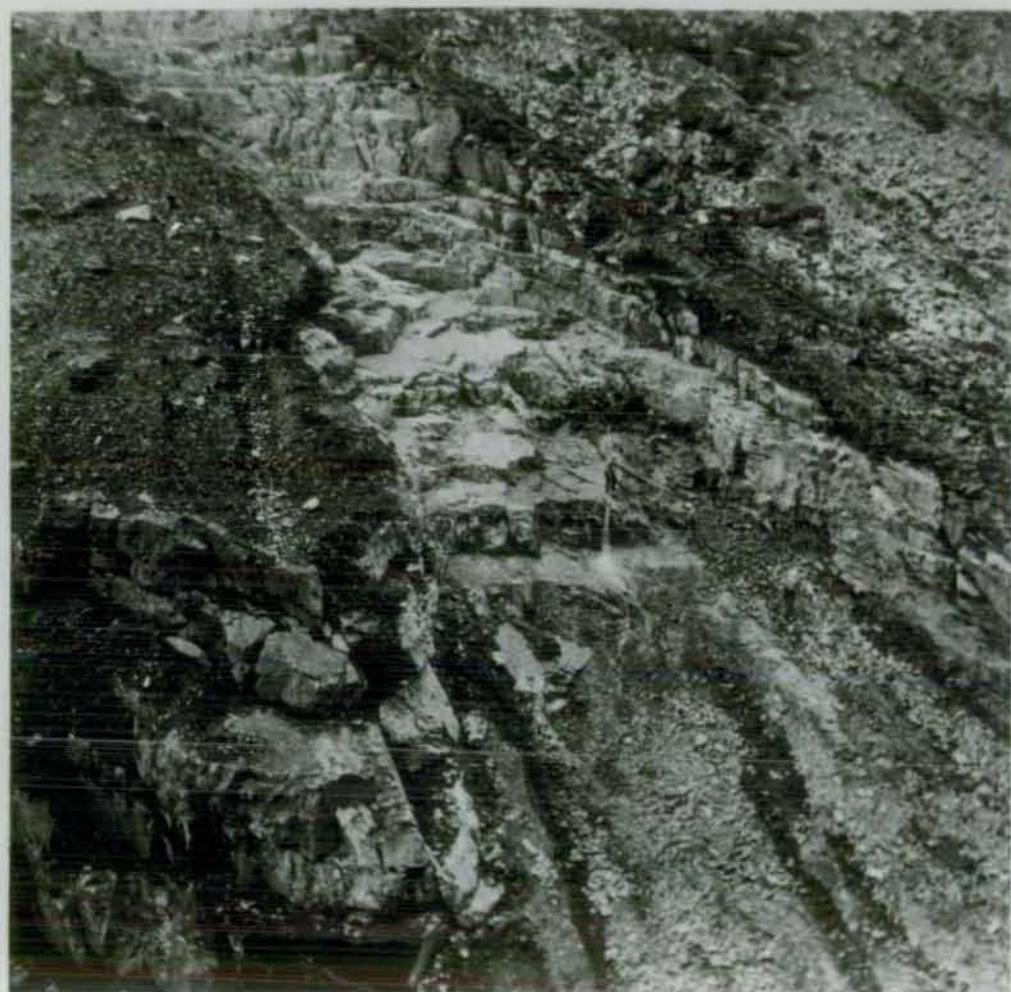
Fig. 6b:- Massive thickly bedded rock in the eastern abutment dipping towards the river. The joint permeability of rock in the lower half of this view was about 100 to 250 feet/year. The cement consumption during consolidation grouting ranged from $\frac{1}{2}$ to 4 cu.ft/100 sq.ft of rock surface.
 Department of Works photograph.

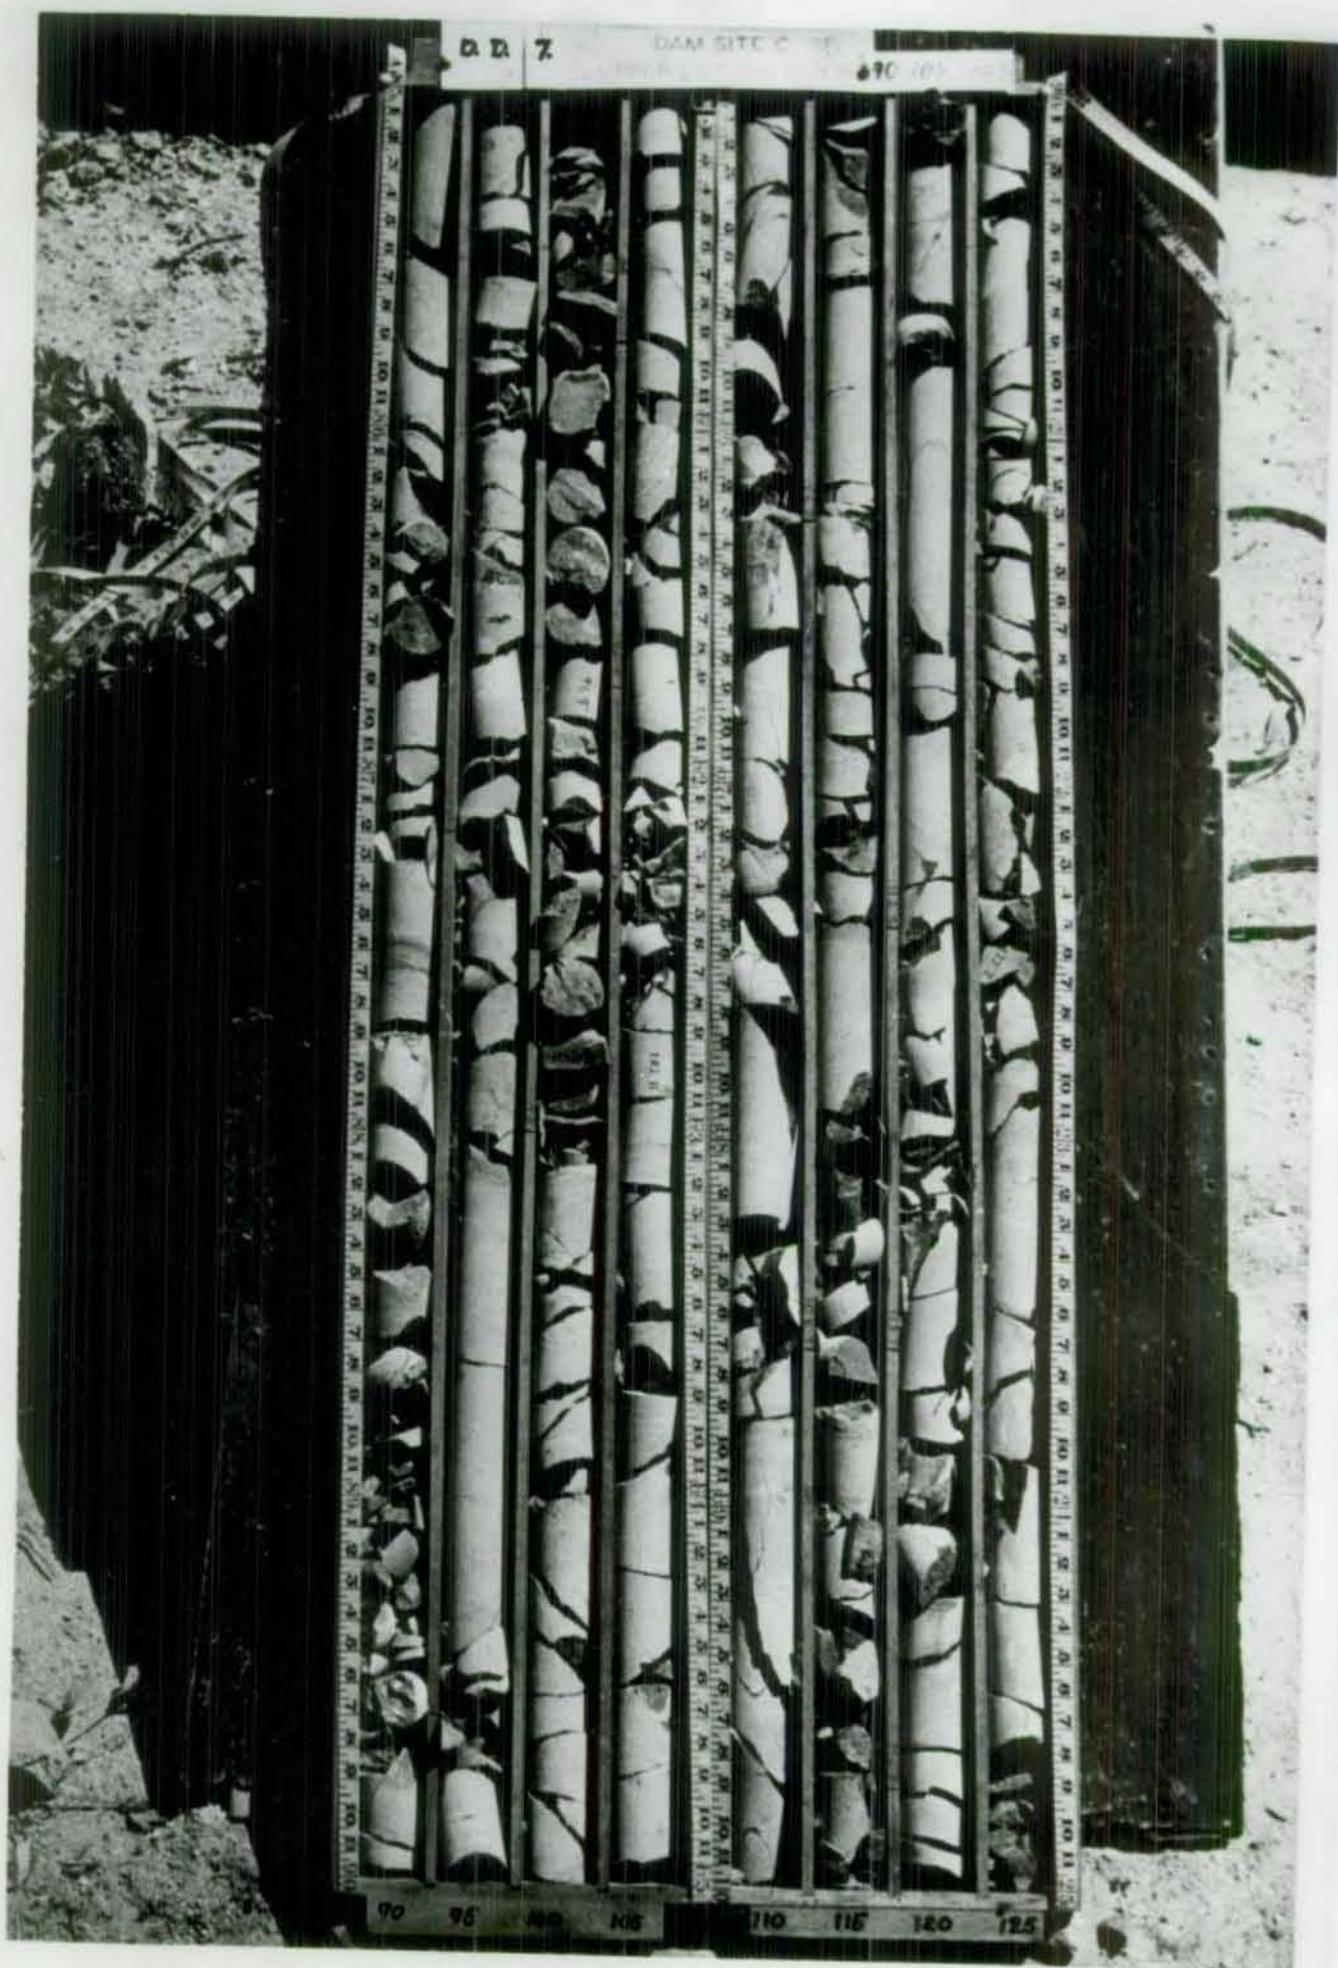
Fig. 7:- Drill core from hole No. 7, 85 to 125 feet, showing intensity of jointing. The joint permeability of test sections from 90 to 123 feet ranged from 60 to 85 feet/year. The depth to water table in this hole was 115 feet.

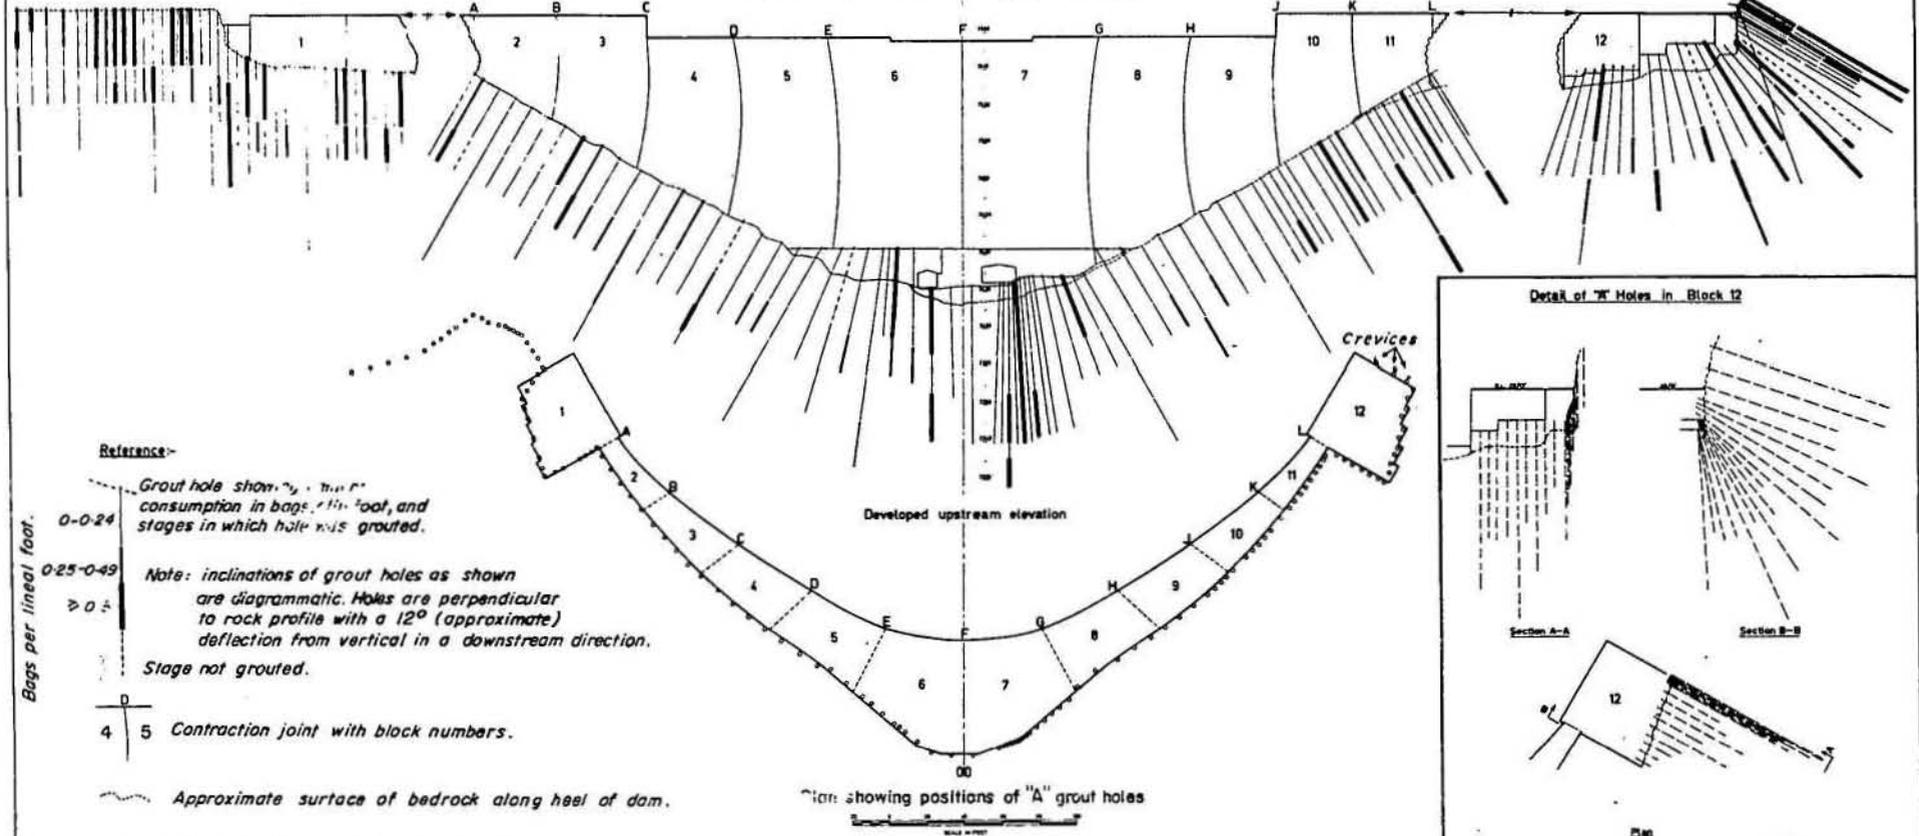
The extension of the "A" hole curtain from Block 12 (the right-hand thrust block) is shown in the detail on Fig. 8. Excavation of foundations for Block 12 confirmed the persistence with depth of open joints previously found in outcrops and costeans, and also indicated by permeability testing and core from diamond drill holes. Values of joint permeability ranged from about 500 to 2300 feet/year. Open joints extend down to a silty sedimentary breccia bed which dips towards the river at about the level of the designed foundation line. Immediately below the breccia bed joints are tighter and the rock is less permeable (200 to 600 feet/year); the excavation was therefore deepened to 5 to 10 feet below the bed to provide better foundations for the thrust block. However, movement of the overlying mass of interlocking joint blocks down the sedimentary breccia bed towards the river was considered possible should the coefficient of surface friction and/or shear strength of the silty material be reduced by accumulation of ground water. An anchored retaining wall to take part of the loading of the mass has been installed and the grout curtain is fanned out from the corner of the thrust block in an up-dip direction so that ground-water drainage from the hillside will either take place freely into the reservoir or be diverted downstream away from the thrust block. Any other direction of the grout-curtain extension might result in an undesirable accumulation of ground water in fissures leading to the sedimentary breccia bed.

Grout was lost from right thrust block foundations and from the foundations of Blocks 10 and 11 by leakage at the cliff face on the downstream side of the right spillway apron, a leakage path of up to 150 feet. Very high curtain grout consumption in the 0 to 30 foot and 30 to 50 foot stages was a feature of this section, and was generally greater per foot than consolidation grout consumption, because all the "B" holes are below the sedimentary breccia bed which marks the downward limit of open jointing, whereas some of the higher stages of the "A" holes are above the sedimentary breccia bed and penetrate rock with very open joints.

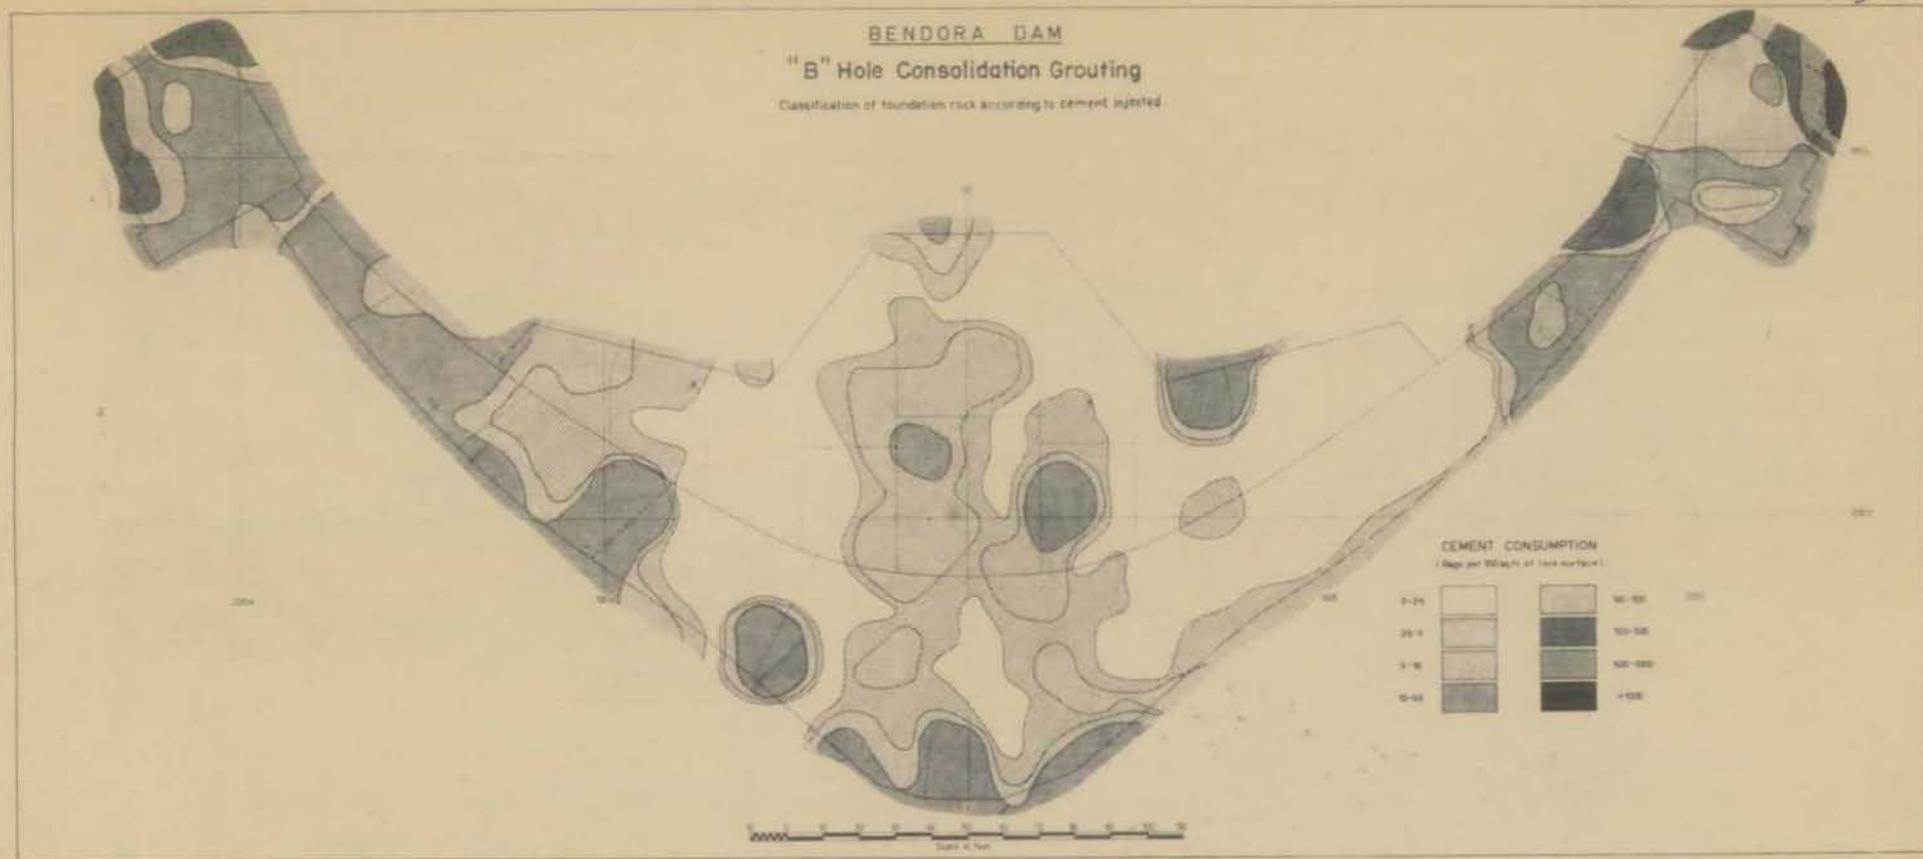
Fig.9.

Results of consolidation grouting at Bendora Dam are given in Table VII. The pattern of grout consumption has been analysed in Fig. 9, in which the foundation rock has been classified statistically into 8 classes, varying from 0 to $2\frac{1}{2}$ bags of cement per 100 sq. ft. of rock surface (in plan) to more than 1000 bags per 100 sq. ft. The map was prepared by plotting cement consumption in bags at each hole* and then moving a transparent overlay with a square sample area of 400 sq. ft. marked on it across the map on a 10 foot grid. The great majority of "B" holes are 30 feet deep, so no attempt was made to allow for volume of rock grouted, it being considered that a uniform "slice" was treated. At each point the cement consumptions of all holes falling within the sample area were added up and divided by 4 to reduce it to consumption for 100 sq. ft. This figure was then plotted to the grid point under the centre of the overlay. Allowance was made for areas adjacent to the edge of the foundations by reducing the divisor by an appropriate amount whenever the sample area on the overlay overlapped the edge. When the whole foundation area had been covered in this manner the figures at the 10 foot grid centres

A high-angle reverse fault with a throw of 4 feet in the left thrust block foundations was responsible for high grout consumption in holes adjacent to it. The fault zone consists of a band of very closely jointed rock with little brecciation, and varies in width from 2 to 4 feet. Some of the grout injected into rock near the fault ultimately leaked out along the upstream wall of the excavation in Blocks 2 and 3.

The area of moderately high grout consumption in the river channel is due to a zone of openly jointed rock which may have controlled the course of the river at this point. Core from drill hole 3 shows that although the rock is quite broken by joints, there is no recognizable fault zone under the river.
