DEPARTMENT OF NATIONAL DEVELOPMENT
BUREAU OF MINERAL RESOURCES
GEOLOGY AND GEOPHYSICS

AN INVESTIGATION OF THE COTTER AND OTHER FAULTS NEAR THE
CORIN DAMSITE, UPPER COTTER RIVER, A.C.T.

W. Oldershaw

Records 1965/86.

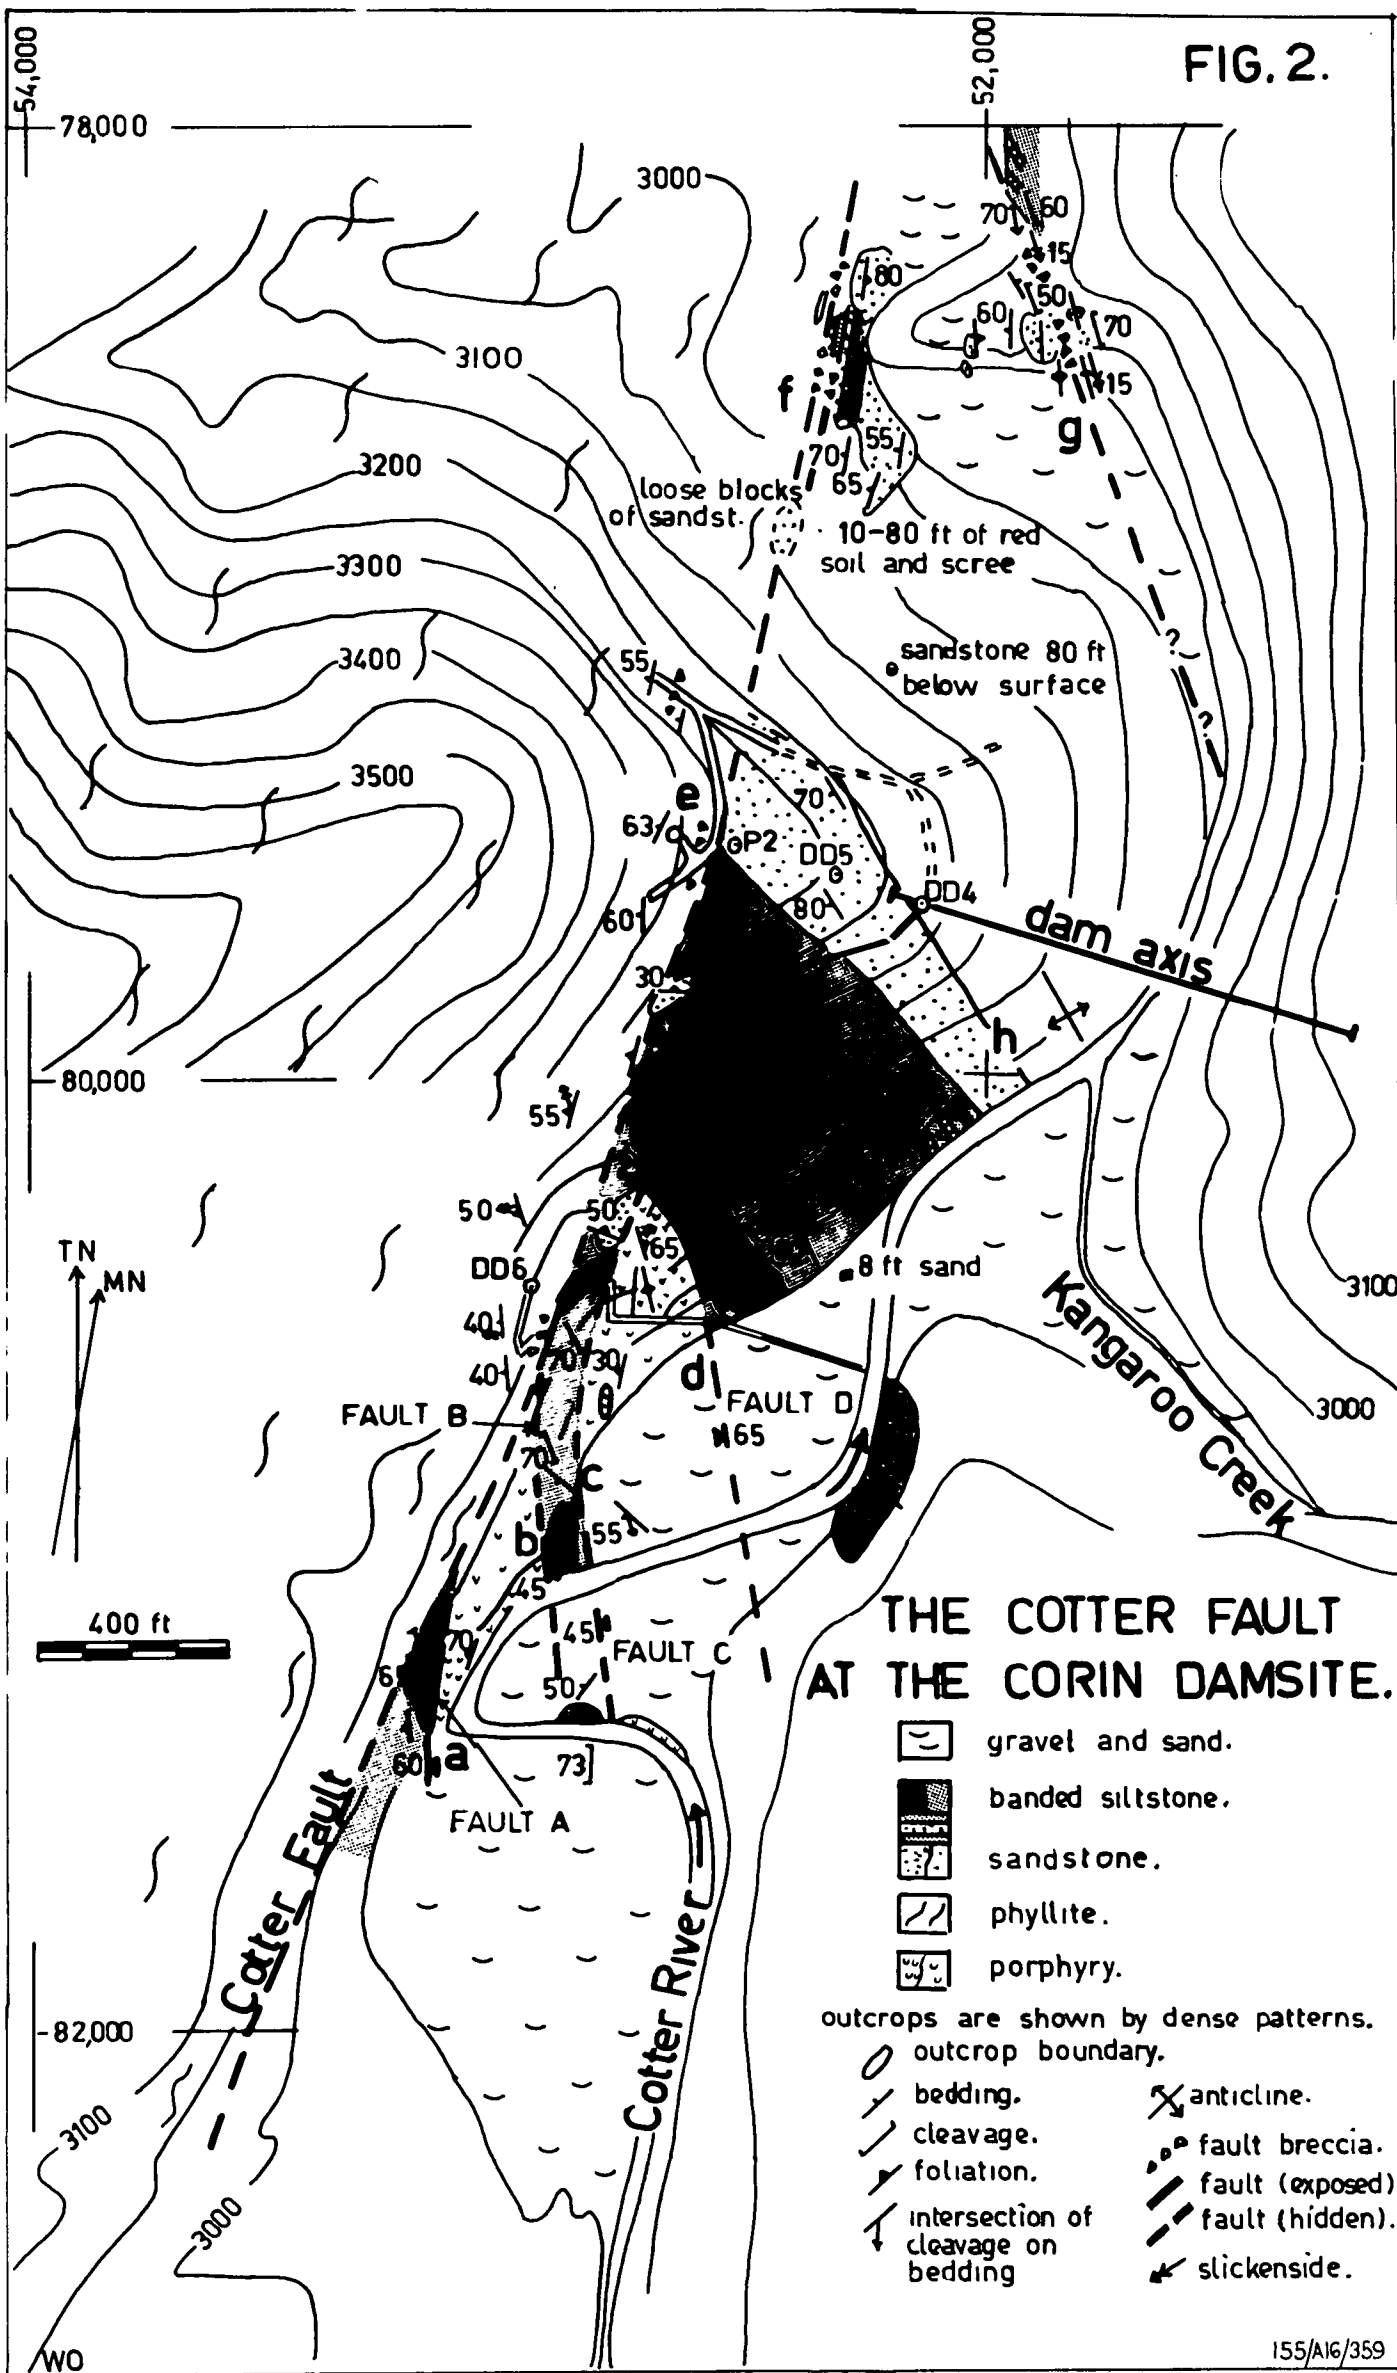
FIG. 2.

At "a" (Figure 2) banded siltstone has been thrust upwards to the east over sheared and shattered porphyry. A 40-foot length of Fault A, exposed in a small gully at 53,200 W; 81,300 S, contains two sub-parallel slightly undulose fault planes, about 12 inches apart, which strike 170° and dip 60° W. (see stereogram, Figure 4).

Fault C, separating the siltstone at "b" from the block of porphyry to the east, is not exposed (Figure 2). Its presence is inferred and its position was determined by detailed outcrop mapping on the steep southward-facing slopes to the east of drillhole D.D. 6. Its extension southward is inferred from the juxtaposition of porphyry and siltstone on the river bank at 52,850 W; 81,350 S. From its inferred position and the intersection of postulated strike lines with the contours, the fault would appear to dip westwards at 45° , parallel to fault B.

Fault D (at "d", Figure 2) dips to the east, whereas the adjacent faults dip to the west. The thrust plane is poorly exposed and crops out only in a few places, but its position can be determined, within a few feet, between 52,600 W; 80,500 S and 52,750 W; 80,150 S on the steep south-facing hillside east of D.D. 6.

Crush breccia crops out over an oval area 30 feet by 10 feet at 52,350 W; 78,500 S ("f", Figure 2). Parts of the breccia consist of mylonite, with a vertical foliation that trends $180-190^{\circ}$, and which contains streaked out lenses of slate,

There are probably hidden north-north-west trending faults between fault D and the fault passing through "g" (Figure 2). Some of these may be revealed during the sluicing and detailed mapping of the dam foundations, but in order to examine the area south-west of the dam it is recommended that the bulldozed track from D.D. 4 towards D.D. 6 be deepened a few feet to bedrock. This will allow the continuity and structure of the banded siltstone to be determined and the transition beds at the top of the sandstone to be studied.

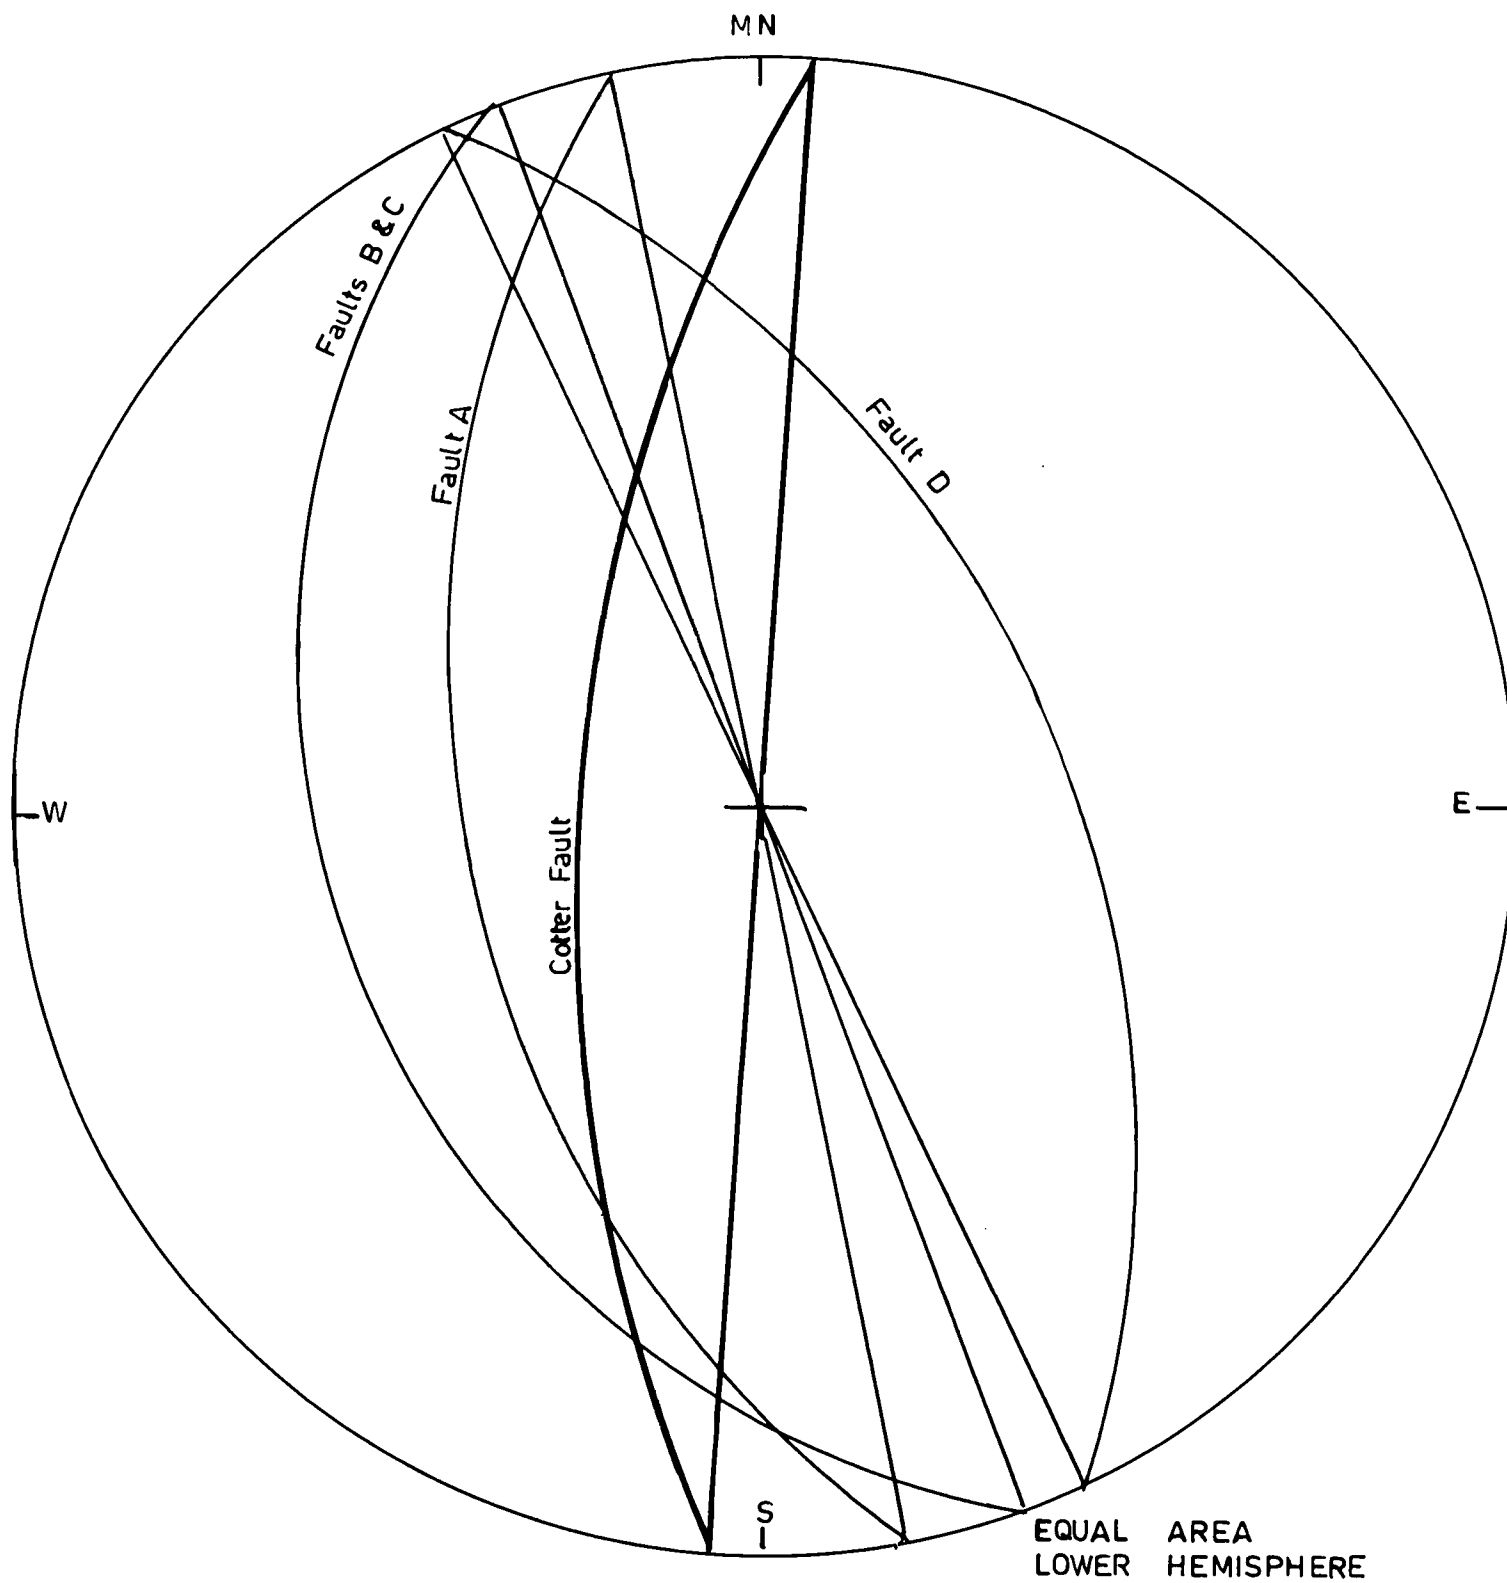
FIG. 3.

The western spur at the Corin damsite consists of a north-west trending anticline which has been cut by several faults dipping at $45-50^{\circ}$ towards 250° and by a later major fault zone, the Cotter Fault, which dips at 70° towards 275° (see Figure 2). In the southern part of the spur the earlier faults emplaced wedges of porphyry into the folded sandstone and siltstone succession. The Cotter Fault is a major high-angle reverse fault which has thrust a block of phyllite and siltstone upwards and eastwards against the faulted sandstone, siltstone and porphyry.

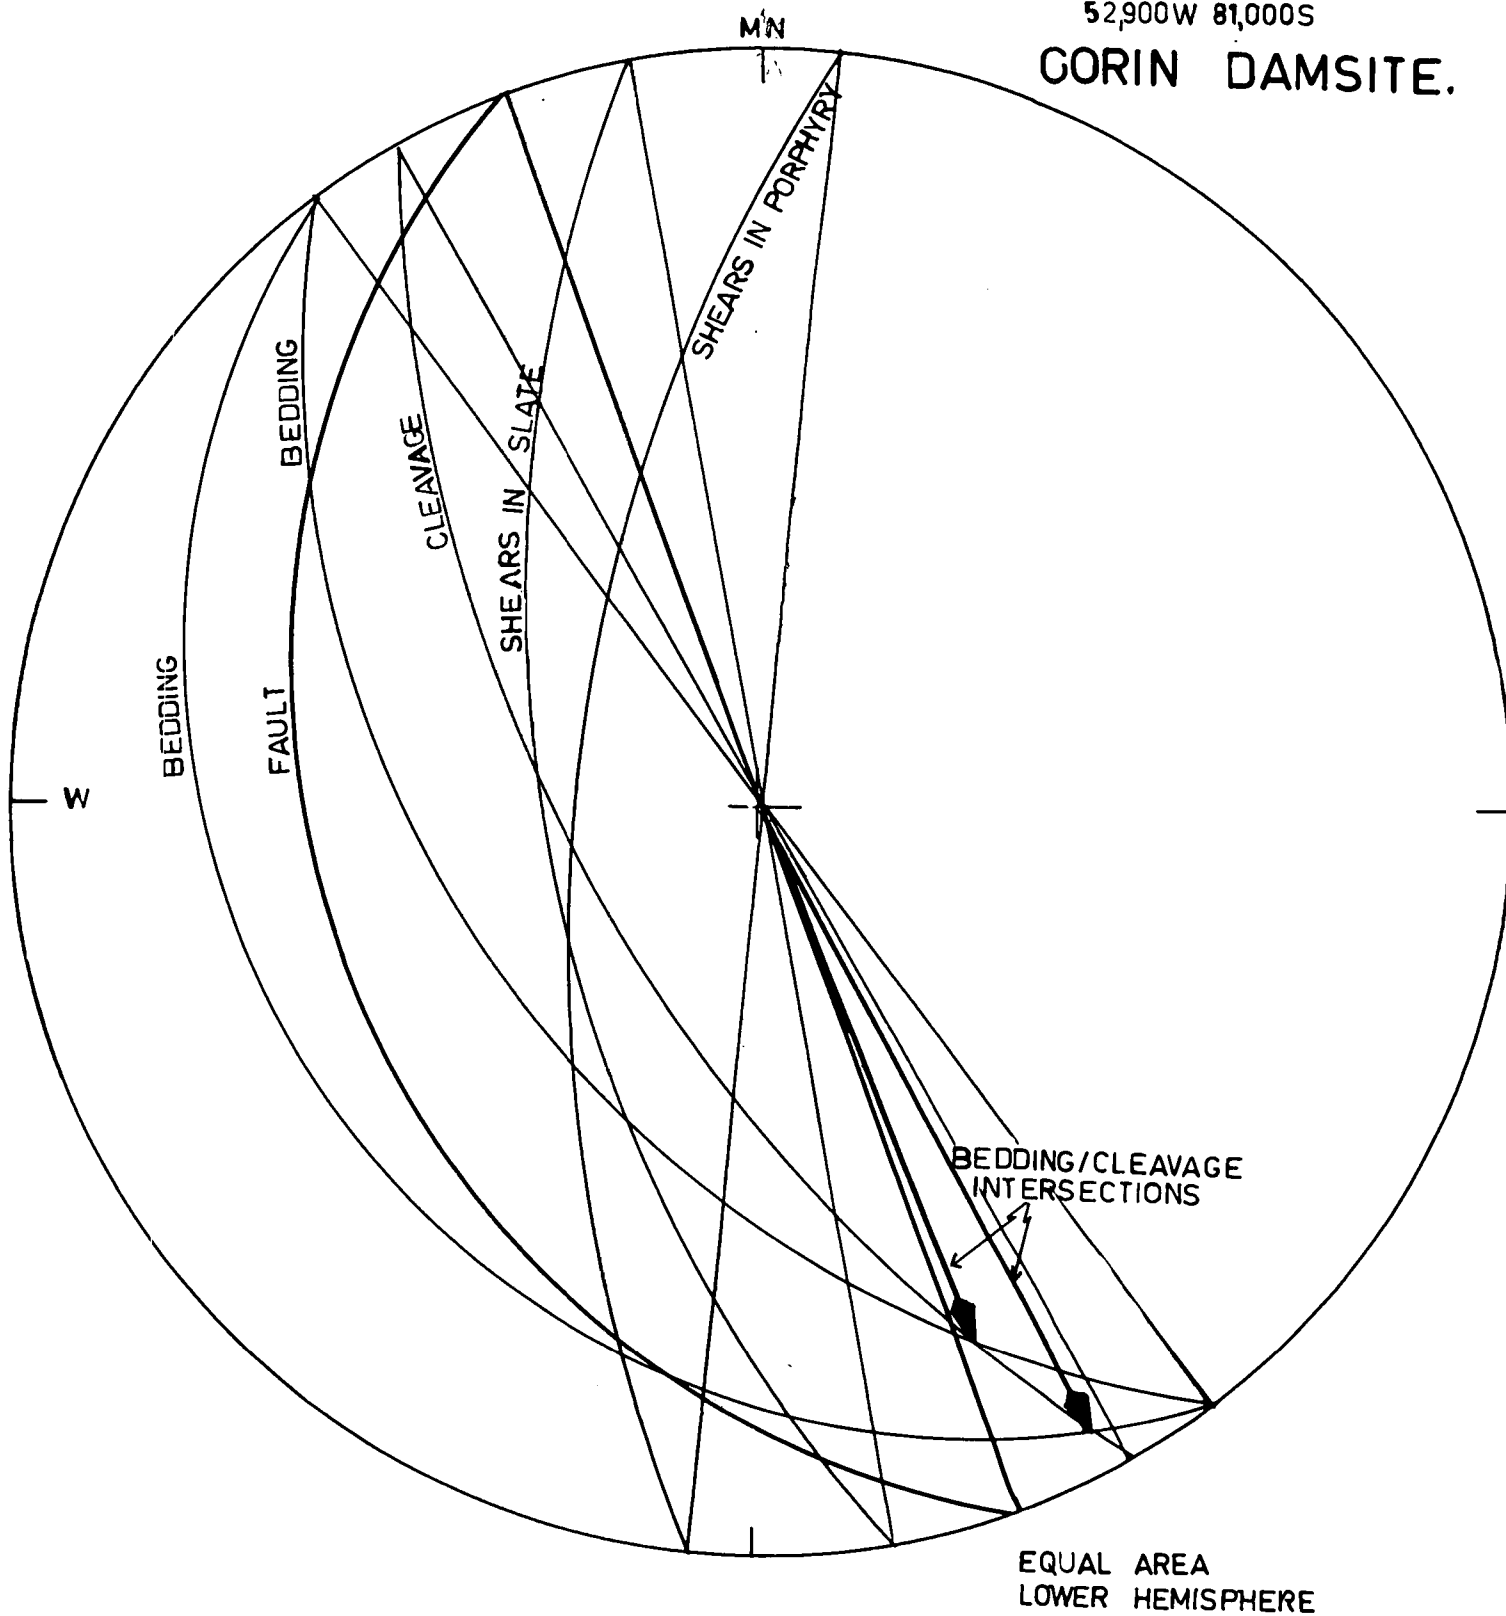
FIG. 5.

exposed; it strikes 160° and dips 45° W. The overlying porphyry is cut by several minor thrusts (see stereogram, Figure 5) and by open, limonite-stained, joints. It is crumbly and deeply weathered.

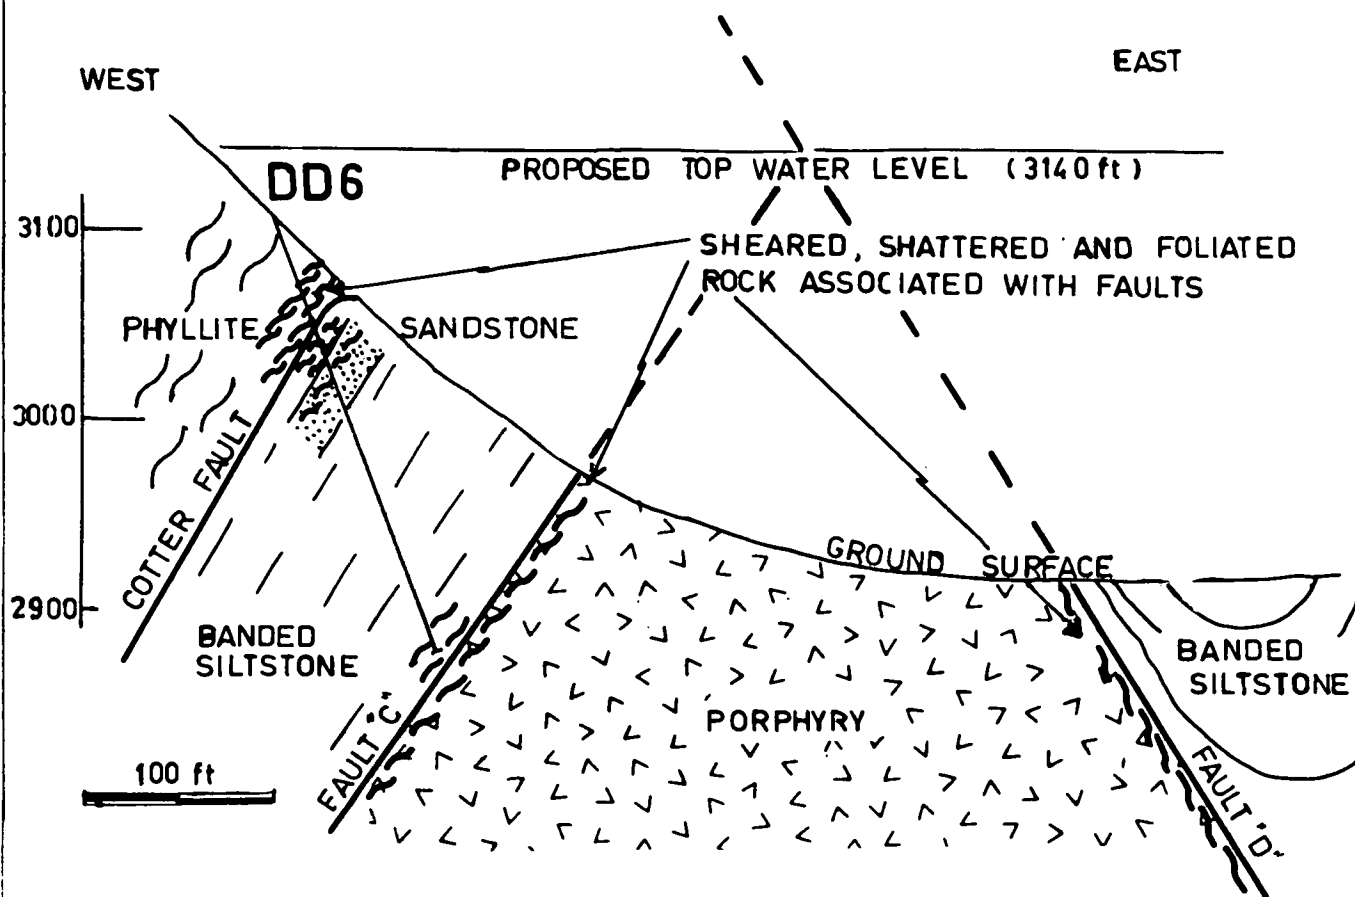
FIG. 6.

D.D. 6 terminated close to the calculated position of the fault plane (see Figure 6). The last few feet of core consist of contorted and sheared, pyrite-rich, banded siltstone similar to that found close to the other fault planes. The water loss during the pressure testing of this rock was only 0.01 gallons per minute per foot at 100 pounds per square inch gauge pressure. Had the hole been continued a short distance it would probably have determined the position of the fault and established the presence of shattered porphyry in the footwall of the fault; the permeability of the crush zone along the fault could also have been tested.

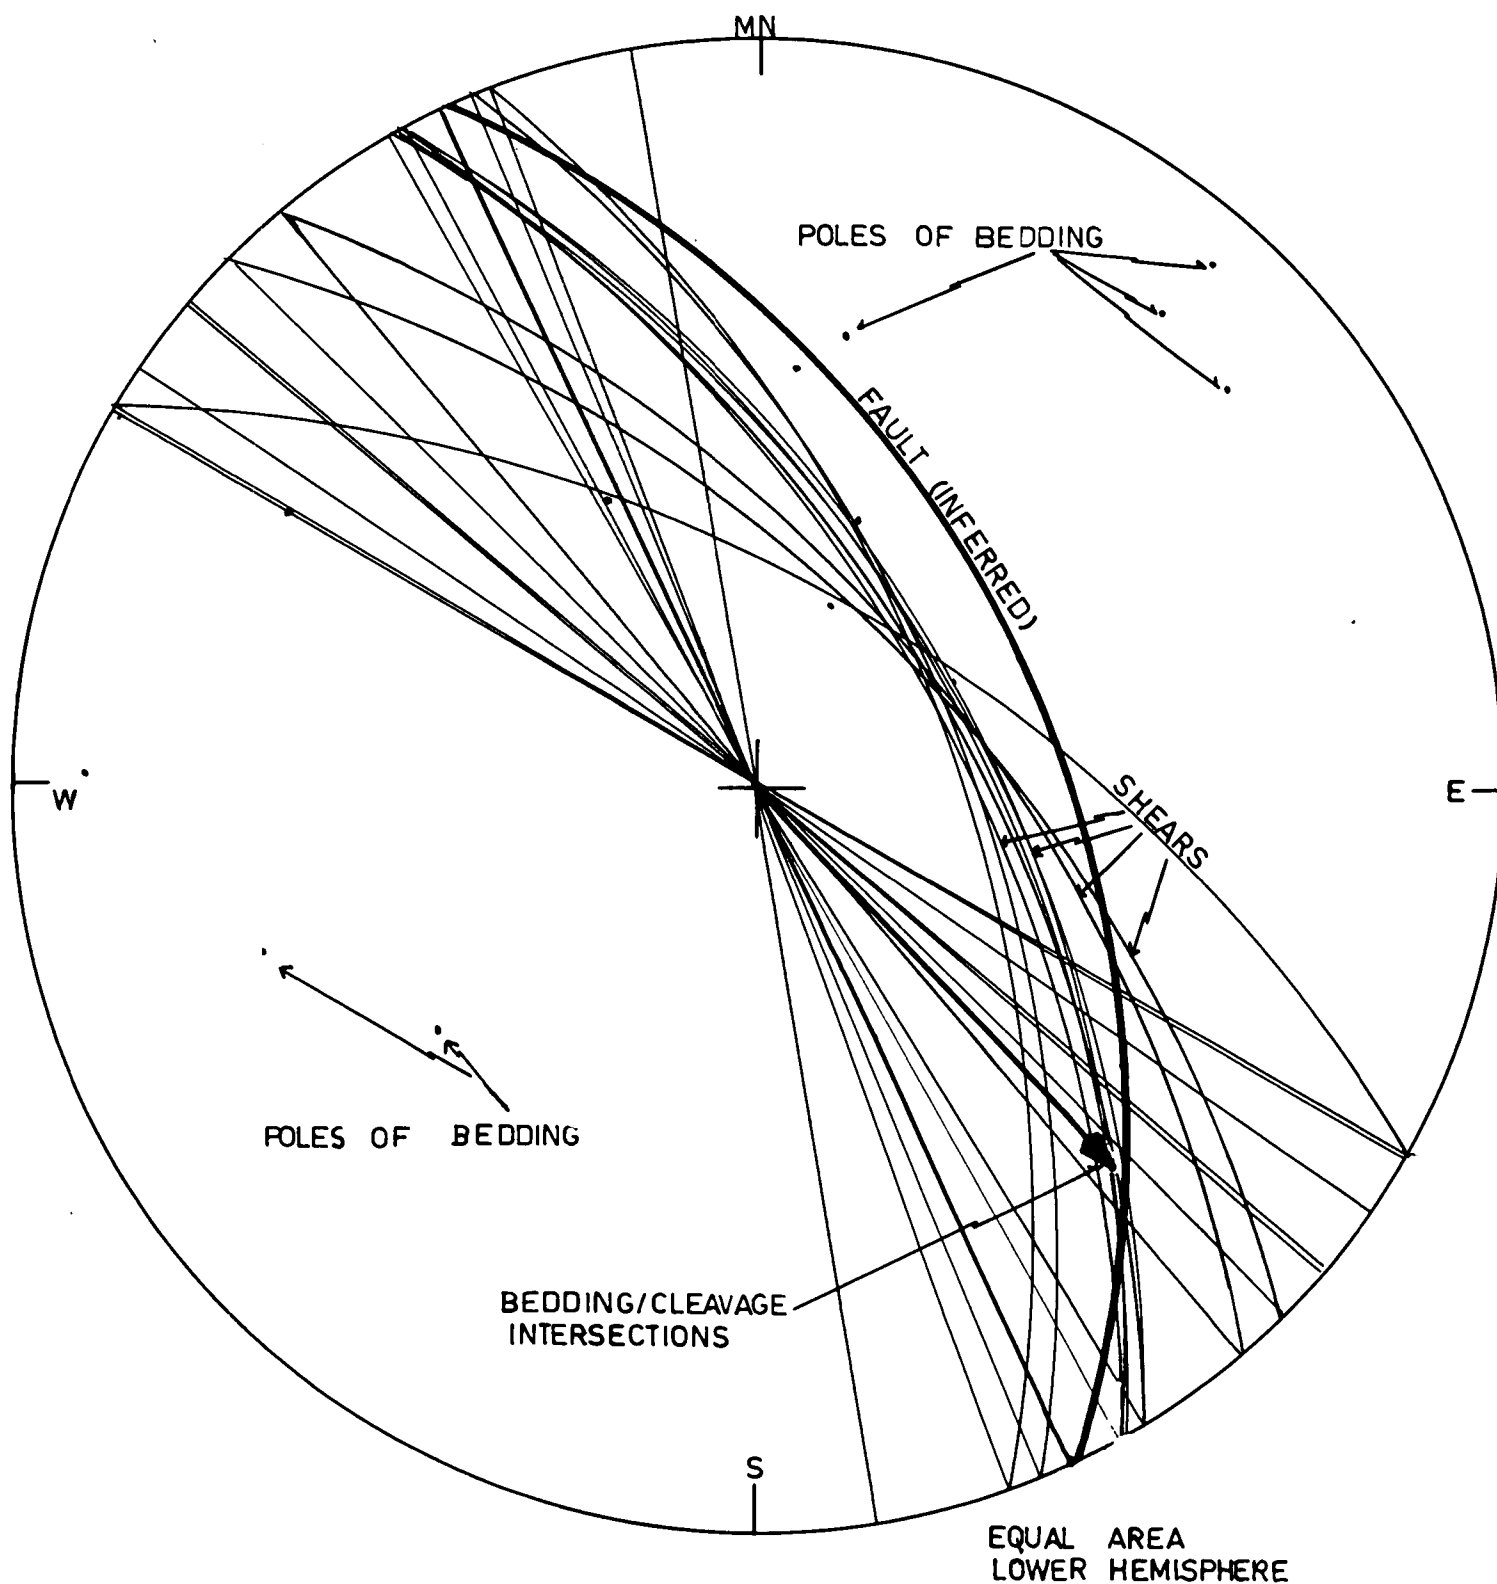
FIG. 7.

THE STEREOGRAM SHOWS THE COINCIDENCE OF THE SHEARING IN THE SILTSTONE ABOVE THE FAULT WITH THE INFERRED POSITION OF THE FAULT.

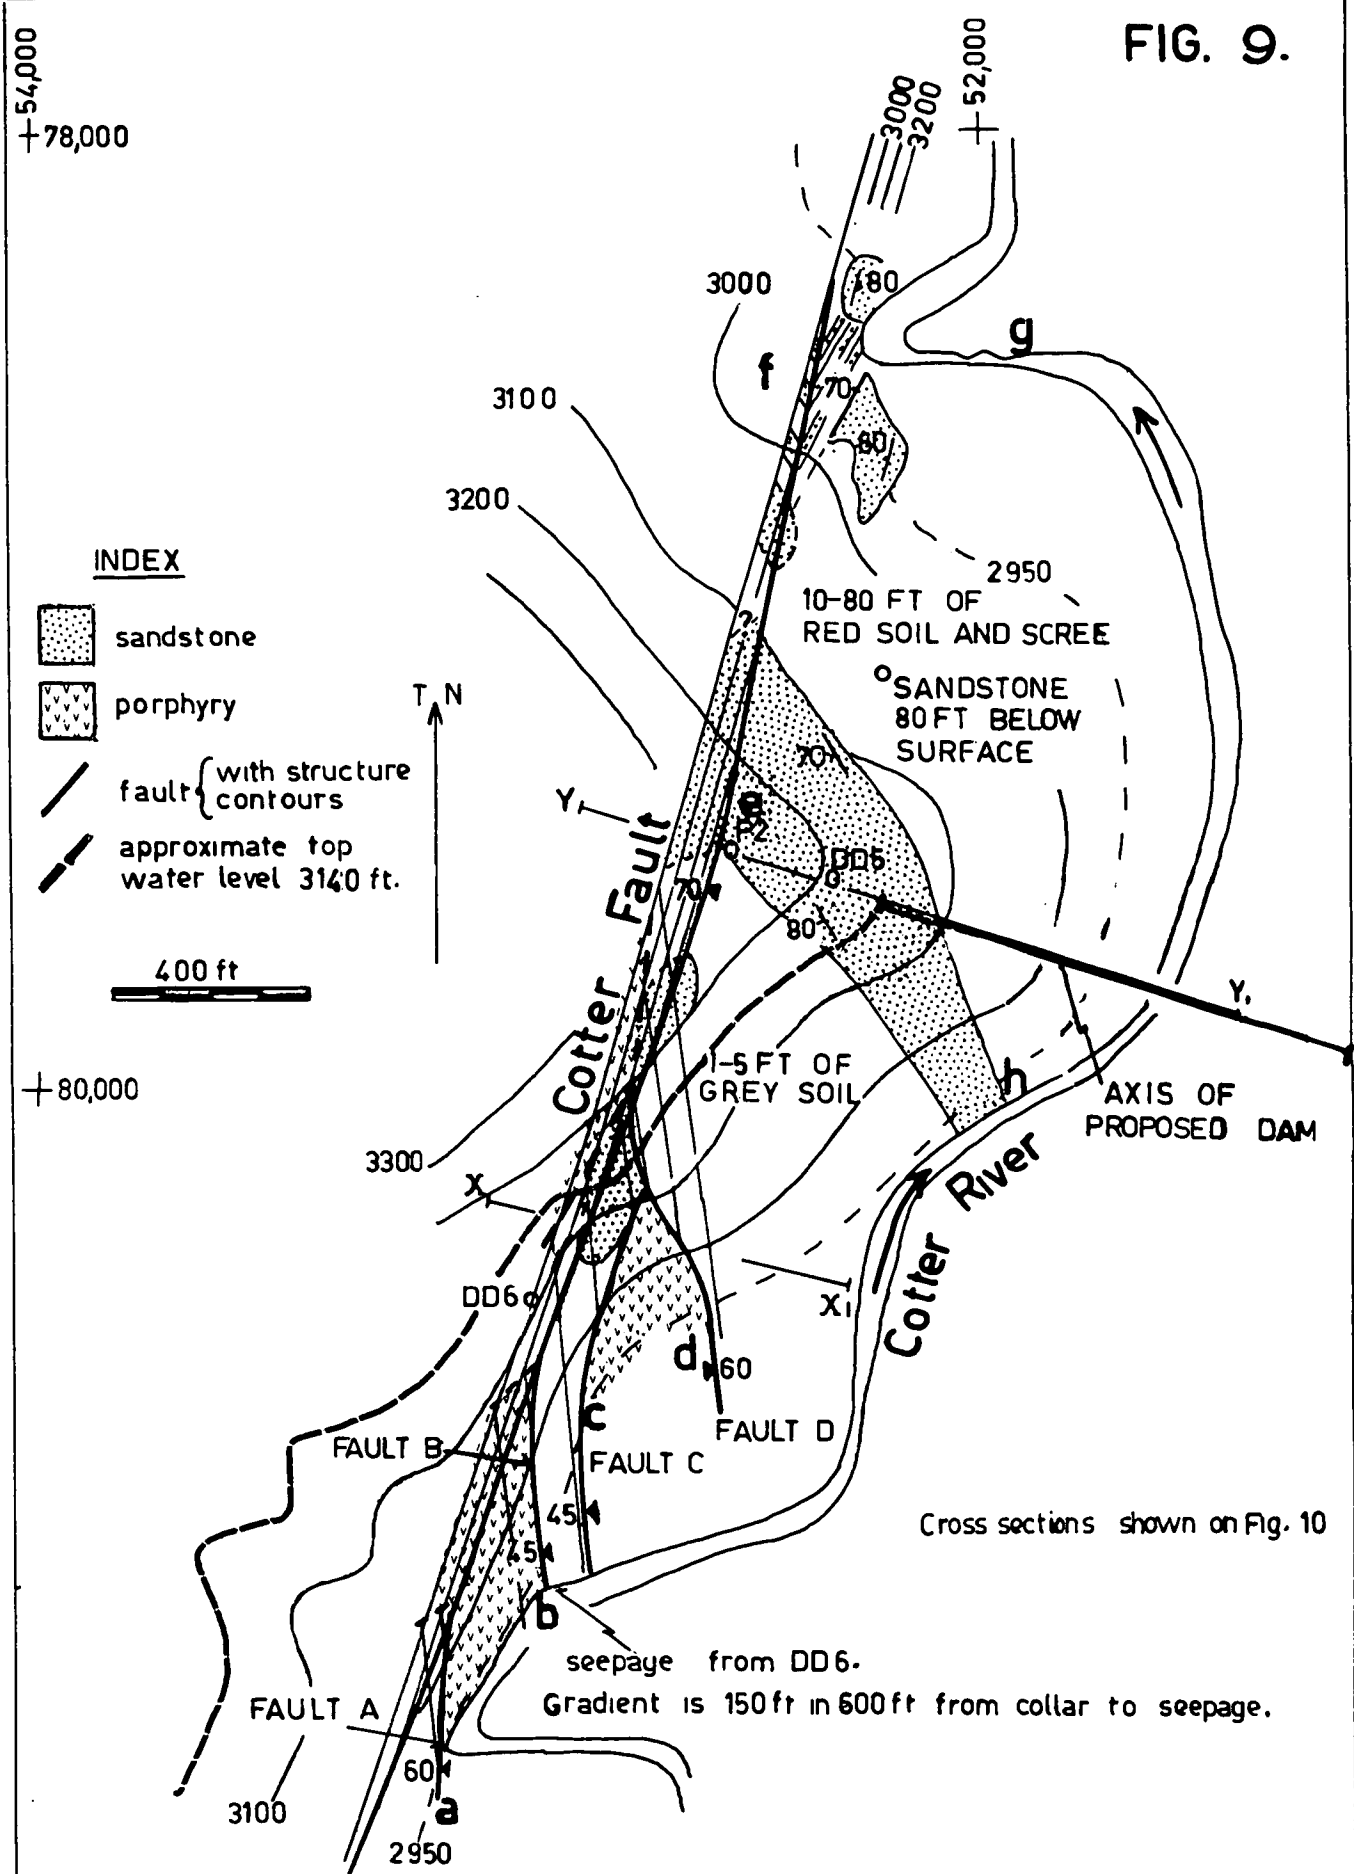
FIG. 9.

The wedge of porphyry between the faults A and B is about 200 feet wide and extends about 400 feet southwards from the Cotter Fault, which truncates it (Figure 9). The porphyry is well exposed in the river cliff between "a" and "b" and on the rocky hillside above. It is a non-porous crystalline rock, but it has been shattered and sheared, especially near the faults bounding it, and it is deeply weathered. It is broken by open, limonite-stained, joints 4 to 6 inches apart, many of which show slickensides. The porphyry has very little soil cover and will be submerged by the reservoir. It will therefore readily become saturated.

The fact that water can leak along the fractured marginal zones of the porphyry was shown by seepage of drilling fluid from D.D. 6 at a small spring on the river bank at "b", more than 600 feet away from, and 150 feet lower than the collar of the hole (E.J. Best, personal communication). The fluid escaping from D.D. 6 probably seeped southwards for 200 feet along the upper weathered part of one of the shatter zones in the Cotter Fault until it encountered the shattered porphyry abutting the Cotter Fault. It then percolated through the shattered porphyry in the hanging wall of fault B to emerge at the small seepage at "b" (Figure 9).

Two lenses of shattered sandstone occur above the wedge of porphyry between faults C and D (Figures 9 and 10). The southern lens, just to the north-east of D.D. 6, crops out below the top water level of the reservoir. Only the sandstone crops out; not the contiguous strata. Because of this, the structure could not be resolved; the sandstone may be interbedded with the siltstone and dip steeply westward (26 feet of shattered sandstone were intersected in D.D. 6), or it may be a fault-bounded lens. The sandstone in D.D. 6 could not be pressure tested because it caved readily. The siltstone immediately below had a permeability of nearly 2,000 feet per year.

None of the strata surrounding the northern lens of sandstone crop out. This lens may be a continuation of the southern lens, for both have a north-dipping foliation. Alternatively it may be a fault-bounded lens brought up along part of the Cotter Fault. This northern lense of sandstone may be faulted into contact with the thick bed of sandstone which extends 800 feet from the river bank at "h" to the Cotter Fault at drillhole P2 (Figure 9).

The Cotter Fault north of drillhole P2 is covered by red soil and sandstone scree up to 80 feet thick, but lenses of sheared sandstone crop out at "f" and at 52,400 W; 78,900 S (Figures 9 and 10).

Fractured sandstone may be continuous between "f" and P2 (Figures 9 and 10), but there is not enough exposure to prove this. Backhoe holes show that there is at least 10 feet of red soil over the area, and 80 feet of soil and sandstone scree was found over the sandstone bedrock along the line of the most westerly proposed spillway. More exposures are needed if this part of the fault is to be mapped.

It is very likely that the grout curtain will have to be extended westwards from the dam to beyond the Cotter Fault at "e". It is recommended that some of the grout holes be cored, because careful examination of the cores will reveal more information about the structure and permeability of the fault zone and will help to determine the vertical and lateral limits of the grout curtain.
