GEOLOGICAL INVESTIGATION OF SLOPE STABILITY OF THE
KASSAM PASS ROAD , NEW GUINEA, 1965 .

J.R.L. Read

RECORD 1966/31

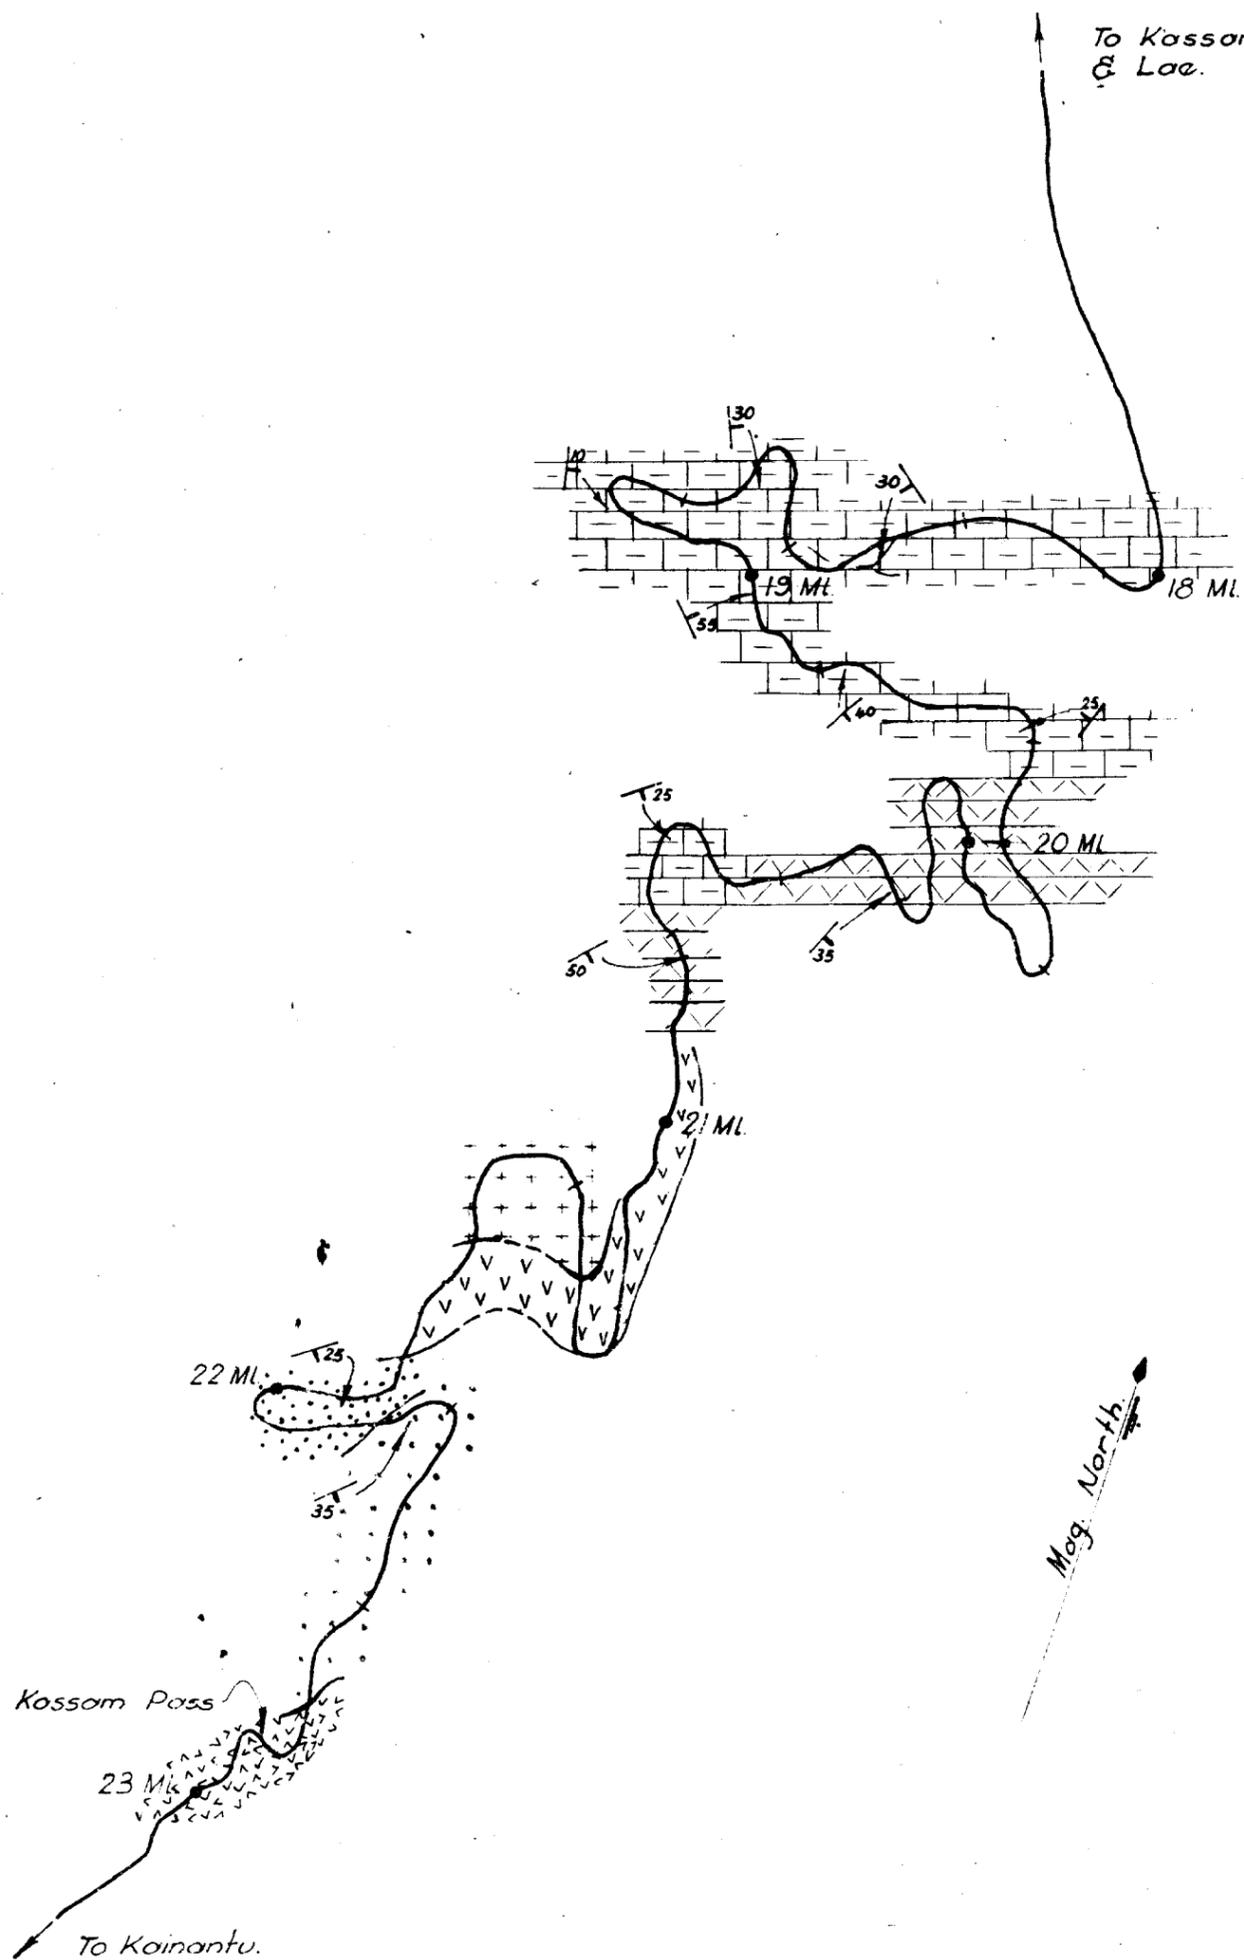
KASSAM PASS ROAD. GEOLOGICAL PLAN.

Stratigraphy: Exposures along Kassam Pass roadway (Plate 2) chiefly consist of closely-bedded sedimentary rocks - limestone, sandstone and siltstone - intruded in some areas by feldspar porphyry and granodiorite. Near the top of the Pass, interbedded volcanic rocks occur. Some of the igneous rocks have been completely weathered to considerable depths.

Interbedded limestone and siltstone is exposed along the lower section of the road between the 18-mile peg and about 19 mi. (miles) + 3000 (feet); limestone is also exposed on the U-bend between 20 mi. + 3100 and 20 mi. + 3944.

Beyond 19 mi. + 3000 and up to about 20 mi. + 5000 the limestone is increasingly, but nowhere entirely, replaced by beds of coarse-grained, brownish sandstone and medium-grained indurated sandstone. The first part of this section is extensively intruded by feldspar porphyry. Basalt overlies the sedimentary rocks beyond 20 mi. + 5000 as far as 21 mi. + 4550 except between 21 mi. + 2250 and 21 mi. + 3600 where a large body of moderately weathered granodiorite is exposed. Sedimentary rocks overlie the basalt beyond 21 mi. + 4550. Indurated sandstone with small interbeds of coarse-grained, brownish sandstone occurs from 21 mi. + 4550 but is overlain, apparently conformably, beyond about 22 mi. + 760 by soft, weathered, medium to coarse-grained arkose.

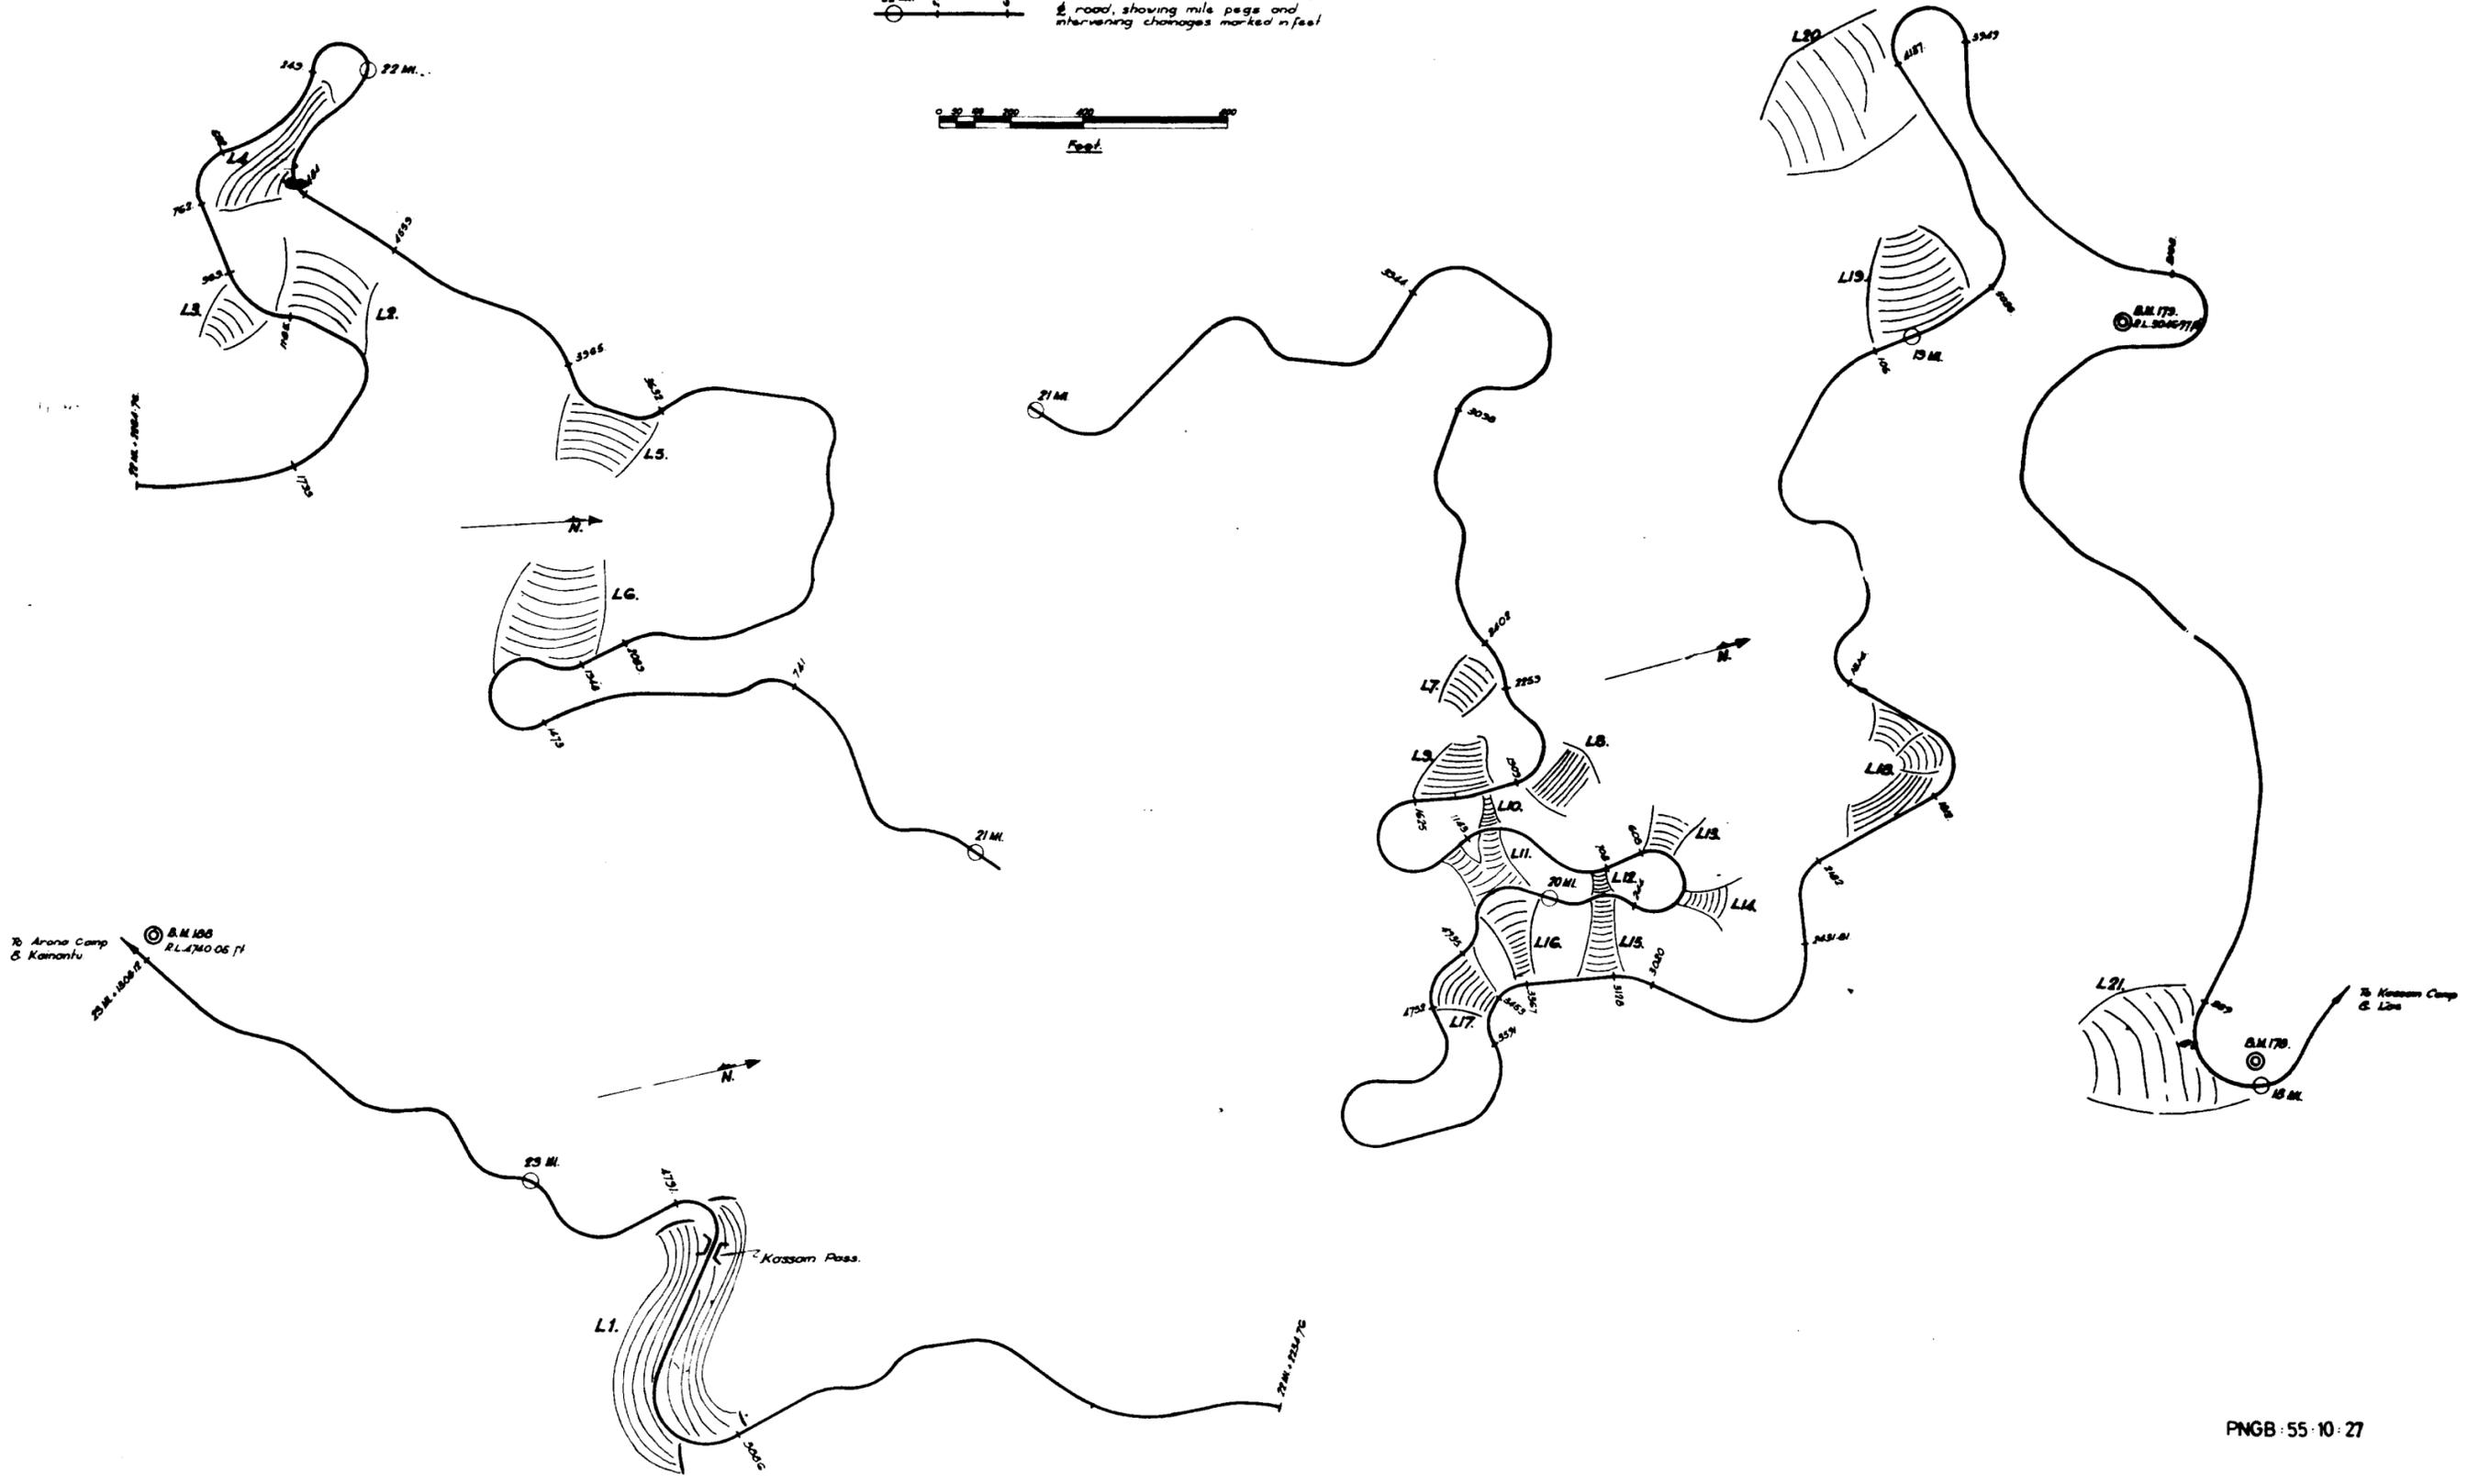
— KASSAM PASS ROAD. —
PLAN SHOWING LOCATIONS OF LANDSLIDES.

Treating the major landslide areas individually, slips L5, L6 and L21 (Plate 4) can be classified as previous landslide and scree slope areas which have been re-activated during road excavation. None is serious although a fair quantity of scree is likely to come down L21 in the future.

In areas L7, L18, L19 and L20 landslides have exposed bedrock on the lower two-thirds of the batter and left an overhang of soil and scree on the upper one-third. The causes are typical of the entire Kassam Pass area - removal of support, aggravated by the cutting of very steep batters, followed by heavy rainfall and consequent sliding of the weakened, unsupported overburden over bedrock. The process has been aided at L9, L19 and L20 by strata inclined almost parallel to the natural slope of the hillside and soil profile.

The road between 22 mi. + 969 and 22 mi. + 1500 has been constructed in the very weak, soft, weathered arkose and this section, together with slide areas L2, L3, and L4, will be unstable in wet weather. Similarly, the road between 20 mi. + 1900 and 20 mi. + 2260 has been constructed on overburden, which is slowly being undermined by a slump in area L8, and will also be unstable in wet weather.

1. In most of the landslide areas - L1, L5, L6, L7, L9, L18, L19, L20 and L21 - there appears to be no practical way of preventing further slide action. In fact, it is considered that in these areas it would be best to allow the slides to take place. Once the overhanging sections have collapsed the slopes will have become as stable as can be expected. Although road will be blocked from time to time it is not thought that there will be any damage to the stability of the road.

2. Realignment is recommended for the sections from 20 mi. + 1900 to 20 mi. + 2260 and from 22 mi. + 969 to 22 mi. + 1500. In both cases realignment farther into the hillside will locate the road on moderately fresh bedrock away from the present unstable slide-prone areas. Some protection of the newly exposed bedrock against weathering and erosion should be considered.

3. Extensive drainage control is recommended between 19 mi. + 3000 and 20 mi. + 1900 and also in both the sections mentioned in paragraph 2. above. As already pointed out further deterioration in all these areas will primarily be caused by water entering the batters. As a preventive measure the water must be controlled by the provision of adequate drains on both the inside (uphill side) and outside of the road. Particular care should be taken to provide adequate drainage outlets which will not allow haphazard release of the collected water back into the wet areas, as at 20 mi. + 603 (slide area L13). Outlet drains should be directed towards natural waterways and the run-off contained within these limits.

5. Any surface drainage system in the realignment area between 22 mi. + 969 and 22 mi. + 1500 should be carried at least as far back as 22 mi. to keep water out of the steep narrow batter and slide area L4.
