GEOLOGICAL INVESTIGATION OF THE ROUTE OF THE KAINANTU-GOROKA ROAD,
NEW GUINEA, APRIL 1966.

J.R.L. Read.

Records 1966/161

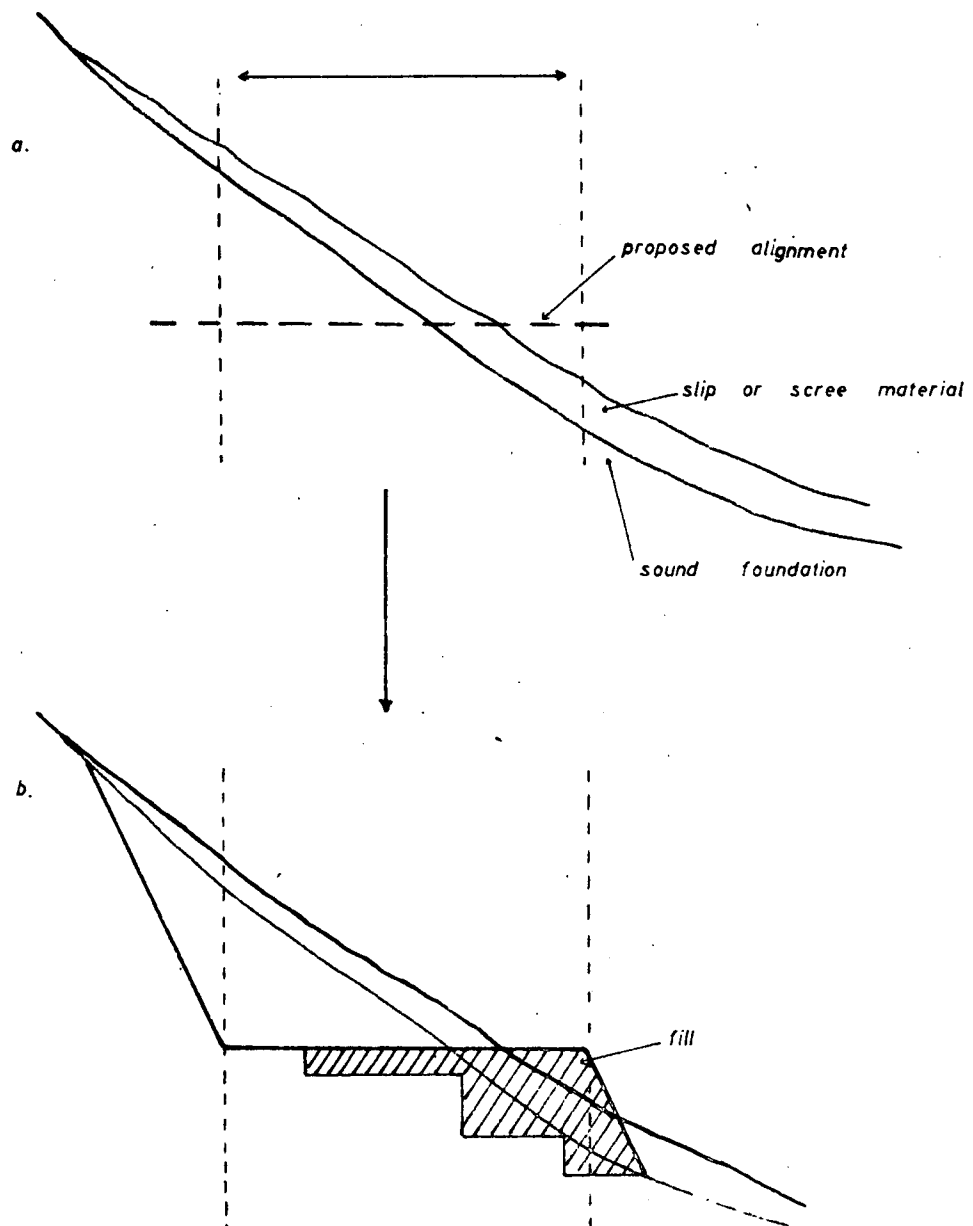
fig 1

A. Side-cut and box-cut embankments should not exceed a vertical height of 20 feet, nor have a slope steeper than $1\frac{1}{2}:1$. Embankments in cuts 20 feet or more deep should be benched; the width of the berms so formed should not be less than 10 feet. Where a cross-slope is steeper than that recommended for the slope of the embankment the angle of the cross-slope should be reduced. These recommendations are aimed at preventing two types of failure:

(i) failure of the ground above the cut due to removal of support from the toe of the slope in the cut. This type of failure is the dominant cause of landslides along the existing and proposed roads. In nearly all cases there is a definite interface between overburden and firm ground; in some cases this interface corresponds to outward dipping relic bedding, and in nearly all instances is aligned roughly parallel to the surface topography. With the removal of support and, in the wet season, entry of water into the overburden and along the interface, failure occurs, and the overburden slides over the firm ground.

(ii) embankment failure. The strength of the residual clays along the alignment - resulting from cohesion and internal friction - rapidly tends towards zero when the mass becomes saturated. It can be observed that few embankments along the existing road which have a vertical height in excess of 20 feet maintain stability for long in the wet season. Any increase in the vertical height, or the slope, of an embankment over twenty feet should be made only if favourable results are obtained from

Schematic drawing of excavation for cut
and fill on side slope.

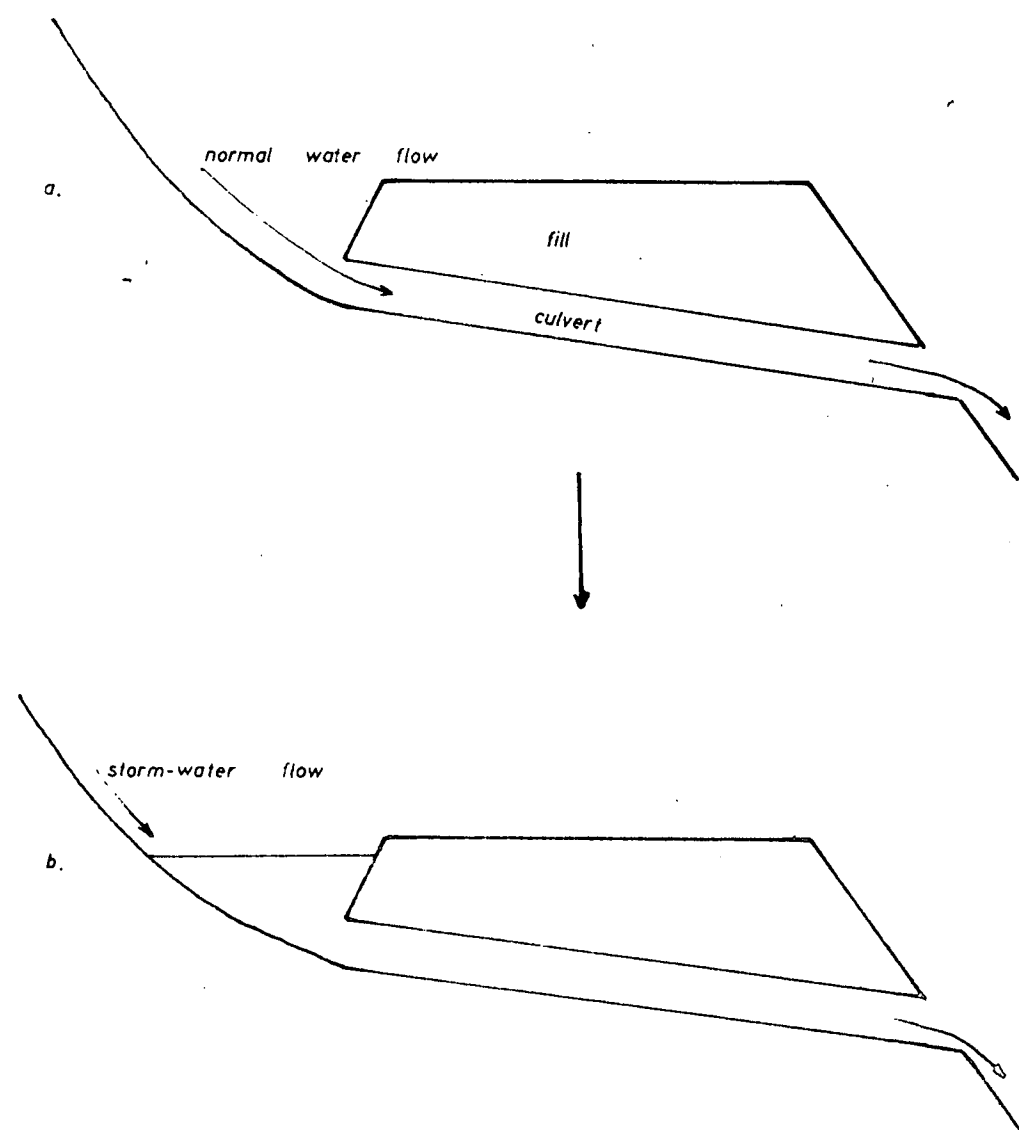
fig 2

Schematic drawing of culvert design

Culverts should be designed so that storm-water run-off can be cleared as rapidly as possible. The contract design for culverts allows for a time lag such that it is possible for a head of water to build up behind the culvert (fig. 2). This increases the likelihood of the culvert becoming blocked and introduces a seepage of water into the fill. Piping, leading to the eventual failure of the fill could result, particularly if compaction of the fill during construction had not been adequate.
