DEPARTMENT OF NATIONAL DEVELOPMENT
BUREAU OF MINERAL RESOURCES
GEOLOGY AND GEOPHYSICS

1966/180

VILLAGE WATER SUPPLY SURVEY, MILNA BAY DISTRICT, 1966.

J.P. MacGregor

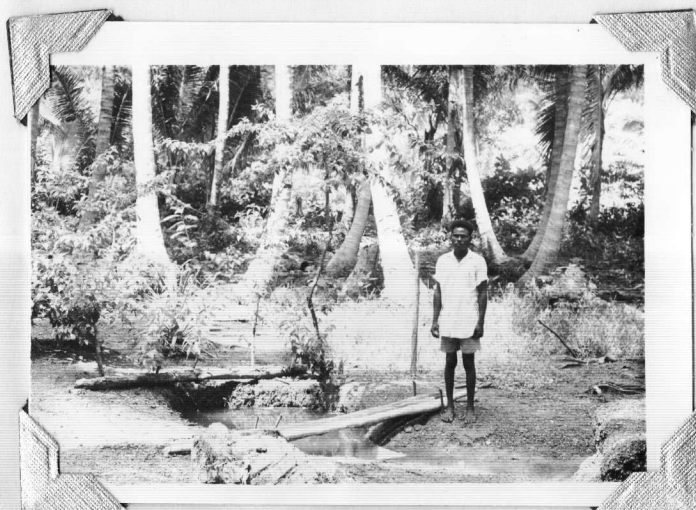
1/20 MIVIU AT PRESENT WATERHOLE

VILLAGE.....YADVITAN-KOTORINA...
TYPE OF RECOMMENDED SCHEME - Pumped/Gravity/Well/Bore/Hydraulic-Pan/
Rainwater-Catchment
LOCATION OF NEW SUPPLY.....30 yards behind tradostero at western.....
.....end of village.....
DISTANCE FROM VILLAGE.....
ACCESS.....
SITE KNOWN TO.....MIVIU.....
TYPE OF AQUIFER.....Sand and gravel on land side of sand bar.....
DETAILS OF SCHEME.....Sanitary well as per Standard PWD drawings -
.....10 foot deep.....
.....Suitable sand and gravel available.....
MATERIALS REQUIRED.....As per plans - 3-4 foot concrete pipe.....
LABOUR REQUIRED.....Local.....
SUPERVISION.....Local Council Executive Committee.....
ESTIMATED COST (\$).....100.....
ALTERNATIVE SCHEME.....Other suitable sites along stream but
.....difficult to provide adequate drainage from them.....
PRIORITY.....Moderate.....Signed...J.P. MacGregor..Date...3/3/66...

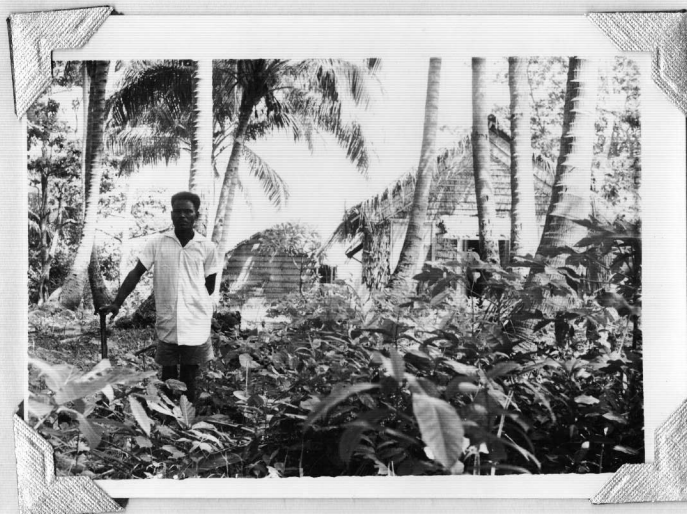
1/21 MIVIU AT WELL-SITE. TRADESTORE IN BACKGROUND
