GEOLOGICAL INVESTIGATION OF BURBONG DAMSITE,
MOLONGLO RIVER, A.C.T., 1965-66

G.A.M. Henderson

Record 1966/212

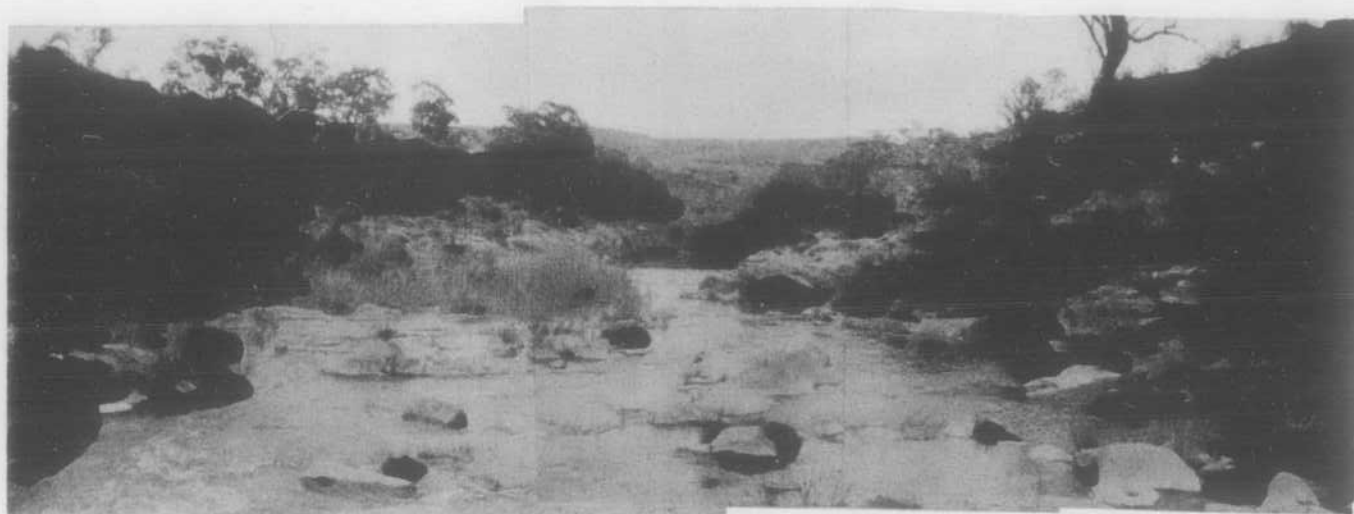
Fig. 1: View of south bank. Plunge of folds in sandstone outcrop in foreground is about 28° towards camera. Proposed dam axis passes along a nearly vertical line running through centre-right of photo.

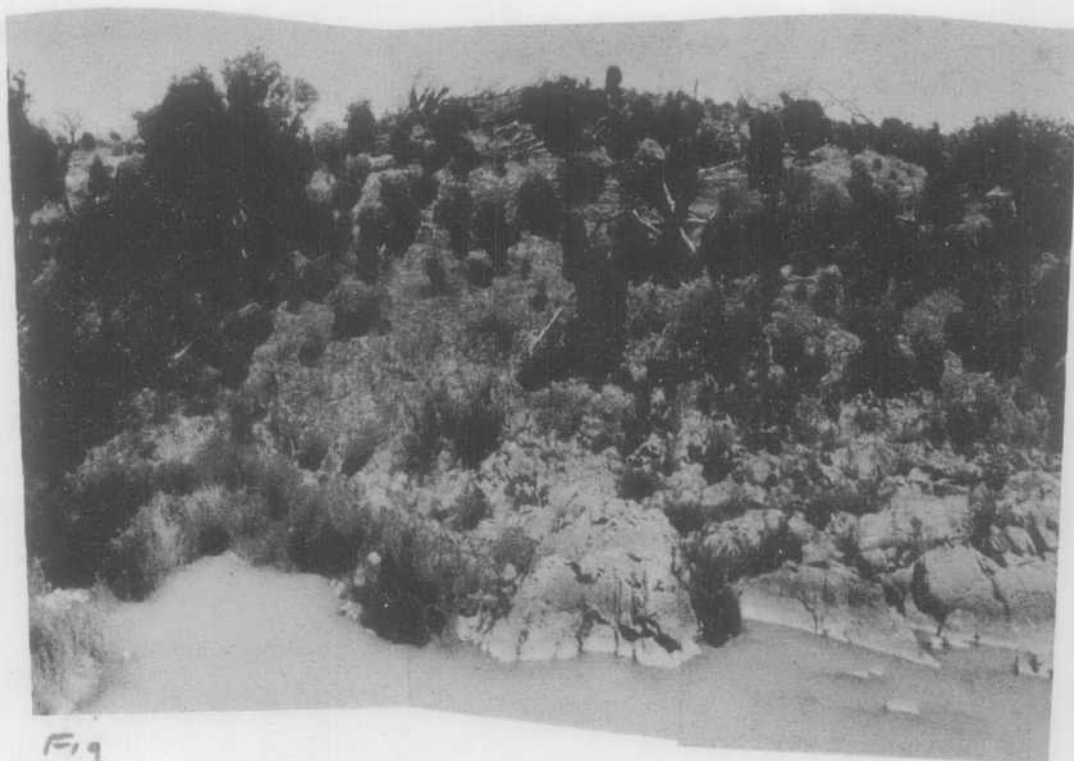
Fig. 1
 Plate 1: View, looking downstream to the west, from a point about 150 feet upstream from proposed dam axis. Proposed axis passes from just beyond large tree trunk breaking skyline, across behind reeds in middle distance, and up to a point near top, left hand corner of picture.

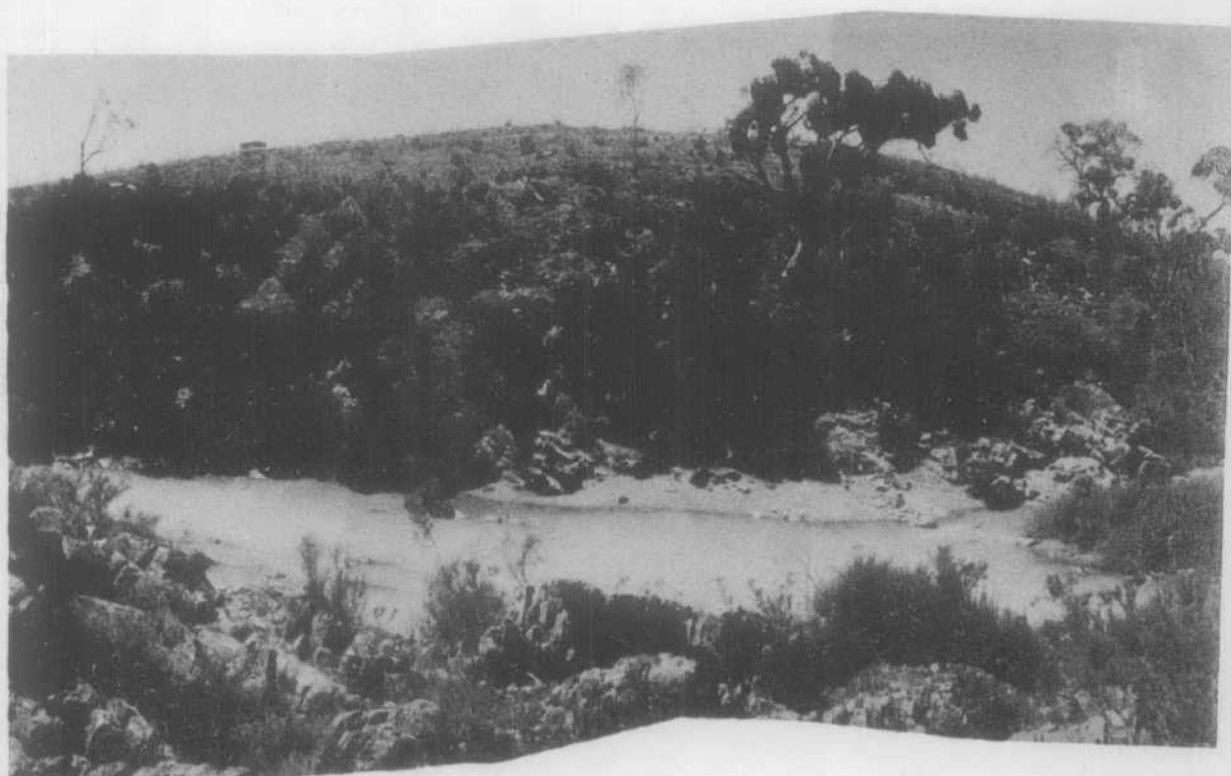
Fig. 2: View of north bank and part of massive sandstone near river on south bank. Plunge of folds in foreground is about 28° away from camera. Proposed dam axis passes along a line running from apparent top of hill to bottom left hand corner of photo.

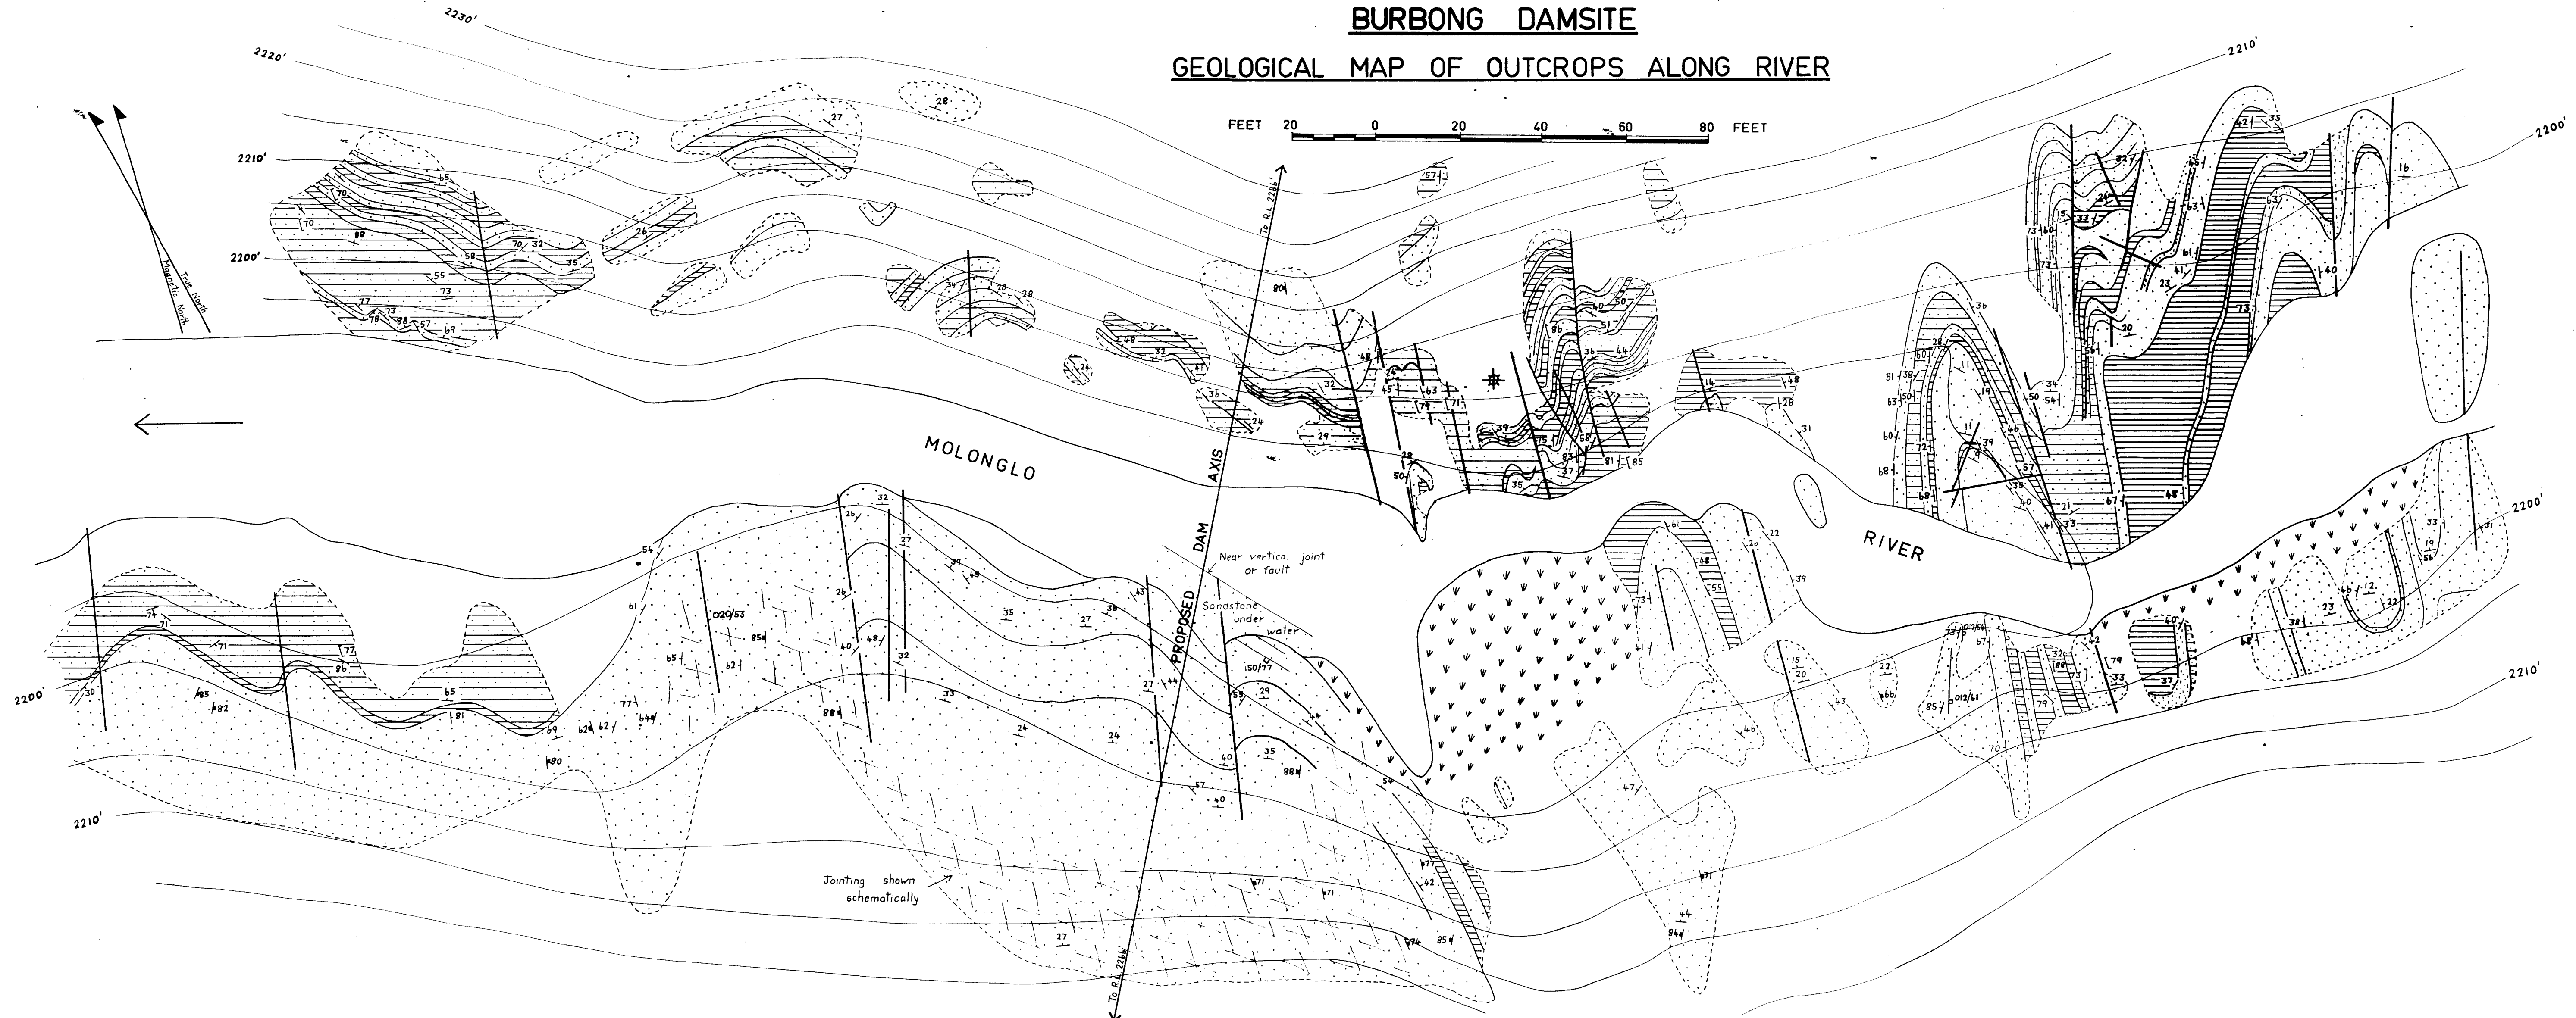
GEOLOGICAL MAP OF OUTCROPS ALONG RIVER

Apart from the axial plane faults, other small faults are developed locally, as shown on Plate 5. One of these faults, striking 110° , cuts across the prominent anticline about 180 feet upstream from the axis. A fault or very prominent joint, which strikes 020° dips 53° E, occurs 110 feet downstream from the axis on the south bank.

A near-vertical fault in the river at the dam axis striking about 150° , is suspected. The sandstone on the south bank can be seen to slope down gently, under the water, to a point where it is abruptly at off to form a near-vertical face. The attitude of the face appears to be parallel to a joint set observed in the sandstone nearby which strikes at 150° and dips at 77° south-west. (See Plate 5).

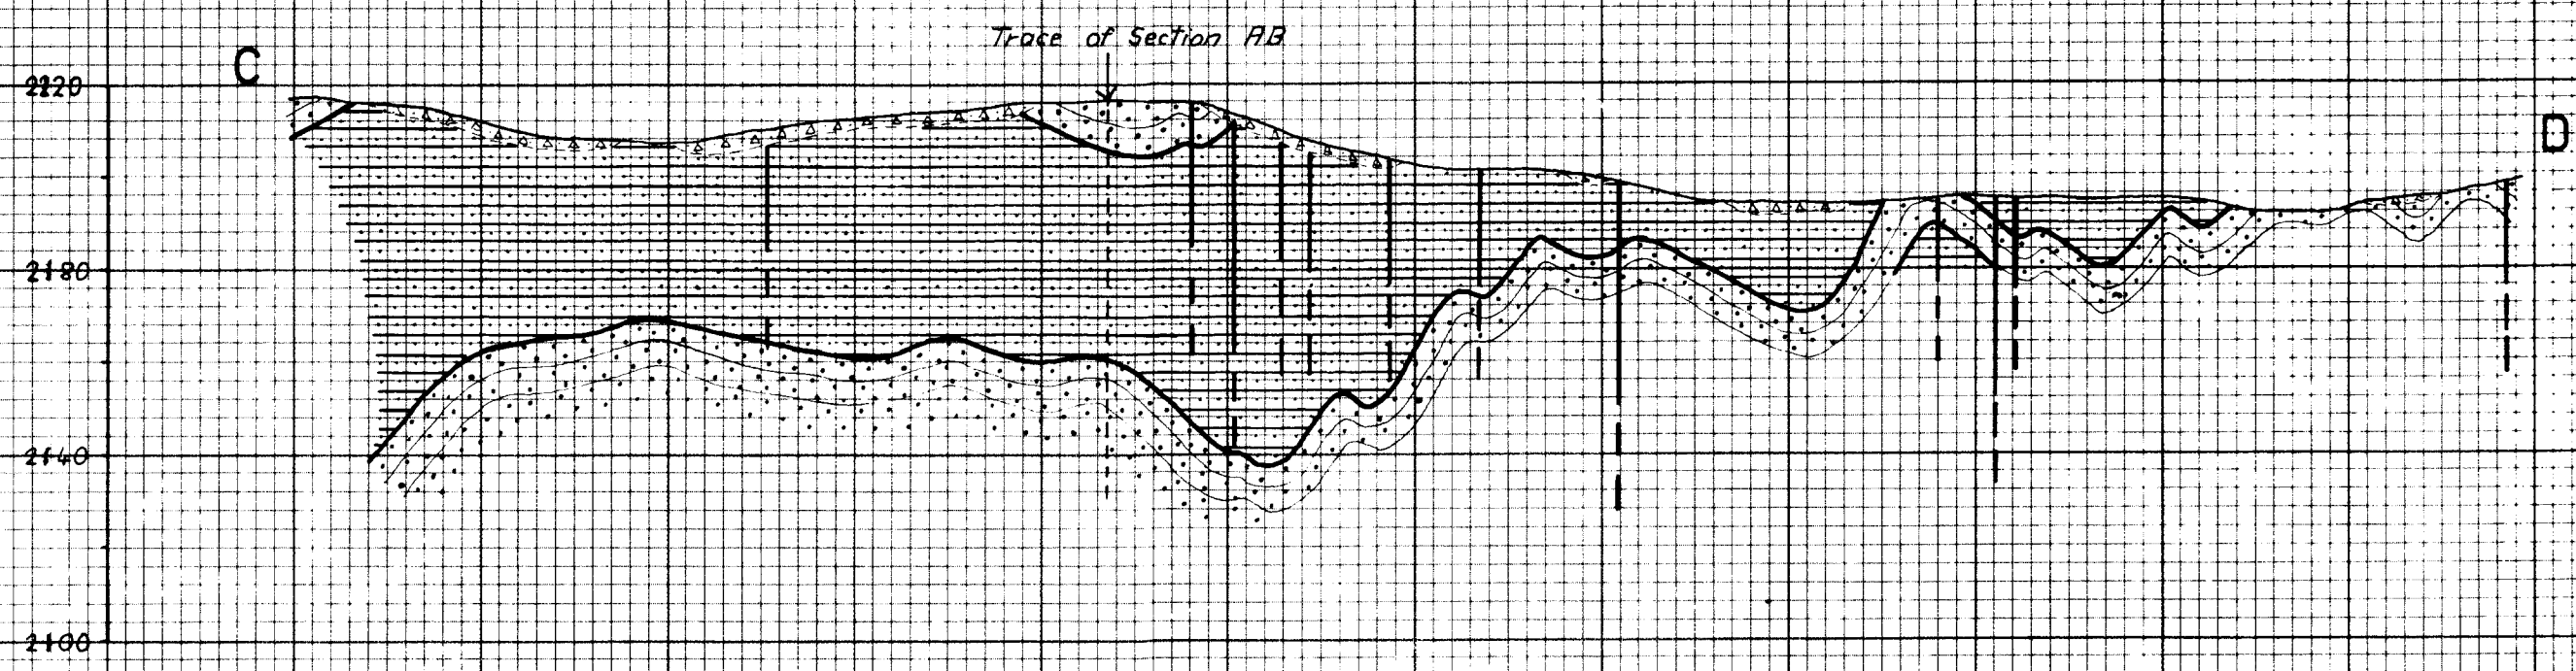
INTERPRETIVE CROSS SECTION NORMAL TO PROPOSED DAM AXIS

In the pool is an underwater ledge, the edge of which faces north-east, and abruptly cuts off the massive sandstone which continues underwater from the south bank. The face of the ledge may represent a fault along which the northern block has been downfaulted, or may be a joint plain from which the northern block has been by the river. A rotational movement of the massive sandstone about the plane could account for the slightly different plunge of the folds in it from the plunge of folds on the north bank. The structure, whether fault or joint, could provide a leakage path through the foundations of the dam, but the leakage path would be narrow and the structure is not likely to be a source of serious foundation weakness. It will need investigation by drilling and water pressure testing.
