GEOLOGICAL INVESTIGATION OF THE GOROKA - DAULO PASS - CHUAVE ROAD,
EASTERN HIGHLANDS DISTRICT, NEW GUINEA.

Record 1967/25

A brief geological investigation of the existing section of the Highlands Highway between Goroka and Chuave was carried out in September 1966 at the request of the Commonwealth Department of Works.

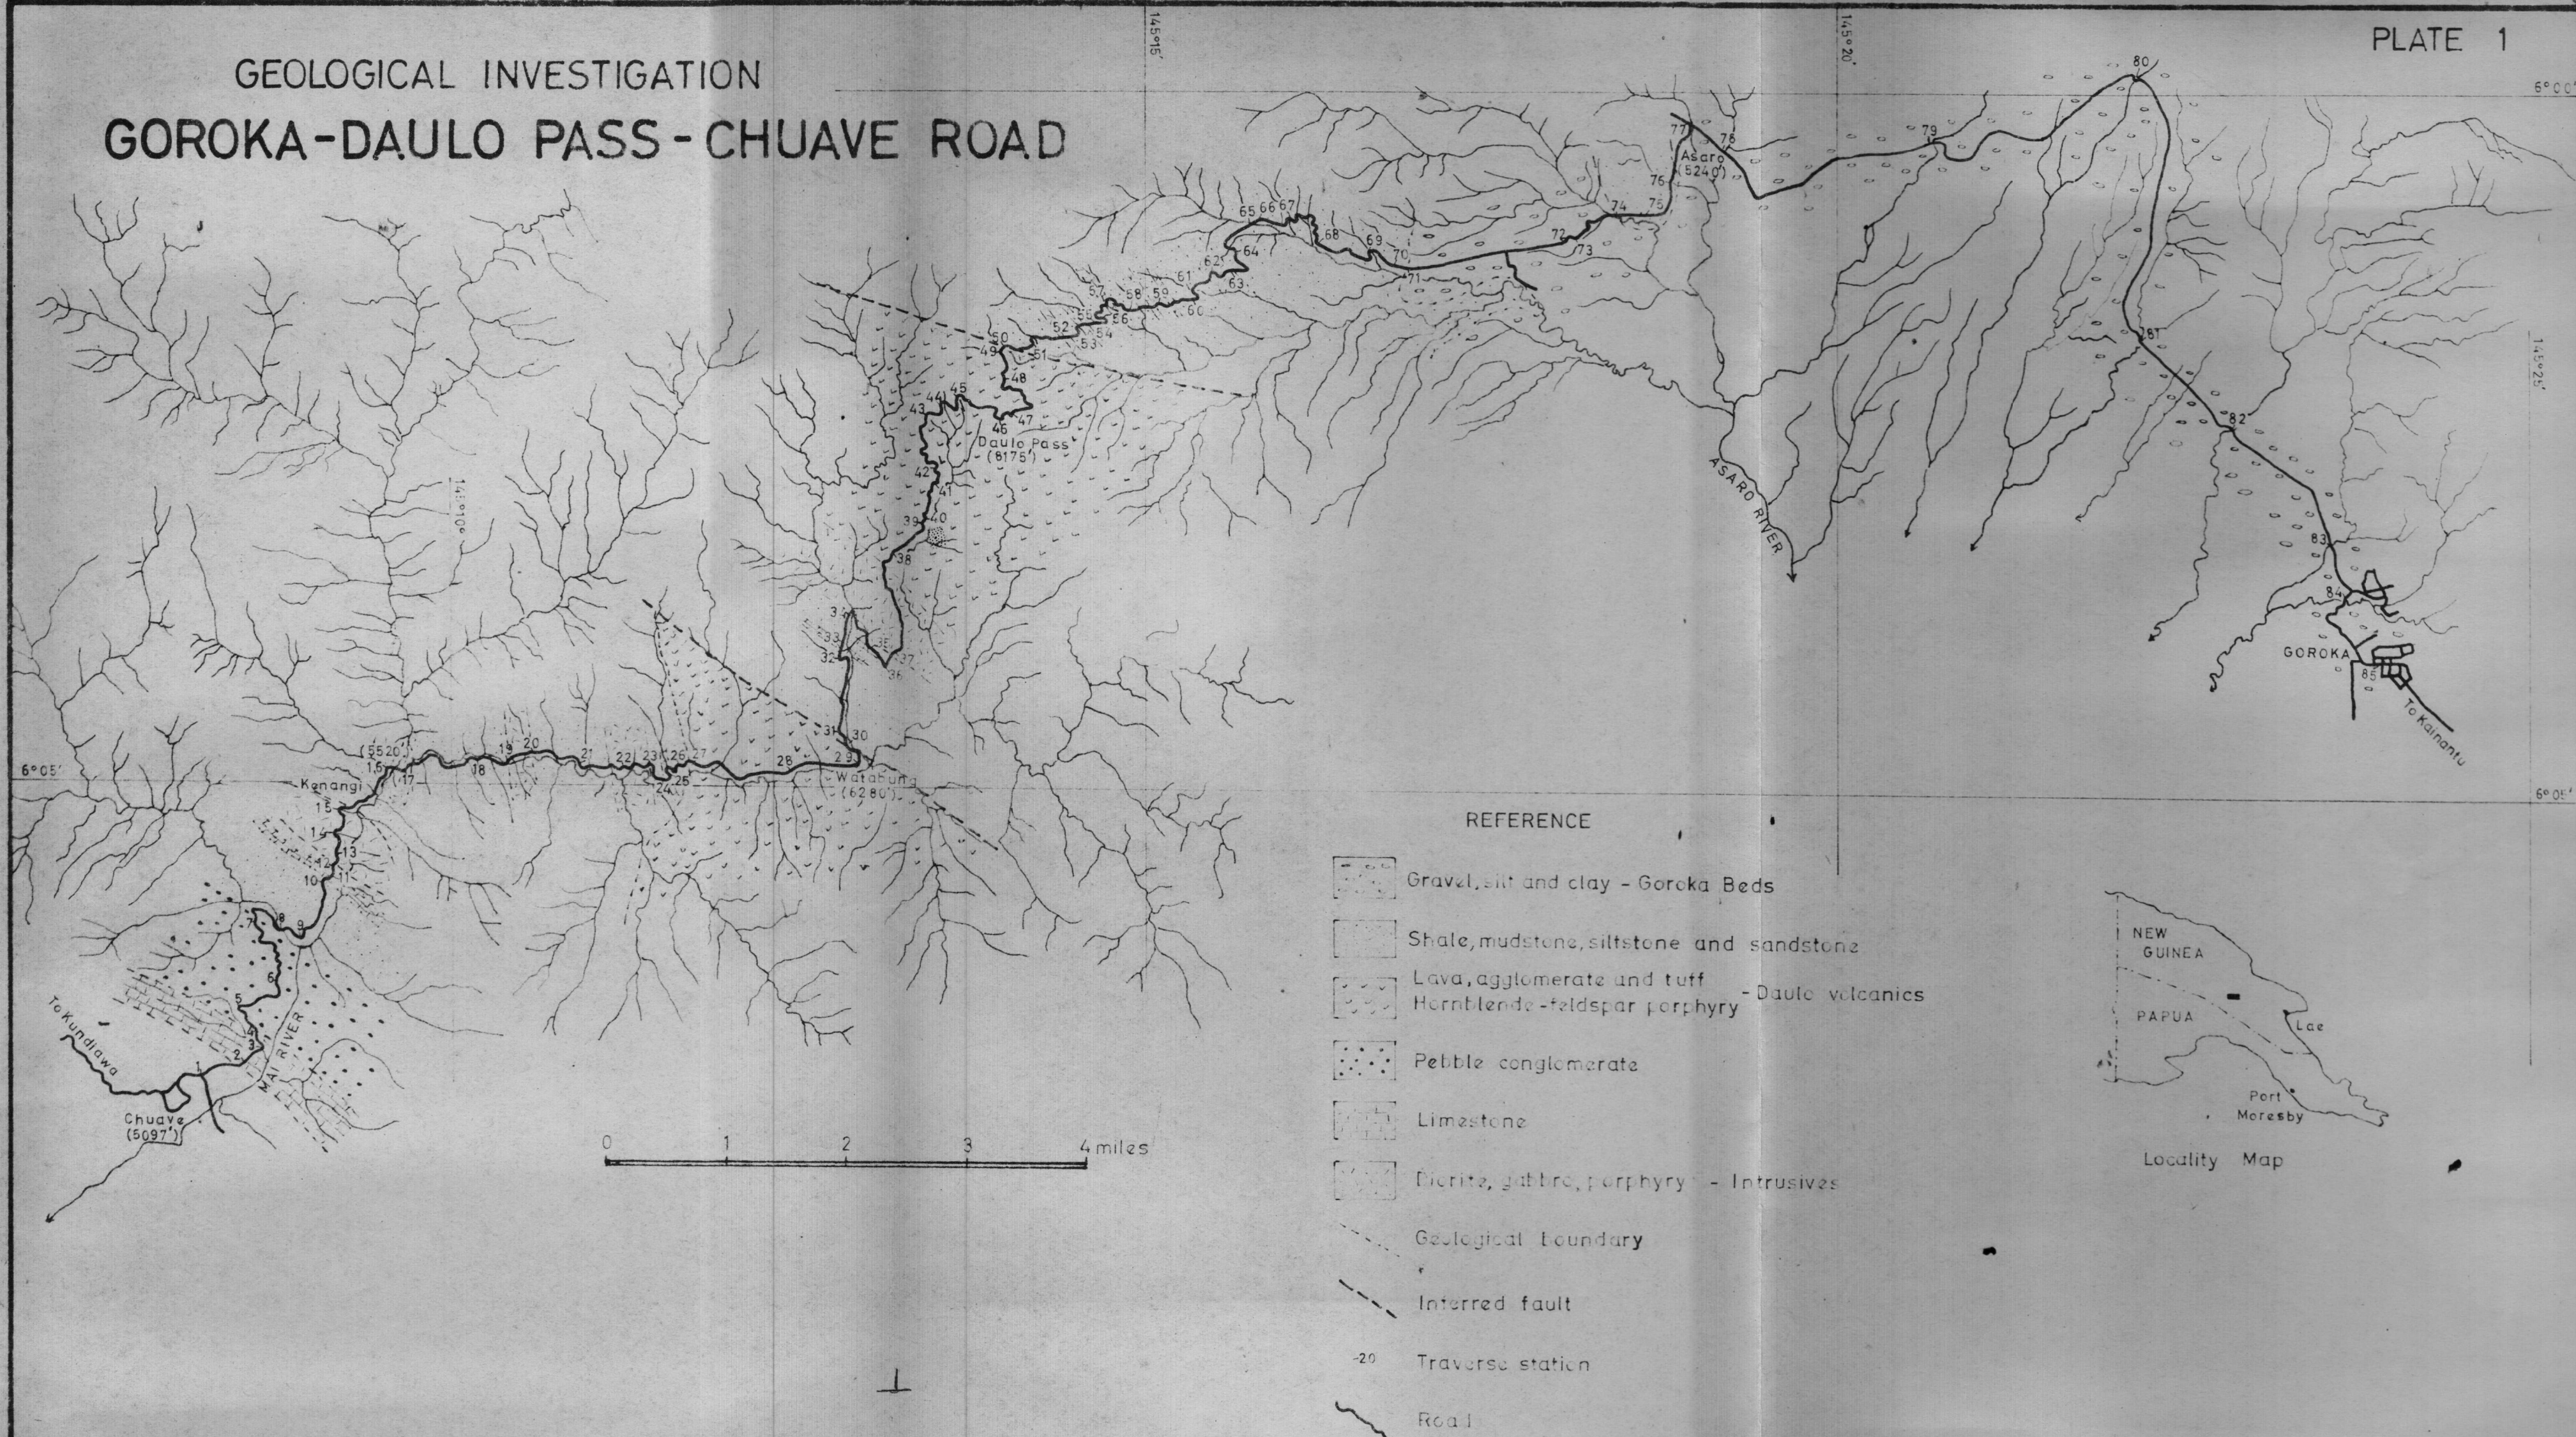
PLATE 1

The traverse from Chuave to Goroka has been divided into several sections and these are described separately. Detailed traverse notes taken at each station, with appropriate mileages, are given in Appendix 1. The location of the stations and the general rock types observed are shown on Plate 1.
