RECORD NO. 1967/115

ST JOHN'S CHURCH, REID, A.C.T.,  
VIBRATION TEST, 1967

*G. HART*

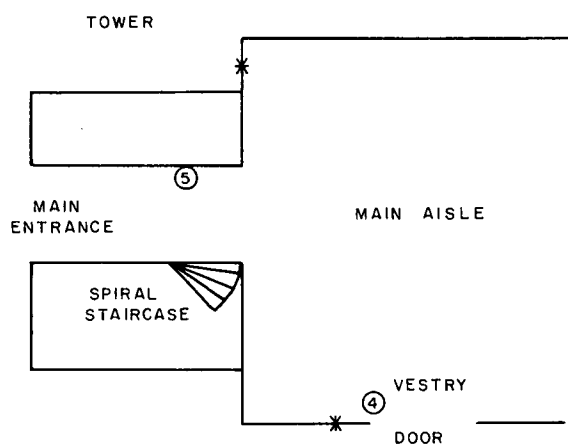
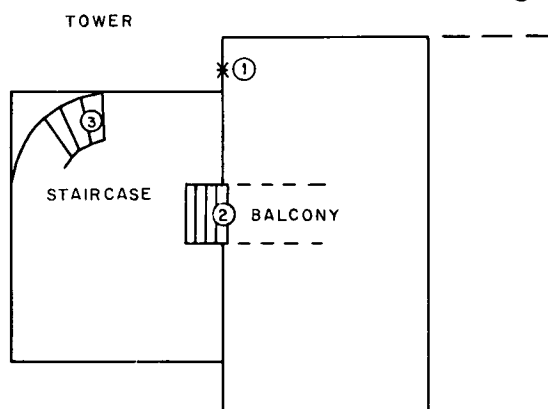
**ST JOHN'S CHURCH, REID, A.C.T.  
SEISMOGRAPH STATIONS**

The church, which is about 140 years old, has developed cracks in some of its walls (Plate 1). The purpose of the test was to find out if bell ringing and organ playing could produce vibrations large enough to be the cause of the damage.

Plate 1 shows the locations where measurements were made and the following table shows the results:

The table shows that all recorded vibration components have maximum velocities less than 0.05 of the safety limit.

The vibrations caused by the bell and the organ are not expected to cause damage to the church. To explain the cracks in the walls of the church, other causes should be sought.
