DEPARTMENT OF NATIONAL DEVELOPMENT

RECORDS 1968/98

GEOLOGICAL INVESTIGATION OF COREE DAMSITE,  
COTTER RIVER, A.C.T., 1967-1968.

D.A. BUCHHORN

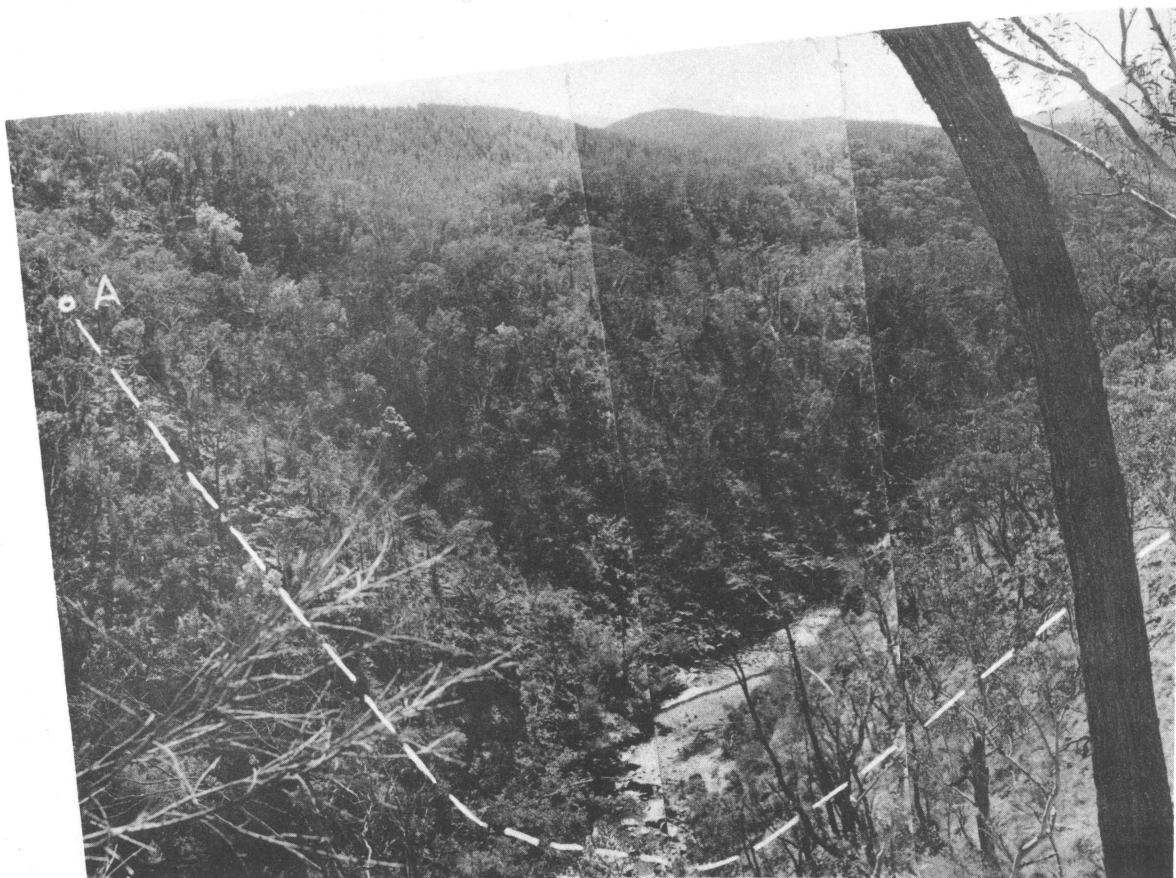
Figure 2. (top) Damsite, looking north-west (upstream). Seismic traverse AB, marked, is possible dam axis. A is at R.L. 2066.
