COMMONWEALTH OF AUSTRALIA

BUREAU OF MINERAL RESOURCES, GEOLOGY AND GEOPHYSICS

Record No. 1968 / 142

**Preliminary Report on the
14 October 1968 Earthquake
at Meckering, Western Australia**

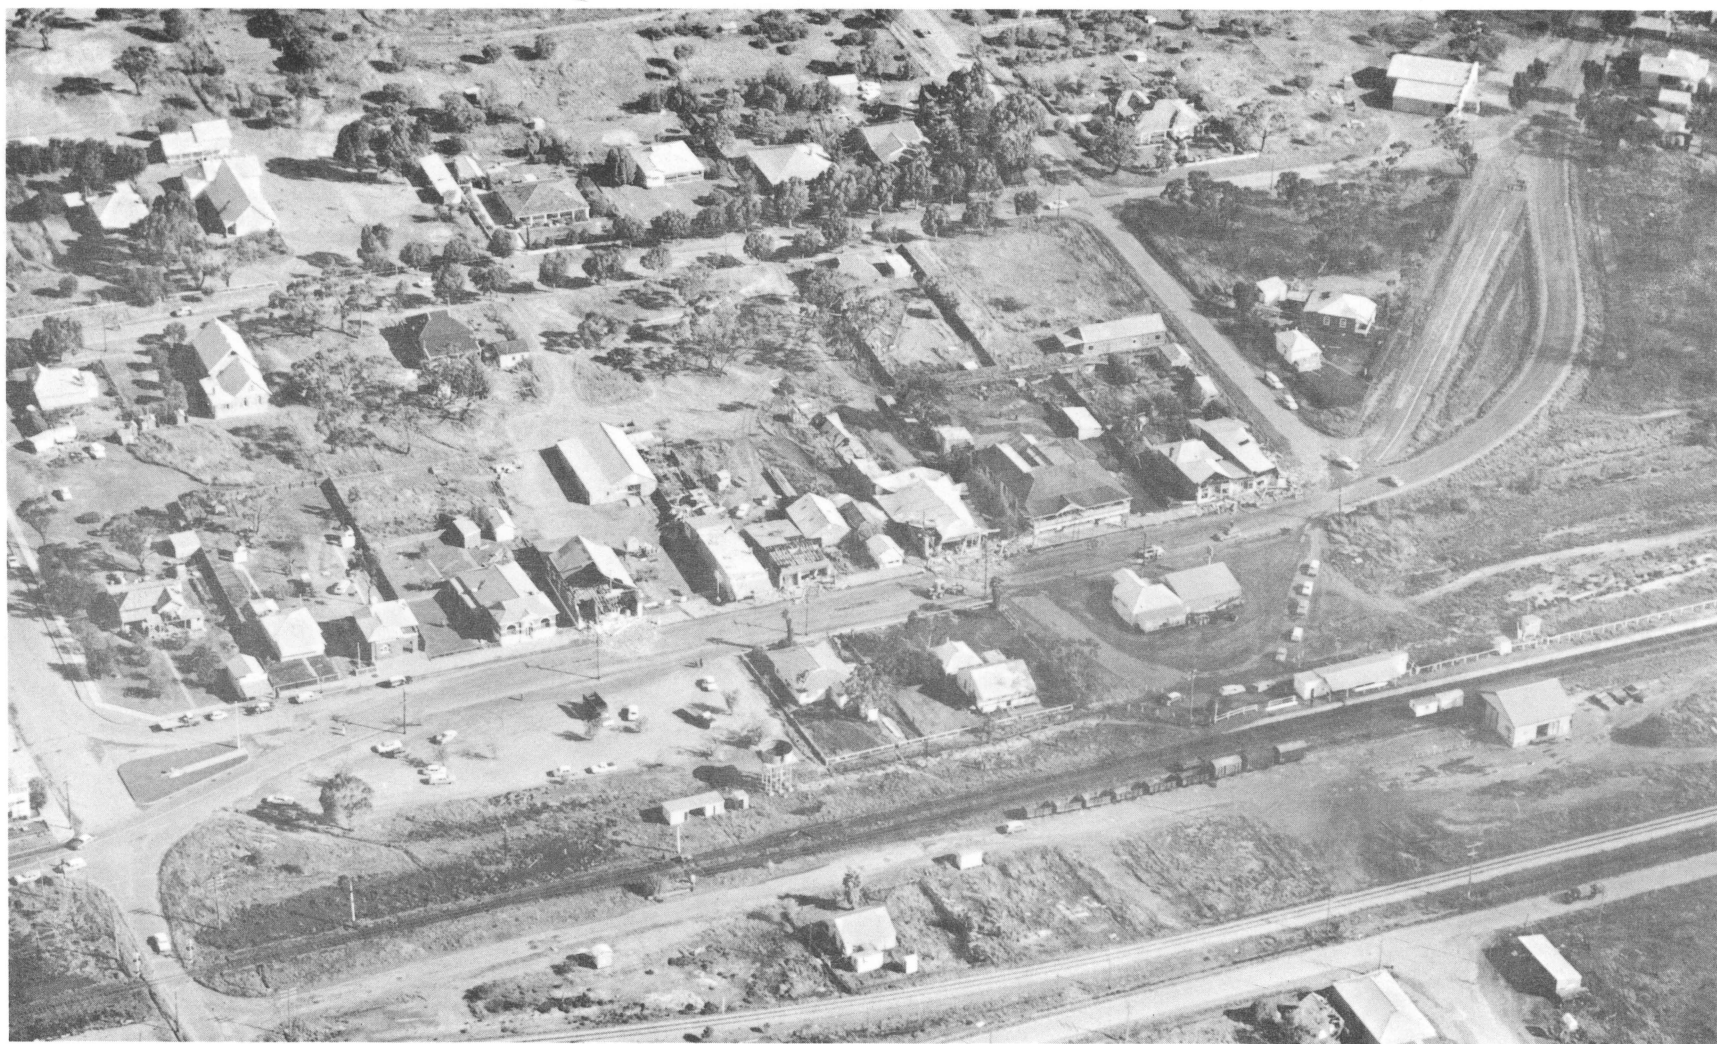
Aerial view of Meckering looking South (14 Oct 1968)

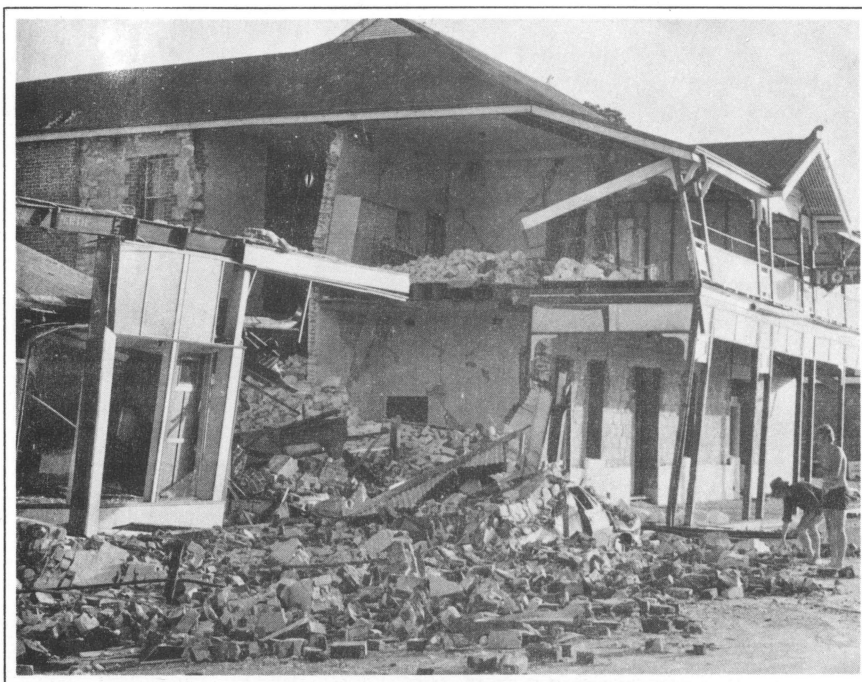
DAMAGE - MECKERING; (a) Hotel

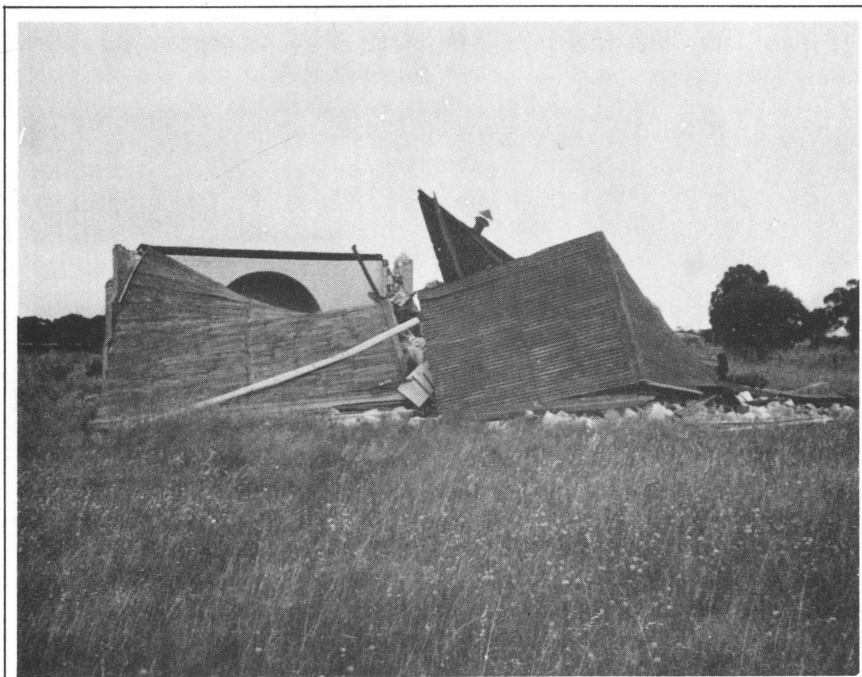
(b) Church

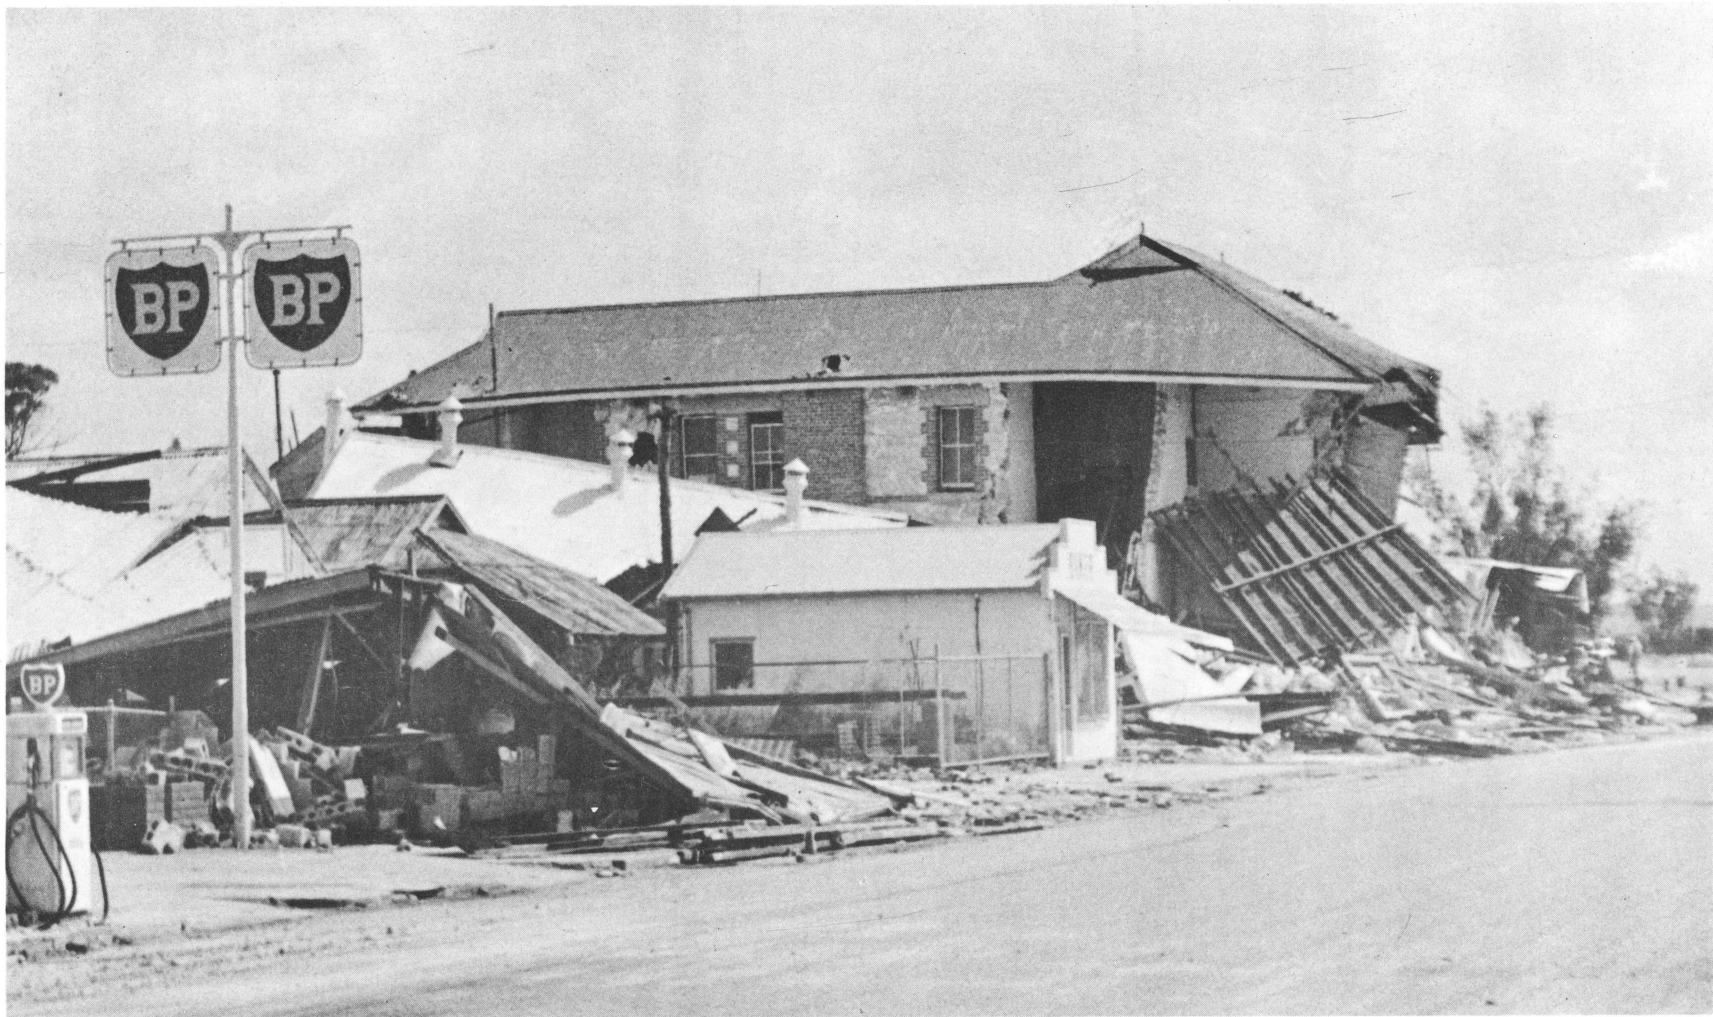
Brick and stone homes, mostly built at least 40 years ago, were completely destroyed in areas near the fracture zone, whereas asbestos (timber-framed) and timber homes and iron sheds (timber and steel framed) in the same area withstood the shaking (notice the fibro-cement shop in Plate 6). A large re-inforced concrete wheat silo only two kilometres (1.2 miles) east of the fault suffered only superficial damage.

DAMAGE - MECKERING: Fibro-cement baker's shop relatively undamaged

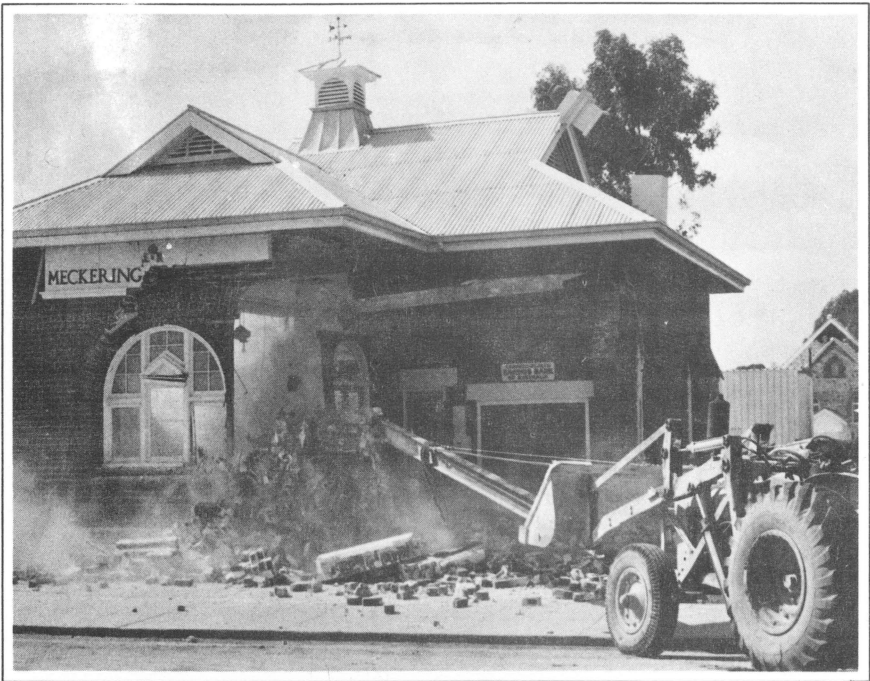
DAMAGE - MECKERING: (a) Post Office being wrecked because of severe damage.

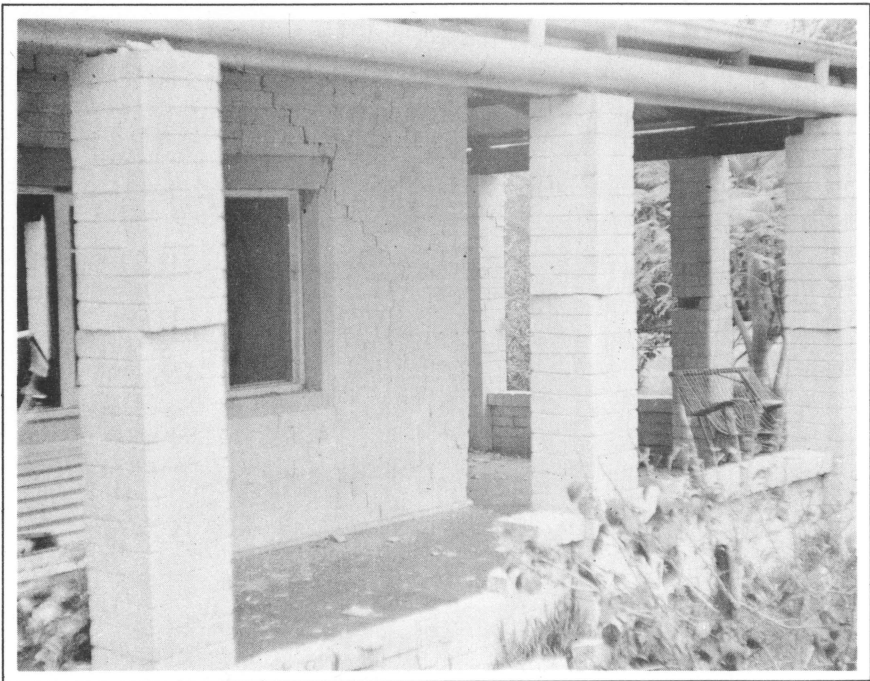
(b) Brick house, 1 mile west of fracture, looking north-west

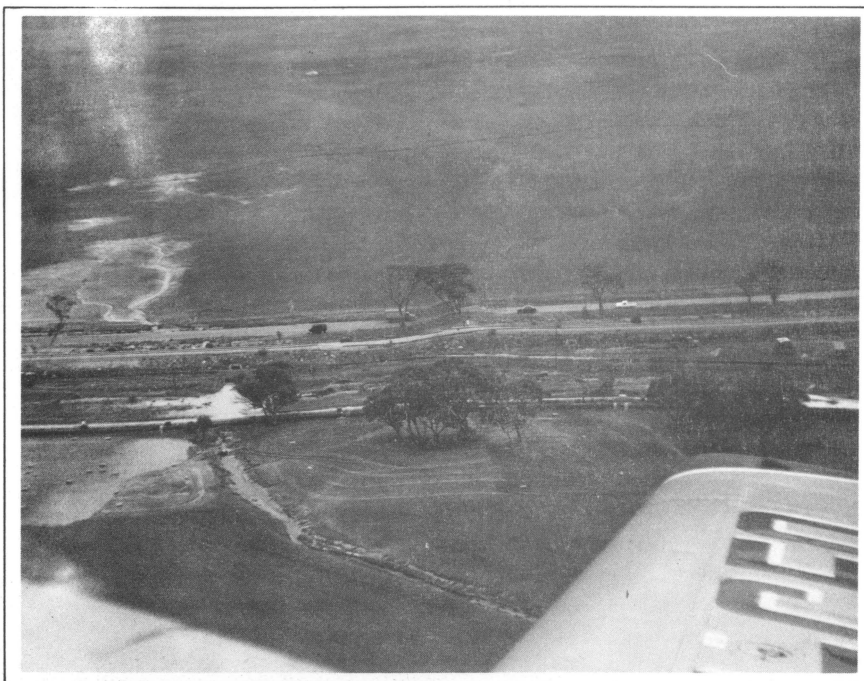
FRACTURE ZONE: (a) Railway cut 1½ miles west of Meckering, looking north. Railway shortening 7 feet. East side up. Pipeline break not visible. (note trees still upright)

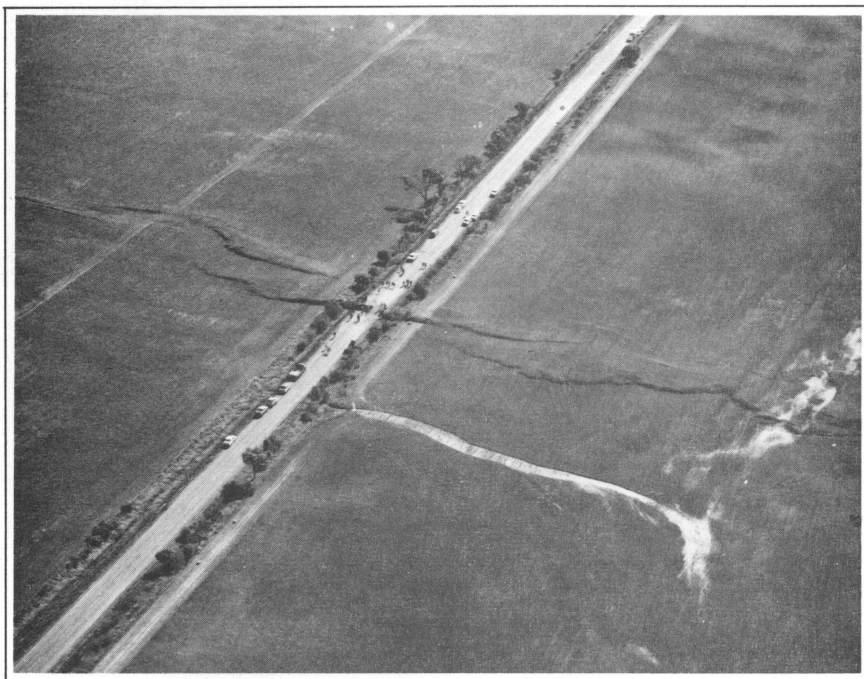
(b) Great Eastern Highway, looking north-east.

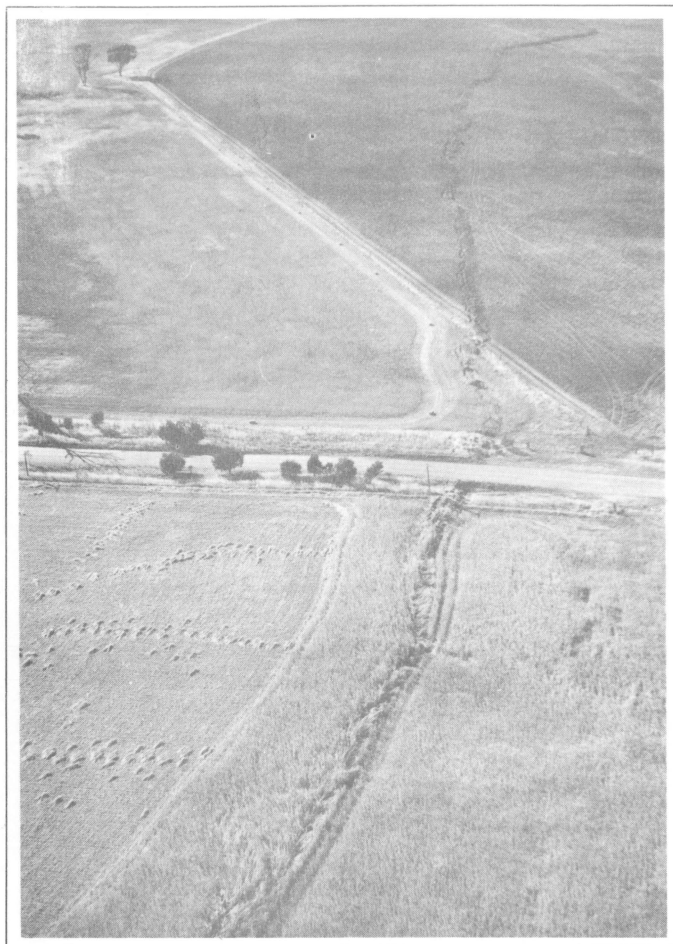
FRACTURE ZONE: (a) Hardy road, 7½ miles south of railway, looking south-east.

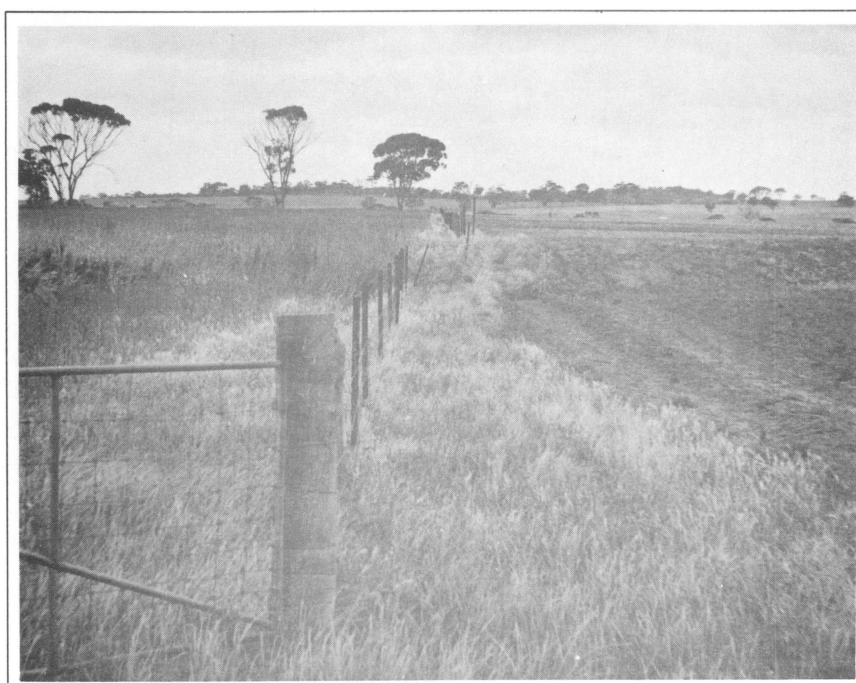
(b) Hardy road 7½ miles south of railway, looking south-east.

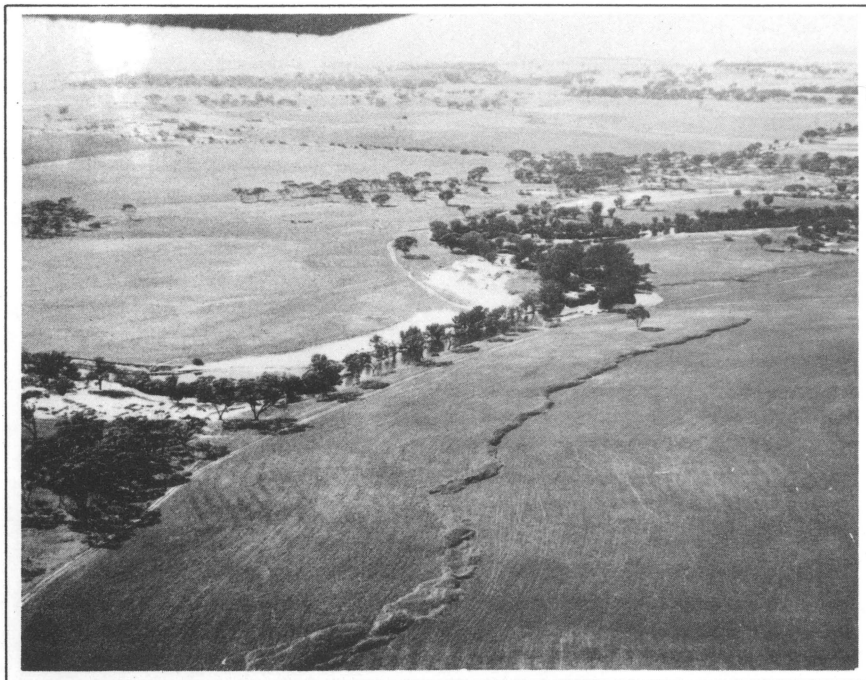
FRACTURE ZONE: (a) Mortlock River dammed $3\frac{1}{2}$ miles south of railway, looking south-east.

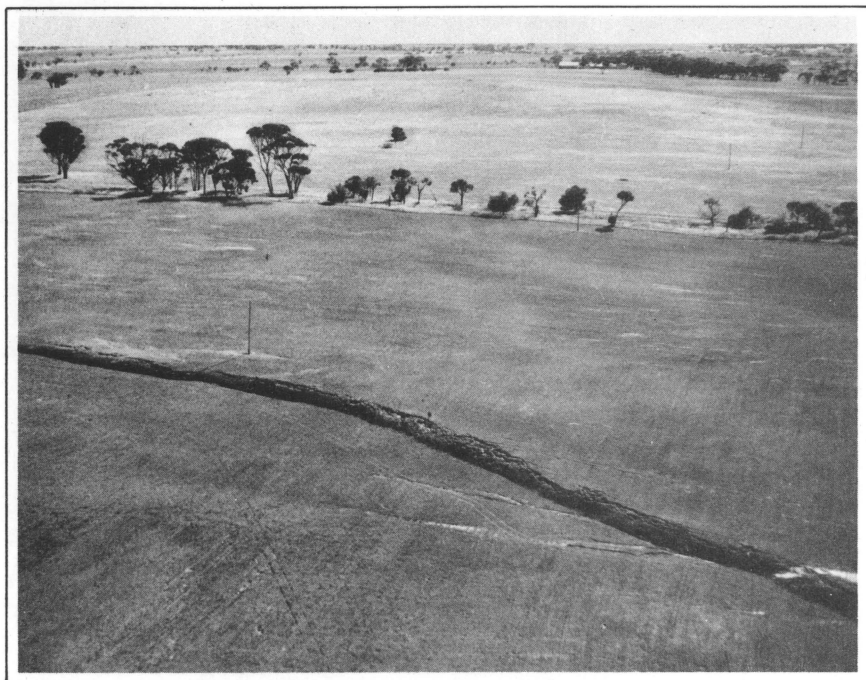
(b) 2 miles south of railway, looking north-east.

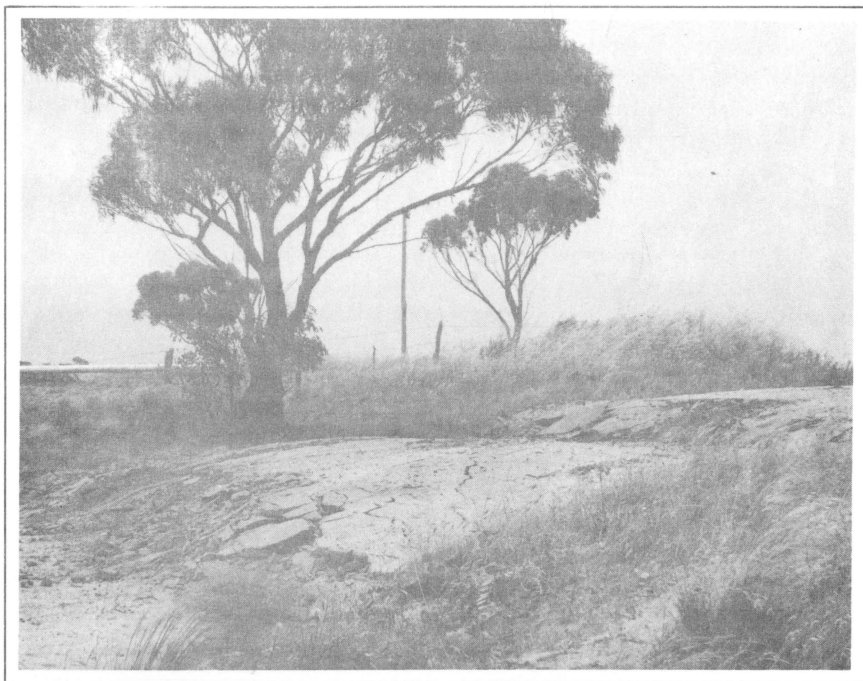
FRACTURE ZONE: (a) Goomalling road 1 mile north-west of Meckering.

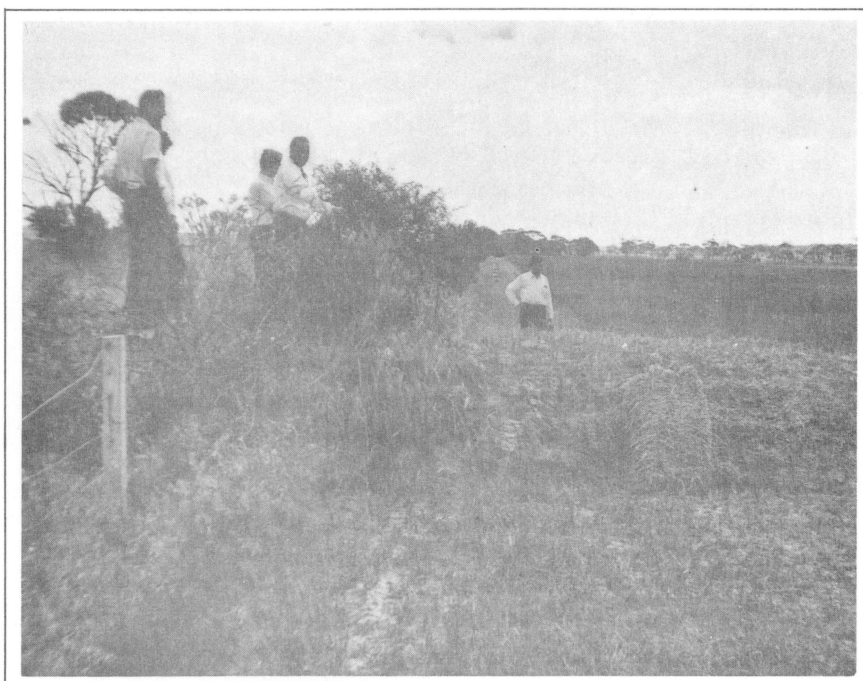
(b) ½ mile south of railway, looking west from east of fracture zone

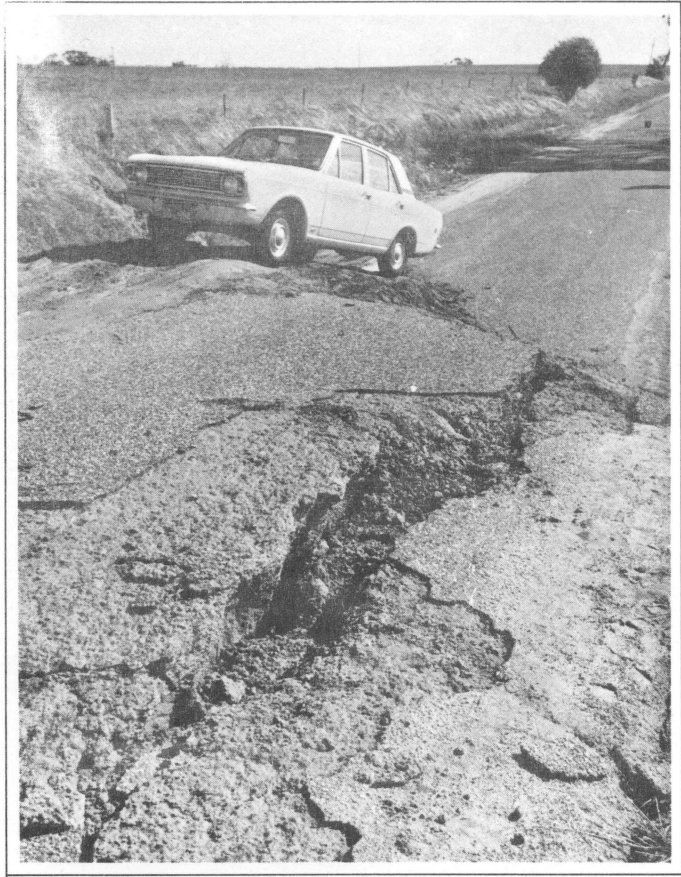
FRACTURE ZONE: (a) York road, 5 miles south of railway, looking west.

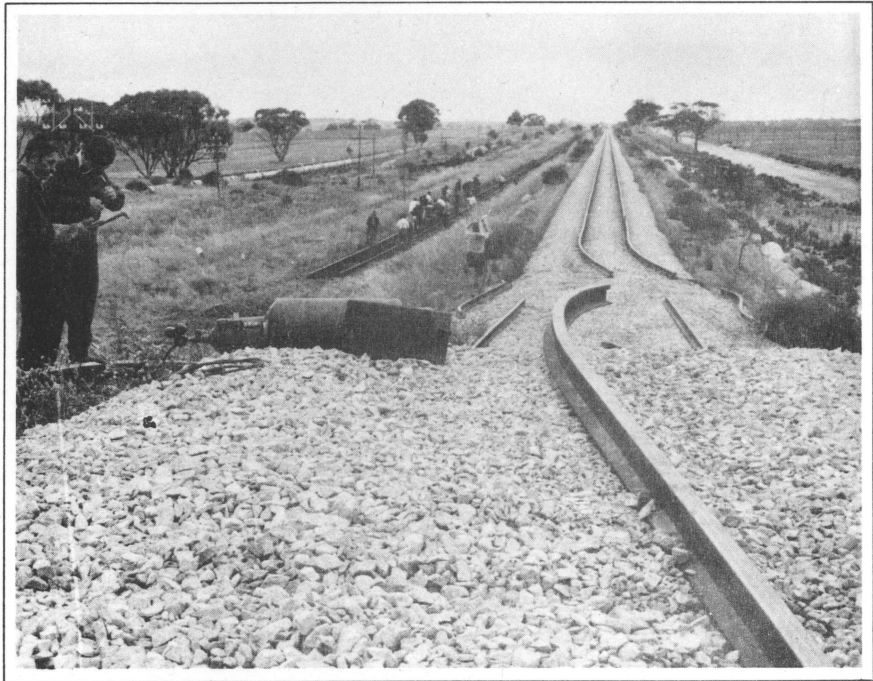
(b) Railway line 2 miles west of Meckering, looking west.

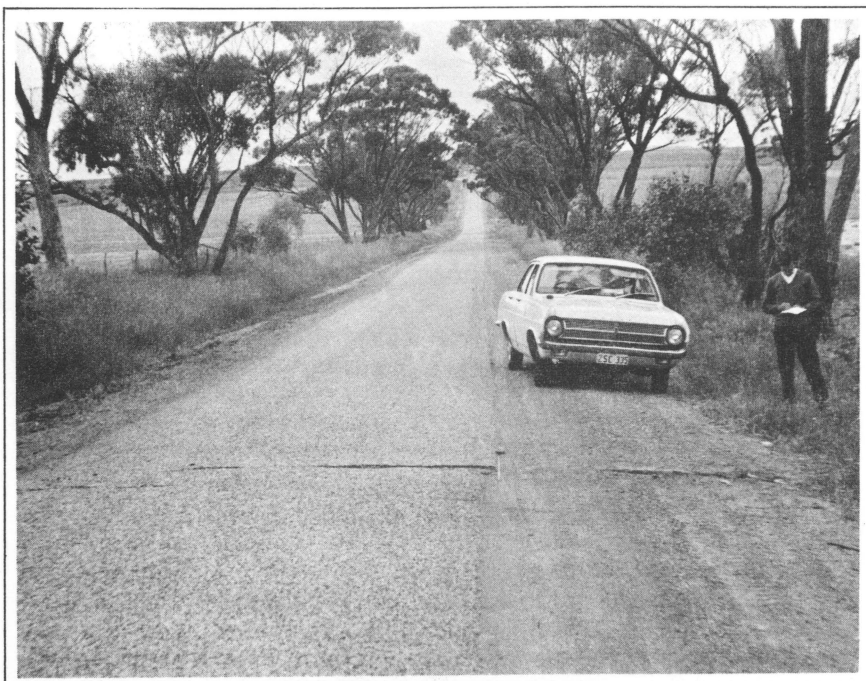
FRACTURE ZONE: (a) Minor transcurrent fault 1 mile east of major fracture; 7 miles south of railway, looking south.
(note en-echelon faulting)

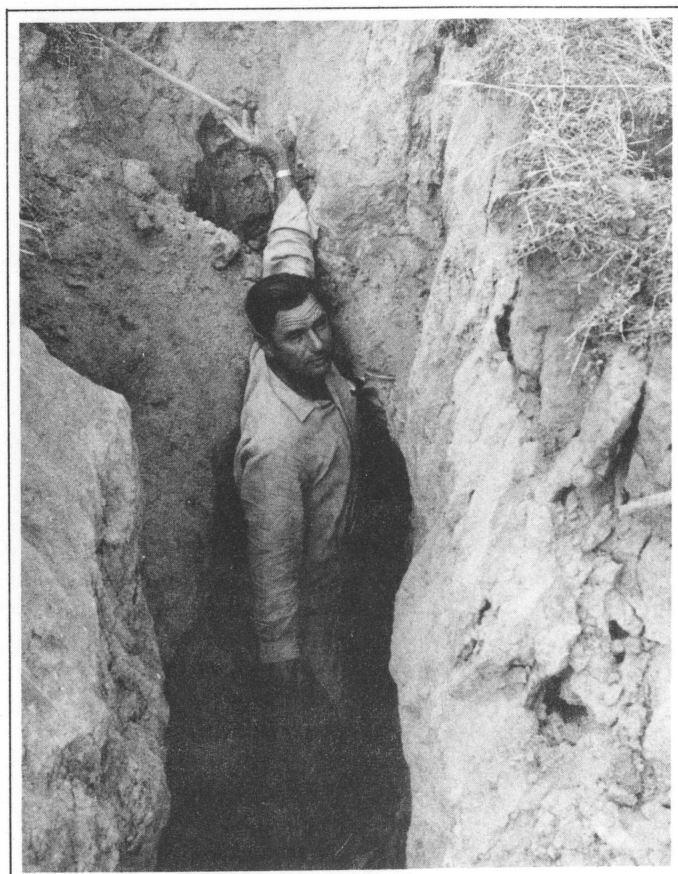
(b) Crack on O.M. Burge's property between Hardy and York Roads where fault is offset.

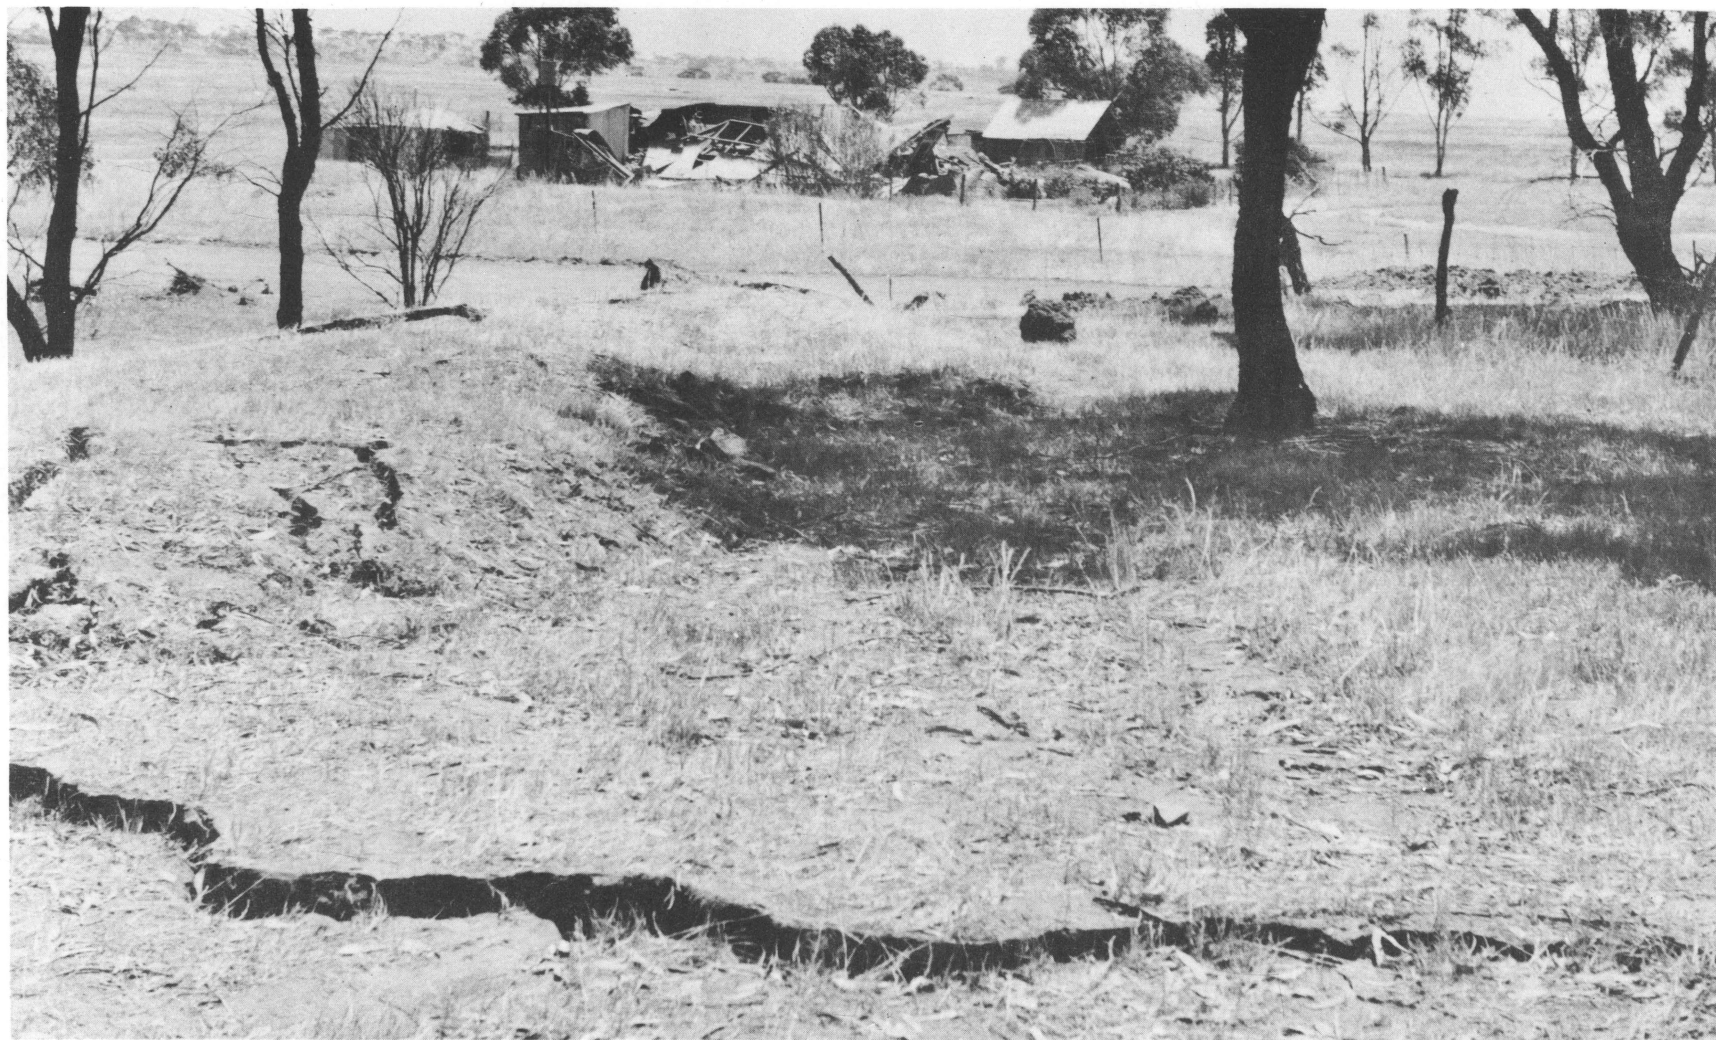
FRACTURE ZONE: Dowerin road, 1 mile north of Meckering, looking north-east

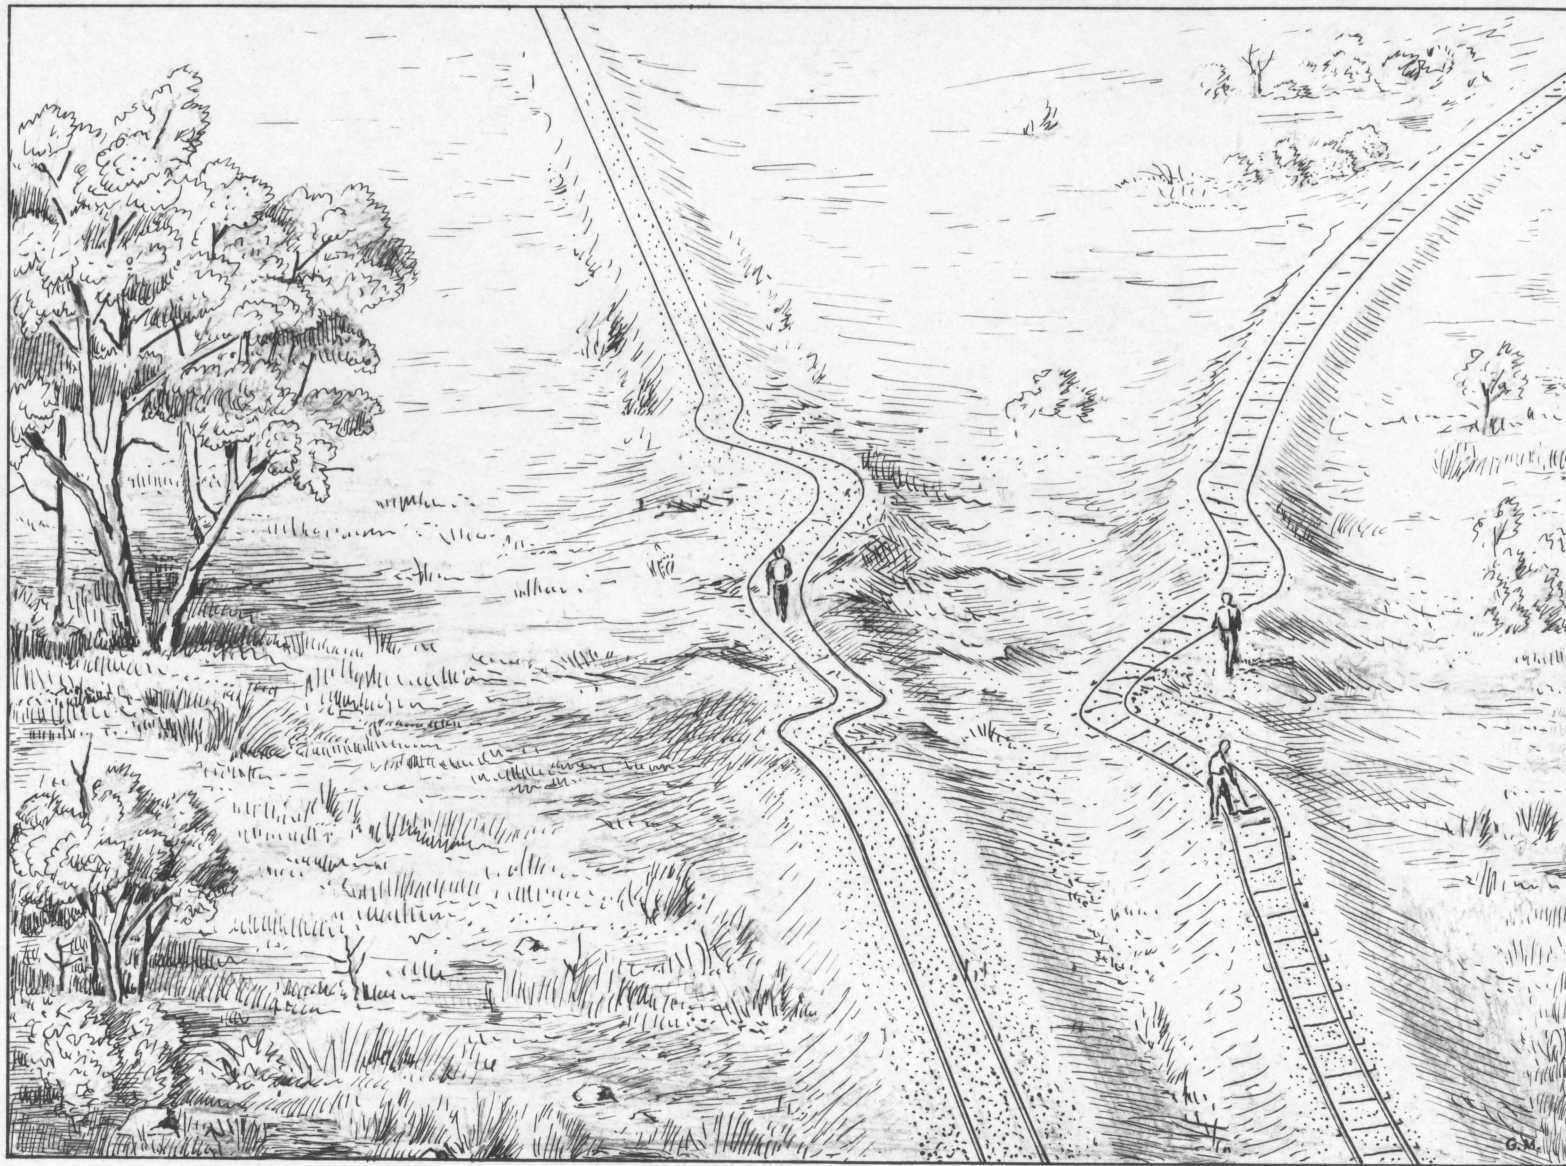
4'8 1/2" railway (left) and 3'6" railway (right), looking east

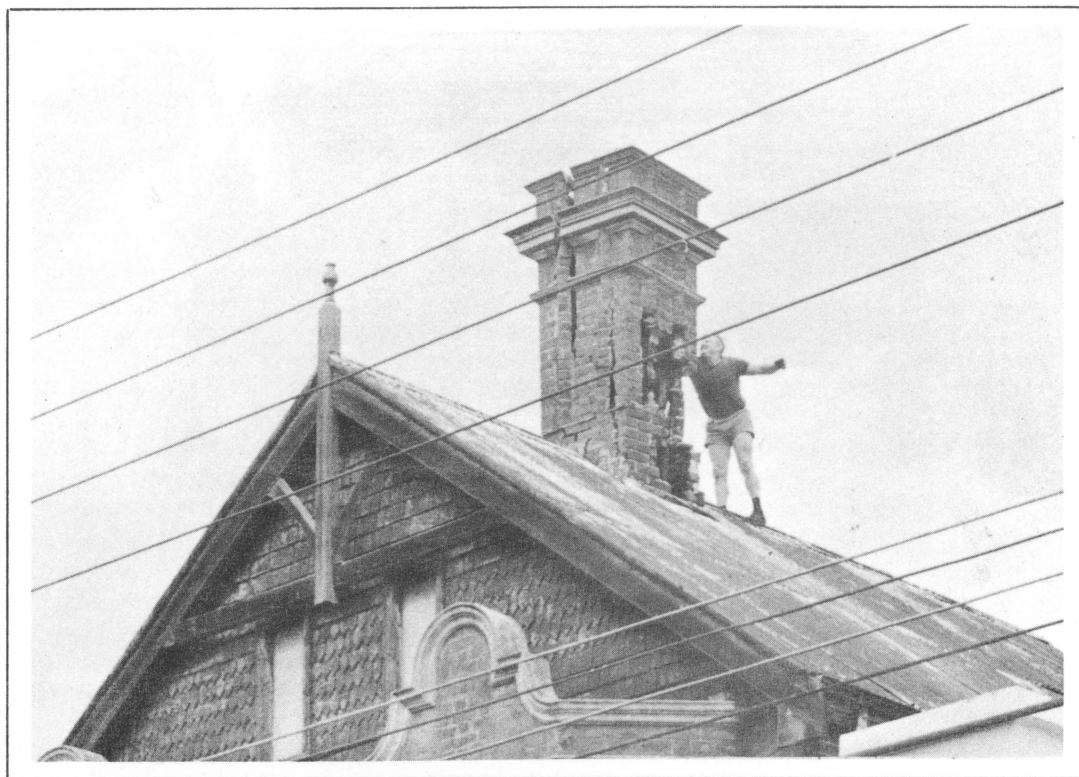
DAMAGE - PERTH Chimney damage

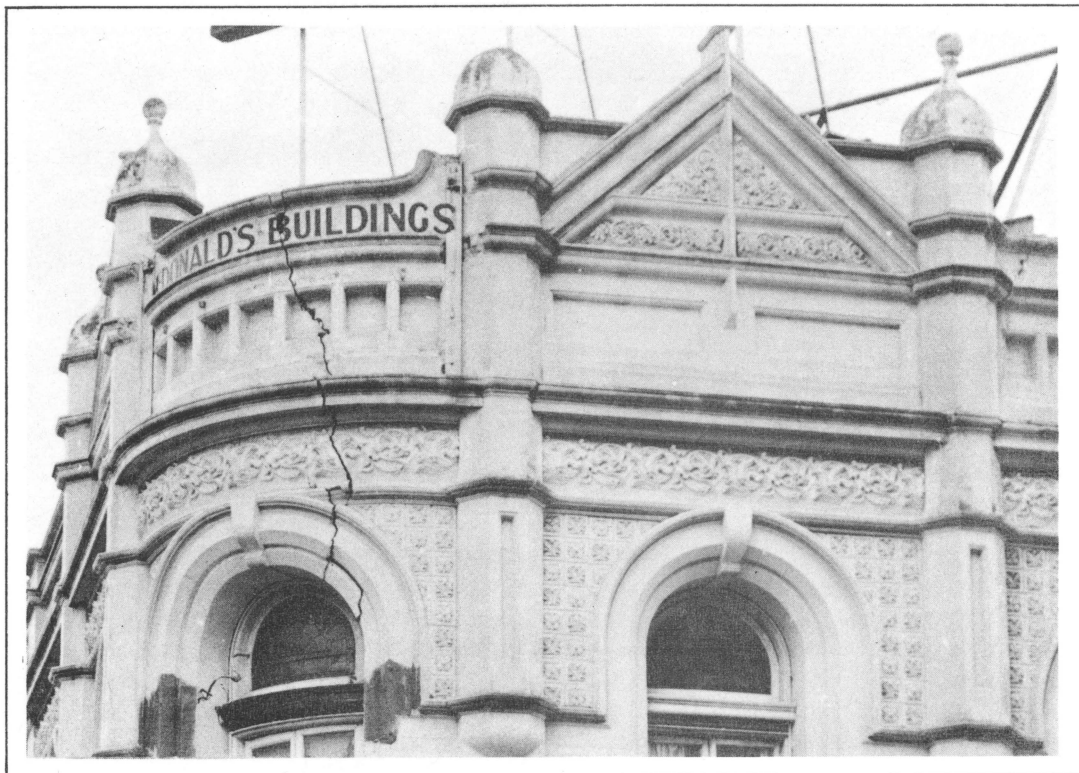
DAMAGE - PERTH Crack in wall

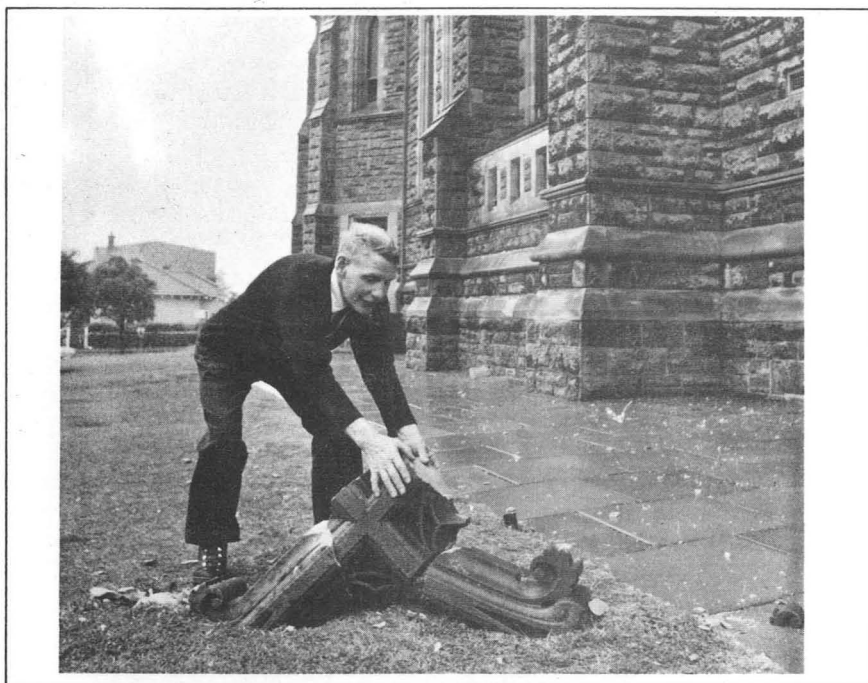
(a) Fallen cross at St Mary's church

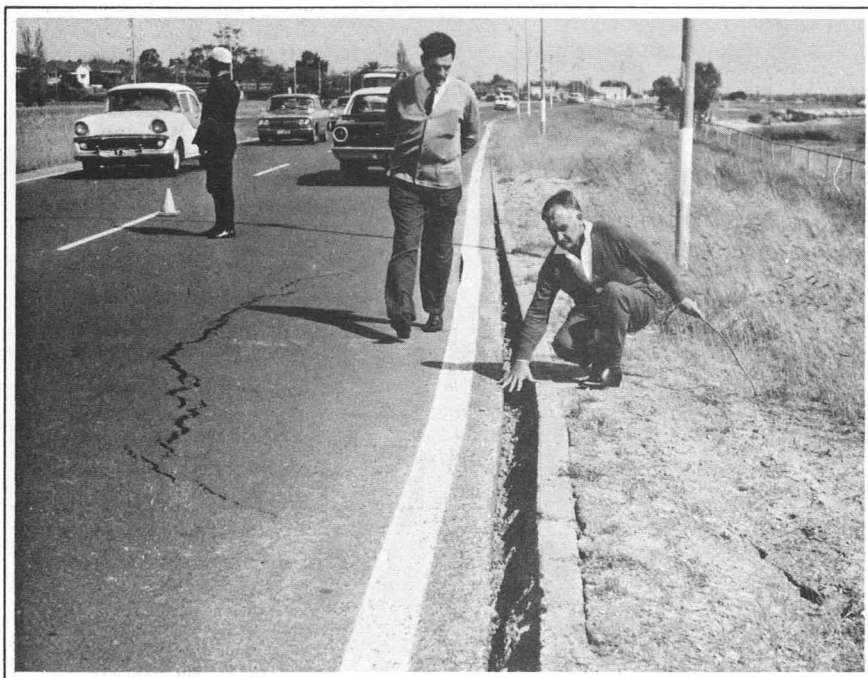
(b) Kwinana Freeway - slumping on reclaimed area
