Record No. 1969 / 1

SIRINUMU DAM, LALOKI RIVER,
Territory of Papua and New Guinea
Stage 2 Geological Investigations,
1967 - 1968

STAGE 2 GEOLOGICAL INVESTIGATIONS 1967 - 1968

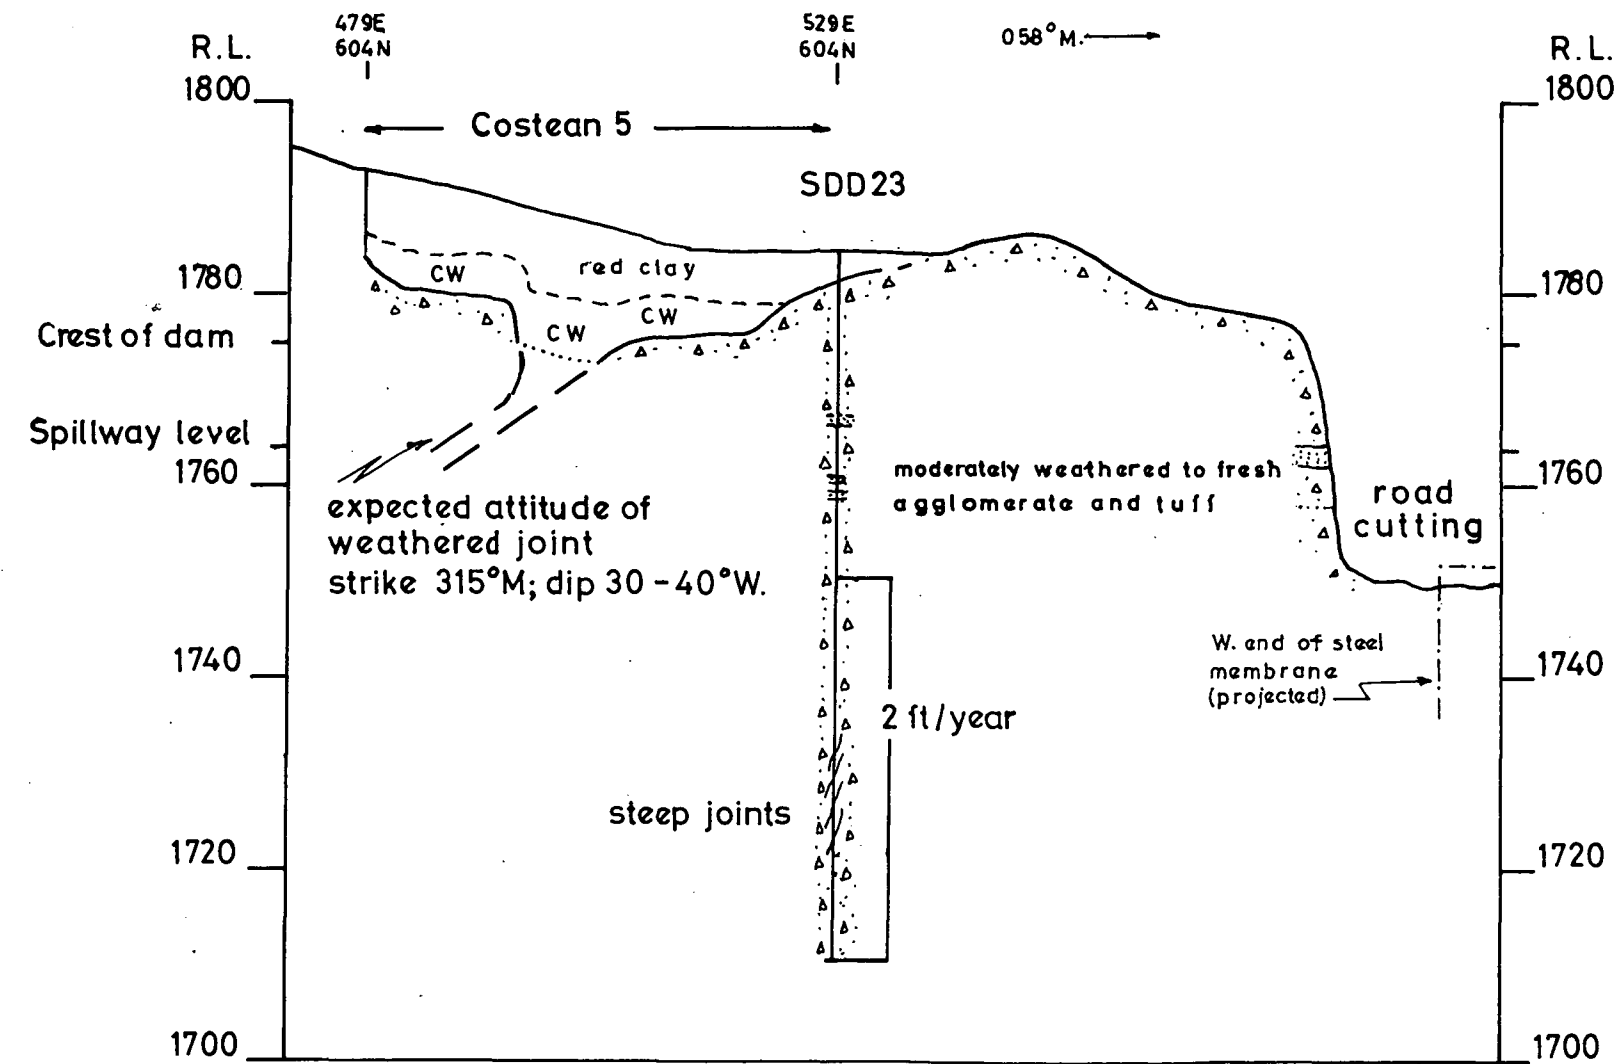
RIGHT ABUTMENT (looking downstream)

4. In the right abutment, a nearly vertical joint strikes 145° M., at right angles to the axis of the dam. Drilling found the width of complete weathering to be 4 feet at R.L. 1714. The joint filling is of low permeability but there is a risk of deterioration due to the acidity of the bottom water of the reservoir.

5. An unrecorded joint of strike 145° M., or alternatively the joint along the face of the right abutment to the existing dam, may be the cause of leakage under the existing dam.

1. The weathered joint in the left abutment should be excavated deeper and upstream to determine the attitude of the joint.
2. The steep weathered joint in the right abutment should be made watertight by thorough grouting; a concrete grout cap may be needed where the joint is exposed below top water level.
3. For the foundation of the rock-fill, all clay and completely weathered rock and all loose rock should be removed. All joints should be inspected and pockets of clay should be removed. The contractor should report all seepages and flows of water when they are discovered.
4. The concrete cut-off and anchor of the steel membrane should be 3 feet wide and 3 feet deep in sound rock, in accordance with the design of Stage 1.

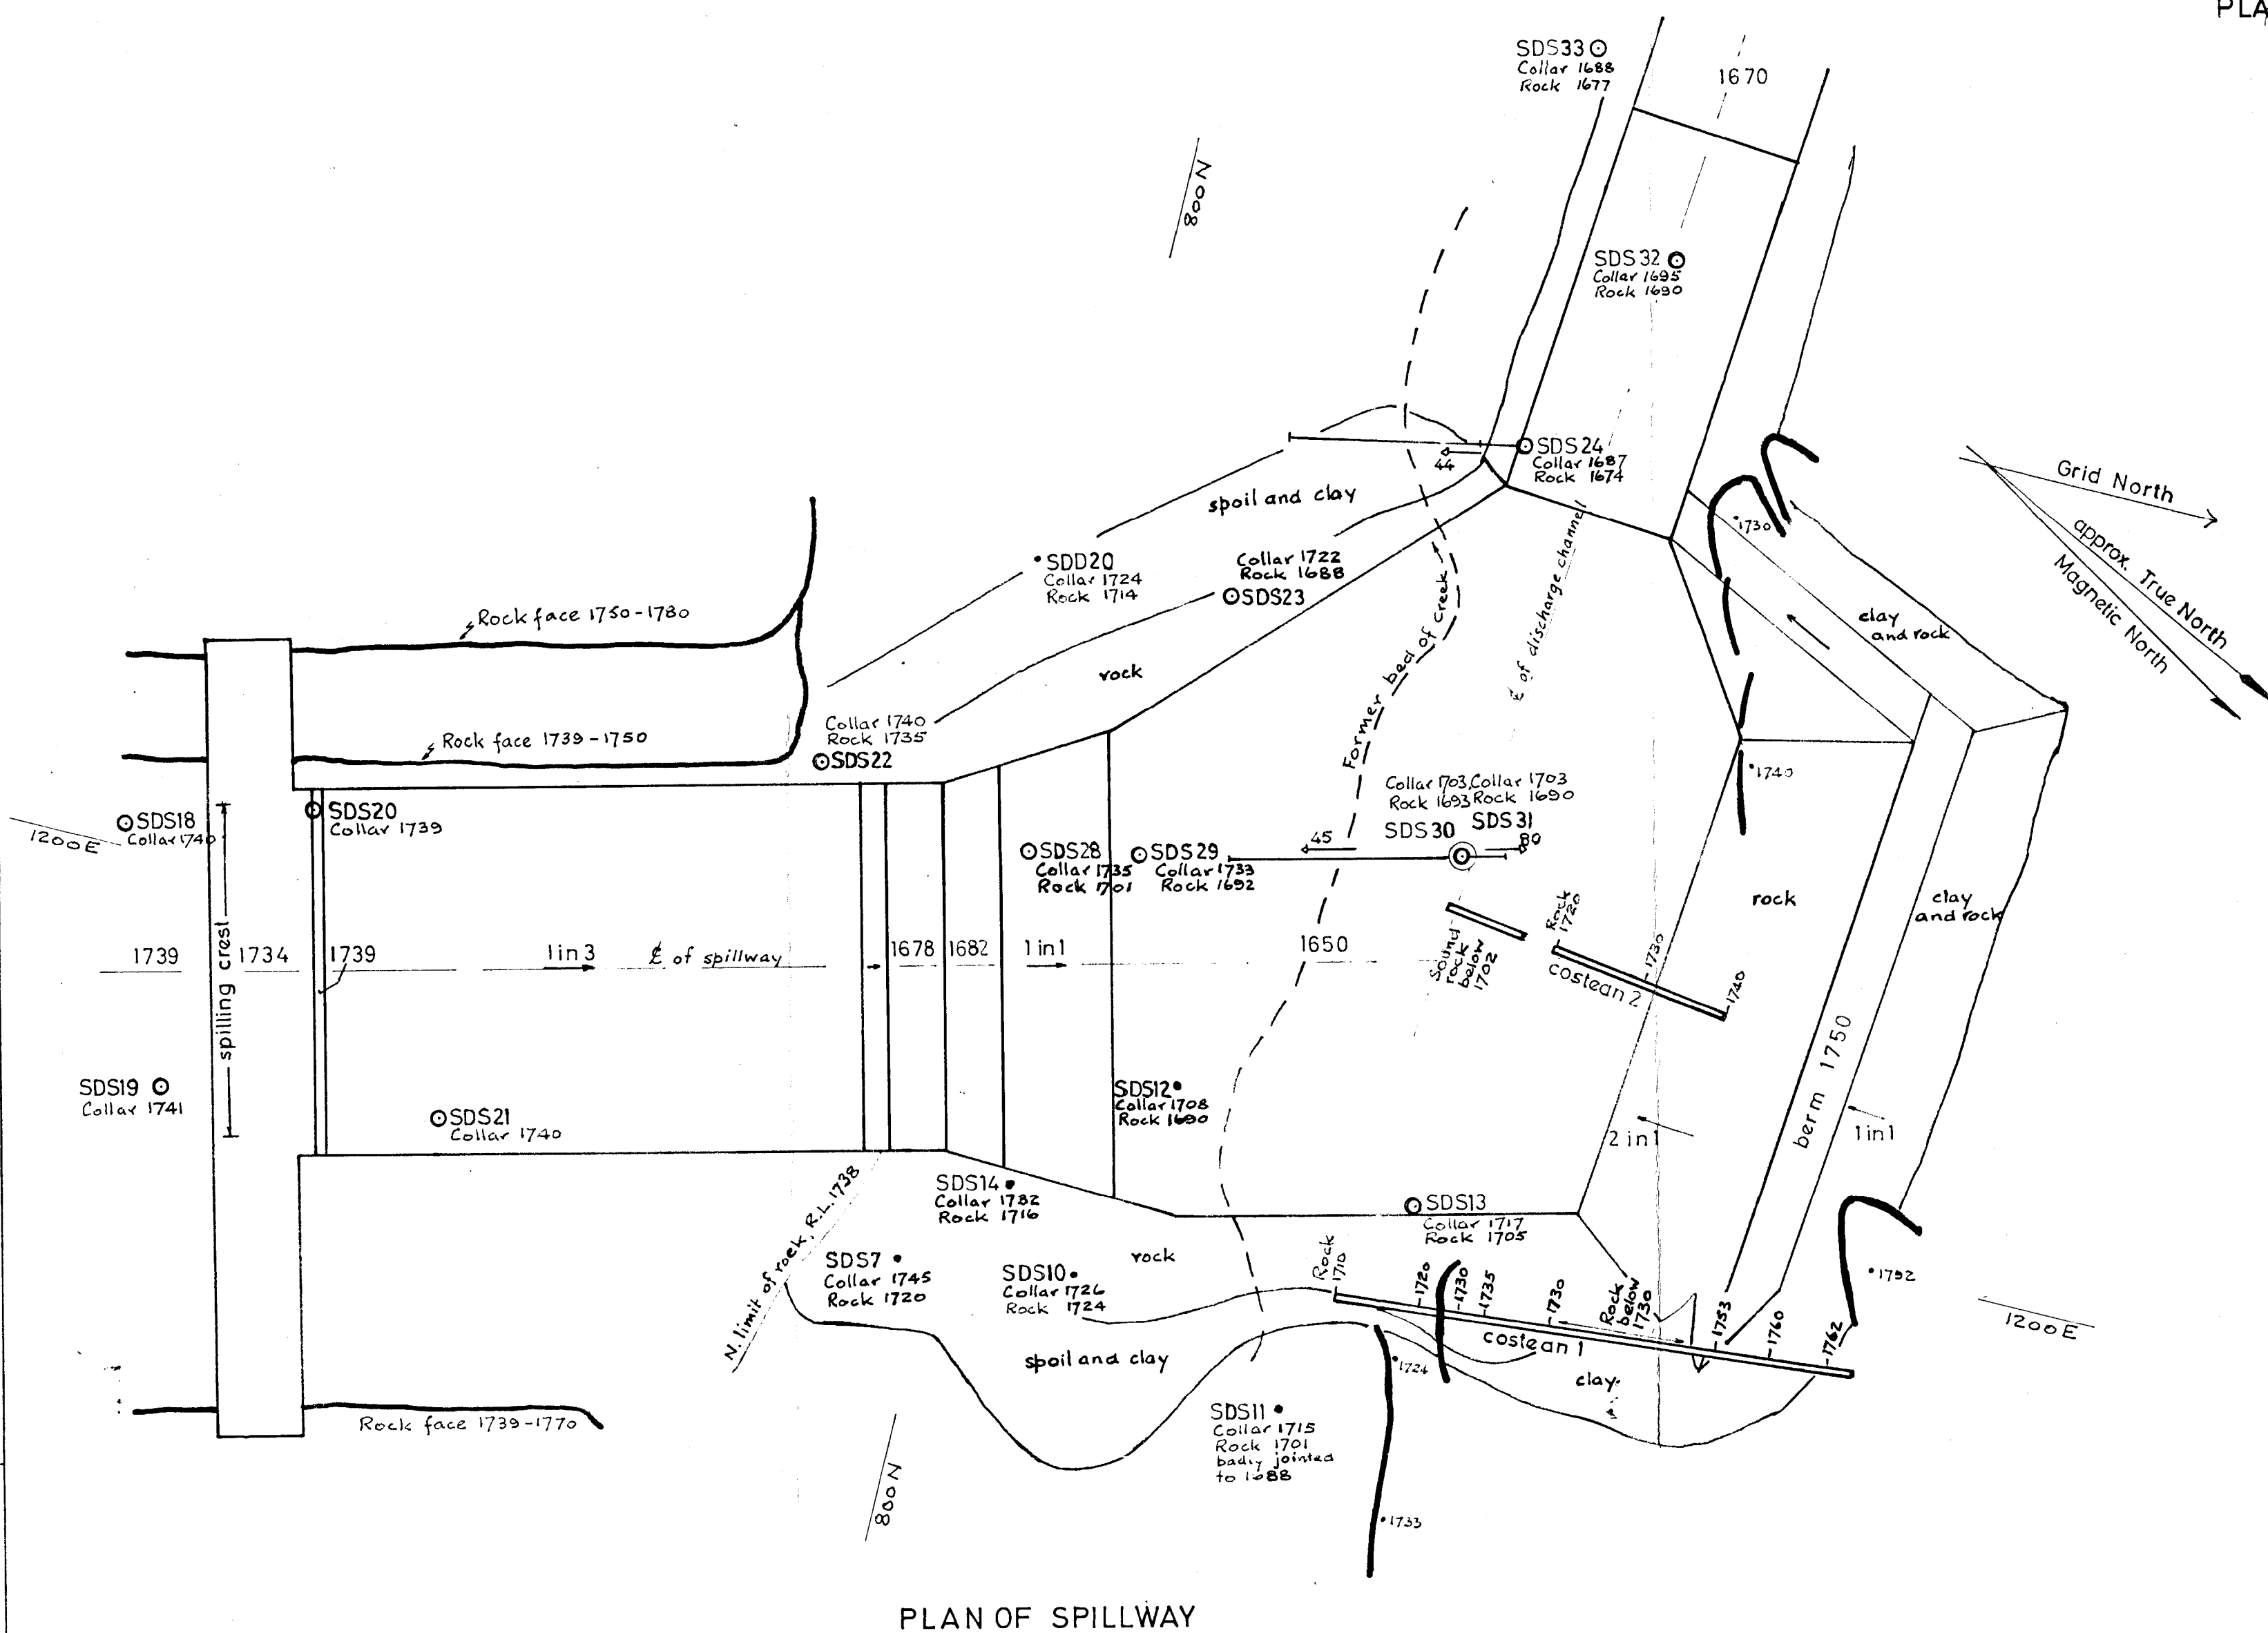
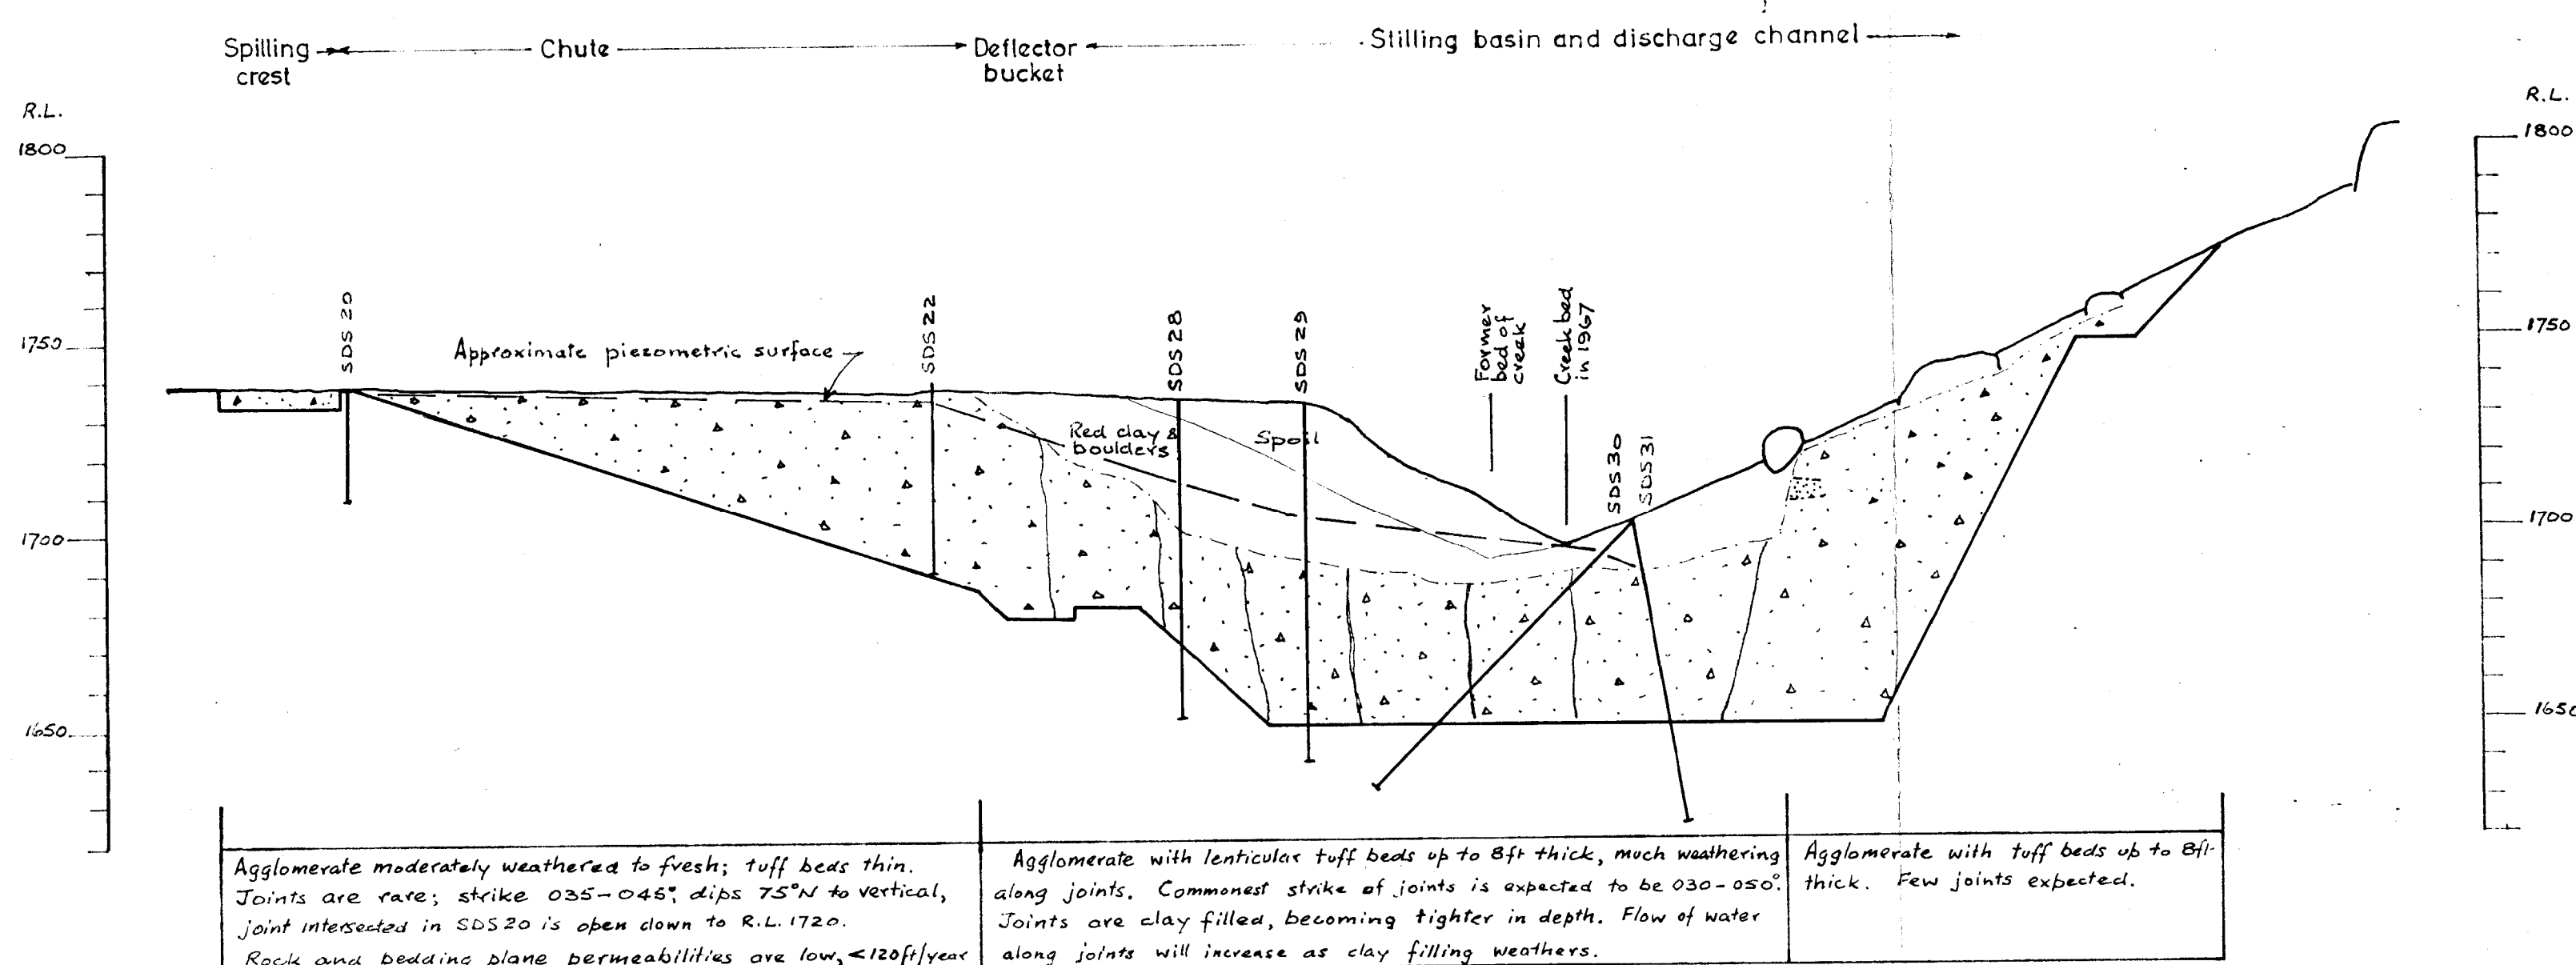
PORT MORESBY HYDROELECTRIC PROJECT
SIRINUMU DAM - PROPOSED SPILLWAY
INTERPRETATIVE GEOLOGICAL
PLAN AND SECTION
Based on C.D.W. drawings HC 68/32&33B
To accompany Record 196/9/1
Geological Office Port Moresby P.N.G. C55-7-19

In the first two feet below the existing spillway floor, the rock is extensively broken. The foundations for the crest and non-spill walls should be on sound rock at 5 feet depth (about R.L. 1734) and continued at this level across the rock bench on the west side of the channel. The rock of the bench is shattered.

6. The spillway crest and chute will be founded on moderately weathered to fresh agglomerate with very little tuff below R.L. 1740. A bed of tuff up to 3'6" thick occurs at R.L. 1740-1752 in the west side of the existing channel. Joints are rare in the agglomerate but common in the tuff bed.

5. Foundations for the spilling crest and adjoining walls should be at R.L. 1734 over the entire width of the existing spillway channel (230 feet).
6. The foundations of the spillway chute, deflector bucket and associated training walls are expected to be in sound rock of low permeability. No special requirements of design are foreseen.

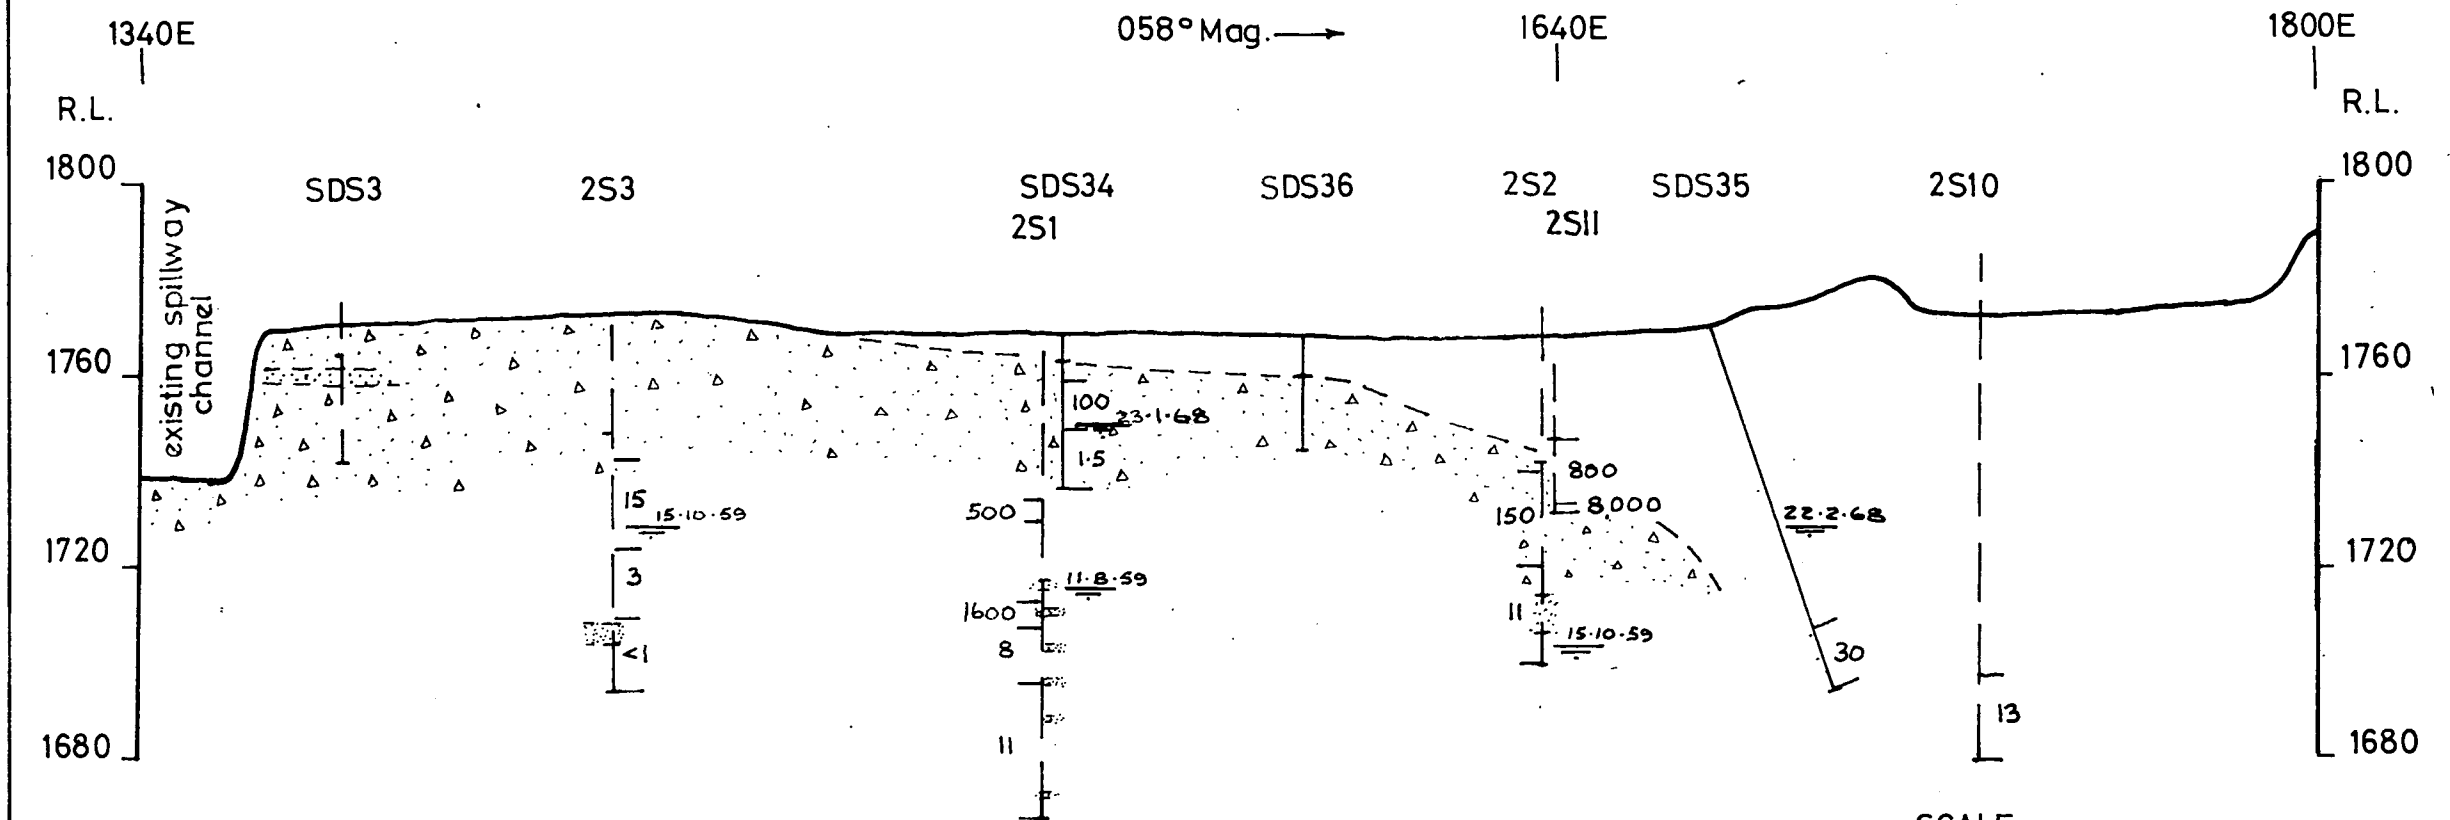
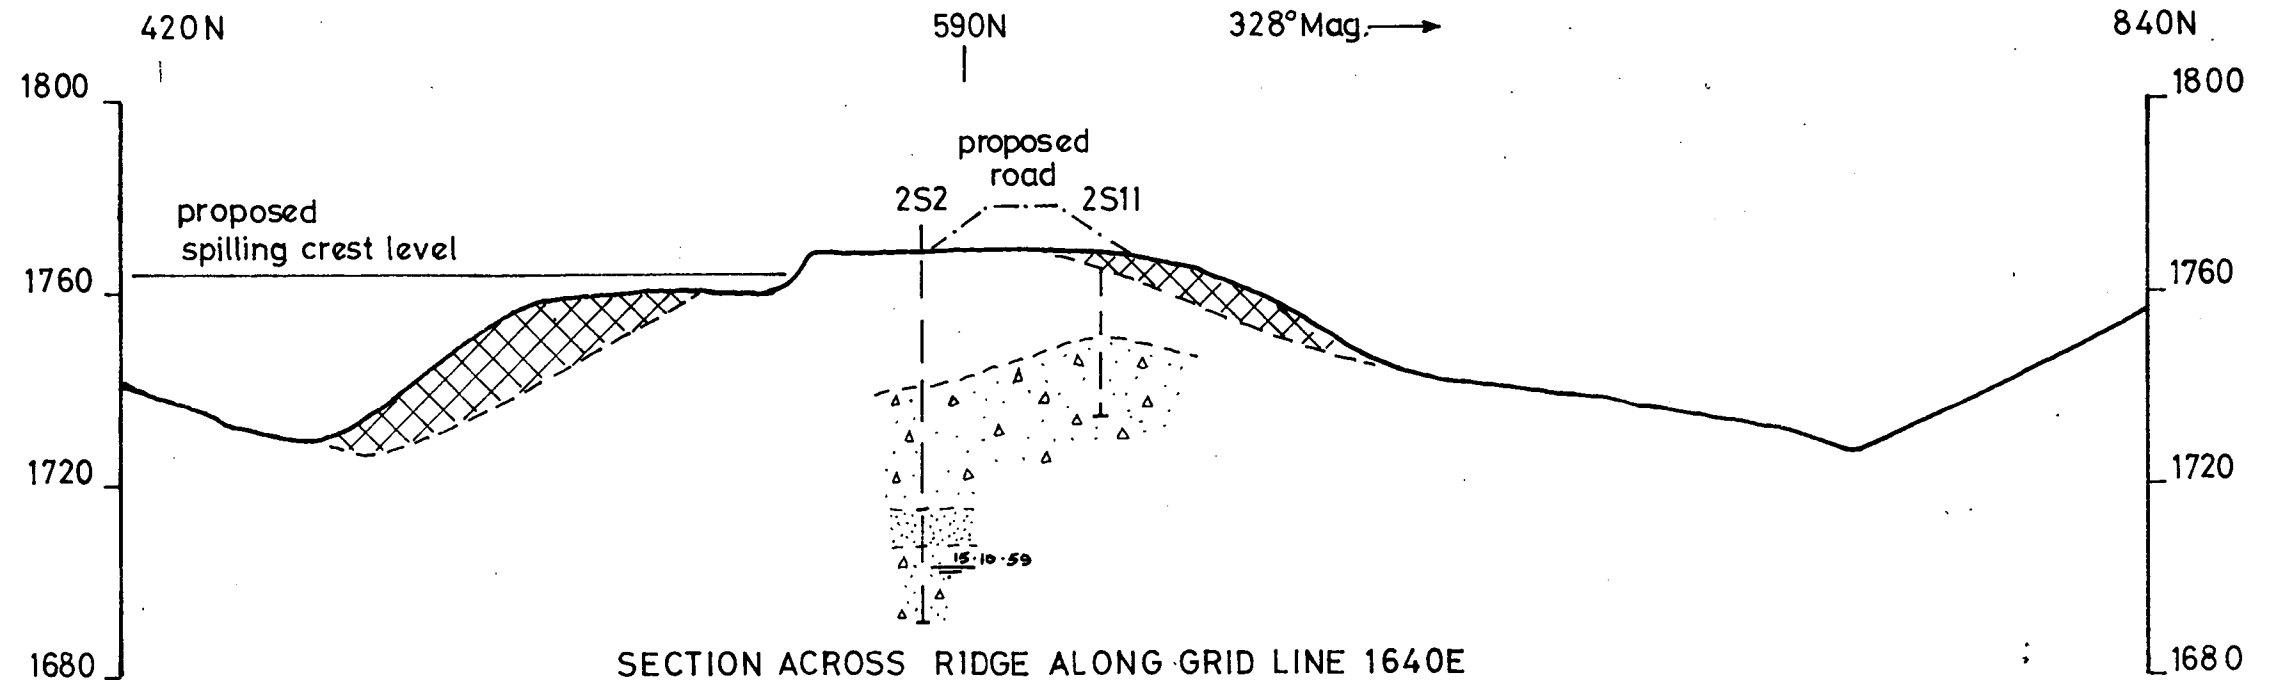
SECTION ALONG RIDGE ALONG GRID LINE 590N

9. In the ridge running eastwards from the spillway the bedrock plunges steeply at about 300 feet from the spillway to depths greater than 100 feet. Completely weathered agglomerate was found in drill holes to R.L. 1680.

10. Narrow zones of high permeability occur in the bedrock of the ridge and leakage is expected in the cracked and weathered rock enveloping the bedrock. Consequently, if the clay blanket on the ridge does not prevent entry of water into the rock of the ridge, leakage from the reservoir through the ridge may occur.

9. The leakage through the ridge east of the spillway should be studied further. The spring in the creek north of the ridge should be located, after removing debris from the creek bottom, and the discharge measured. Piezometers should be installed along the ridge to observe groundwater movement. The watertightness of the ridge can probably be improved by placing a rolled clay blanket on its south side between the bed of the creek and top water level.
