**Geological Report on
Site Investigation and Construction
of Corin Dam, Cotter River, A.C.T.**

E.J. Best

Record 1969/111

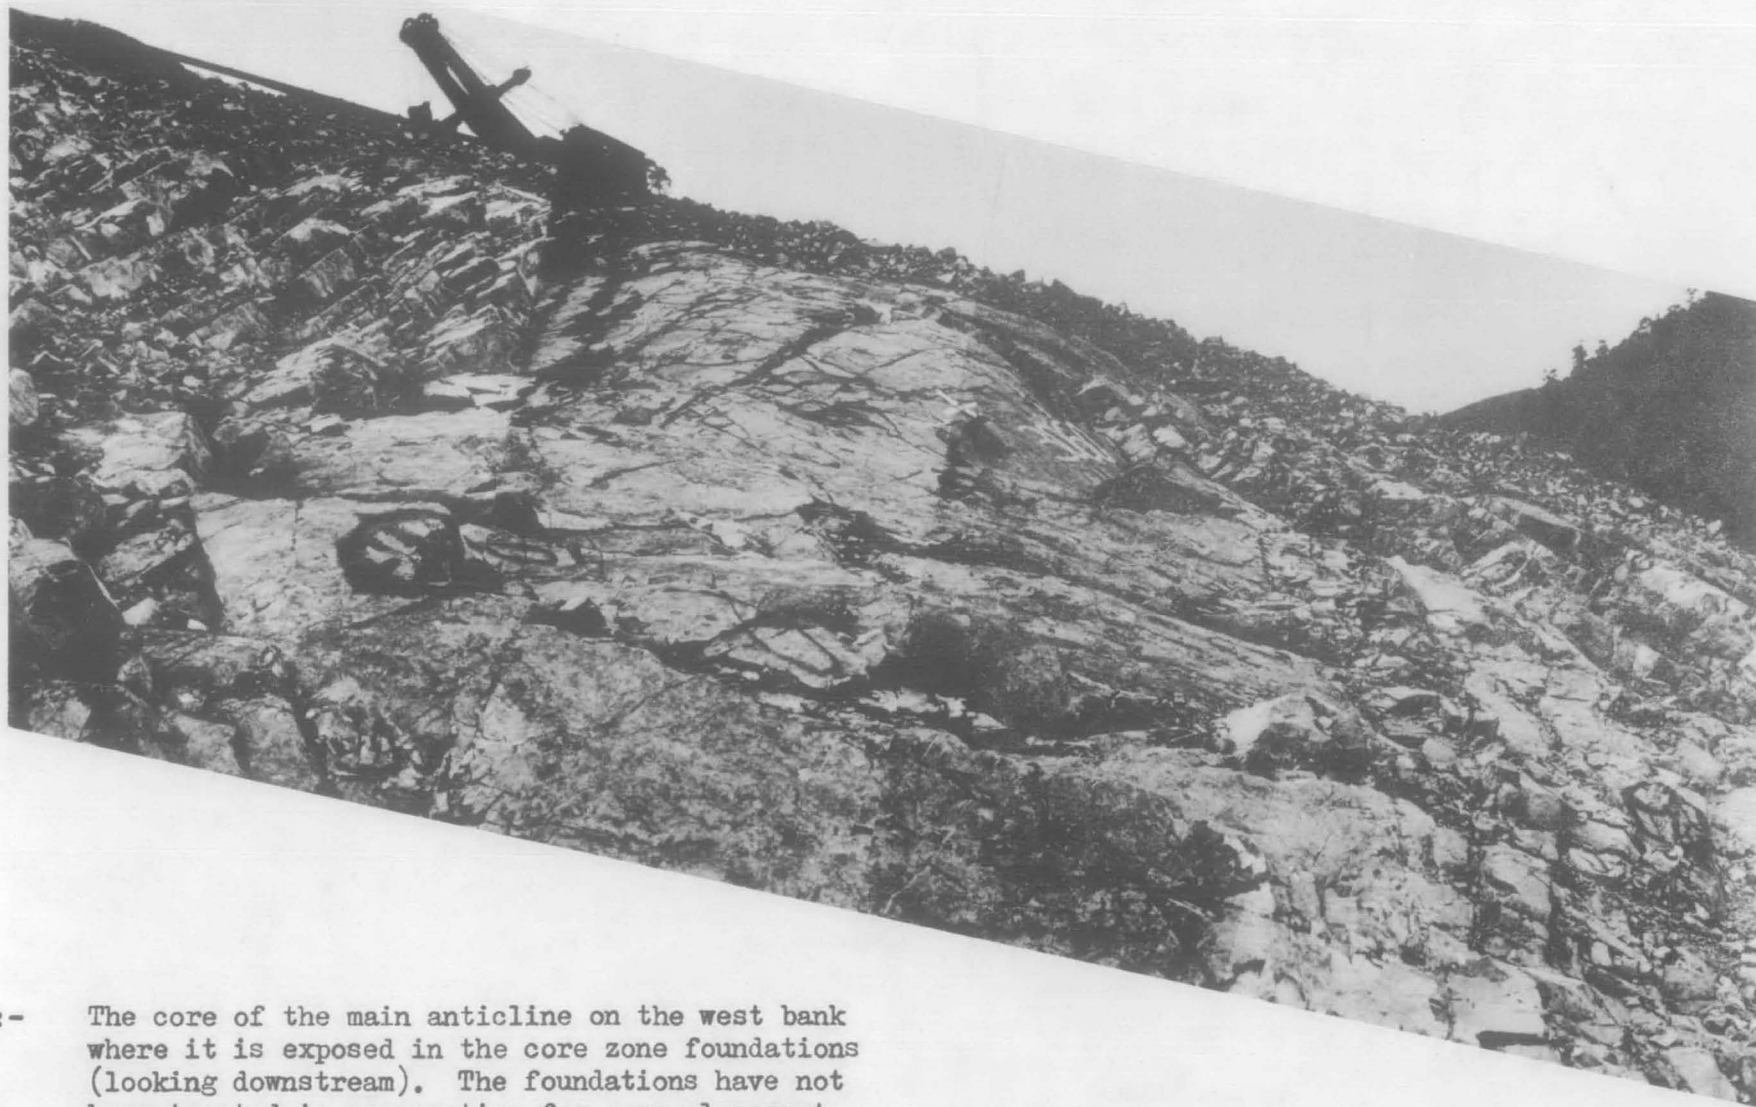
Fig. 6 :- The core of the main anticline on the west bank where it is exposed in the core zone foundations (looking downstream). The foundations have not been treated in preparation for core placement. The white cross on the rock marks the point 220 E, 1020 N on the dam grid.
M 454/6-9

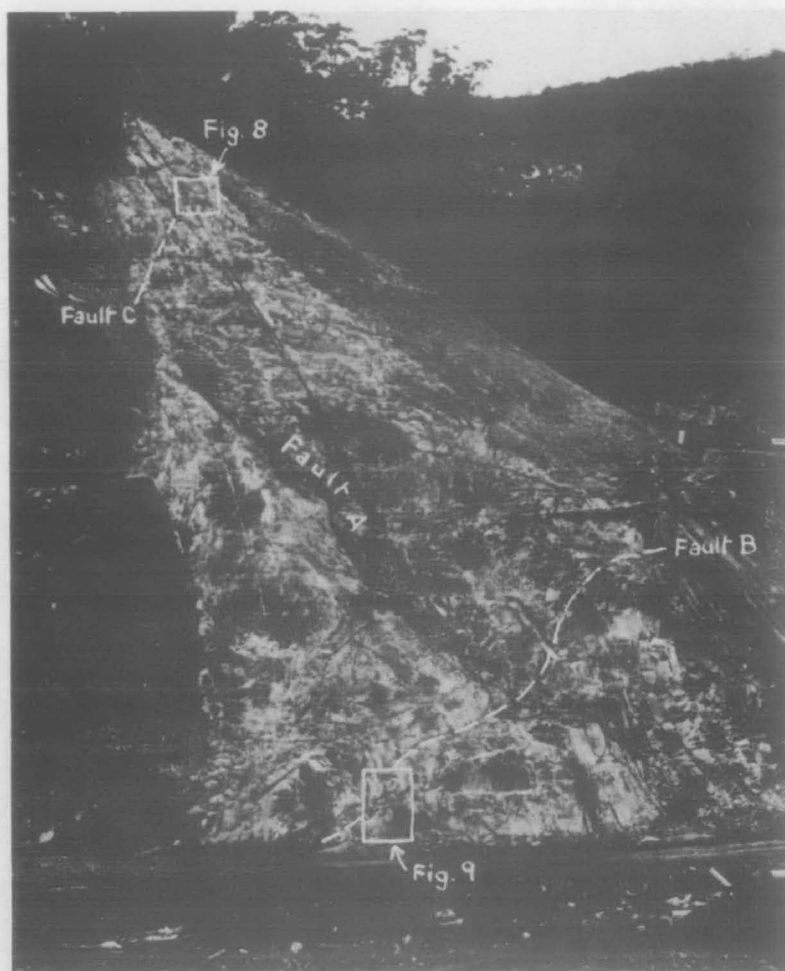
Fault A is a zone of crushed rock, with much clay, which crops out in the eastern core zone foundations and dips obliquely upstream at 40° (see Fig.7); it was the most significant structural defect in the dam foundations and required extensive surface treatment. The fault zone ranges in thickness between 6 and 48 inches, and rock in the hanging wall of the fault is extensively sheared and weathered for several feet adjacent to the fault zone. The displacement along the fault is not known; if the anticlinal axes mapped on both sides of the fault are the same fold, the displacement would not be great.

Fig. 7 :- The eastern core zone foundations, after removal of overburden by sluicing, showing the prominent surface trace of Fault A, and the positions of Faults B and C.

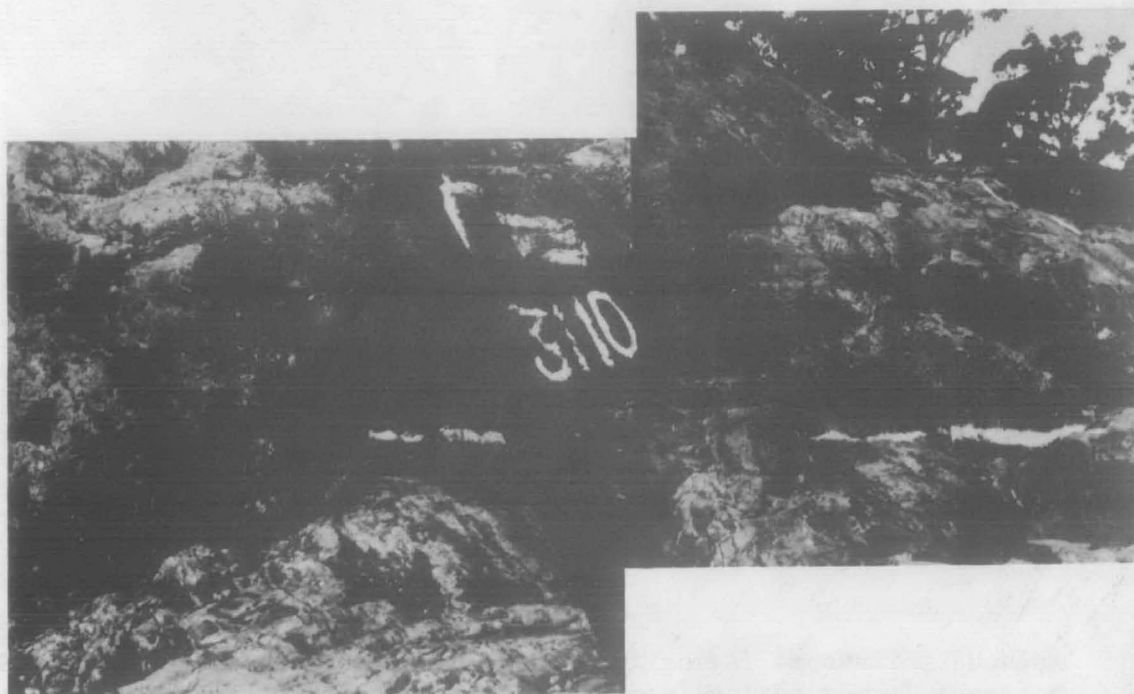
Fault C crops out in the core zone foundations high on the eastern bank (see Figs 7 and 8); it consists of up to 12 inches of finely crushed sandstone, which has weathered out to form a distinct notch in the bedrock surface. The footwall of the fault is silicified and contains many quartz veins and stringers. The fault dips at 60° to the south-west, and a projection of the fault plane down to the level of the diversion tunnel correlates closely with a fault of similar attitude mapped in the tunnel walls. Fault C displaces the 40° fault (A), but it has not been traced downstream in the rockfill zone foundations.

Fig. 8 :- Fault C exposed in the eastern core zone foundations. The fault is bounded on both sides by thickly-bedded sandstone. The location of this photograph is shown in Fig. 7

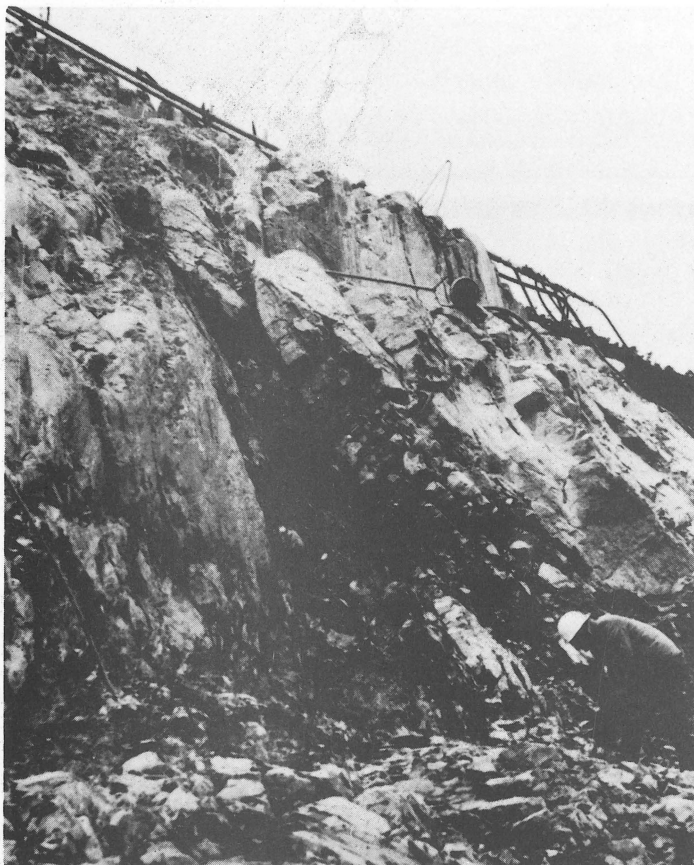
Towards the valley floor, fault A terminates against a steeply-dipping, north-trending fault zone which is marked by a zone of highly cleaved, laminated siltstone, with some decomposition to clay; this is fault B, which dips at 70° - 75° to the west and has a strike of 170° M (see Figs 7 and 9). The wedge of rock at the intersection of the two faults, i.e. on the hanging wall of fault A and the footwall of fault B, is so highly contorted and fractured that the sequence of interbedded sandstone and siltstone is unmappable, even at a scale of 10 feet to 1 inch. The fault zone (fault B) generally ranges in thickness between 4 and 10 feet. However, towards the downstream limit of the core zone, the fault zone gives way to a series of clay seams in jointed sandstone, with no apparent dominant plane of displacement (foreground of Fig.9a). The fault was penetrated at depth by drillholes D.D.7 and D.D.3. Hole D.D.3 shows considerable shearing in the footwall of the fault at a depth of 100 feet below the river bed. The amount and direction of movement on fault B is not known; however, the displacement must have been considerable, as it is not possible to correlate any of the strata to the west of the fault with the geological succession on the eastern side of the fault.

Fig. 9 (a) :- Fault B (dipping 70° to the west) as exposed in the eastern core zone foundations after removal of overburden by sluicing. This view is taken from the downstream boundary of the core zone (see Fig. 7).

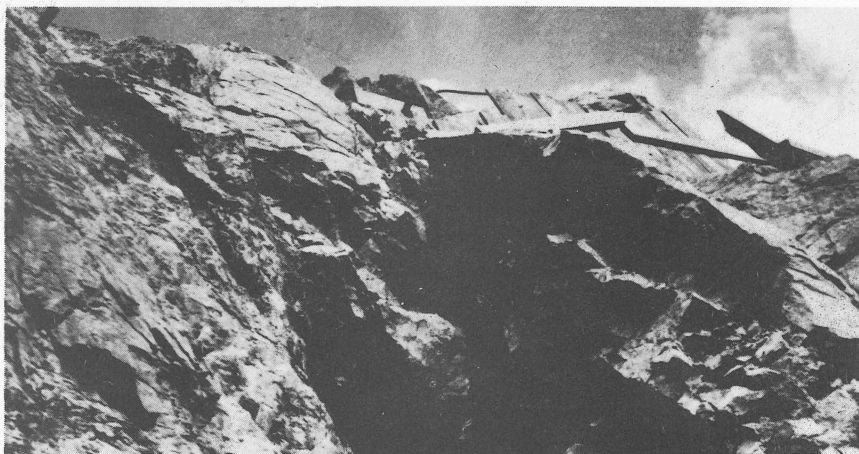
Fig. 9 (b) :- Fault B, after excavation of clay and loose rock from the fault zone but before the placement of dental concrete. Hammer is at co-ordinates 652 E, 1005 N.

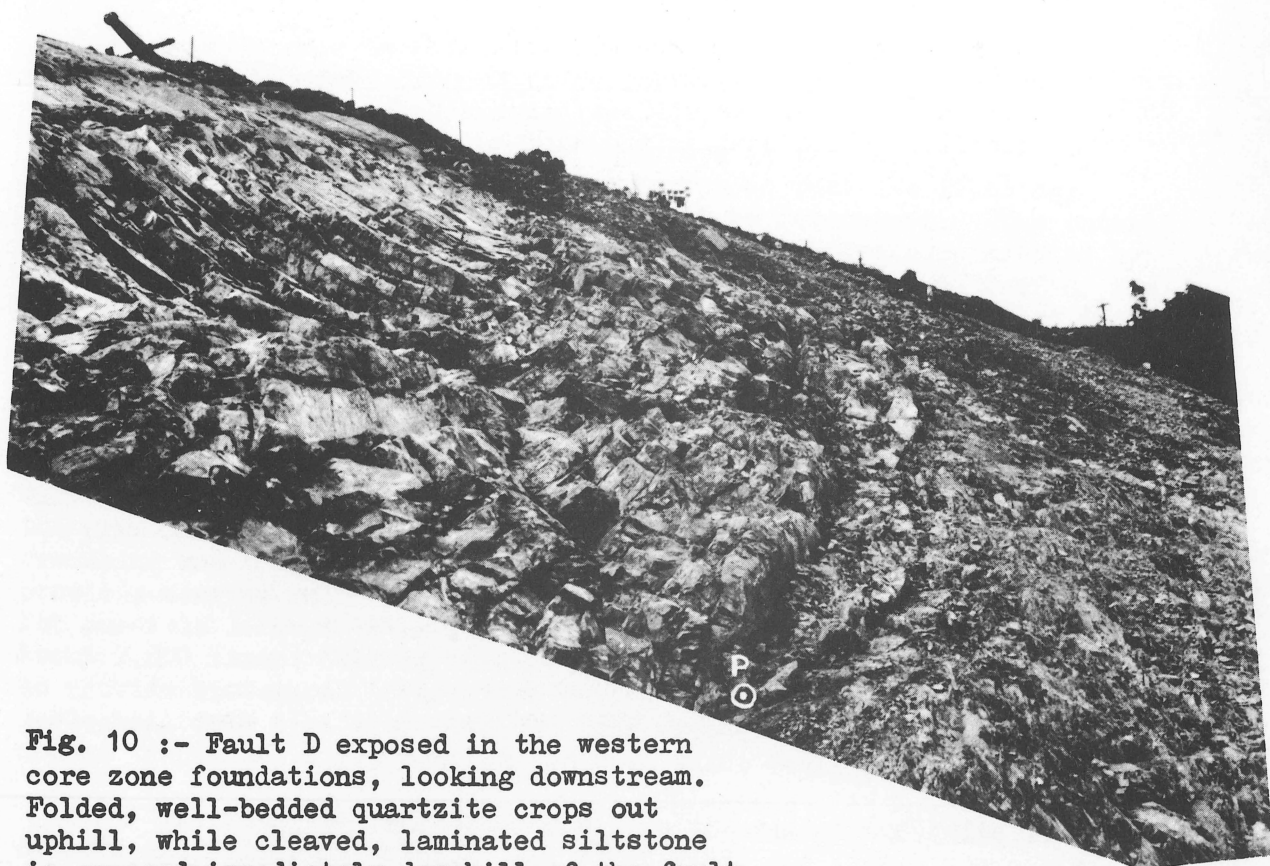
Fault D crops out on the west bank as a near-vertical zone of very crushed quartzite 24 inches wide (see Fig.10). Downstream from the dam axis, the fault bifurcates and continues along strike as two zones of crushed quartzite 9 to 12 inches thick; both branches of the fault were mapped in the spillway chute excavation. Upstream from the core zone, the main fault plane becomes less distinct and branches out as a series of thin seams of crushed rock. It was deduced from the site investigation data that the displacement along this fault is at least 250 feet, with downthrow to the west. However, mapping of the spillway ski-jump excavation has proved conclusively that the thickly-bedded quartzite in drillhole D.D.17 is the same sequence as the prominent quartzite rib exposed on the west bank, near the upstream face of the dam and in the spillway channel excavation. It is now evident that the total vertical displacement on fault D is about 400 feet with downthrow to the east; this is made up of about 200 feet displacement on each of the north-trending arms of the fault exposed in the spillway excavation.

Fig. 10 :- Fault D exposed in the western core zone foundations, looking downstream. Folded, well-bedded quartzite crops out uphill, while cleaved, laminated siltstone is exposed immediately downhill of the fault. Co-ordinates of P are 360 E, 1000 N.
G 9390 - 9392 18/10/66

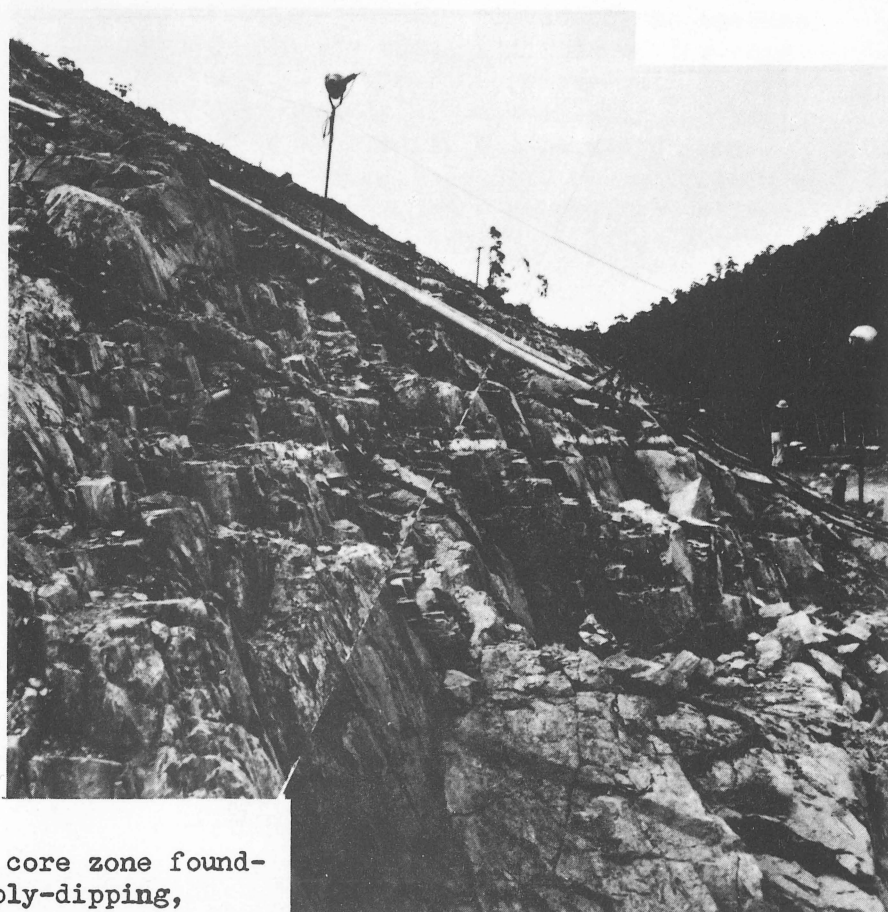
Fig. 11 :- Typical core zone foundations in the steeply-dipping, interbedded sandstone and siltstone on the lower slopes of the west bank.
G 9393-9394 18/10/66

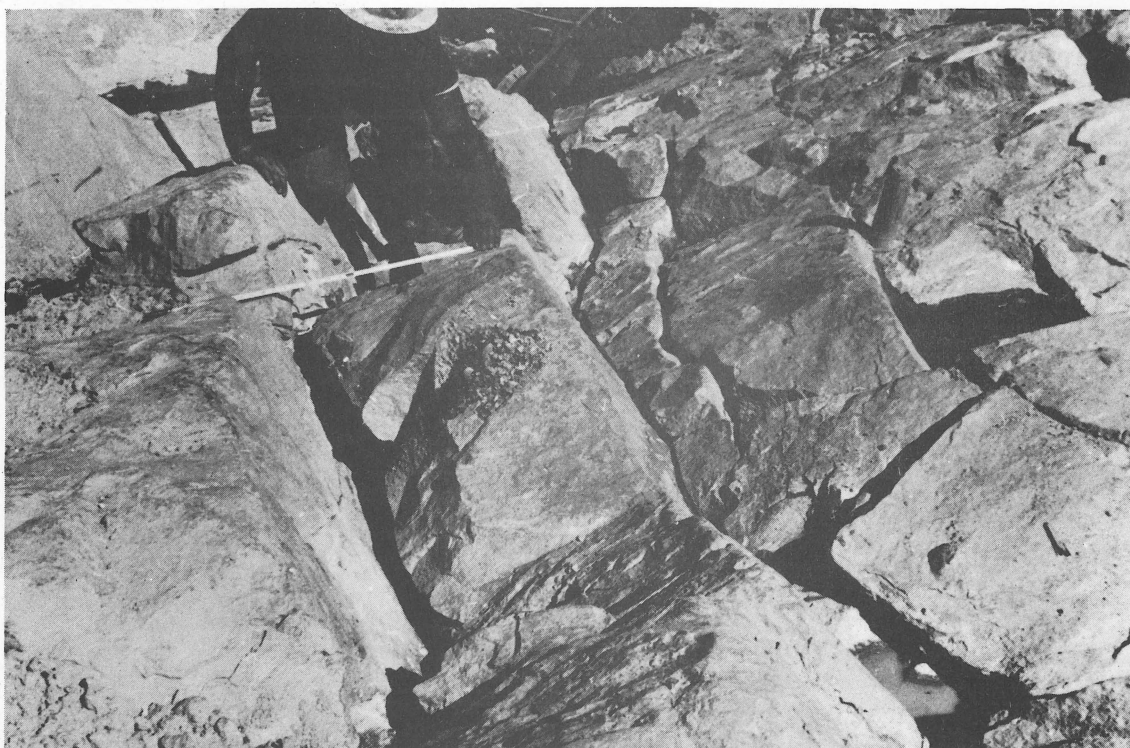
In the sandstone and quartzite, dominant joints are open (see Fig. 14) and iron-stained to considerable depths (250 feet in drillhole D.D.5). Joint places in the siltstone, however, are generally tight and clean, except in areas of major faulting.

Fig. 14 :- Open bedding plane joints in thickly-bedded quartzite exposed in the valley floor core zone foundations (co-ords 540 E, 1025 N). These joints were backfilled with fine aggregate concrete during foundation treatment.
M 484/34

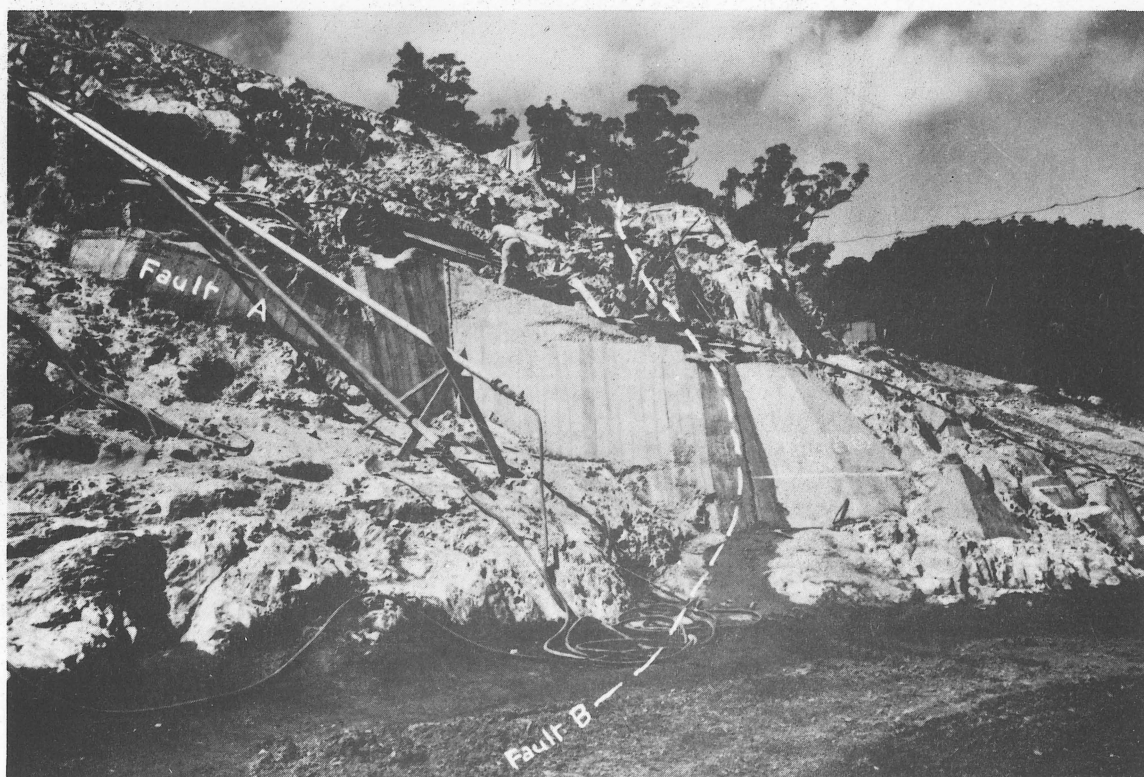
Fig. 15 :- Dental concrete foundation treatment after the excavation and concrete backfilling of Fault A. This view looks upstream to the intersection of Fault A by Fault B. Small areas of concrete dental treatment of steep rock faces can be seen downhill of the trace of Fault B.
G 9851

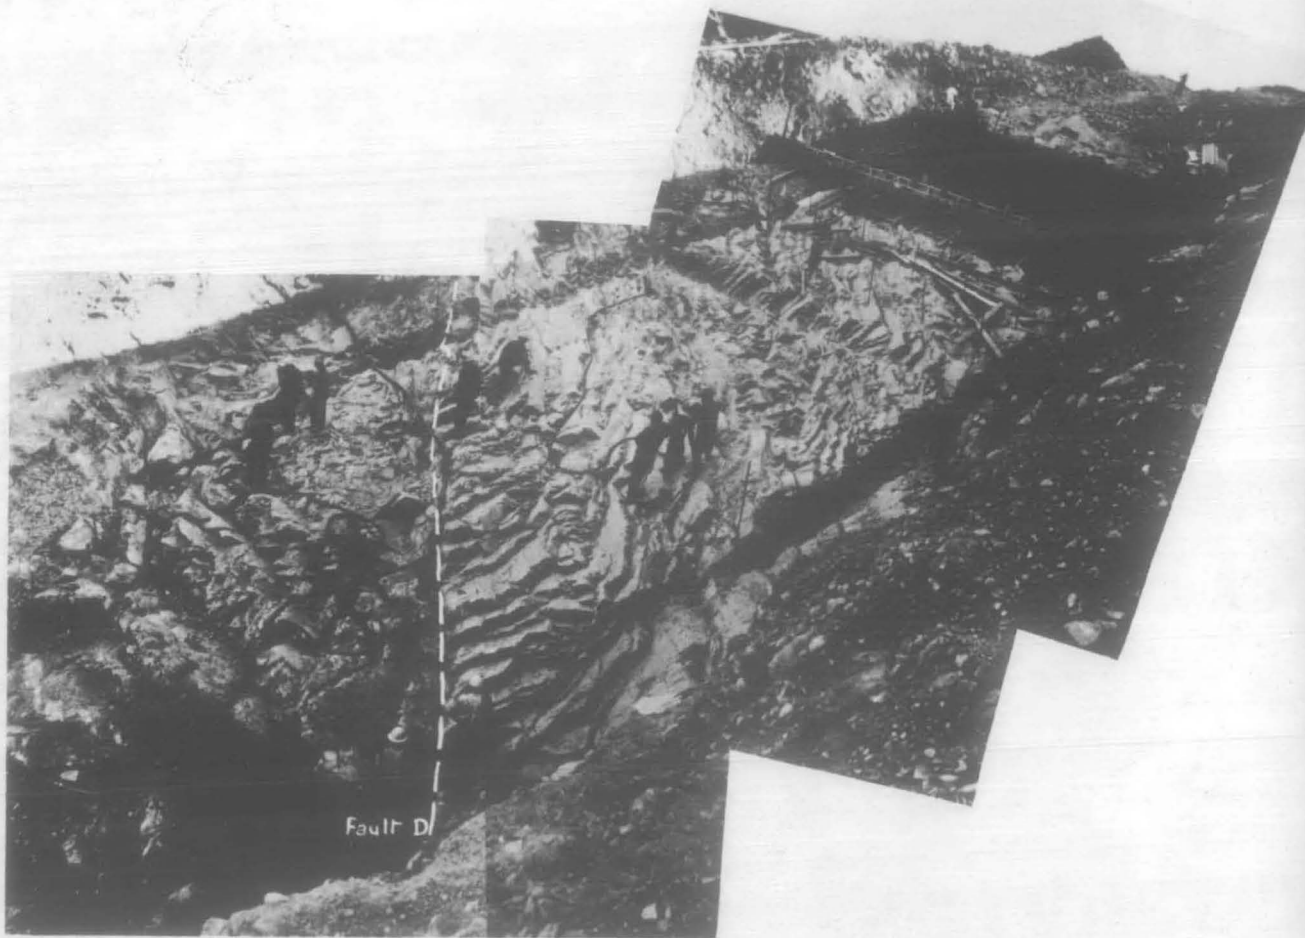
Fig. 18 :- Foundations of the spillway chute between chainages 460 and 540 feet. The thickly-bedded quartzite at the downhill end of the cleaned area has been downthrown against well-bedded quartzite along Fault D.
M 488/12-16 20/3/67

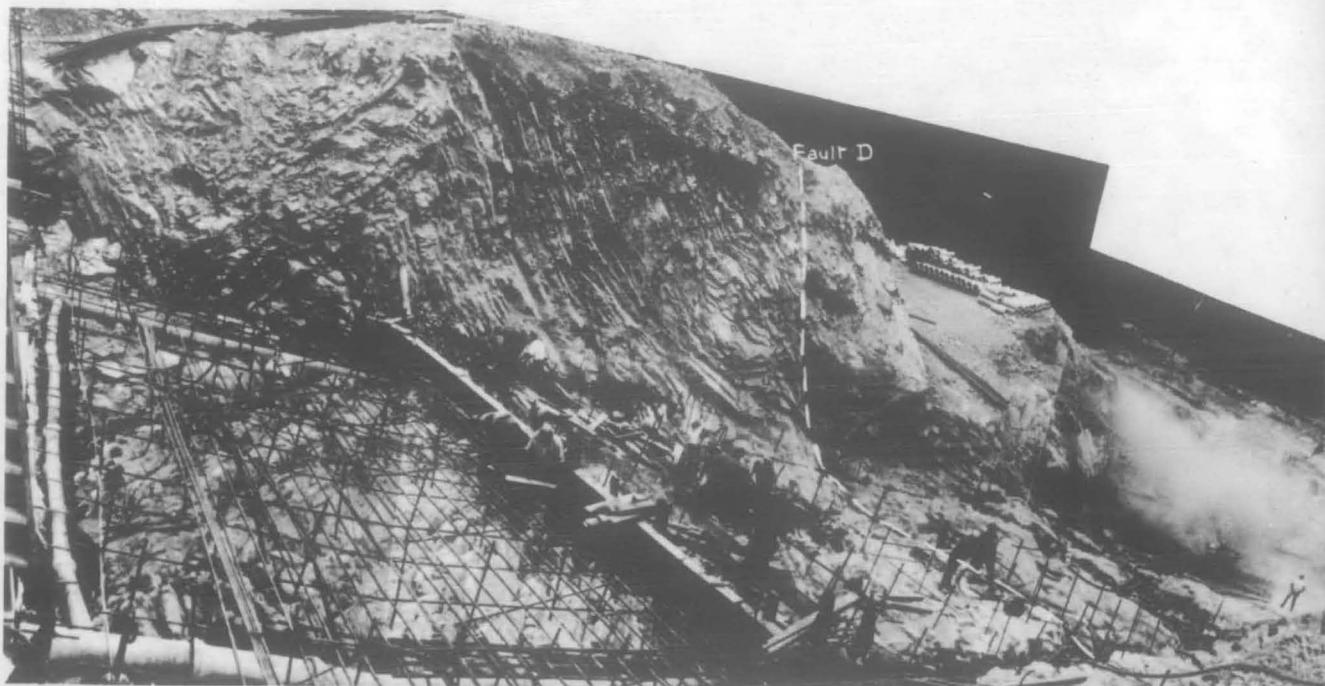
Fig. 19 :- The western wall of the spillway chute excavation between chainages 460 and 540 feet, showing adverse bedding dips, tight folding and closely-spaced jointing in the well-bedded quartzite. The instability of this face under load was a major factor in the decision to adopt a free-standing design for the spillway chute training walls.
M 489/17-22 31/3/67

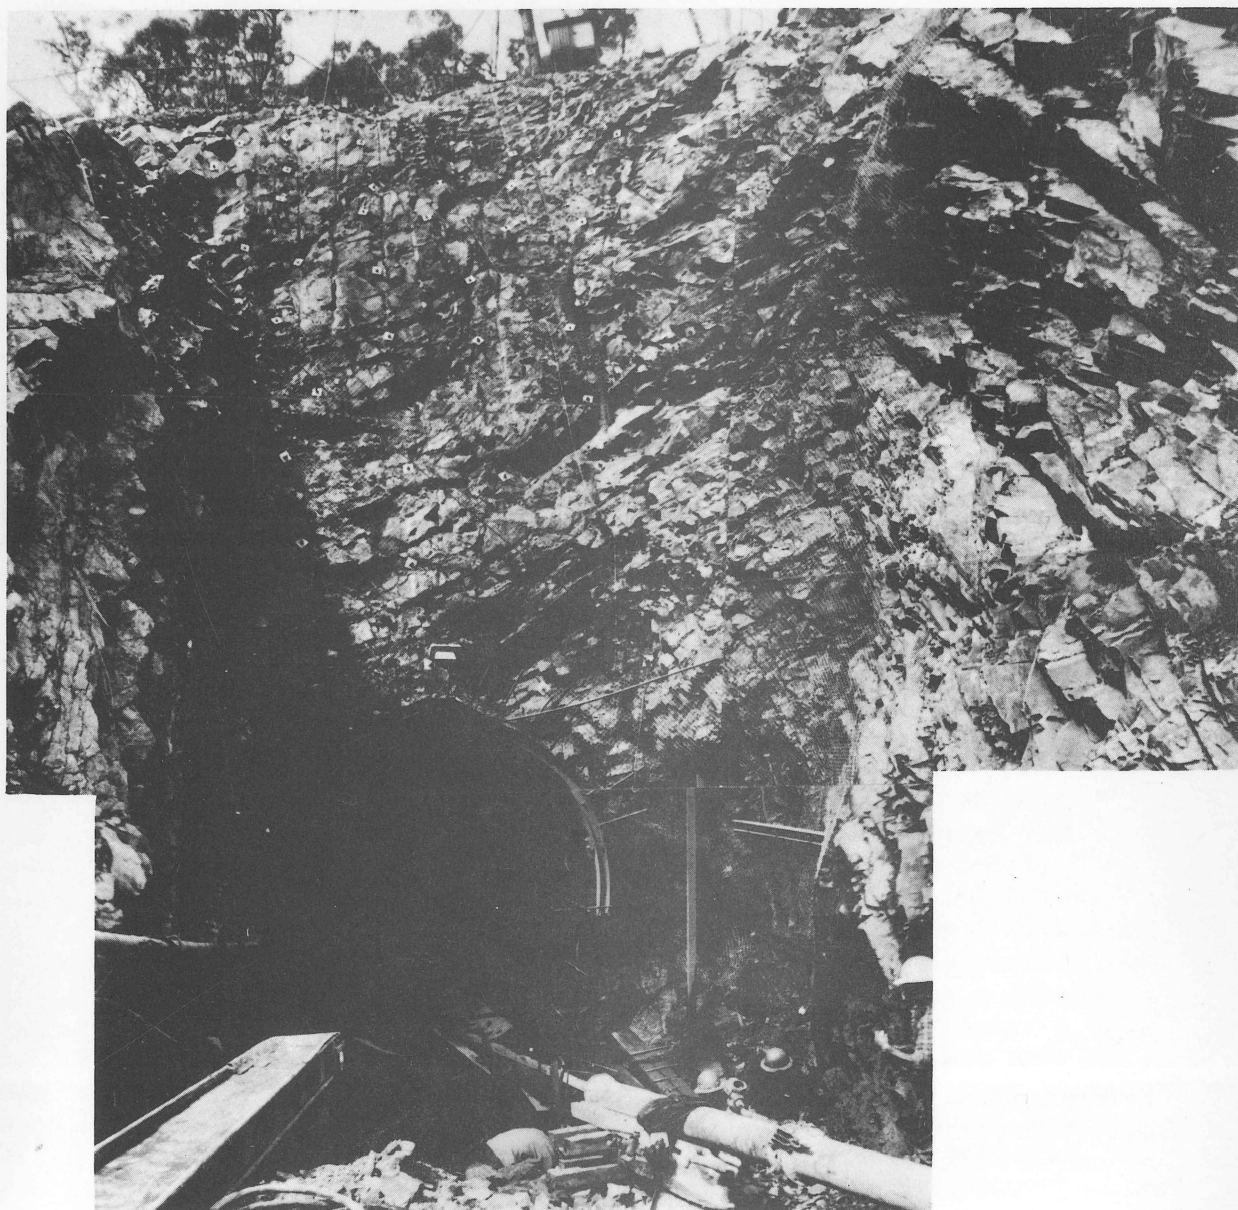
Fig. 20 :- Composite photograph of the inlet portal excavation showing the rock bolts and wire mesh supporting the portal face.
