BUREAU OF MINERAL RESOURCES, GEOLOGY AND GEOPHYSICS

**Magnetic Test  
Moorabbin Airport Compass Swinging Site**

**BMR  
Record  
1970/103  
c.4**

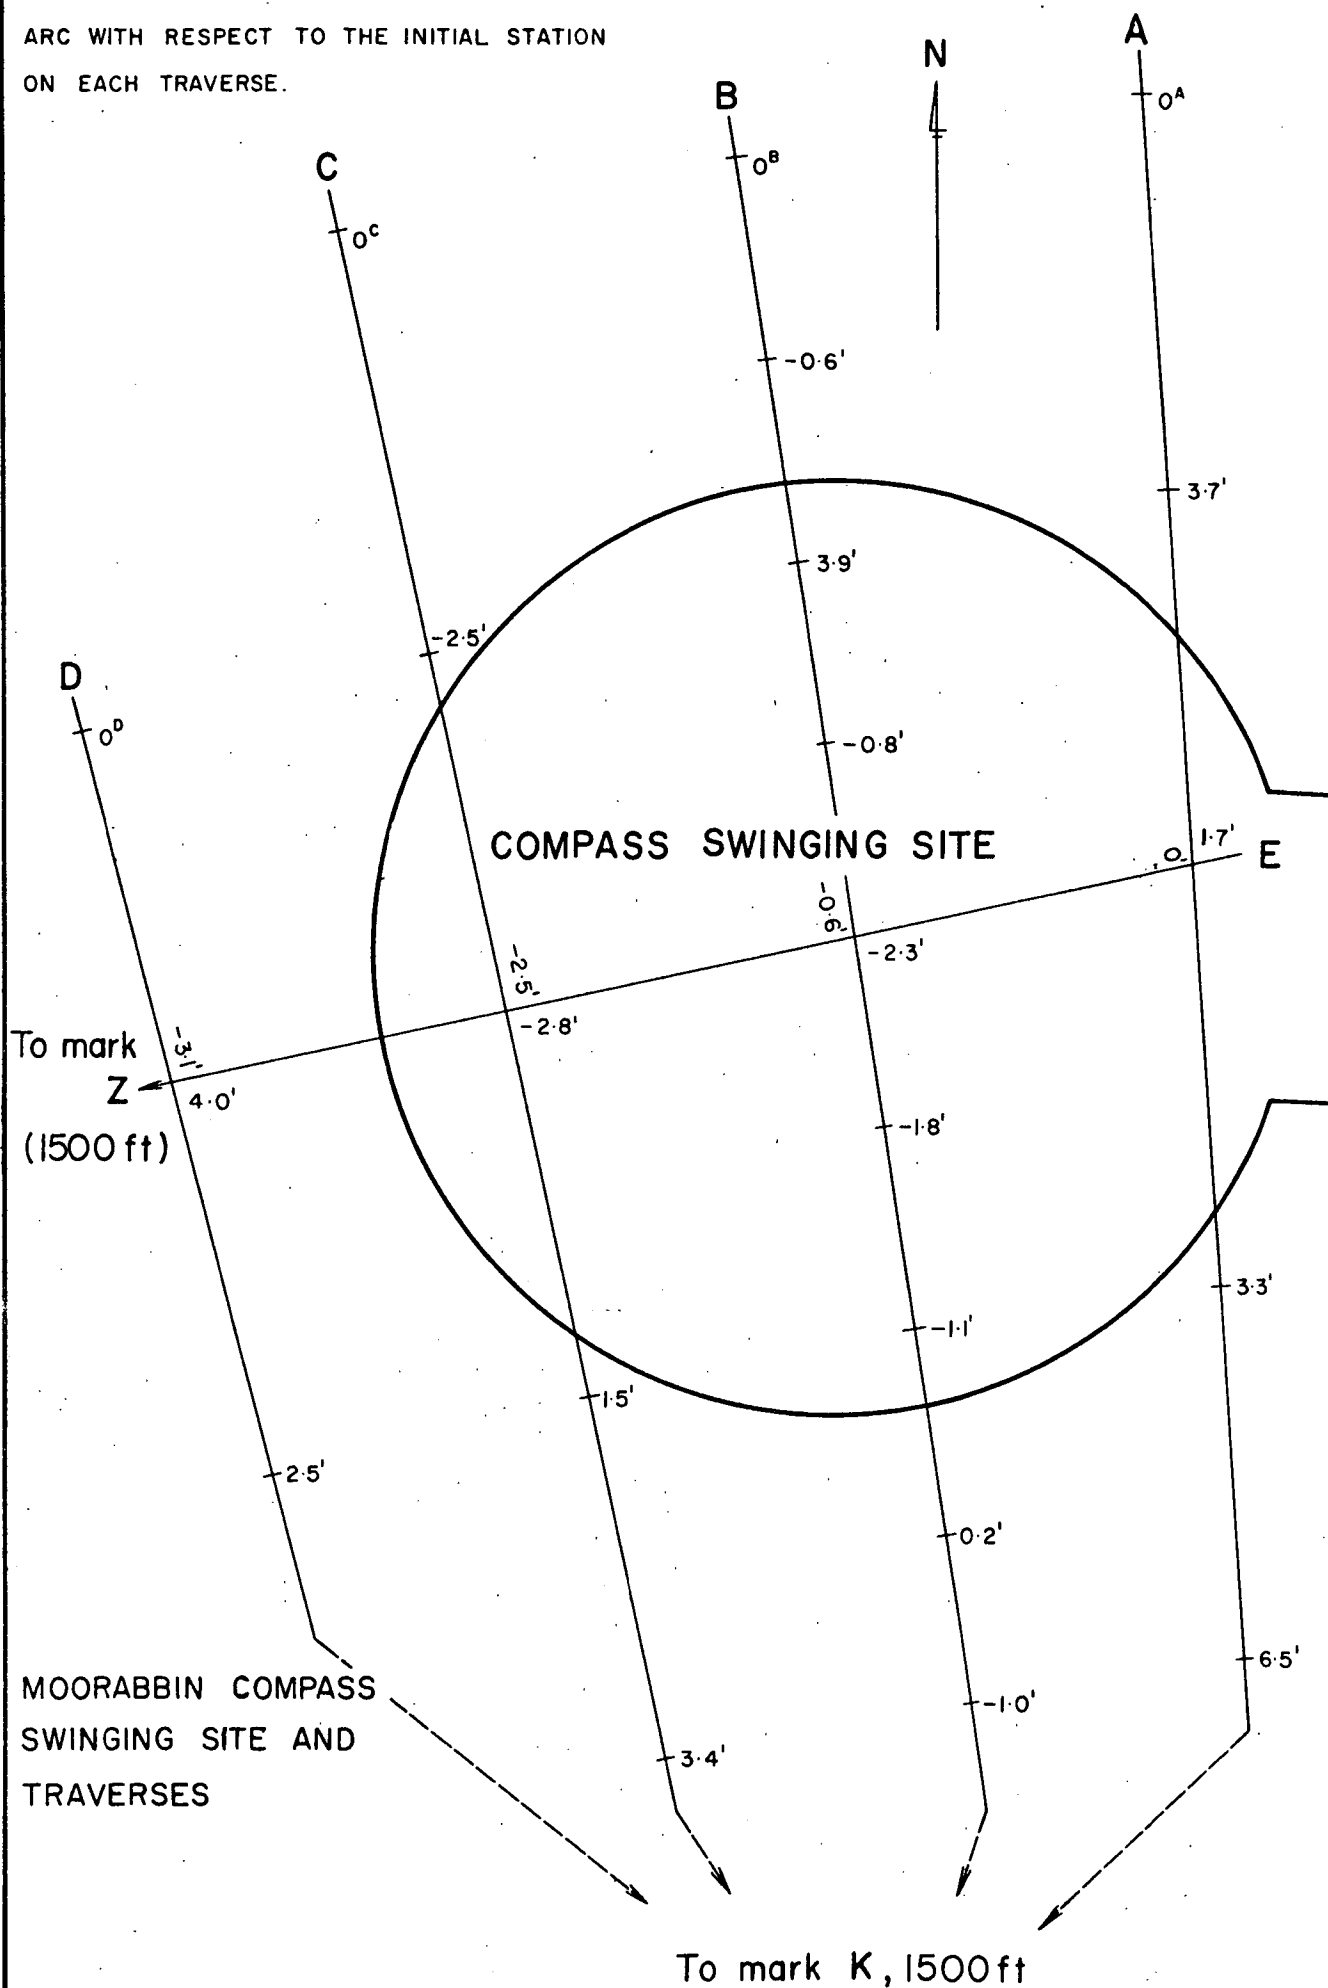
PLATE I

Using mark D and beginning at the northernmost point on line B the declination with respect to the direction of the mark K was measured. This was then repeated at 20 foot intervals moving along the line BK across the site. The initial reading was taken as zero and the differences from this reading are marked at each observation point (plate 1). Differences less than 4 feet were measured.

Similar measurements were made along traverses A, C, and D, using 40-foot intervals, and differences less than 7' were measured. The differences are only meaningful along each line because AK, BK, CK, DK directions are not parallel and a separate zero is necessary for each.

Measurements were next made using mark Z giving an EZ direction approximately at right angles to A, B, C, and D. Again differences less than 4 feet were measured.

The proximity of the marks (approx. 1500 ft) and deviations of the observation points from a straight line (estimated maximum  $\pm 1$  ft) would cause a variation of approximately  $\pm 3$  feet along each line. As the declination measurements are accurate to  $\pm 0.2$  feet and the day was magnetically quiet, these deviations probably account for most of the differences.

The results indicate that there is no anomaly at the present compass swinging site which would account for the large discrepancies experienced.

VALUES ARE STATION DIFFERENCES IN MINUTES OF  
ARC WITH RESPECT TO THE INITIAL STATION  
ON EACH TRAVERSE.
