DEPARTMENT OF  
MINERALS AND ENERGY

# BUREAU OF MINERAL RESOURCES, GEOLOGY AND GEOPHYSICS

Record 1971/52

GOOGONG DAM SITE - QUEANBEYAN RIVER N.S.W. -  
FEASIBILITY INVESTIGATIONS 1970 and 1971

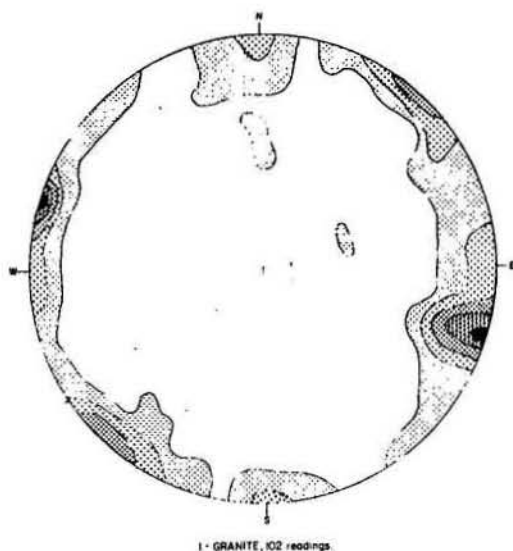
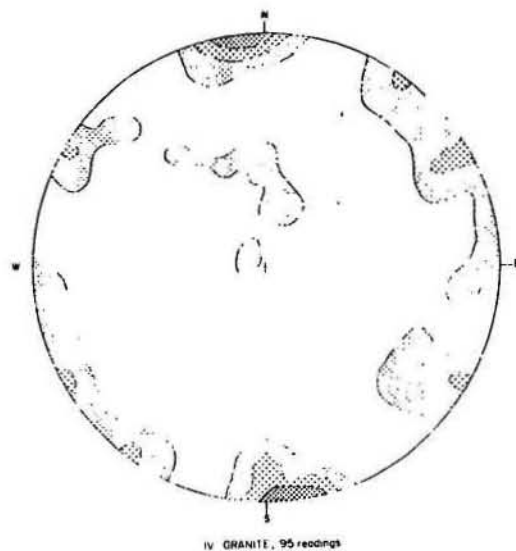
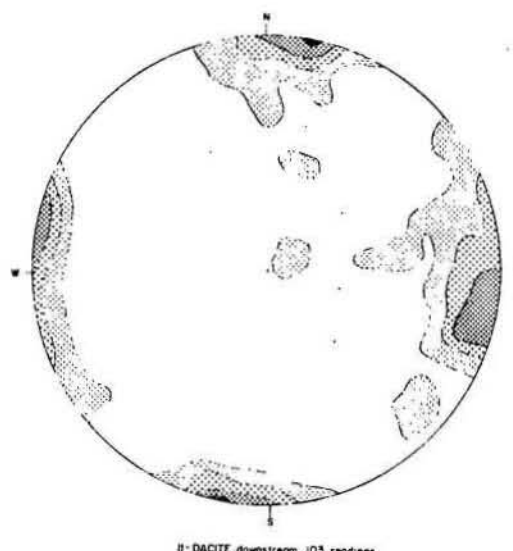
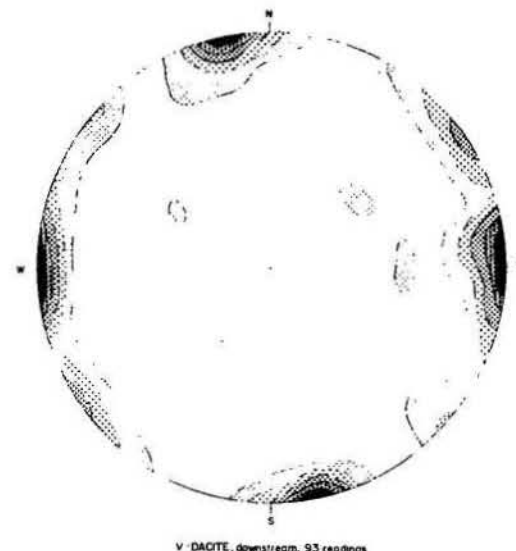
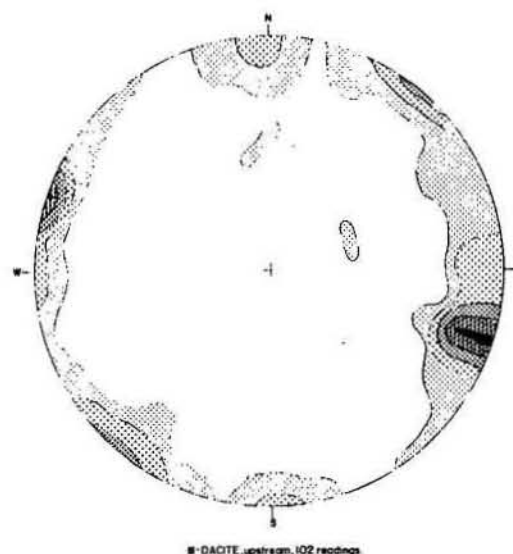
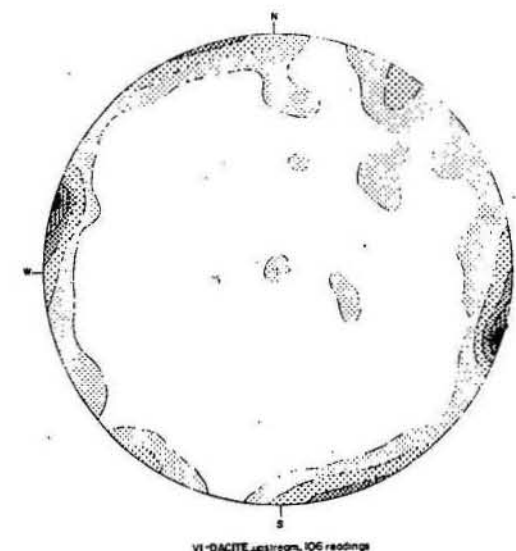
Six stereographic projections of the poles of joints and cleavage planes were prepared and contoured by appropriate methods to provide joint diagrams (Figure 3) for structural analysis of the systems of rock fractures at the site.

Each diagram is based on approximately 100 readings from one of six subdivisions (Plate 4) of the site. The diagrams thus permit not only the determination of the main directions of fracture in each area but also a comparison between fracturing in each abutment and rock type.

The granite on the left bank, like the dacite, contains  $020^{\circ}$ , vertical joints (Fig. 3). The granite on the right bank, however, rarely shows the system. The joint diagrams of both show lower concentrations corresponding to maxima at about  $080^{\circ}$  and  $140^{\circ}$ . All systems are nearly vertical. Although younger than the dacite, the granite near the dam does not seem much less fractured. In the lower spillway section, however, there is a marked difference in degree of fracturing. Drillholes D20 and D21 reveal very little fracturing. Eight-foot runs of unbroken core were frequently recovered from granite.
