DEPARTMENT OF  
MINERALS AND ENERGY

Record 1971/110

ZINC POLLUTION IN THE MOLONGLO RIVER SYSTEM

A.D. Haldane

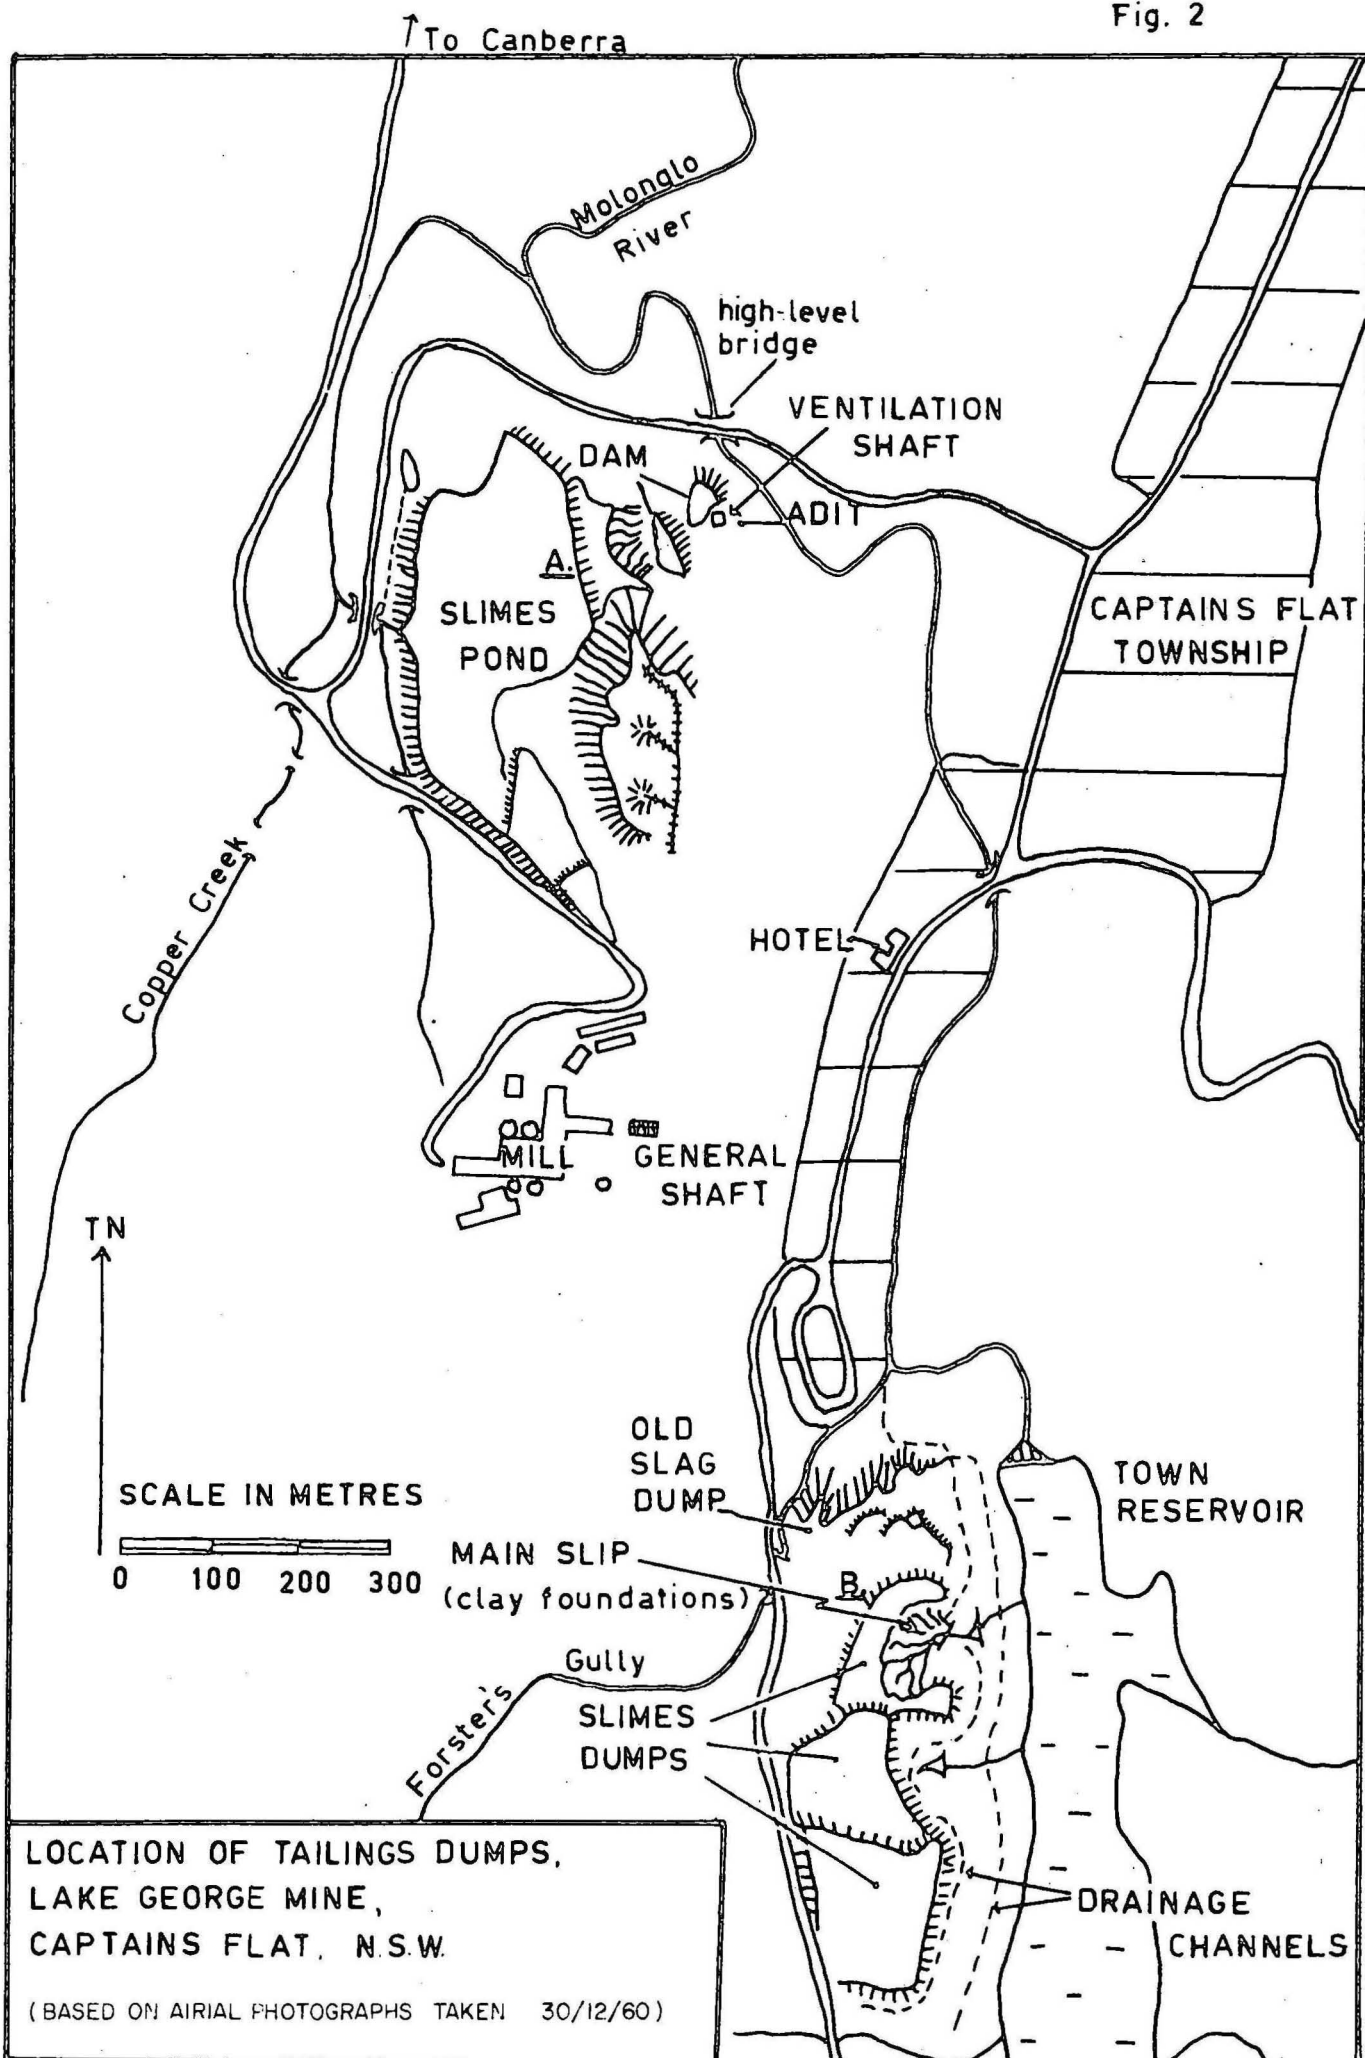
Fig. 2

During August 1939, a slimes pond (A, Fig. 2) used for the settlement of tailings from the floatation plant burst its retaining wall and discharged tailings and mill water directly into the Molonglo River near the high-level road bridge immediately downstream of Captains Flat township. There is no record available of any investigation of the effects of this collapse.

In July 1942 - there was another collapse, this time in the dumps immediately adjacent to and uphill of the town reservoir (B, Fig. 2). An estimated 30 000 m<sup>3</sup> of tailings consisting mainly of siliceous gangue, pyrite, and weathering products slipped into the reservoir displacing an equivalent volume of water which carried tailings and soluble material into the Molonglo
