Record 1972/34

BLOWOUT AT PETREL NO. 1 WELL AND SUBSEQUENT
EVENTS

Statement on Blowout at Petrel No. 1 and
Subsequent Events

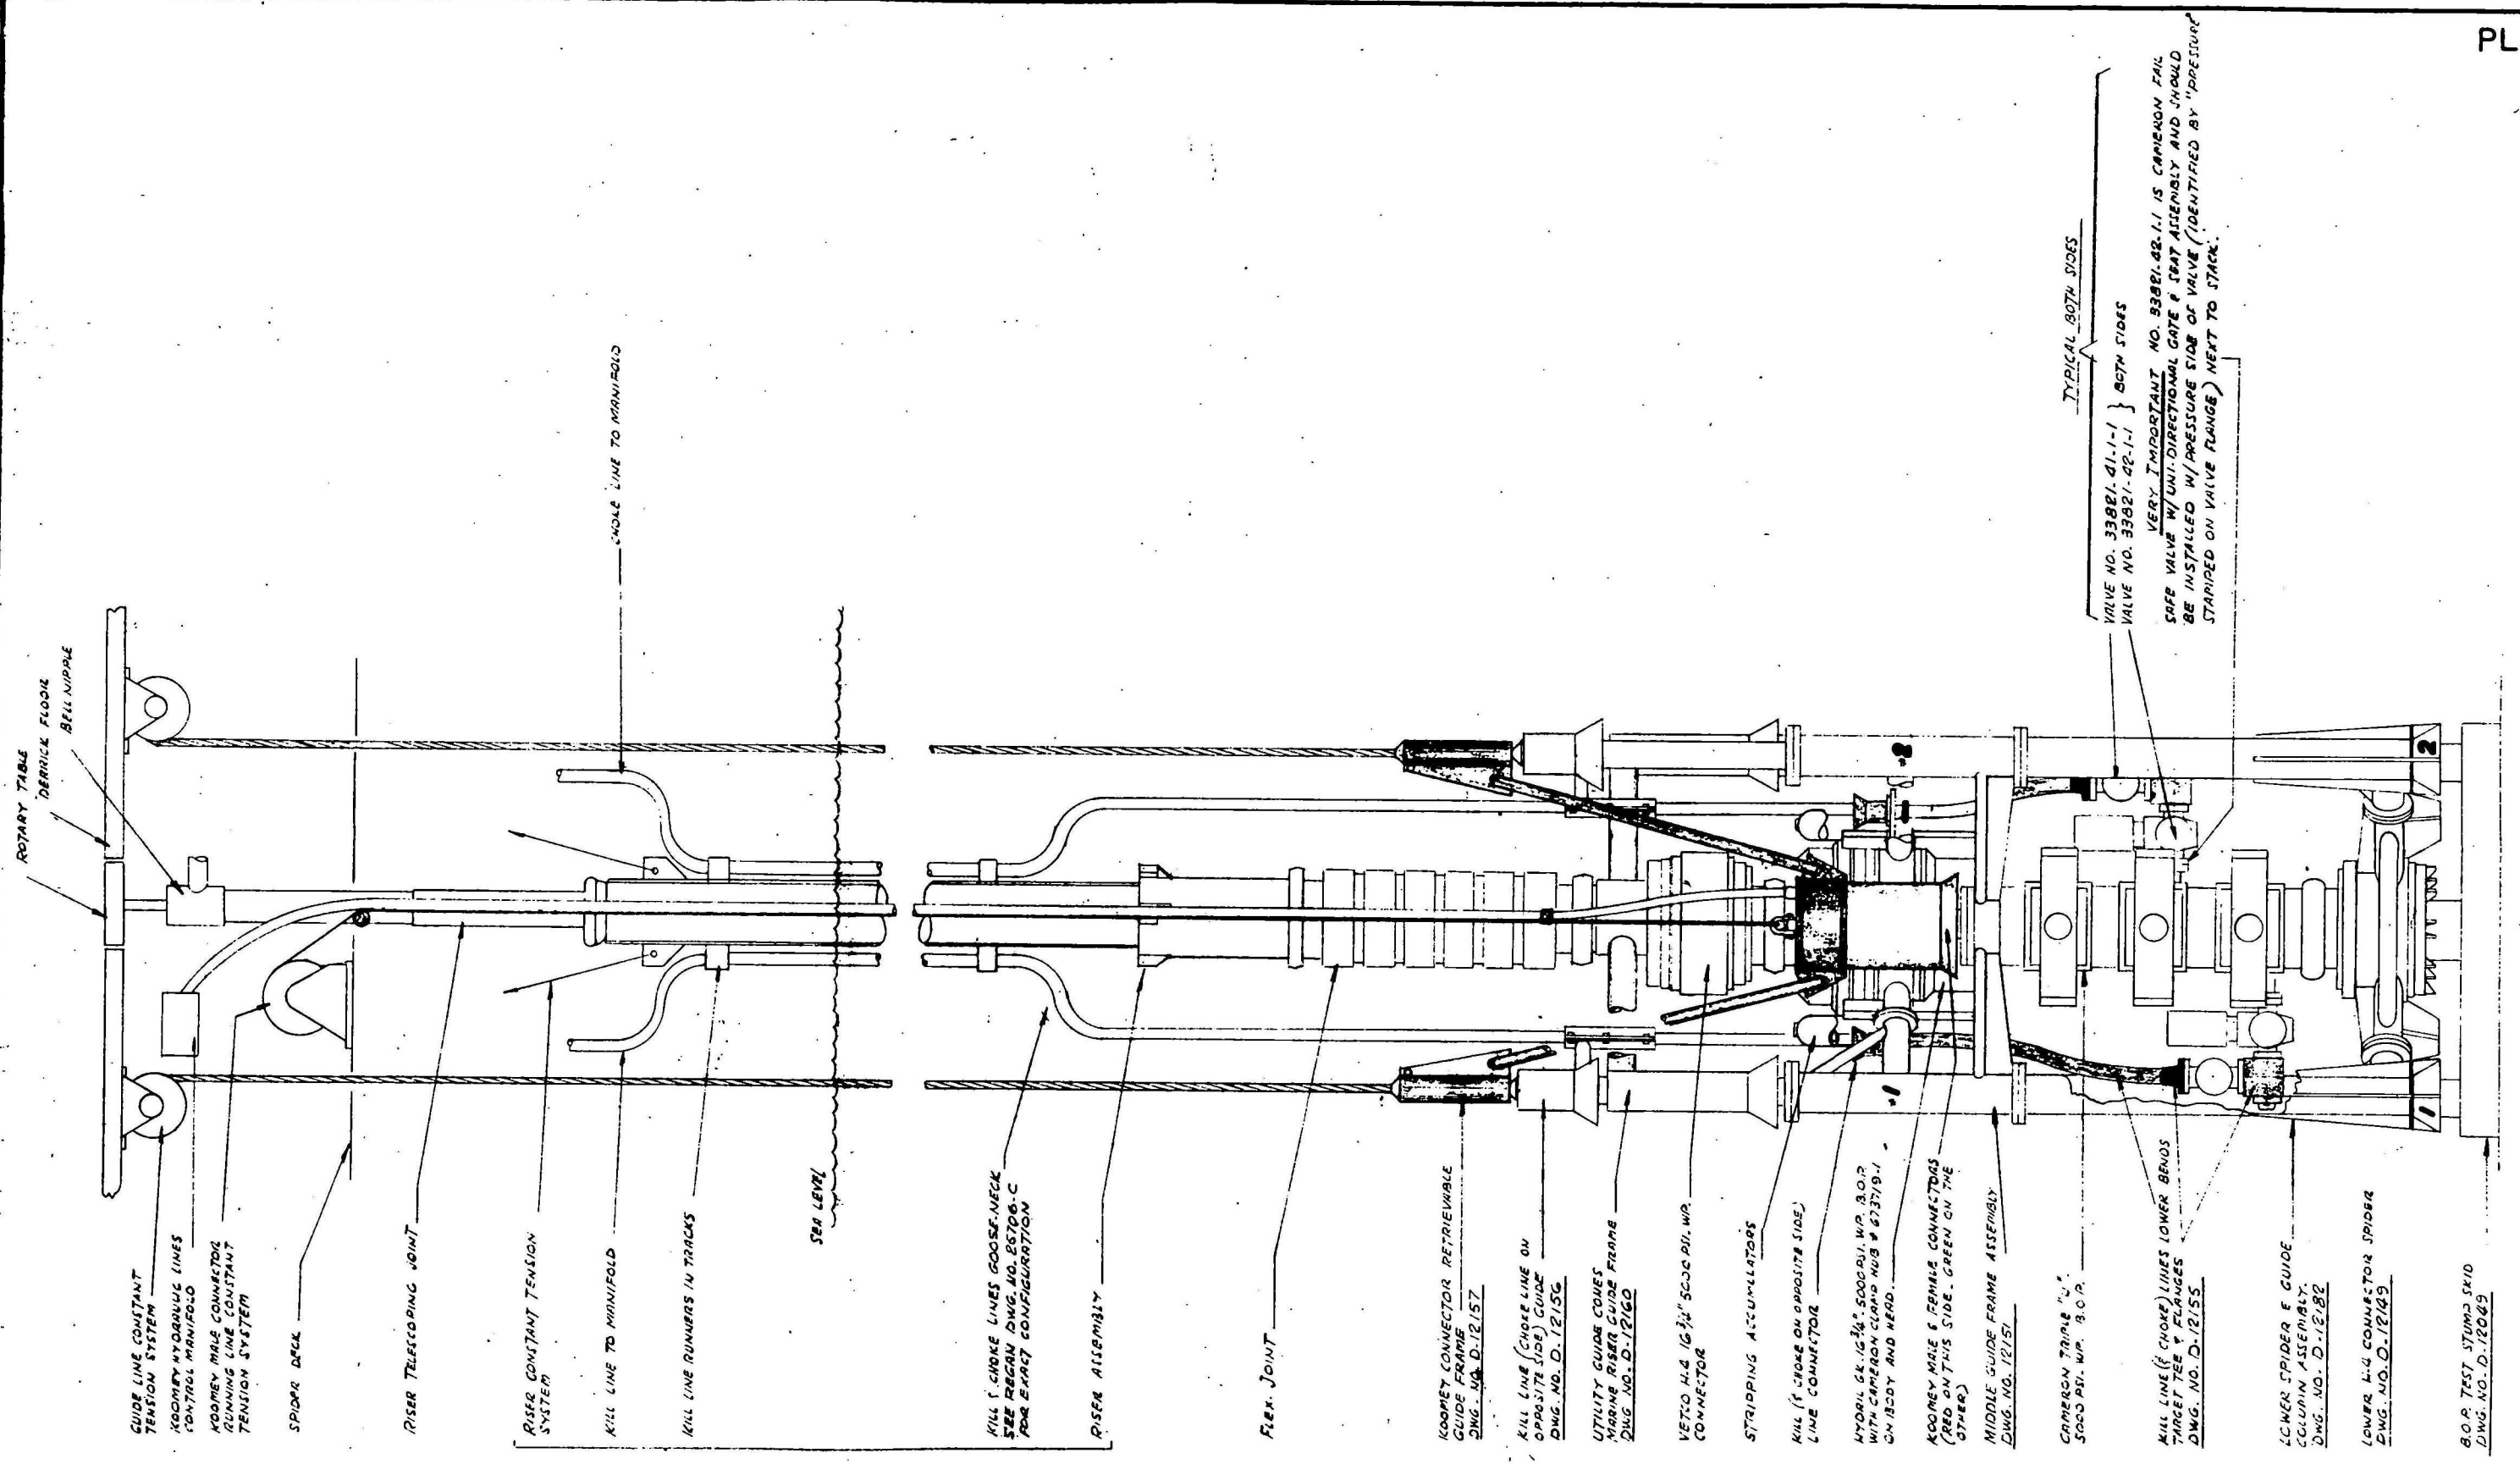
SUB SEA PRESSURE CONTROL EQUIPMENT
FOR SEDCO 135 G AT PETREL No.1

pressures. On this well the blowout preventer stack consisted of one Hydril (an expandable doughnut-shaped rubber seal), two sets of pipe rams (designed to close on drill pipe) and one set of blind rams (designed to close in empty hole). This is a conventional type of B.O.P. arrangement which is generally considered to be adequate to give the necessary protection in the event that abnormally pressured formations are encountered and the well tends to blow out. The Hydril has a rated working pressure of 5,000 psi and each set of rams has a rated working pressure of 5,000 psi. They were tested to half of these pressures each week.

A possible explanation of the failure of the Hydril is related to the pressures which built up in the annulus. The Hydril is designed so that drill pipe and tool joints (which connect two lengths of drill pipe and are of a larger diameter than the pipe) can be pulled through it. This is accomplished by closing the Hydril with the minimum pressure required to effect a seal and incorporating in the system a valve to regulate this pressure. This valve will allow the Hydril to open a little to permit the tool joint to pass. The annulus pressure can also affect the pressure under which the Hydril is closed and, in the circumstances existing at Petrel No. 1, the Hydril may have been closed with sufficient pressure to cause the Hydril rubber to be damaged when the drill pipe moved through it.

Both sets of pipe rams were then closed but the lower set apparently did not seal. No definite explanation is available for this failure but a possibility is that a piece of metal (similar to that recovered on the rig) may have jammed between the jaws preventing them from closing completely.

This was done and the blind rams were closed, but there was no apparent reduction in the rate of flow of gas. (Subsequent inspection by divers showed that the blind rams had operated and were within 0.724 inches of their fully closed position. This indicates that the drill pipe was crushed by the blind rams but did not part.)

- (a) The desirability of requiring that, when an imminent blowout situation exists, action be taken to ensure that the drill pipe can remain stationary and be independent of the motion of the drilling vessel.
- (b) The desirability of including shear type blind rams in the B.O.P. stack.
- (c) The desirability of running two Hydril units on every underwater B.O.P. stack.

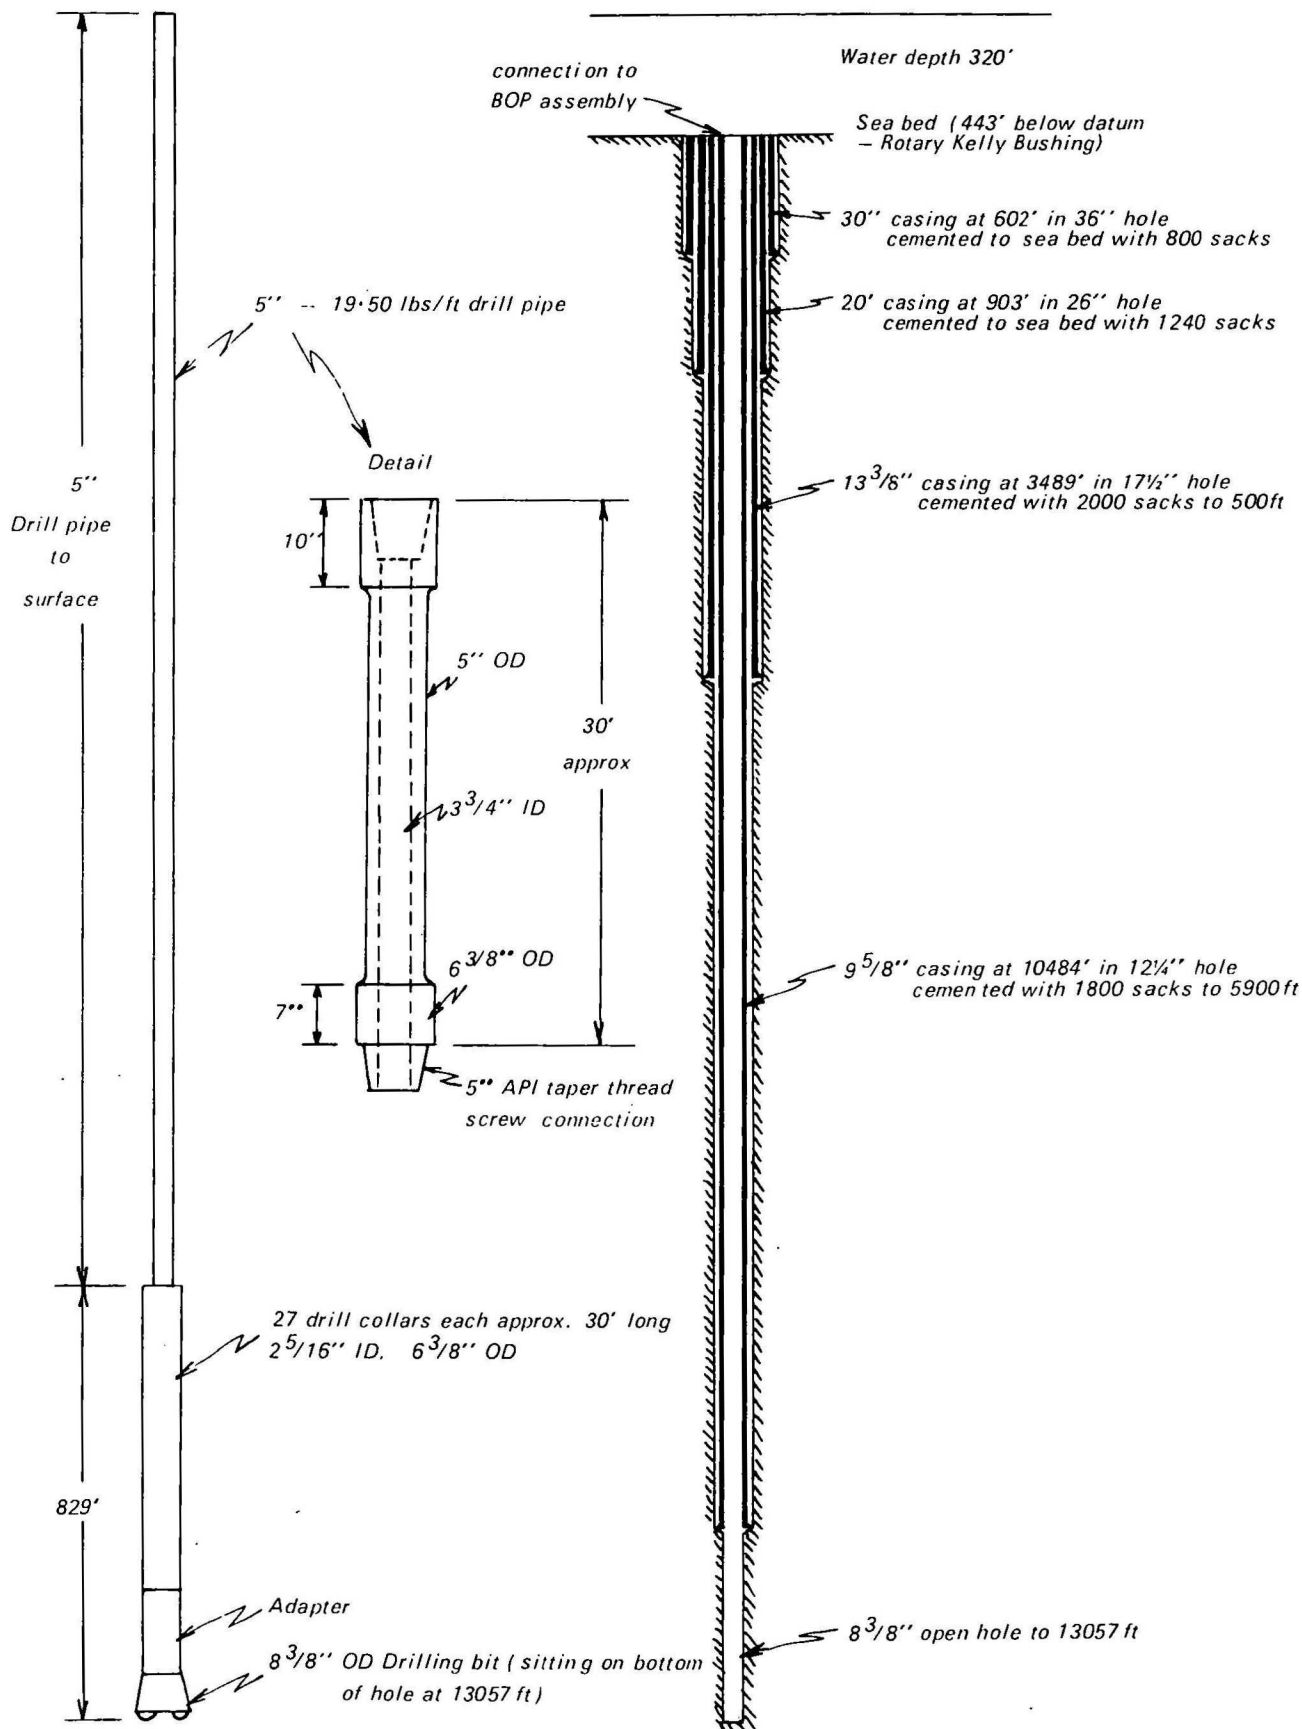
DRILLING STRING ASSEMBLY

Casing had been run in the hole to a depth of 10,484 feet. This depth was sufficient to protect the formations from any pressures which could reasonably have been expected to the programmed depth. The grade of casing was sufficiently heavy to more than withstand pressures which might be encountered. Further details of the equipment in use is given in Appendix 2 and on Plates 1 and 2.
