THE MAJOR PAPUA NEW GUINEAN EARTHQUAKES NEAR MADANG (1970)

AND BENEATH THE NORTH SOLOMON SEA (1971)

I.B. Everingham

Record 1973/18

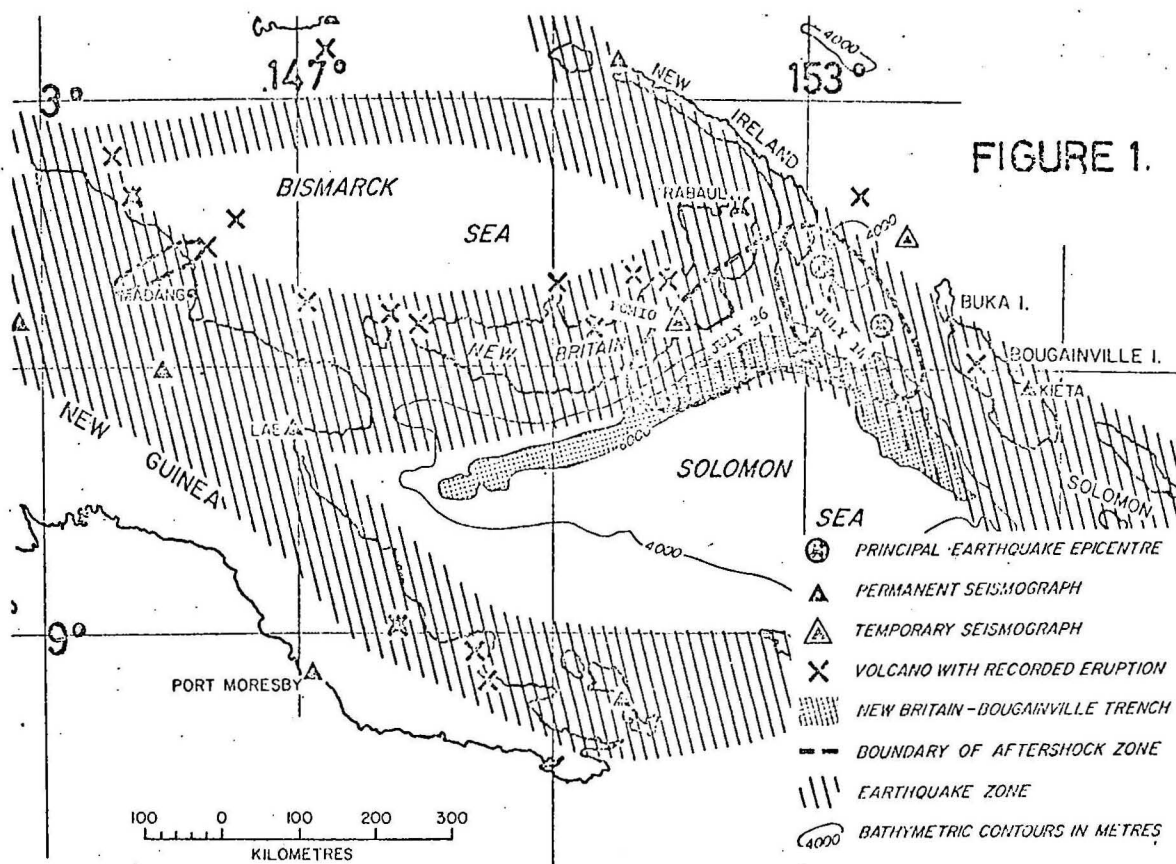
The fault-plane solution and hypocentre pattern suggested a near-vertical, left lateral, strikeslip fault trending ENE near the north coast of New Guinea (Fig. 1). Maximum intensities were at least MM8, and MM7 intensities were experienced over an area of about 25 000 km². Extensive landsliding occurred in the epicentral region, and half the village houses were destroyed. Damage in Madang (population 15 000), 30 km from the fault, was mainly to unreinforced masonry structures and corrugated iron water tanks. Bridges, wharfs, and roads in the Madang District were also damaged.

shocks with MS greater than 6.9 have occurred in the area since 1900. Aftershock and fault-plane solutions suggest that the earthquake resulted from faulting of two parts of a single fault zone that extends from west of Bougainville Island along the trend of the trench to Pomio on the south coast of New Britain (Fig. 1).

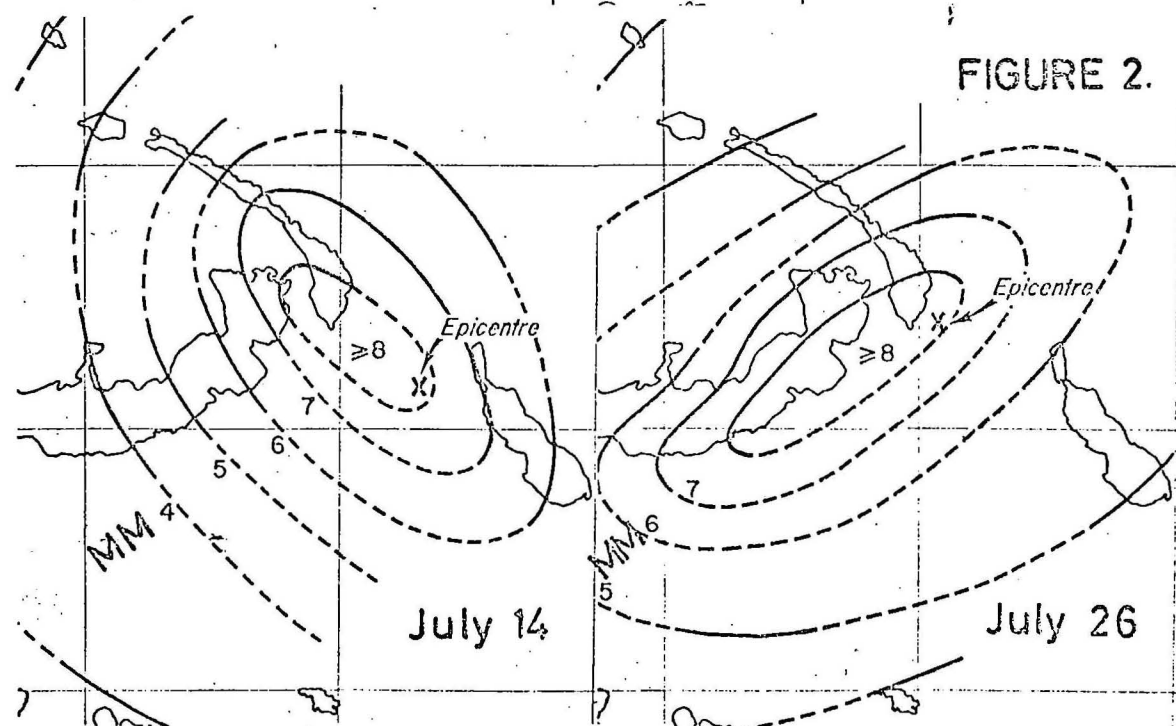
Maximum intensities were at least MM8, and the MM8 isoseismal approximately enclosed the zone of aftershock epicentres for each earthquake; i.e. the shaking appeared to be directly related to distance from the faulted zone, not the epicentre (Fig. 2). Hence although Rabaul was twice as far from the first epicentre as from the second, the intensities at Rabaul during the two earthquakes were about the same. The longer axes of the elliptical MM7 isoseismals were roughly 500 km long, and for each 'quake the area with MM7 intensities is estimated to be roughly 400 000 km².
