Record 1973/24

GEOLOGICAL INVESTIGATIONS TENNENT DAMSITE,  
A.C.T. 1970

G.A.M. Henderson

Tennent Damsite on the Gudgenby River, 32 km south of Canberra, is one of two alternative sites for Canberra's next major water supply dam. The other site is on the Queanbeyan River at Googong. Tennent Damsite was investigated initially during 1966-1968, and further investigations were carried out during 1970. The damsite is situated in a gorge on the Gudgenby River; the river valley widens upstream to the south to provide a suitable reservoir. The entire reservoir area lies within granitic rocks - Tharwa Adamellite in the north and Clear Range Granodiorite in the south. The meridional-trending Murrumbidgee Fault lies about 1.5 km east of the damsite.

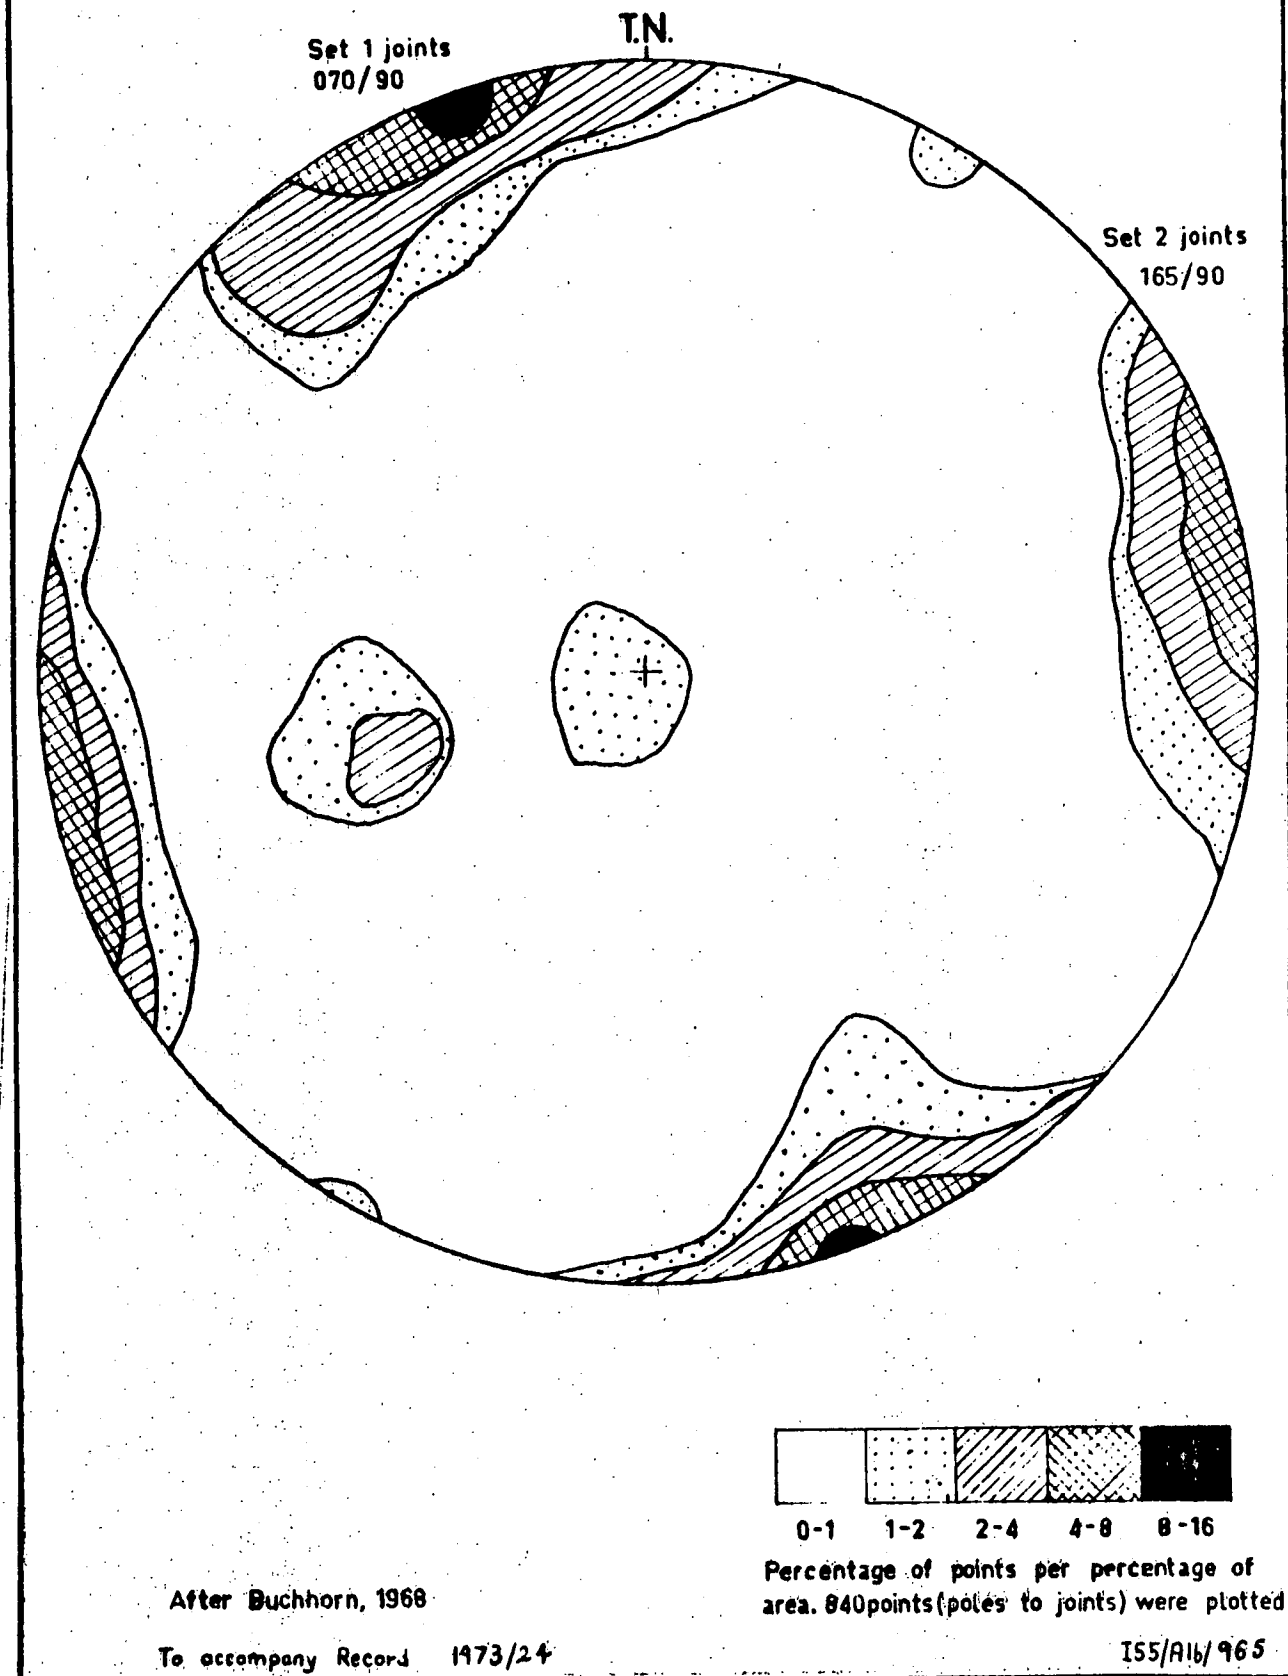
## STEREOGRAM OF JOINTS IN RIVER BED AND ON WEST BANK

Two major steeply dipping joint sets are found on the west abutment, in the river bed and on the lower part of the east abutment (Buchhorn's joint sets 1 and 2). The orientation within each joint set ranges considerably but they average about  $070/90$ \*\* (set 1) and  $165/90$  (set 2) (see Fig. 2); set 2 joints are approximately parallel to the foliation. Both of these sets of joints are persistent throughout the damsite area.

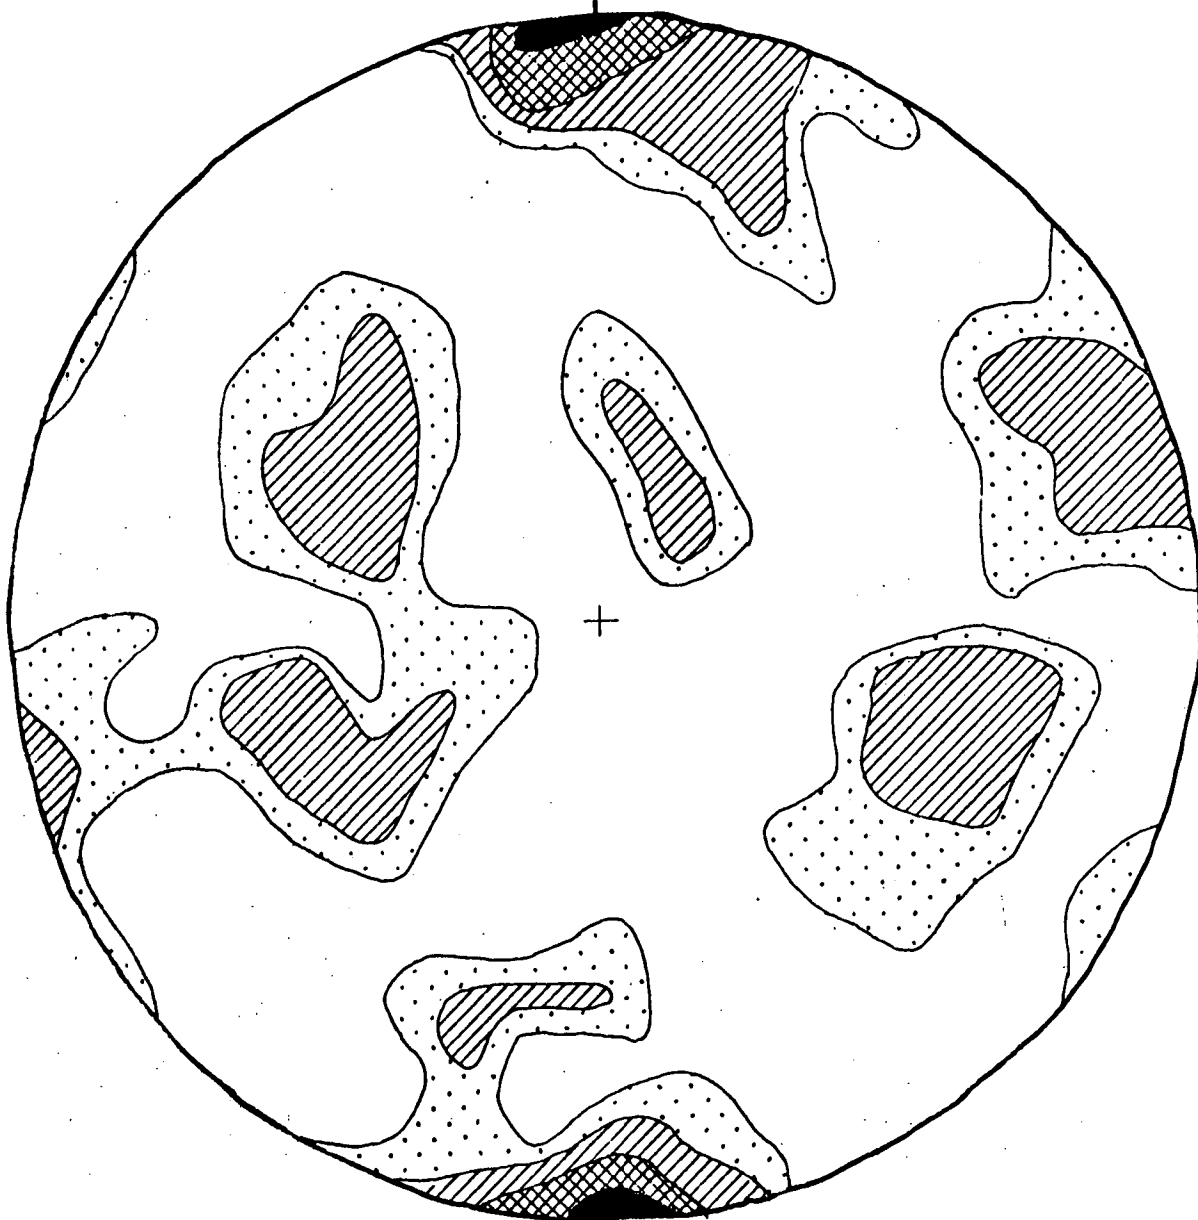
## STEREOGRAM OF JOINTS IN COSTEANS ON UPPER PART OF EAST BANK

Percentage of points per percentage of area. 102 points (poles to joints) were plotted

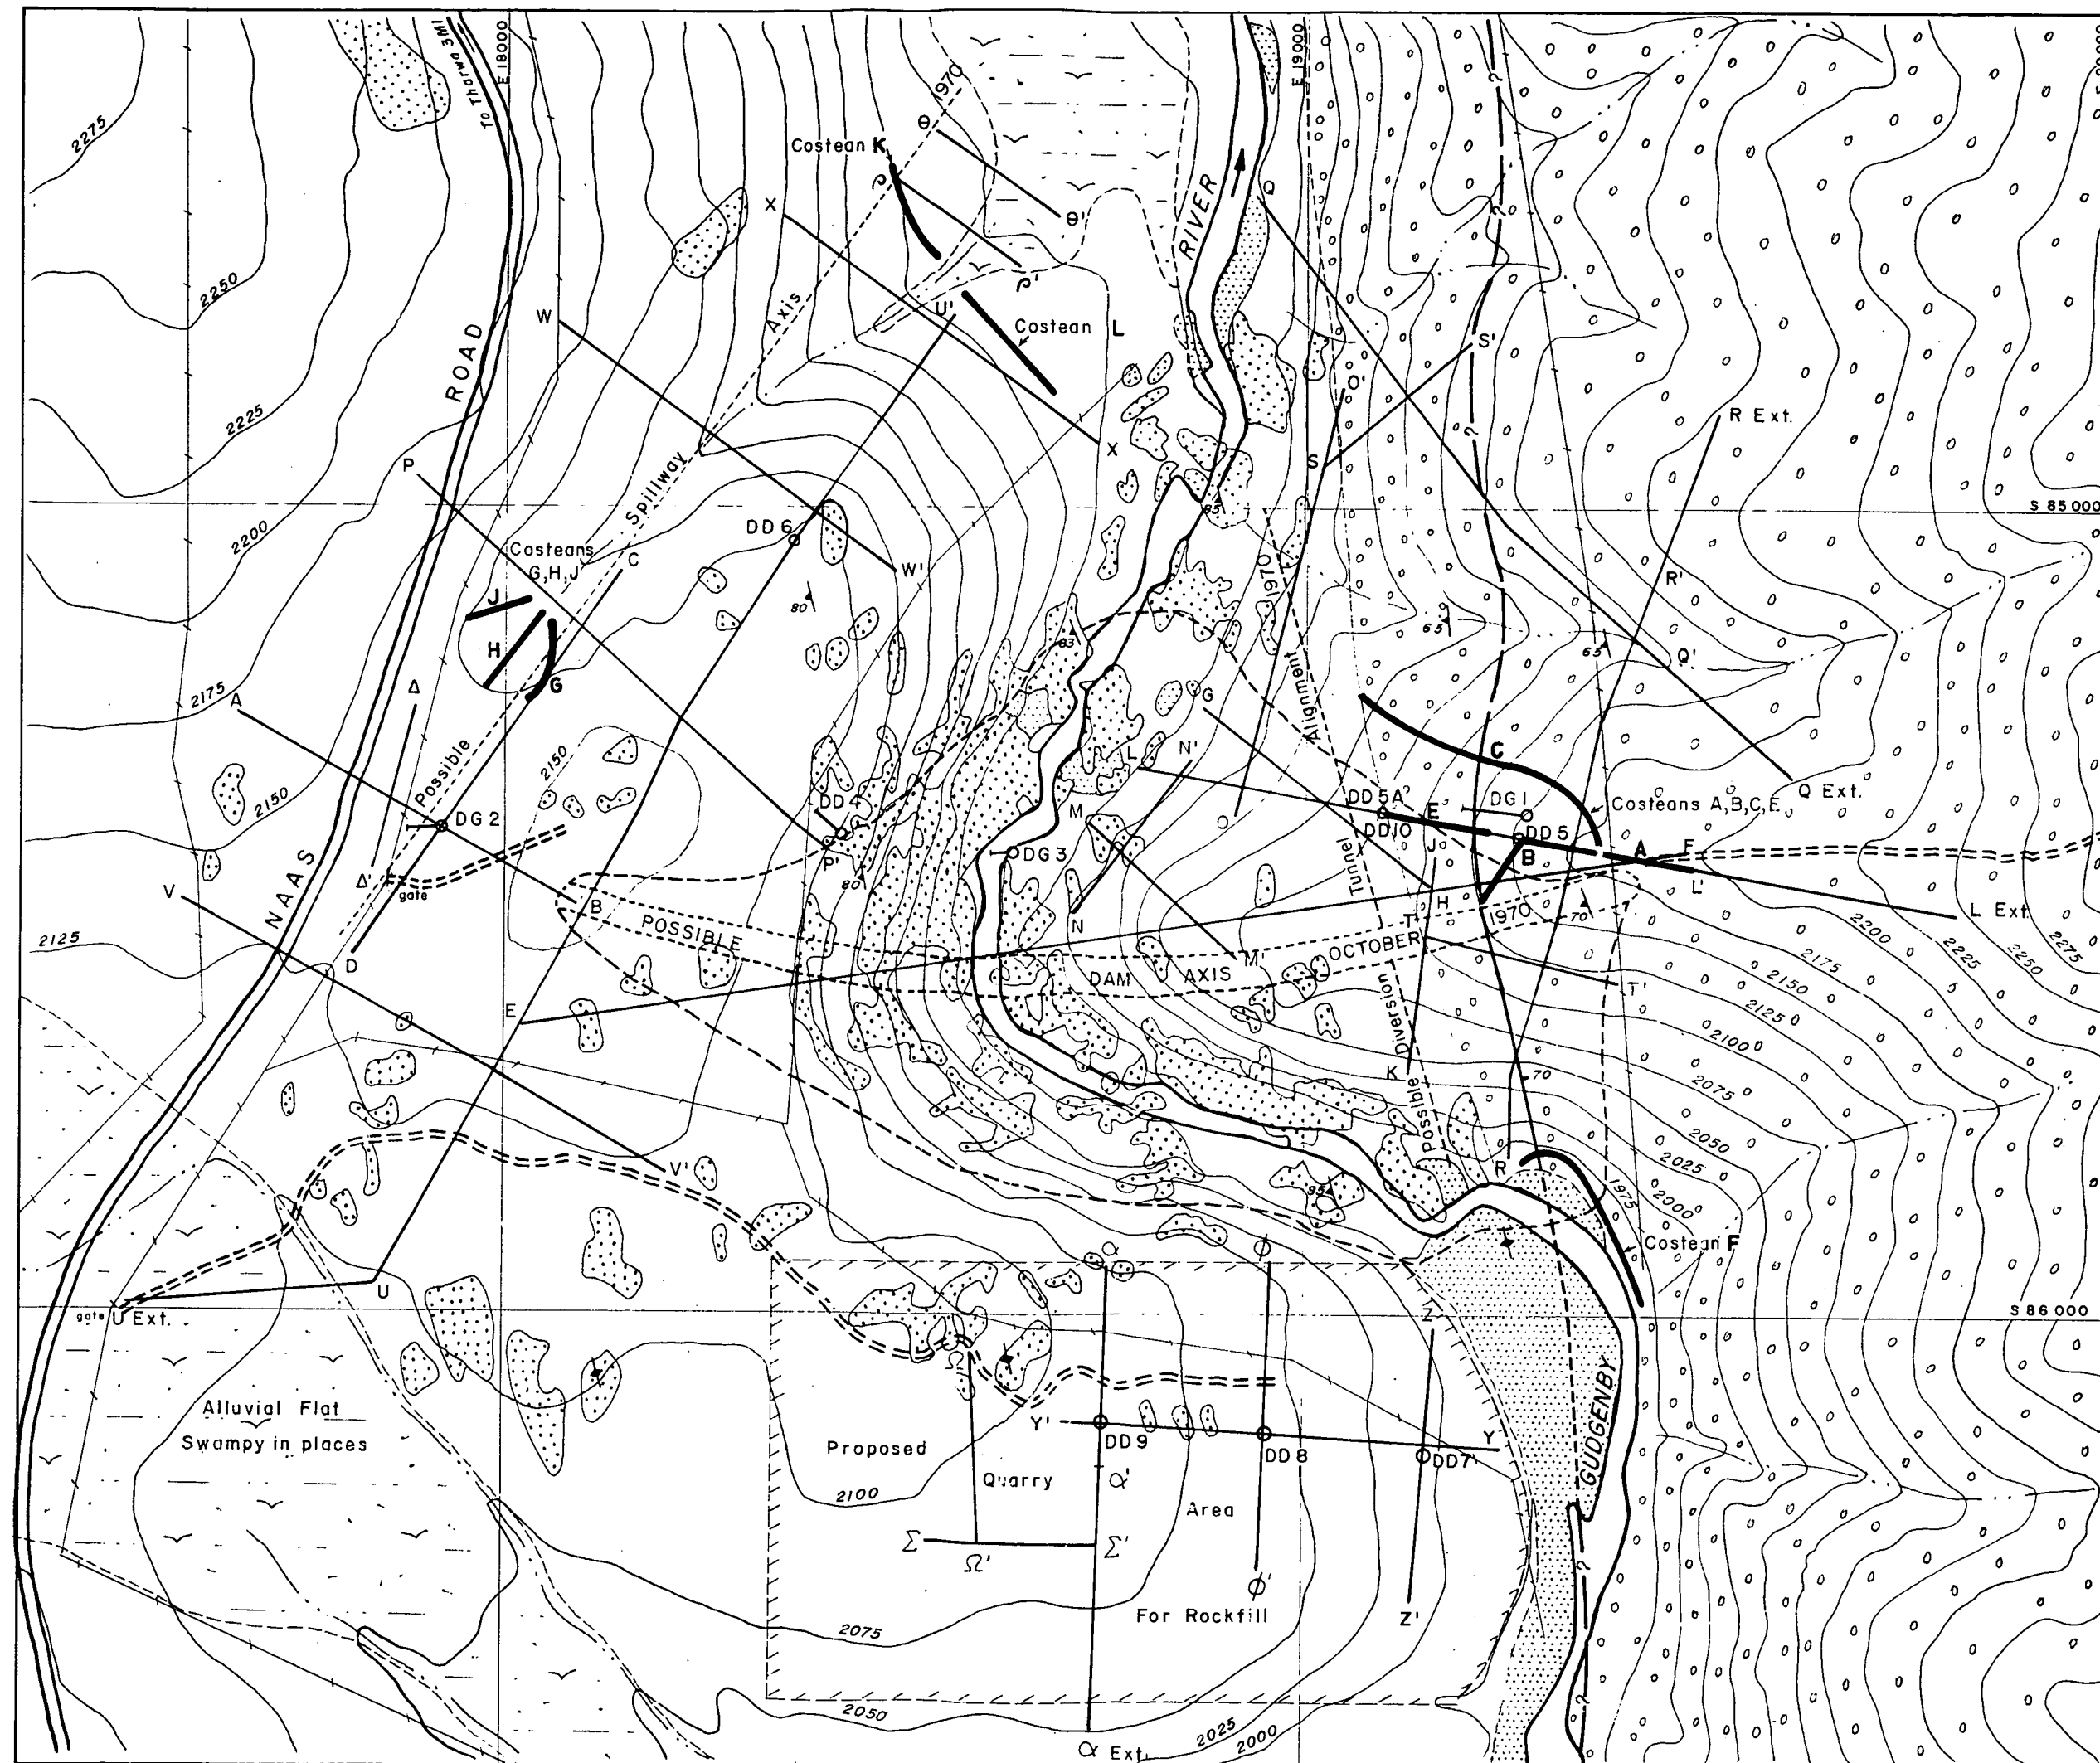
# TENNET DAMSITE GENERALIZED GEOLOGICAL MAP OF DAMSITE AREA SHOWING SITE INVESTIGATIONS

The weathering pattern at the damsite is related mainly to the presence or absence of strong shearing. Thus for the purposes of this discussion the damsite area is divided into a western zone which includes the unsheared grey adamellite found on the west abutment, in the river bed and on the lower part of the east abutment, and an eastern zone which includes the sheared pink and grey adamellite on the upper part of the east abutment. The zones are shown on Plate 2.

The route originally proposed for the diversion tunnel in the east abutment followed seismic traverses RR' and QQ' (Plate 2). Most of this route would be in sheared rock, and a tunnel in such rock would probably need considerable support. The structural interpretation shown on Plate 2 and also in cross section on Plate 4 indicates that pink adamellite, similar to that found at a higher level in DD5, would be encountered along much of the route. The inlet portal of this route would be in sheared rock.

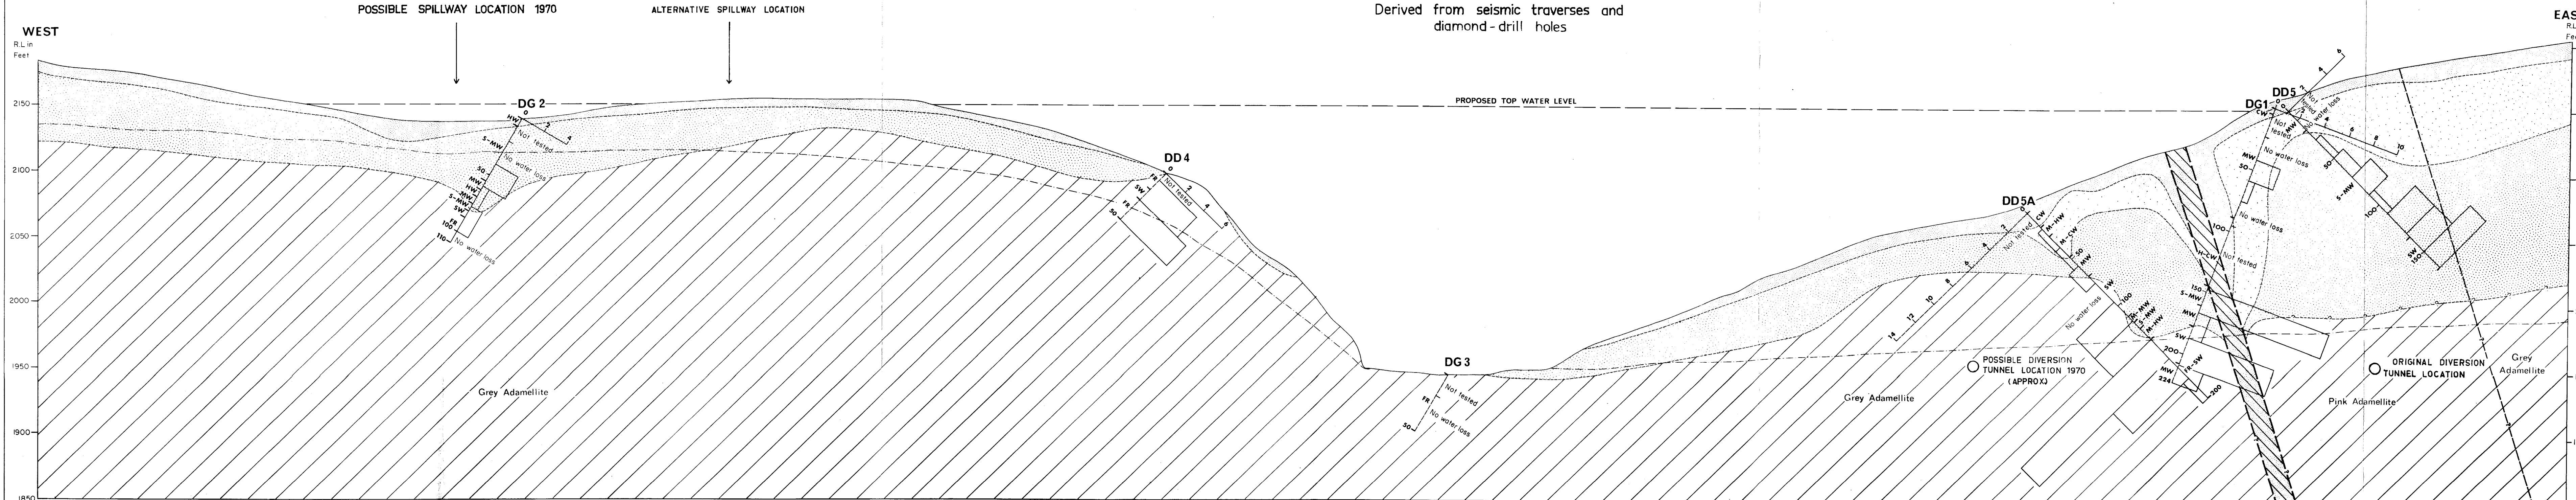
# TENNENT DAMSITE INTERPRETIVE GEOLOGICAL CROSS SECTION

Despite the zones of deep weathering observed in some drill holes the general depth of highly to completely weathered rock in the western zone is not great. Table 1 shows the depth of weathering in the drill holes on the west abutment and in the river bed. The holes are listed in order of increasing RL of the drill hole collar to show a general tendency towards increased depth\* of weathering with height above river level. This feature is also apparent on the cross-section (Plate 4) which is derived from both the drilling and seismic results. Additional information on depths of weathering near the surface in the western zone was obtained from costeans G, H, J, K, and L.

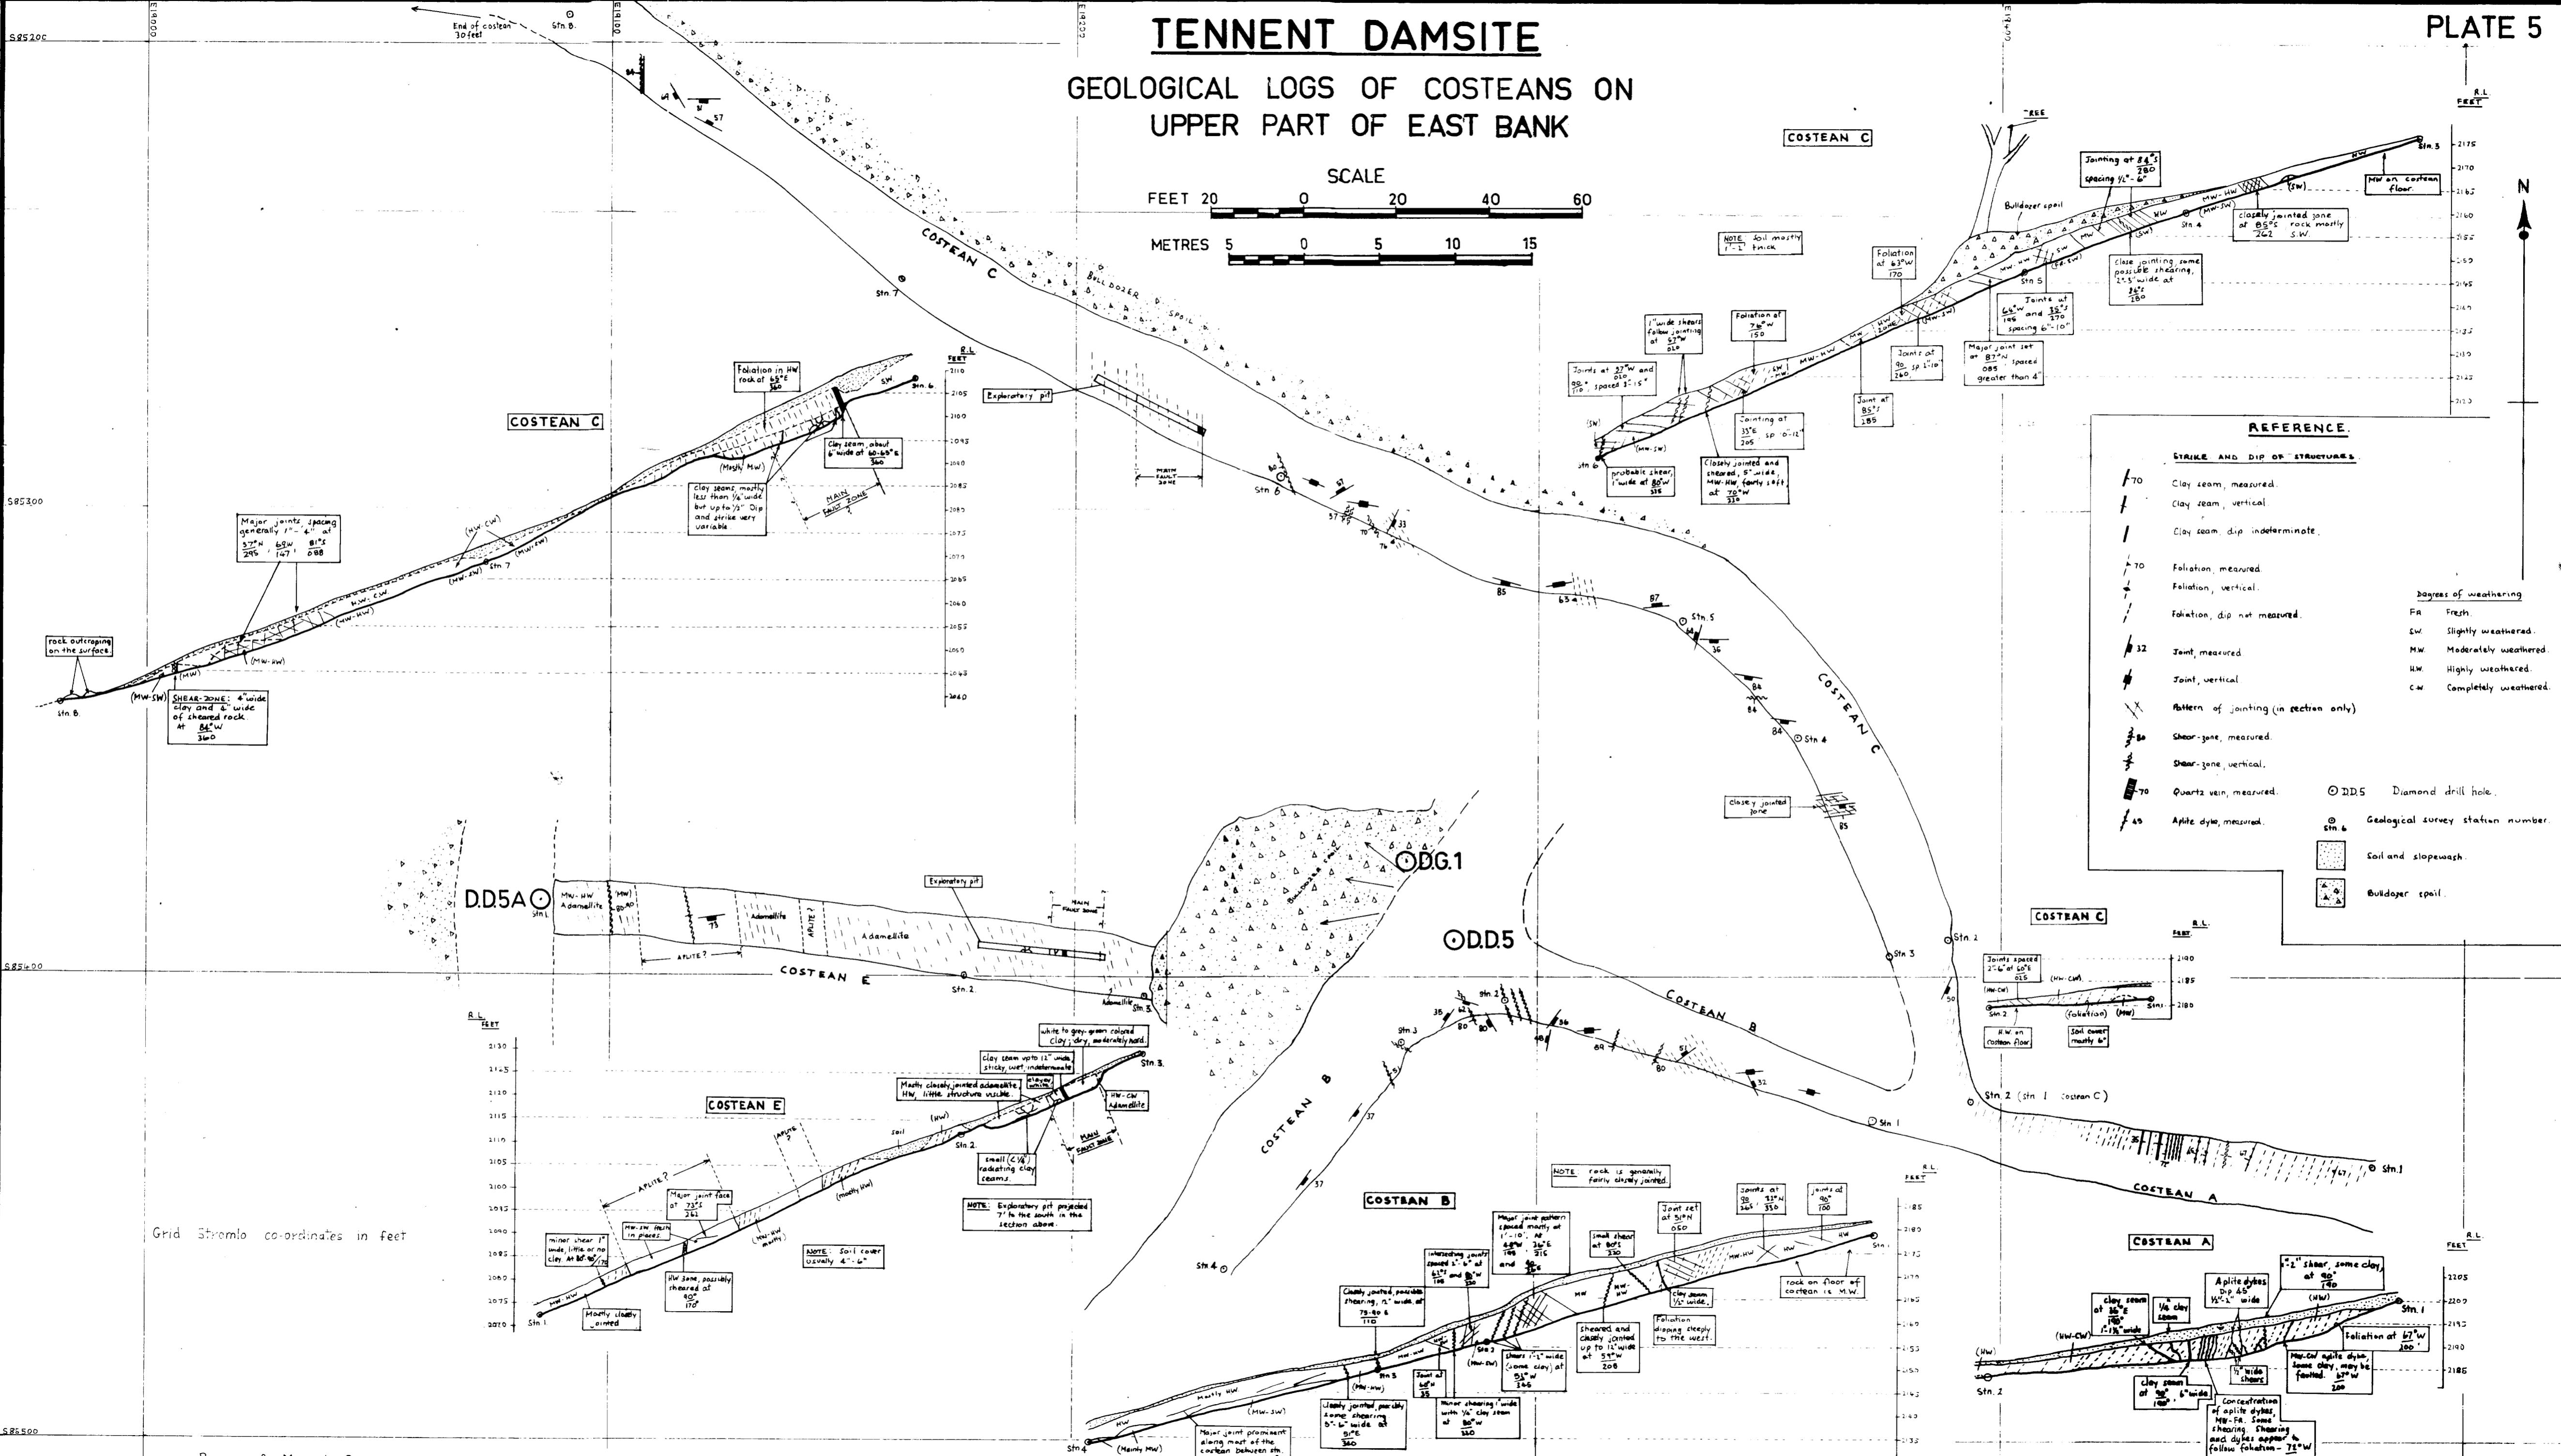
## GEOLOGICAL LOGS OF COSTEANS ON UPPER PART OF EAST BANK

In the eastern zone of weathering, in the sheared zone on the upper part of the east abutment, weathering is deeper than on the west abutment; outcrops are sparse and small. The seismic results indicate that the depth of highly and completely weathered rock ranges from 3 to 6 m. The drill core and costeans, however, indicate that weathering is irregular, particularly in the grey adamellite immediately west of the fault zone. Zones of highly weathered rock are found in drill holes DG1 and DD5A at depths of more than 30 m. Weathering in the pink adamellite as seen in drill hole DD5 is more uniform than in the grey adamellite and is mostly moderate. Variable weathering was also encountered in drill hole DD10, which was drilled at a low angle (30°) in an attempt to gain undisturbed samples of highly weathered rock for strength testing. However, the quality of the samples was unsatisfactory. The hole was not logged.

On the upper part of the east abutment, zones of highly weathered rock, including the main fault zone, will require excavation and backfilling with concrete. The depth of excavation will depend on the condition of the rock encountered in the zones, the condition of the surrounding rock and the width of the zones.

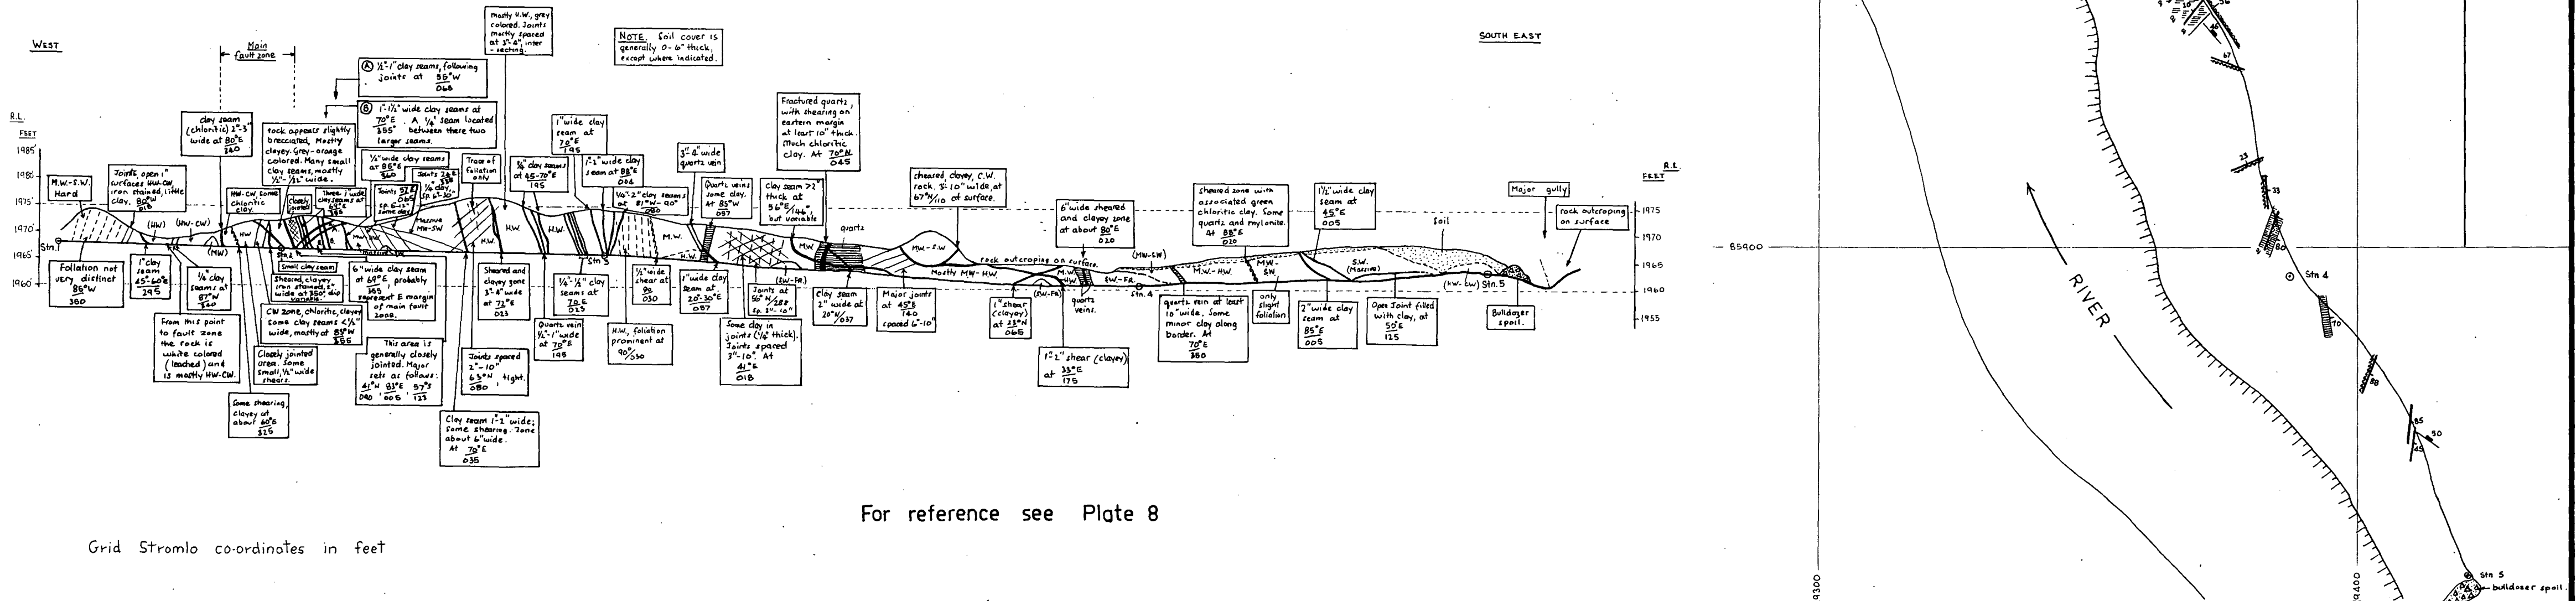
## GEOLOGICAL LOG OF COSTEAN F ON EAST BANK NEAR PROPOSED INLET PORTAL

Another route, proposed in 1970, lies in the grey adamellite on the lower part of the east bank west of the shear zone. The grey adamellite is stronger than the pink adamellite giving better tunnelling conditions, but for this route the inlet portal would lie in the rockfill zone of the dam, and would therefore require an inlet structure about 30 m long as a shield around which to place the rockfill (see Plate 2). Another disadvantage of this route is that the tunnel direction would almost parallel the foliation and a major joint system, both of which strike at  $165^{\circ}$ ; this parallelism could result in some overbreak. However, this tunnel route would be about 270 m long compared with 400 m for the original location. Another advantage is that the inlet portal would be in sound rock instead of the soft, decomposed, and strongly sheared rock exposed in Costean F.

3. A decision on the alignment of the diversion tunnel should be followed by drilling at the portal sites and possibly at other points to determine the suitability of the alignment and to give more information on expected excavating conditions and support requirements.
