GOOGONG DAM SITE - QUEANBEYAN RIVER N.S.W. -
GEOLOGICAL DESIGN INVESTIGATIONS, 1972 and 1973

G.B. Simpson

PART 2 - DRILL HOLE INFORMATION

GOOGONG DAM SITE - QUEANBEYAN RIVER, N.S.W. -
GEOLOGICAL INVESTIGATIONS,
1972 AND 1973

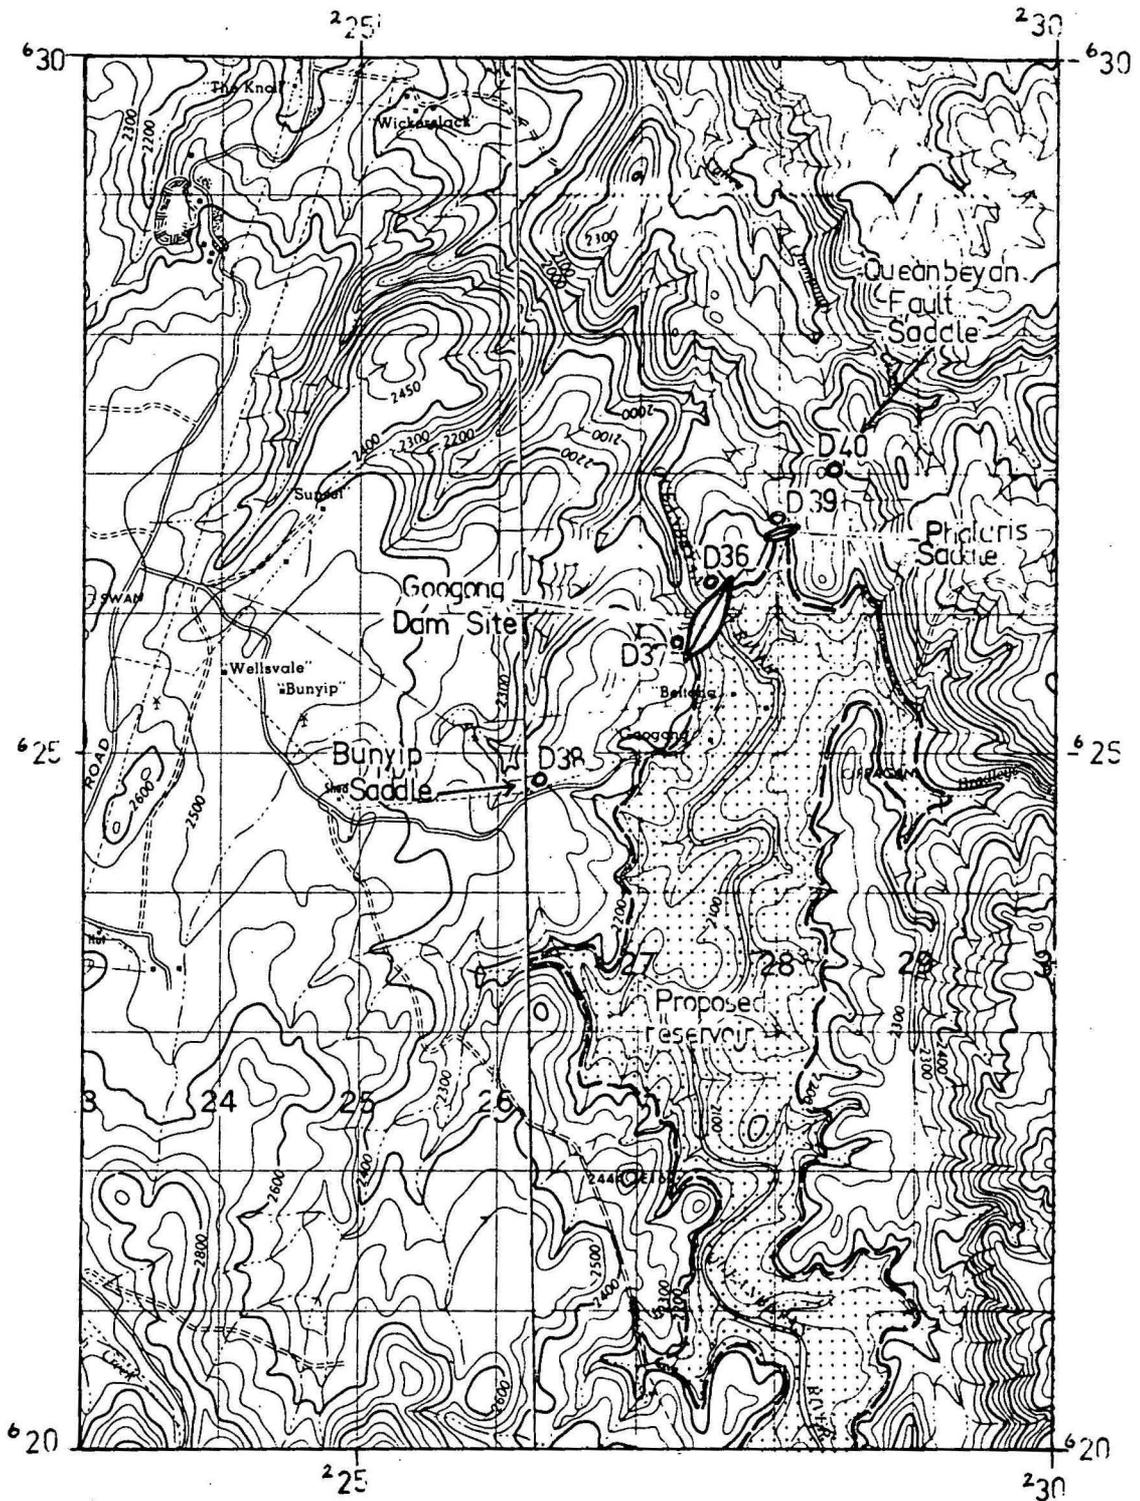
FIGURE 2 -- LOCATION OF GROUNDWATER OBSERVATION BORES

There are two possible paths of leakage from the reservoir area other than through the dam foundations and the Phalaris Saddle. These are through the Bunyip Saddle, 1500 m southwest of the dam site, and through the Queanbeyan Fault saddle, 500 m northeast of the Phalaris Saddle, at the head of the valley containing the core material deposit. The location of these saddles is shown in Figure 2.

A zone of close vertical jointing, approximately 20 m wide and trending northwest, passes through the saddle near drill hole 38. This zone is continuous and can be traced on aerial photographs and on the ground for more than 800 m on either side of the saddle. The most elevated seepage in the creek, immediately to the north of the saddle, occurs at the intersection of the jointed zone and the creek. The jointed zone may provide a leakage path; however, the permeability of the jointed zone is not known.

It is considered unlikely that leakage through the saddle will be significant. The stream to the north of the saddle should be monitored for changes in flow during construction and reservoir filling. Water level measurements should be continued in D38, especially during reservoir filling when levels should be taken twice weekly. A pump test should be carried out in D38 to give a measure of the permeability of the dacite in the saddle.

The minimum horizontal distance from the top water level through the saddle to the northeast of the Phalaris Saddle is approximately 1000 m. The Queanbeyan Fault passes through the saddle and the geology is complex. The saddle is underlain by granite, slate, and limestone and numerous quartz veins. The slate has a well-developed cleavage striking approximately north and vertical. The limestone was not observed in outcrop, but was the only rock type intersected by drill hole D40 (Geological log, Part 2). The

Available evidence suggests that significant leakage should not occur through the saddle, however further investigations similar to those recommended for the Bunyip Saddle should be carried out.

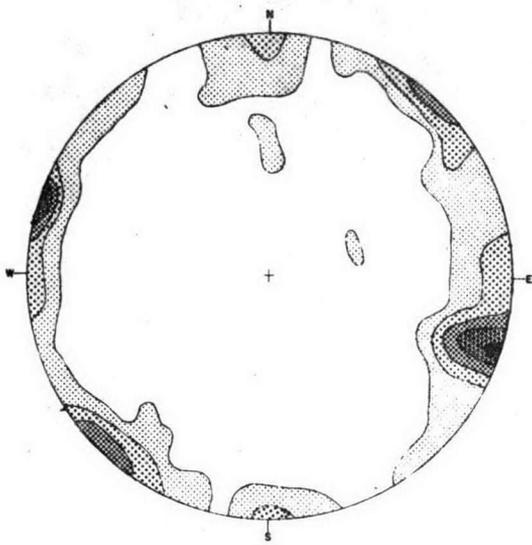
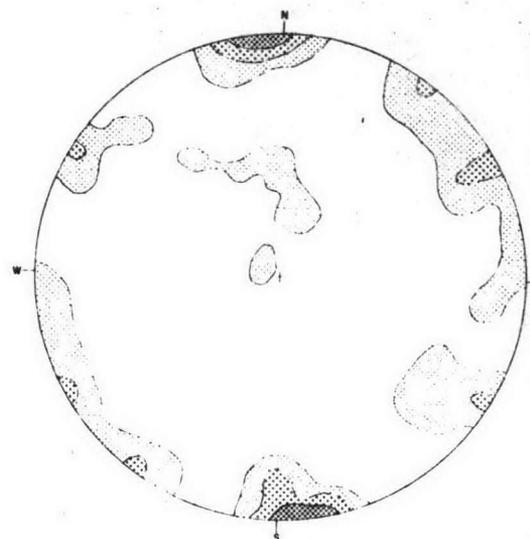
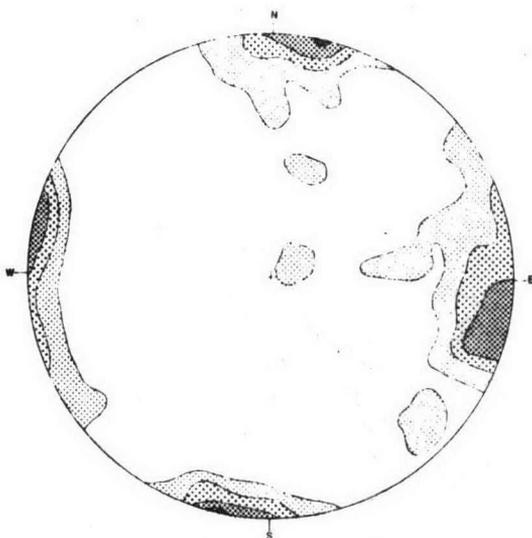
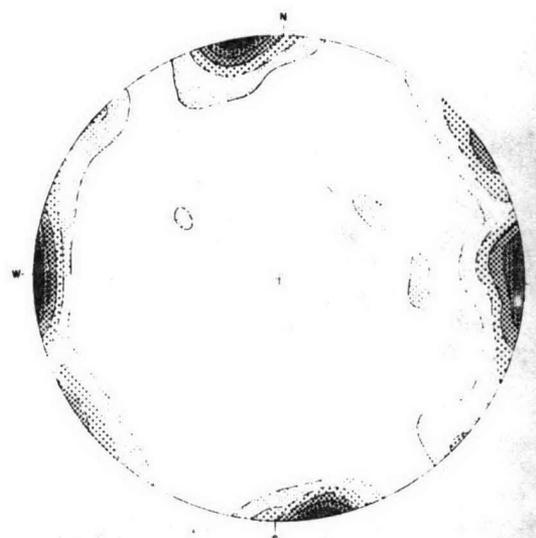
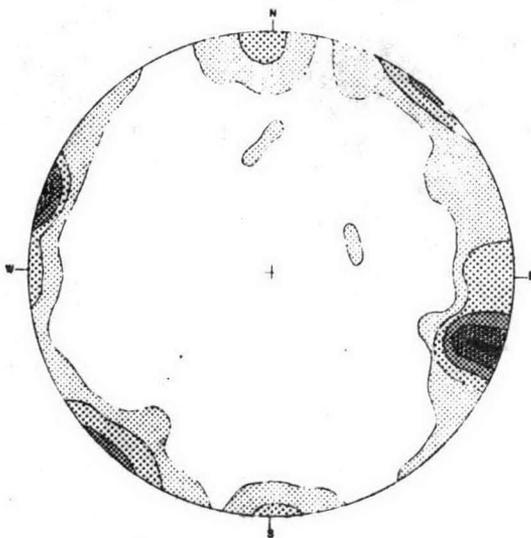
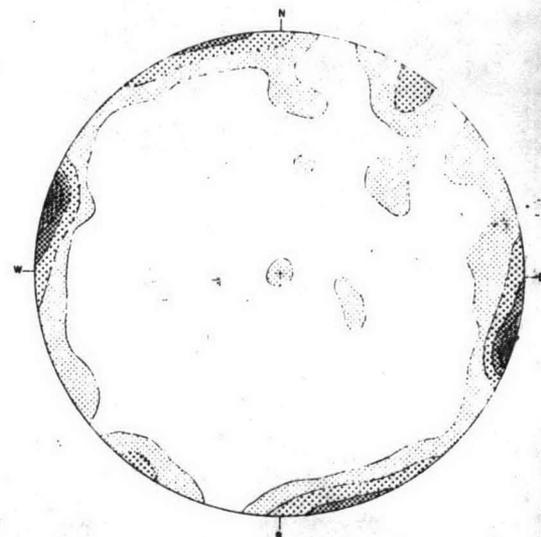
FIG. 4

The Googong Granite is the youngest rock at the dam site and crops out to the west of the dacite. In hand specimen the granite is light grey in colour, with quartz and feldspar crystals up to 7 mm diameter, and dark fine-grained micas. The granite is adamellite in composition. (slide No. 73360039, Appendix 9) In thin section, evidence of deformation can be seen: quartz shows wavy extinction and in places is fractured. The granite, particularly on the left bank, is prominently jointed parallel to the 020° vertical cleavage in the dacite (Fig. 4).

The dacite is moderately closely jointed (see Appendix 1 for joint terminology and description of biased sampling correction). The main set is parallel to the 020° cleavage, and a second, less marked joint set strikes approximately east with near vertical dips (Figs 4 and 7). Joints are mostly tight, limonite-stained and devoid of clay, and some are filled with carbonate. In the spillway section the groundwater level is well below the surface and joints above the watertable are commonly coated with a few millimetres of white clay. Slickensides are sometimes present on joint surfaces.

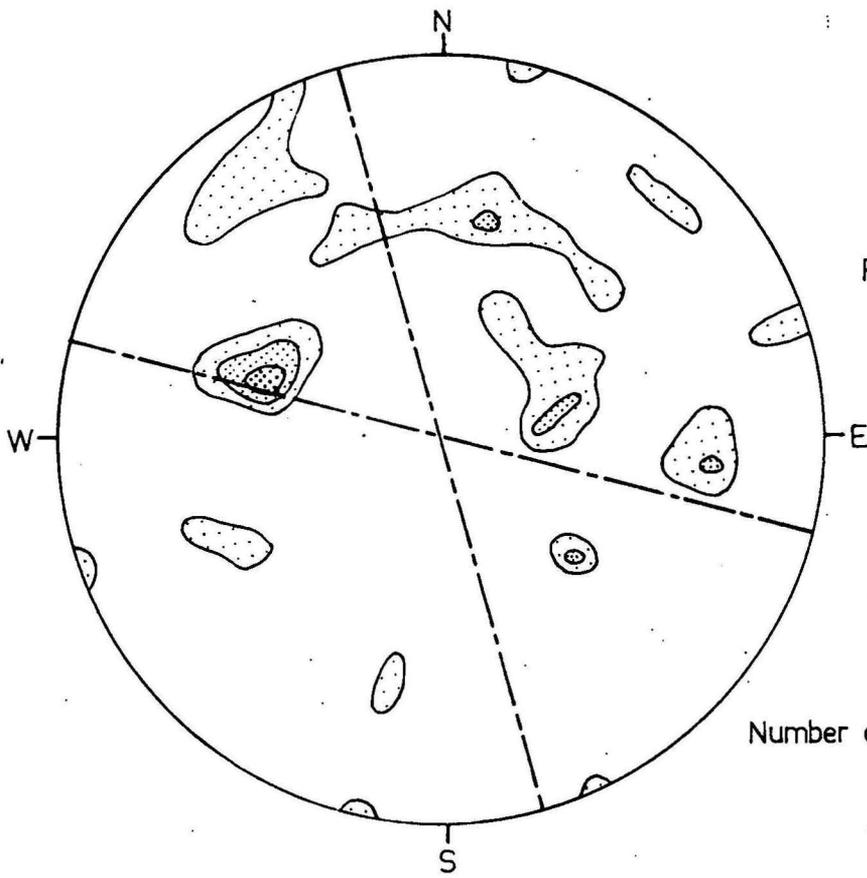
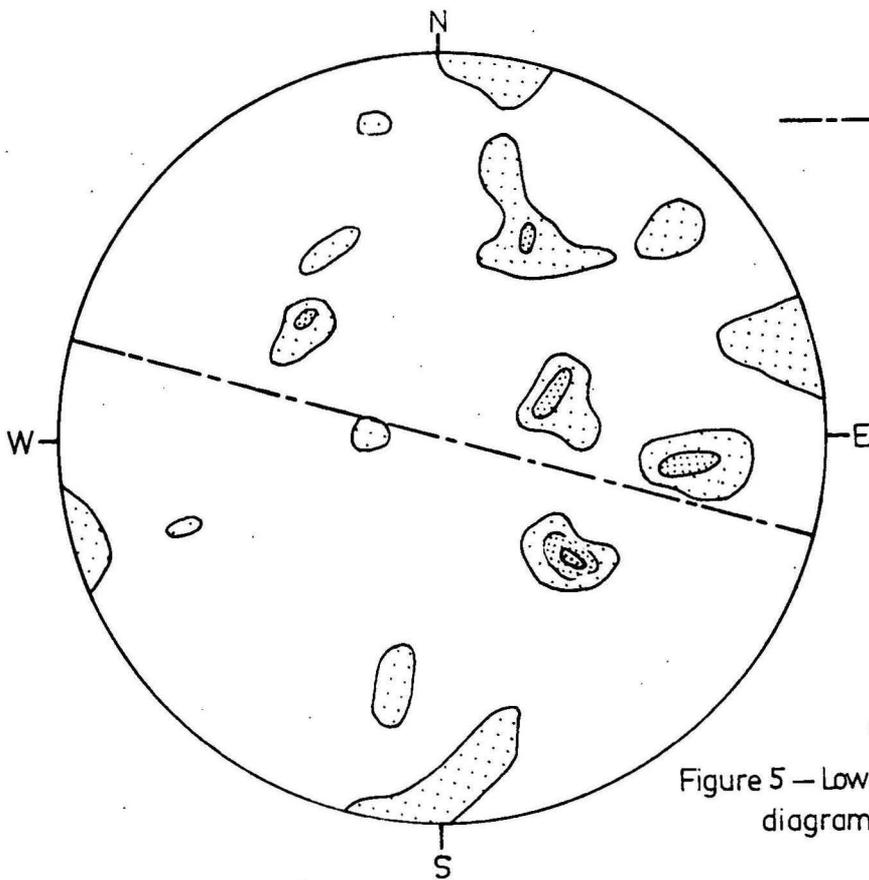
Figure 5—Lower hemisphere contoured stereographic diagrams of poles to joints along the diversion tunnel

DIVERSION TUNNEL
 Poles to joints in granite and dacite
 Drillholes 22, 23 and 24
 116 readings

DIVERSION TUNNEL
 Poles to joints in dacite
 Drillholes 23 and 24
 76 readings

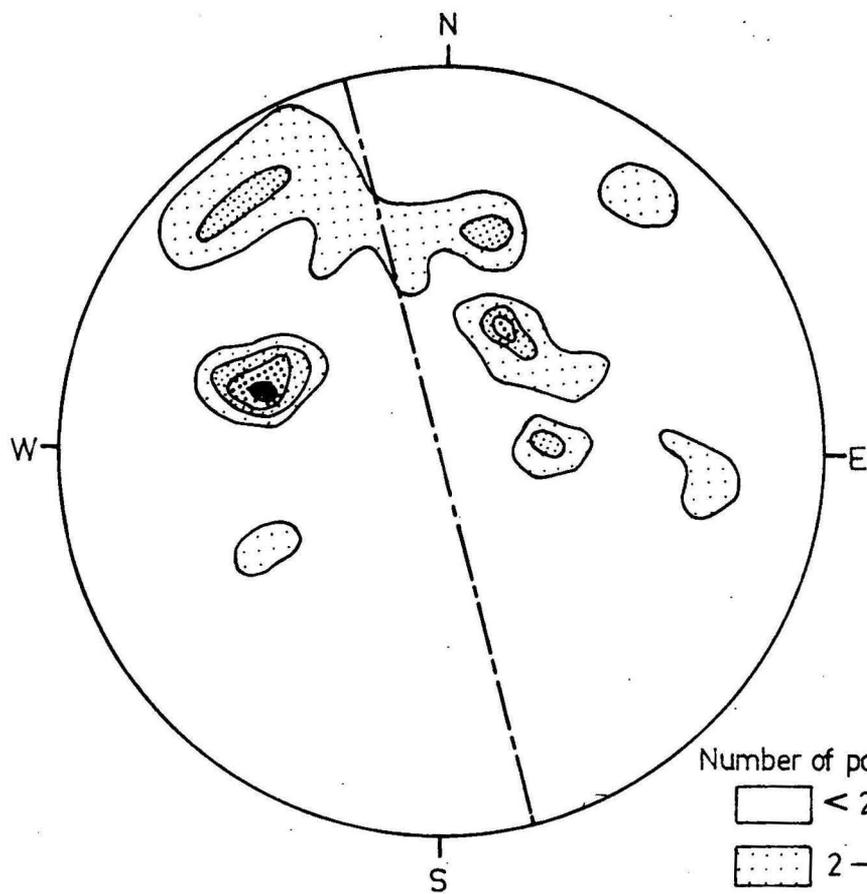
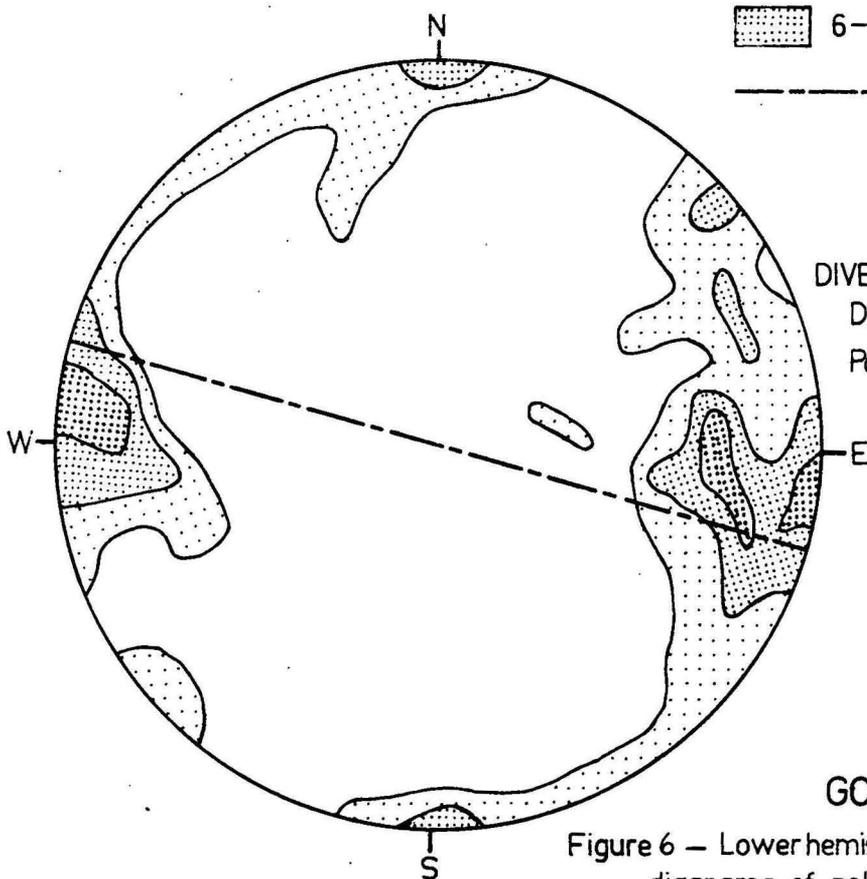
Figure 6 - Lower hemisphere contoured stereographic diagrams of poles to joints in granite at the diversion tunnel outlet portal, and poles to quartz veins in the dacite

DIVERSION TUNNEL
 Drillhole 22
 Poles to joints in granite
 40 readings

DIVERSION TUNNEL and UPPER SPILLWAY
 Drillholes 23, 24, 27, 28 and 29
 Poles to quartz veins in dacite
 37 readings

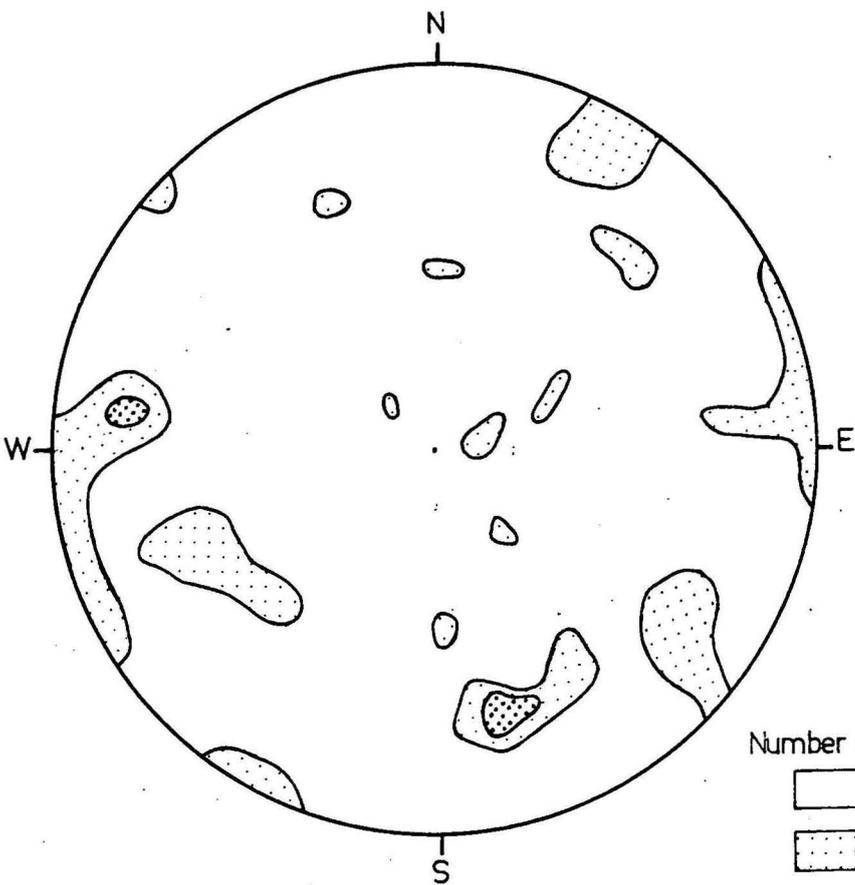
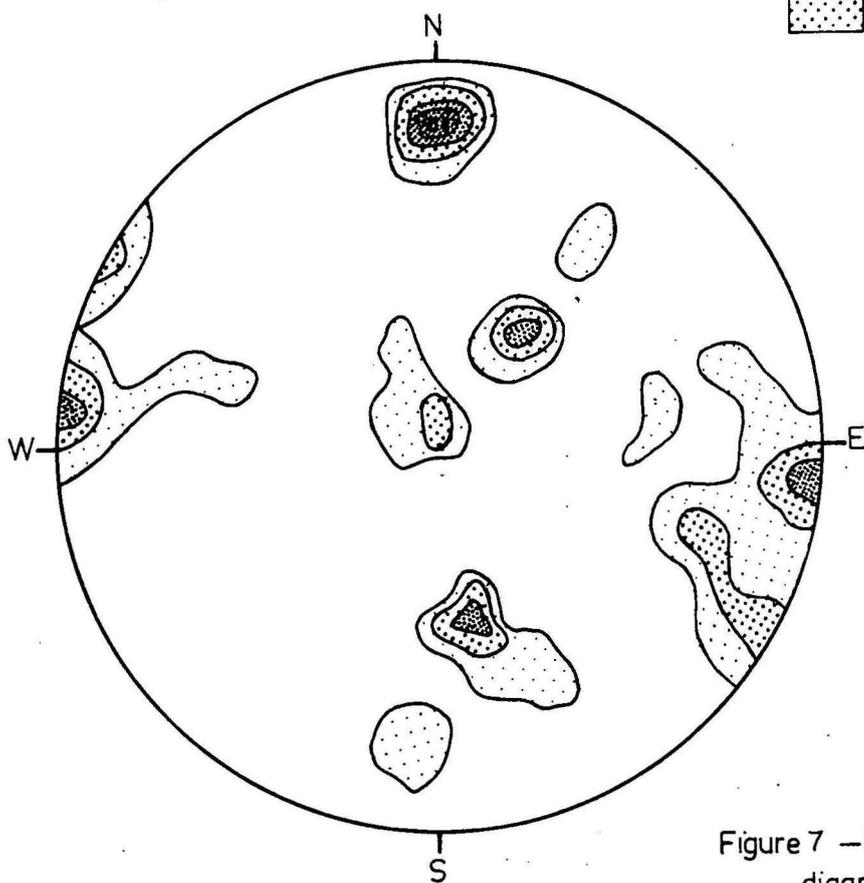
UPPER SPILLWAY QUARRY

LOWER SPILLWAY QUARRY

No critically oriented rock defects which might cause massive instability of excavated slopes have been observed in the upper spillway quarry area (Fig. 7).
