BUREAU OF MINERAL RESOURCES, GEOLOGY AND GEOPHYSICS

Record 1974/189

INVESTIGATION OF DRAINAGE PROBLEM, SECTIONS 23 AND 30, AINSLIE, A.C.T.

P.D. HOHNEN

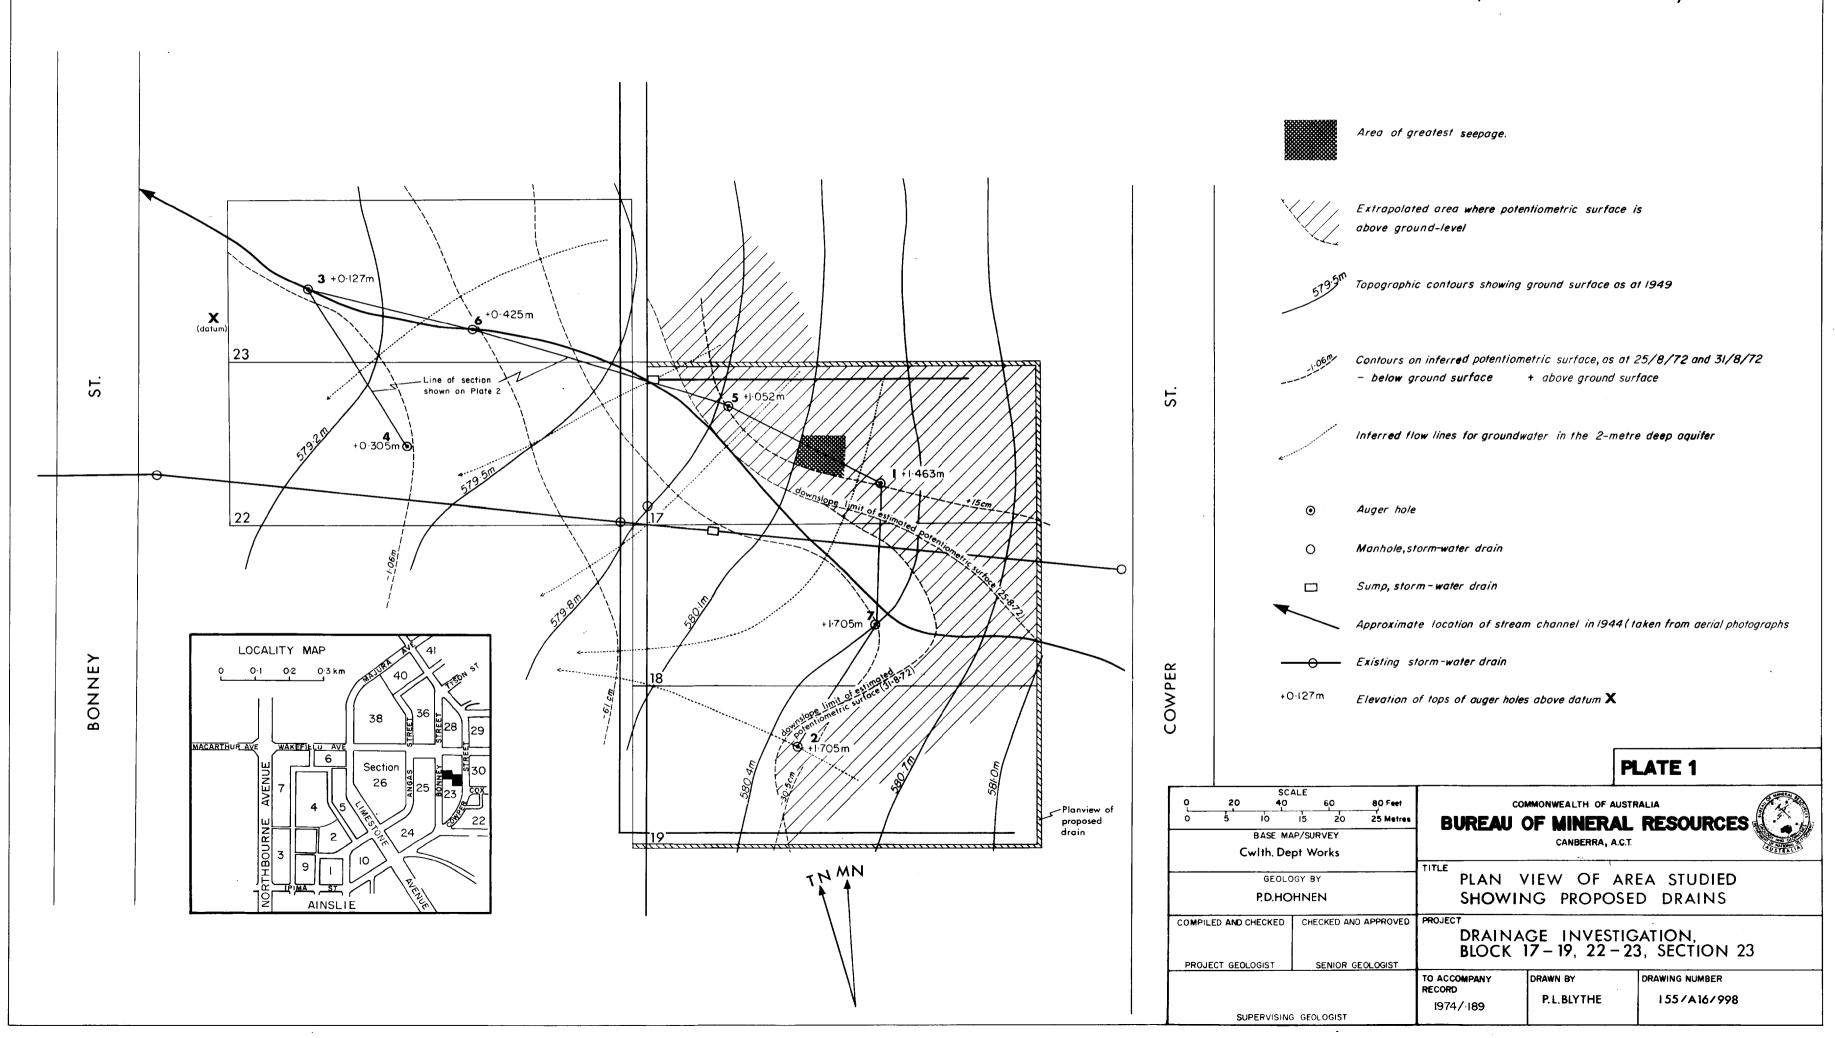
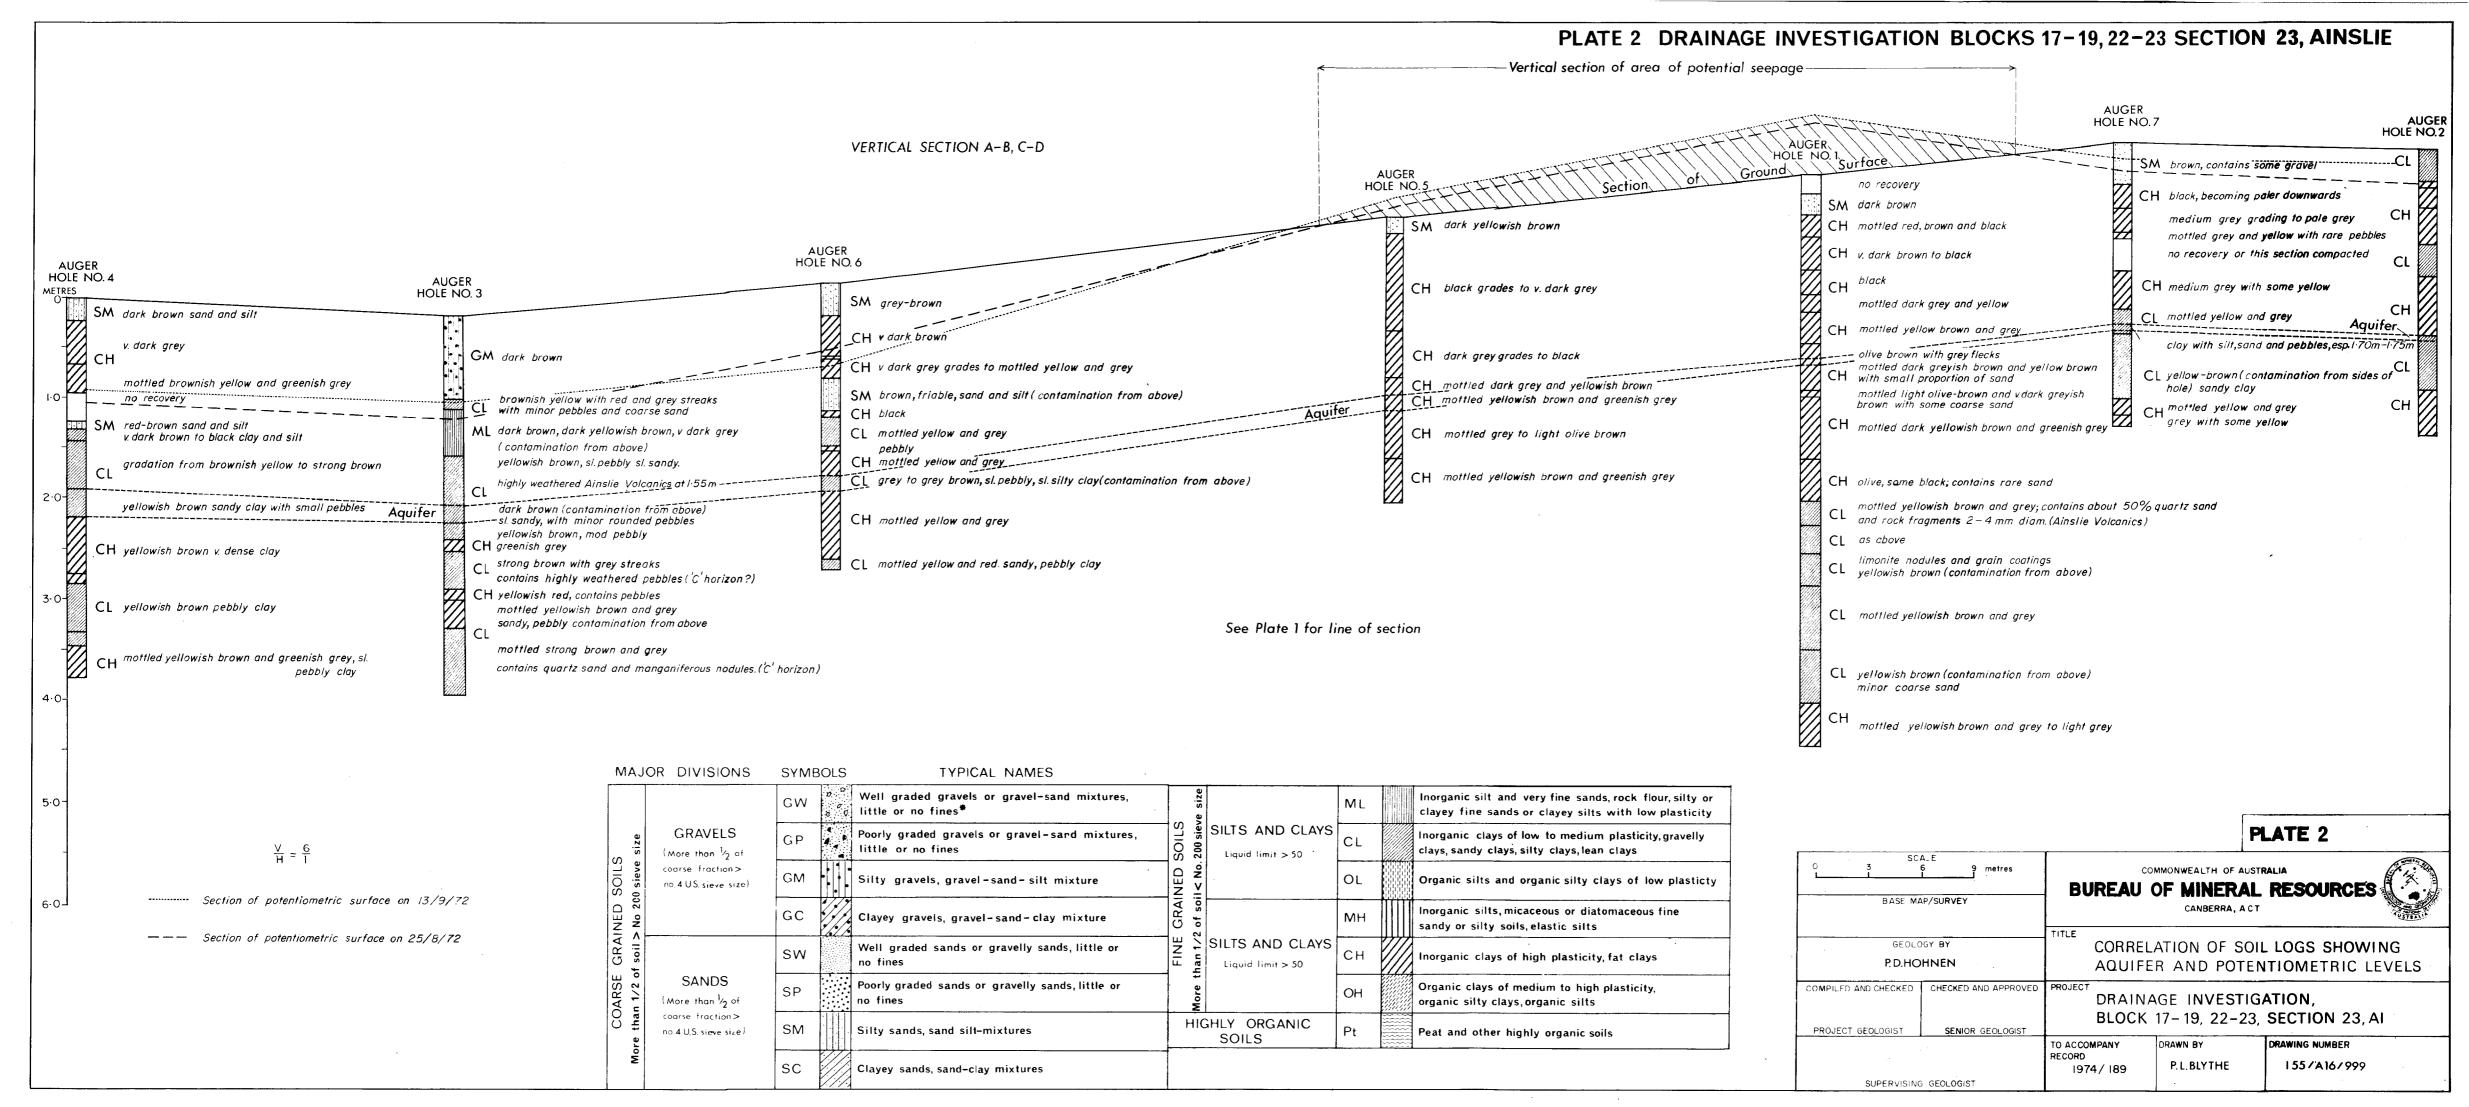
PLATE 1 DRAINAGE INVESTIGATION BLOCKS 17-19, 22-23 SECTION 23, AINSLIE

On 18 August 1972, after an unusually dry winter, the topsoil on all blocks was almost saturated, and on Block 17 an area of seepage (Flate 1) was producing a trickle of water. The seepage was probably caused by the up-rooting of a willow tree whose roots tapped a shallow aquifer.

The saturated clay soils in this area derive their water from a confined sandy clay aquifer at a derth of more than 1.5 m below the surface. Water from the aquifer seeps into the overlying clays and keeps them in a saturated condition.

A trench drain at least 2 m deep should be constructed along the eastern frontage of Blocks 17, 18, and 19; it should also pass along the northern side of Block 17, and along the southern side of Block 19 (see Pl. 1).

Drainage pipes should be laid in a well-graded sand bed and covered by compacted, impermeable fill. The design should provide that the sand bed coincides with the aquifer. It might be necessary to over-deepen the trench in places and back-fill with the selected sand pack.

The proposed drains should connect to the existing stormwater drain below Blocks 18 and 22; the groundwater, under natural seepage pressure, will rise to enter the existing stormwater drain, but the level of entry should be at the top of the stormwater pipe to prevent recharge of the aquifer by stormwater.
