Record 1975/19

DRAINAGE INVESTIGATION AT MONARO CRESCENT, RED HILL, ACT

J.A. Saltet and P.D. Hohnen

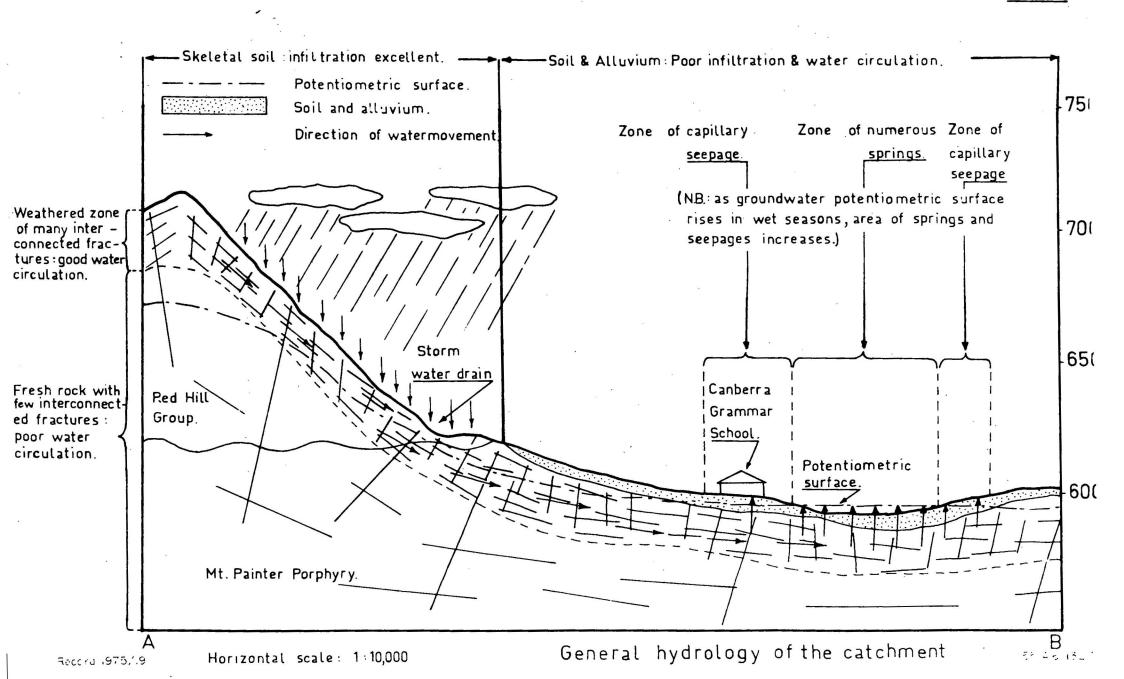
WATER LEVELS IN OBSERVATION BORE C17, 1970 TO 1974.

Aerial photographs taken in 1944 show that a drainage problem existed in the area before urban development and is a natural condition; however, it may have been aggravated by the filling of erosion gullies during development. Shallow piezometers (0.9 m deep) installed near Quiros Street in October 1969 showed water level 13 cm above ground level. After heavy rainfall on 30 and 31 October the piezometers showed a rise of the potentiometric surface to more than 25 cm above ground level. Early in 1970, bore C17 was completed and water levels of up to 2 m above ground level were measured immediately after drilling.

Because the auger holes along Monaro Crescent were unable to penetrate the fractured rock aquifer, it was not possible to prove that vertical leakage is taking place upwards into the soil profile from the underlying fractured rock; however, bore C17 positively indicates high pressure in the fractured rock aquifers, and earlier work in the adjacent catchment to the north at Torres Street (Wilson & Noakes, 1959) proved that soil water was directly controlled by pressure from the fractured-rock aquifer below.

Because of the difficulty in completing the holes as piezometers, it was not possible to monitor water levels in the auger holes to assess seasonal variations near the site of the proposed drain. The plot of the water levels in bore C17 shows that the water level in 1972 was the lowest prevailing over the last five years, and that the seasonal variation is about 1 m; however, as the standing water level in this bore has never fallen below a point 1 m above the ground level, it is considered that any seasonal variation in the water level in the auger holes would have been negligable.

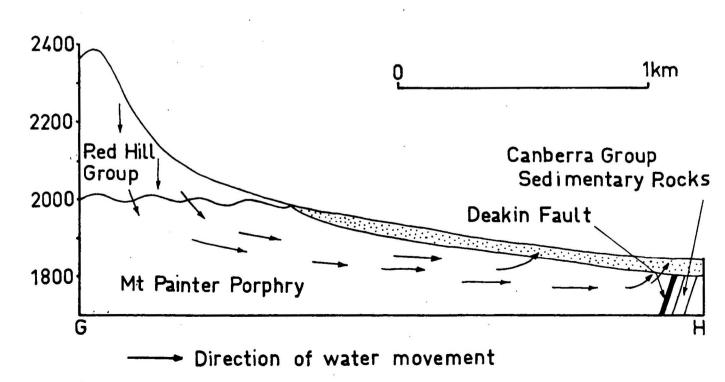
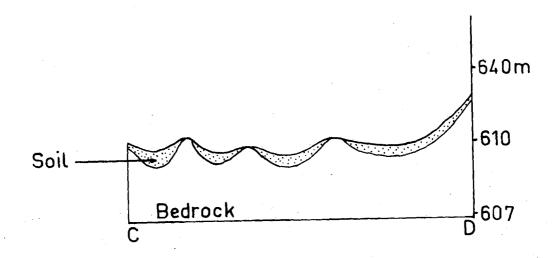
Schematic cross-section showing the narrowing of the drainage basin near the intersection of La Perouse St. and Flinders Way. Assuming that the cross-sectional area of the soil profile is X in profile C=D, the cross-sectional area of soil in profile E-F is reduced to $\frac{X}{6}$, and hence the ability of the soil to transmit water is reduced. See Figure 1 for location of profiles.

Effective drainage of groundwater from the catchment would be achieved only when average discharge from the aquifers is of the same order as average recharge. The flow pattern shows an area of constriction at the northern corner of the hockey fields where the flow lines converge and the cross-section of the fractured-rock aquifer is approximately 10 percent of the cross section within the catchment further upslope. To attain equilibrium between discharge and recharge, water from natural recharge plus artificial recharge through lawn watering must pass through this constriction or be removed by drainage or by pumping. No reliable estimate of groundwater discharge to attain this condition has been made, but about 70 to 90 m³ per hour has been estimated for the fractured-rock aquifer, and that from the soil aquifers is considered to be minor by comparison.
