RECORD 1975/179

GEOLOGICAL AND GEOPHYSICAL INVESTIGATIONS AT EMU BANK,  
BELCONNEN TOWN CENTRE, A.C.T., 1975

G. BRISCOE & D.C. RAMSAY

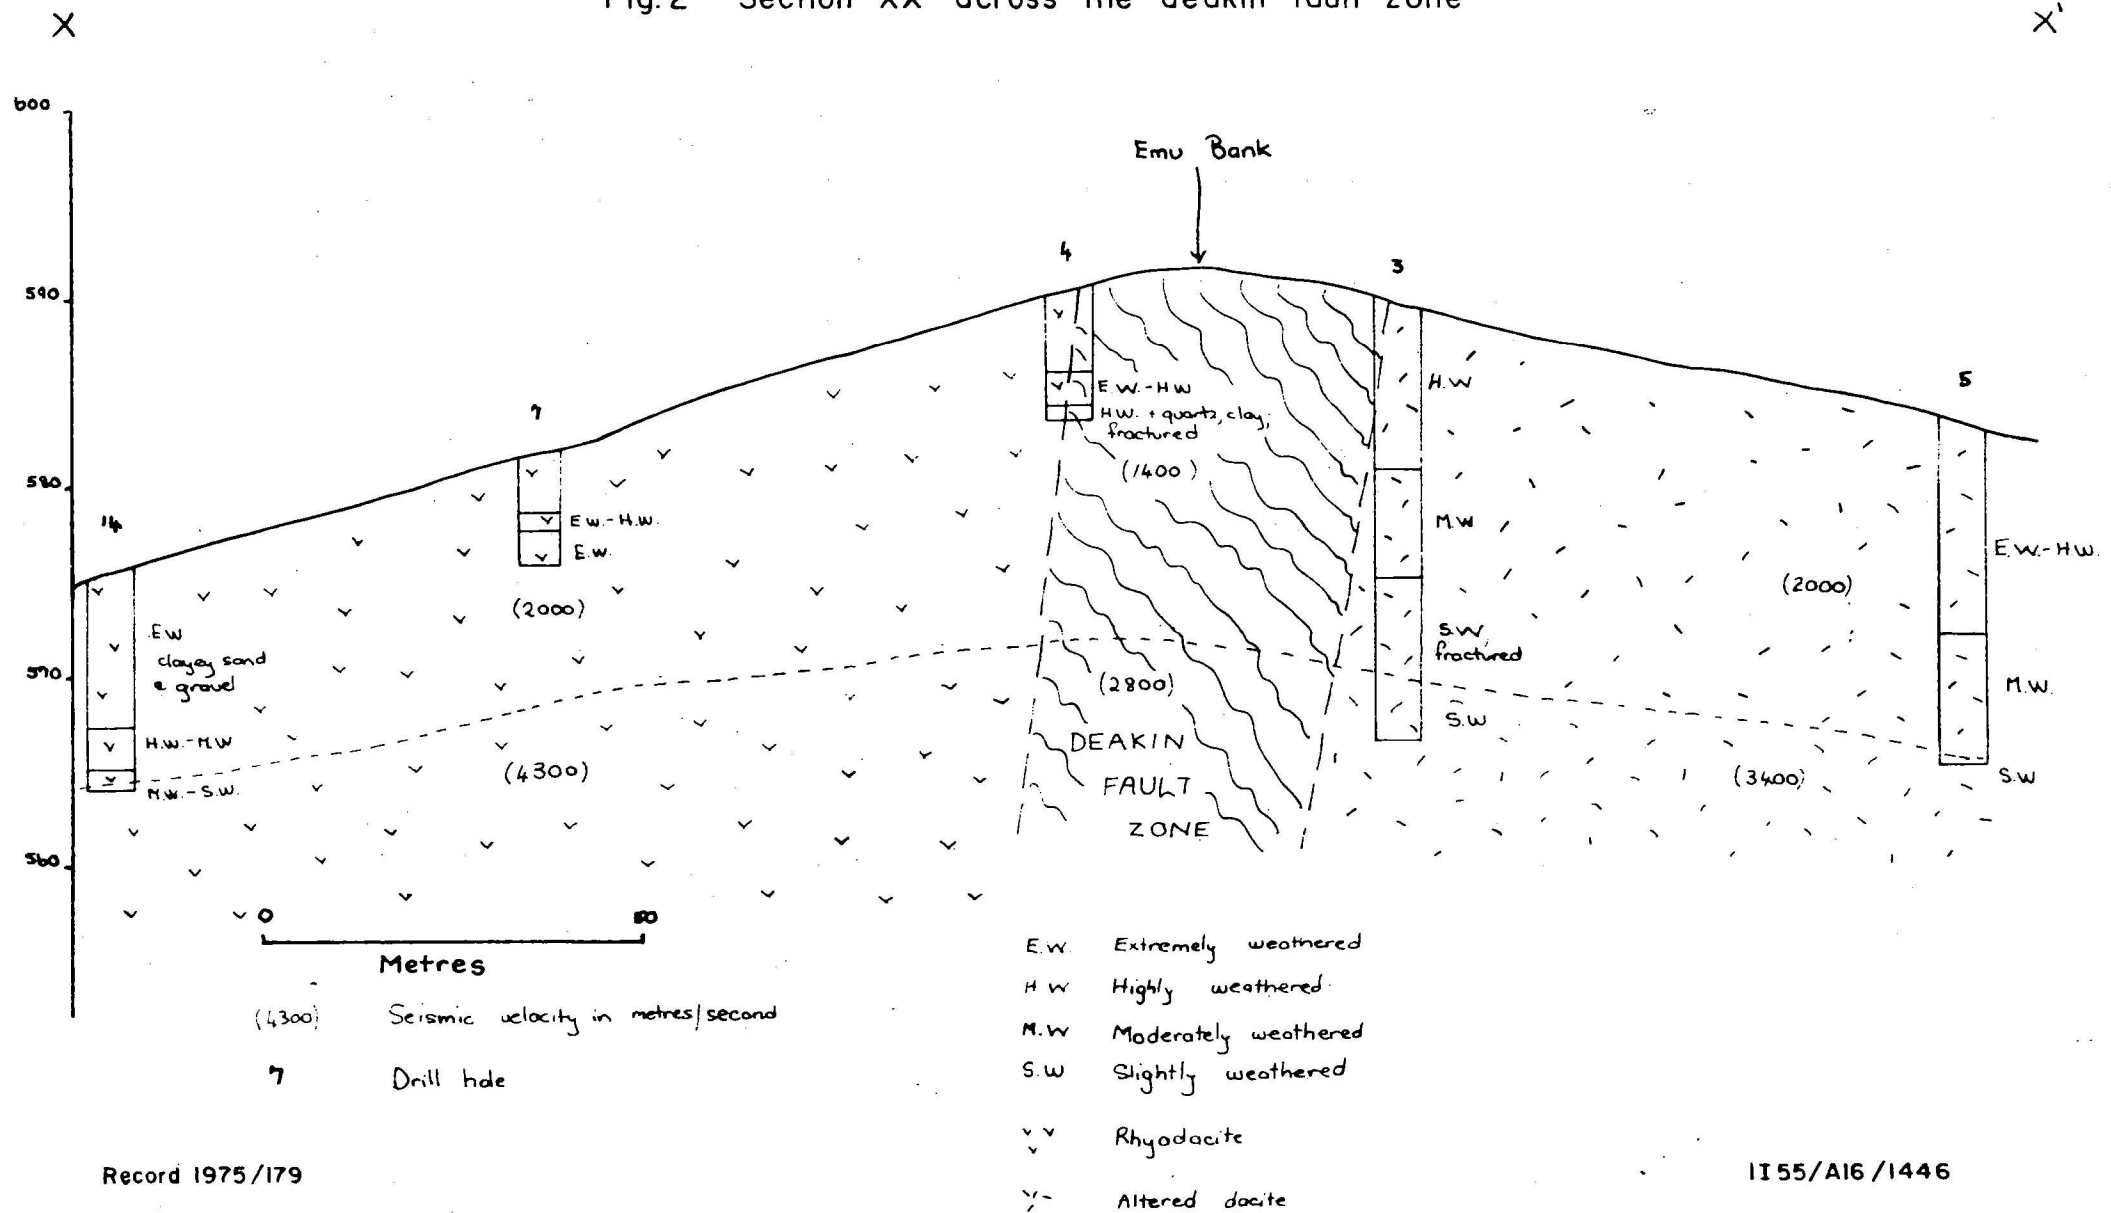
Fig.2 Section XX' across the deakin fault zone

Within the investigation area the Deakin Fault occupies a curved zone 16 to 50 m wide which strikes  $170^{\circ}$  in the south (Section 54) and  $130^{\circ}$  in the north (through Section 55).

The rock conditions and depths of weathering in most of drill hole B1 are considered to be representative of the fault zone. The low-velocity layer (1400-1600 m/s) from 12 to 20 m below the surface consists of very closely fractured quartz and silicified volcanic rock with weak zones of highly to extremely weathered rock and clay; fault breccia and slickensides are common.
