DEPARTMENT OF
NATIONAL RESOURCES

Record 1977/18

PRELIMINARY GEOLOGICAL INVESTIGATIONS OF TENNENT DAM SITES
2 AND 3, GUDGENBY RIVER, A.C.T., 1975

R.C.M. Goldsmith and G. Briscoe

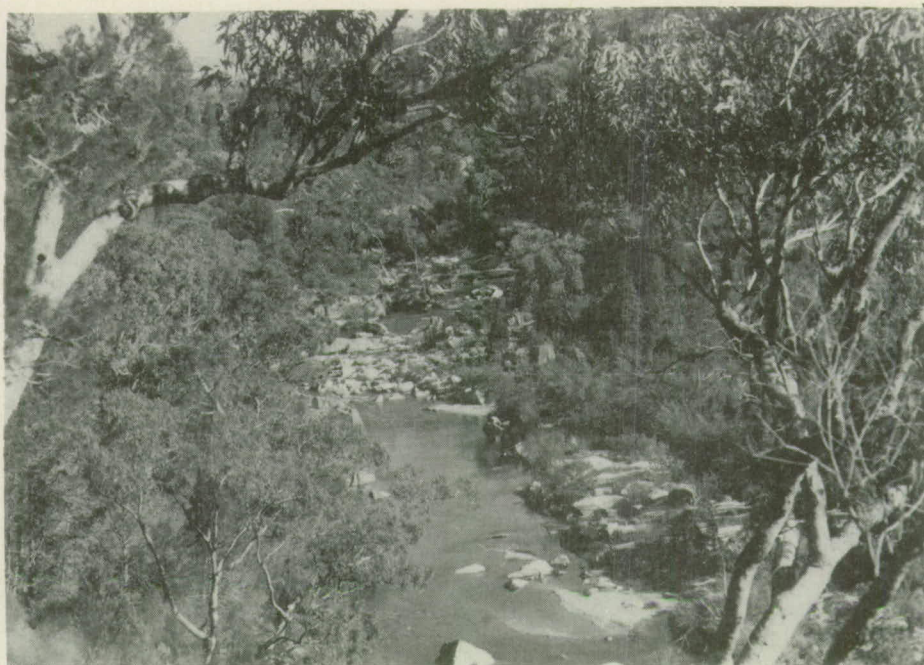
Gudgenby River - looking upstream from damsite 2
axis

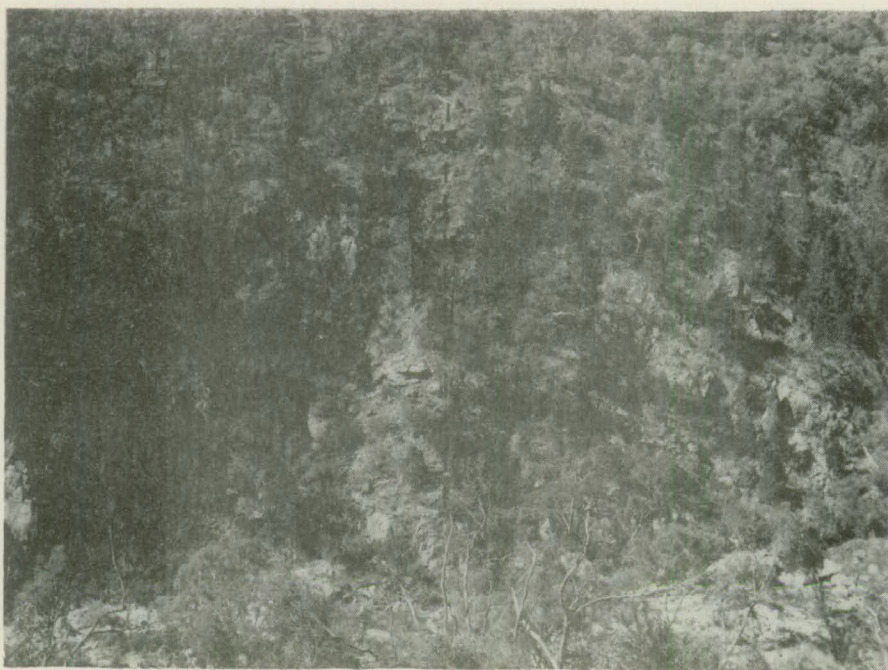
Fig. 2 View of right abutment, dam site 2

Right abutment. Foundation conditions are generally poorer on this abutment, which has a deeper and more variable weathering profile than the left abutment. The highest recorded refractor (3800 m/s) is overlain by 15-25 m of highly to moderately weathered rock (1450-1600 m/s; Plate 4). Above RL

Suitable foundation rock lies below an intermediate velocity layer 1450-1600 m/s, and is much deeper than on the left abutment. If drilling confirms this material as highly to moderately weathered rock, then a considerable thickness of rock will have to be removed.

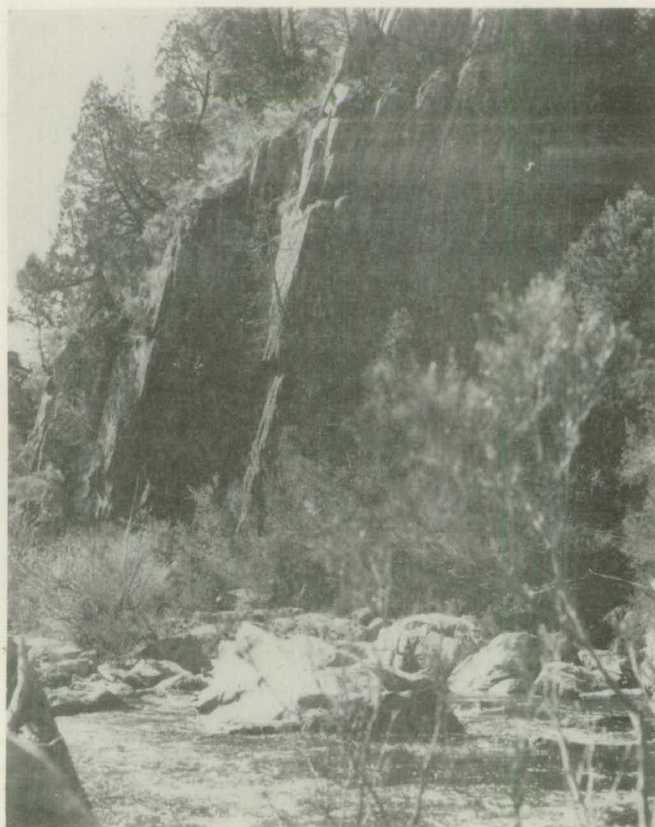
Fig. 3 Jointing in adamellite, dam site 2, right
abutment
Note the curved trees on the top left-hand side.

The lower part of the right abutment is formed by cliffs 60 m high (Fig. 3) and a large unstable mass of rock and soil (see section on stability).

Set 2 - $90/088-096$ - These are mostly tight, continuous for < 5 m, and mostly widely spaced. There are some discontinuous shallow dipping joints evident in the steeper sections of the right abutment (Fig. 3).

- e) Open joints in outcrops at the base of the slope display a wedge mechanism for rotation of blocks to a potential toppling condition (Fig. 9).
- f) Low-angle open joints dip both into and out of the rock face (Fig. 3), and facilitate the lateral movement of rocks by wedging.

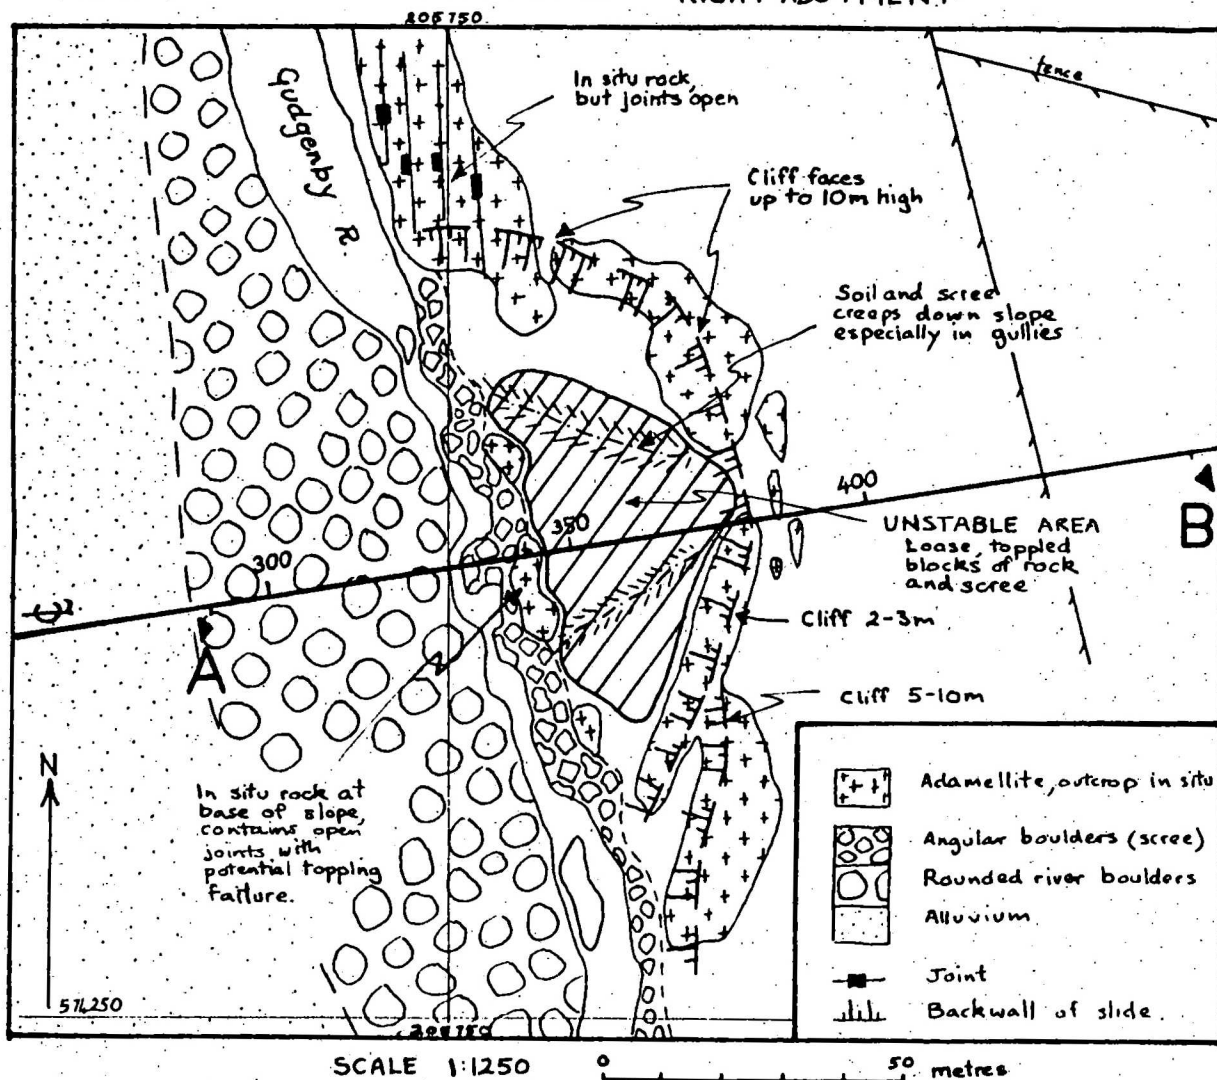
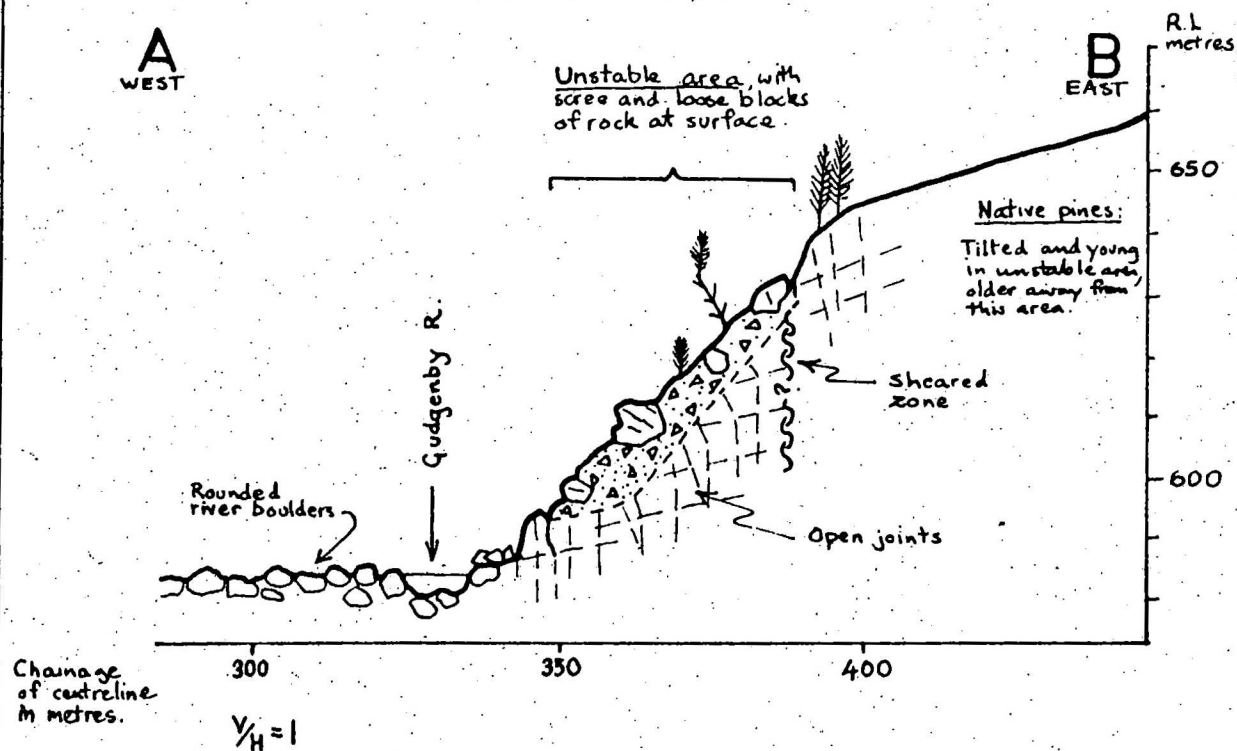
FIGURE 4

Stability of right abutment. The right abutment is stable from about stn 400 to 500 m but to the west of Stn 400 a 10 m cliff marks the backwall of a slip plane. A combination of toppling, and sliding failure, has resulted in an unstable zone (60 x 80 m in area) of transported material with rotated blocks of rock, scree, and soil (Fig. 4).

MAP OF UNSTABLE AREA ON THE RIGHT ABUTMENT

SECTION OF LOWER PART OF RIGHT ABUTMENT SHOWING UNSTABLE AREA.

The loose part of the unstable zone will have to be cleaned out to provide suitable foundation for the dam. The remaining rock will have to be grouted, and concrete poured in the depressions. The depth of loosened rock and open joints may be up to 20 m behind the slope, and may require treatment for up to 35 m. Additional failure may be induced in the backwall as the loosened material is removed.

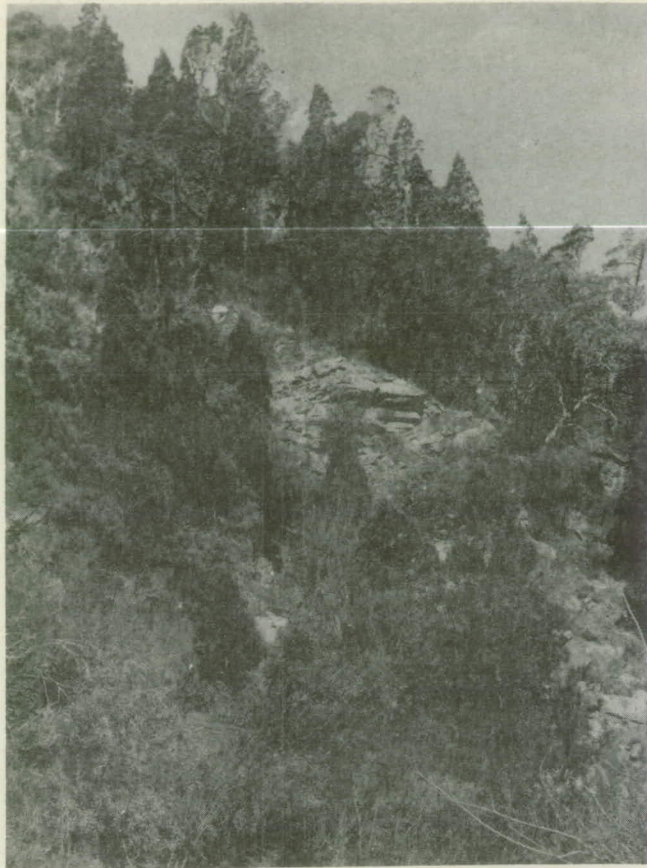
Fig. 6 View of unstable area, dam site 2

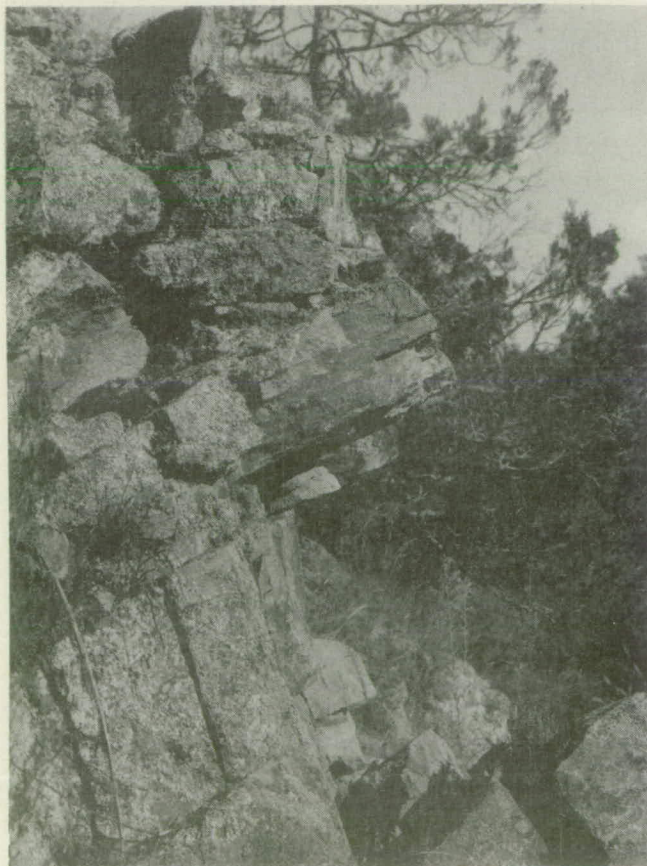
Fig. 7 Toppled blocks, dam site 2

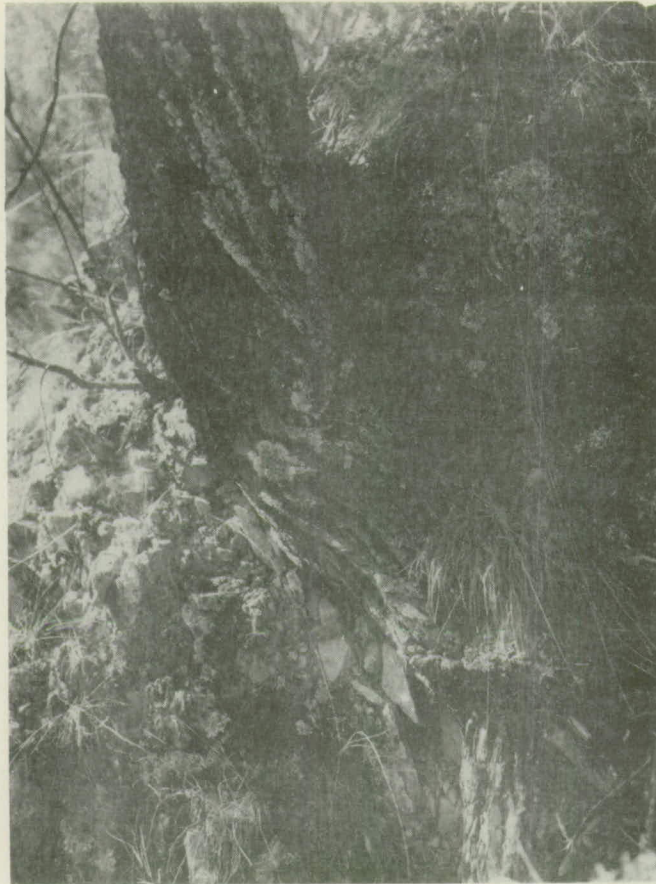
Fig. 8 Tree deformed by movement in slope, dam site 2

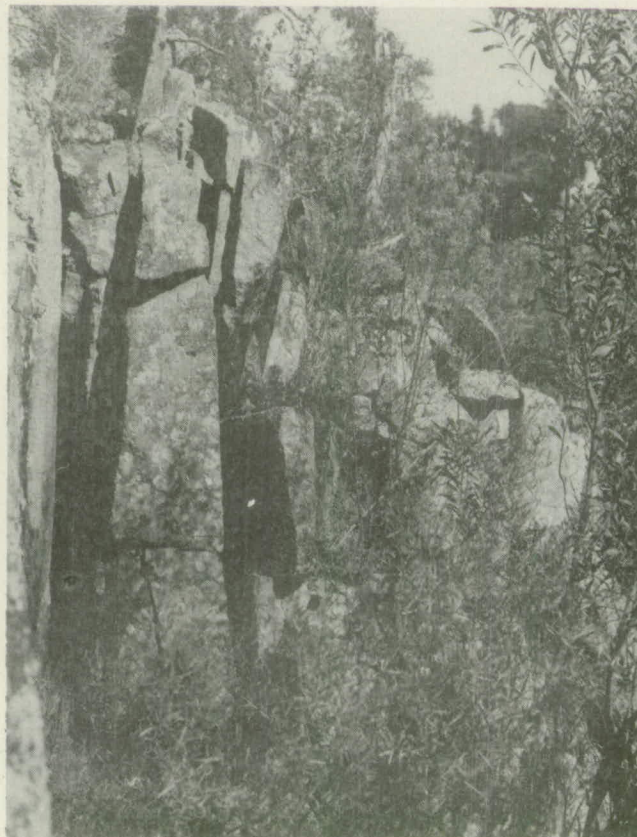
Fig. 9 Potential toppling condition, dam site 2

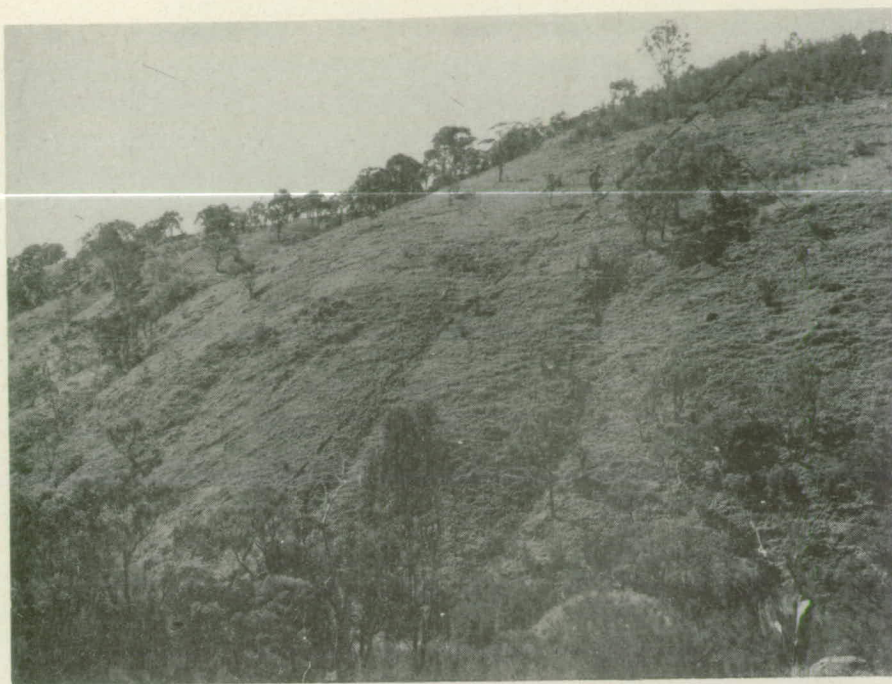
Fig. 10 General view of right abutment, dam site 3

The steep slope combined with the fractured and sheared rocks on the right abutment have resulted in sheet erosion and several areas of superficial land slippage. Below a bench on the slope (at about stn 630) the gradient steepens to 35-40° and slippages in soil and scree have occurred. The potentially unstable loose rock and soil is confined to the 250 to 850 m/s velocity layer. No instability occurs on the left abutment.

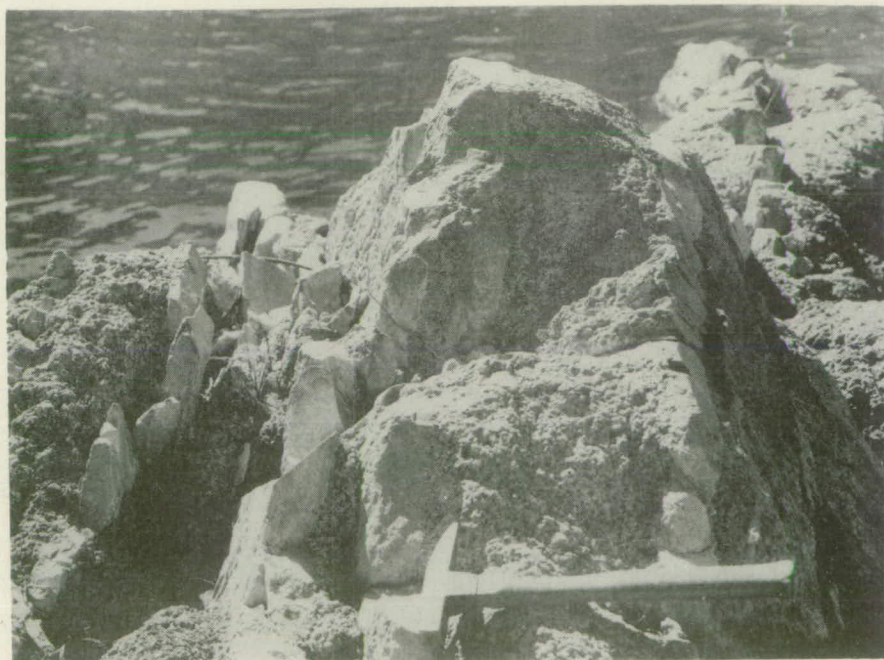
Fig. 11 Adamellite and aplite dykes cropping out in river, dam site 3
