BUREAU OF MINERAL RESOURCES,  
GEOLOGY AND GEOPHYSICS

Record 1977/31

THE EAST SOLOMON SEA EARTHQUAKE OF 20 JULY 1975; AND NOTES ON  
SEISMIC RISK IN BOUGAINVILLE

I.B. Everingham, B.A. Gaull and V.F. Dent.\*

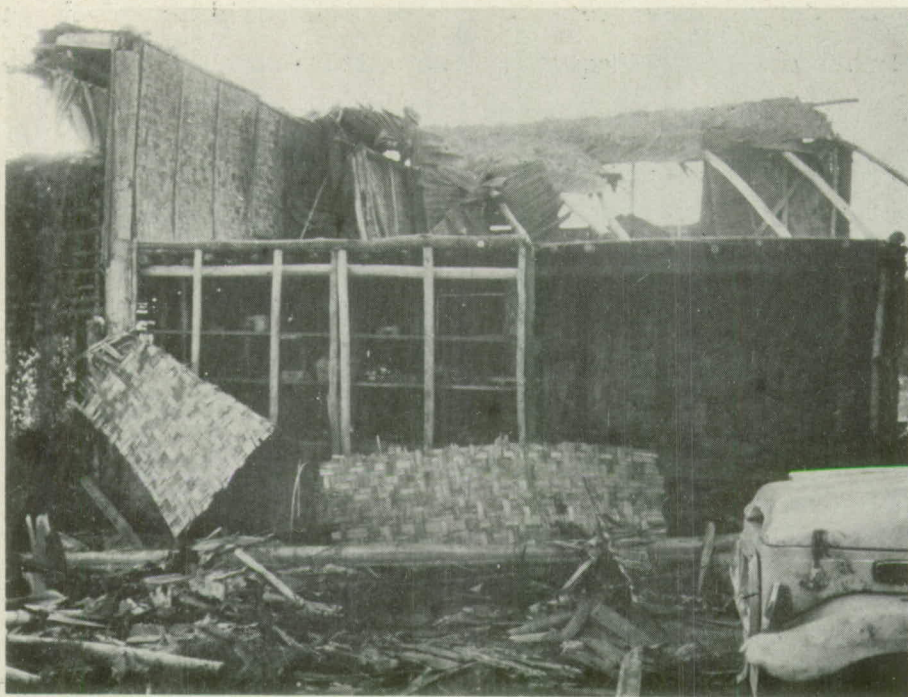
Substantial damage was incurred at Boku airstrip, where the concrete-based fibro-timber Welfare building was rendered unserviceable, and three structures which were built mostly from local bush materials collapsed completely (Fig. 8). None of these structures was well designed.

Figure 8. Collapsed local material buildings  
near Boku airstrip.

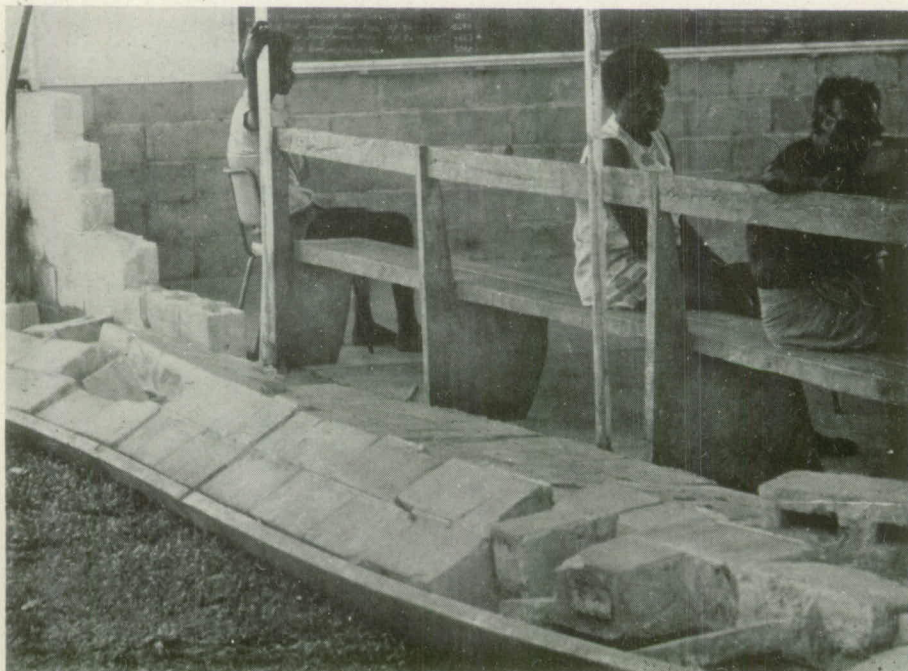
Figure 9. Collapsed concrete besser-block wall,  
council building, Bana. Note that ties were made  
to the vertical pipe columns.

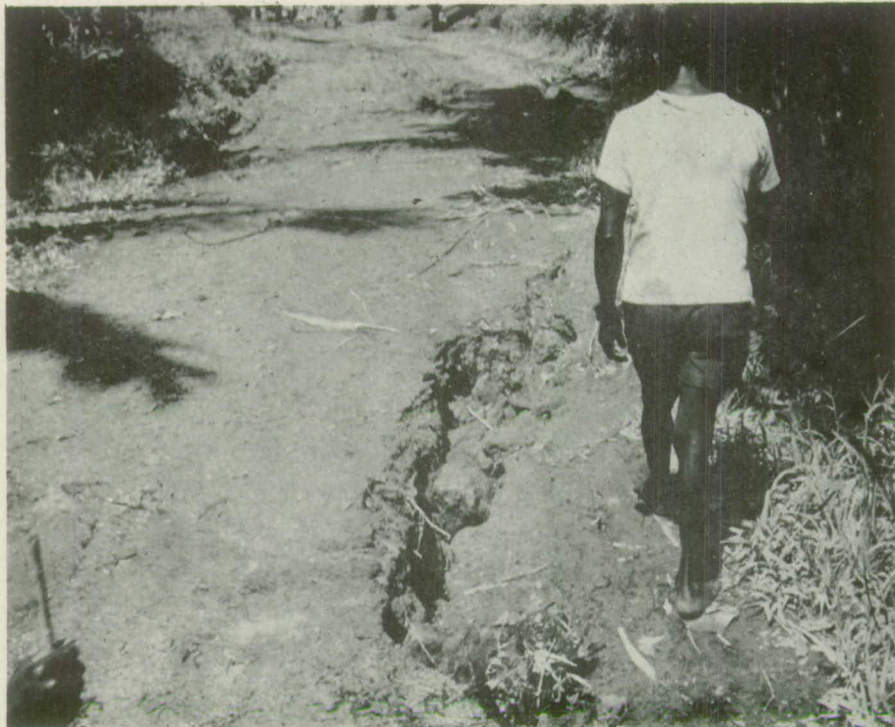
Twenty kilometres north of Buin on the Buin-Koniguru road, slumping and cracking of the ground was prominent, especially on the ridges (Fig. 10). The estimated intensities for Buin and Koniguru were about MM VI and MM VIII respectively. This difference is again attributed to the geological/topographical amplification of ground motion on ridges.

Figure 10. Cracking typical of built up road edges, Buin-Koniguru road.

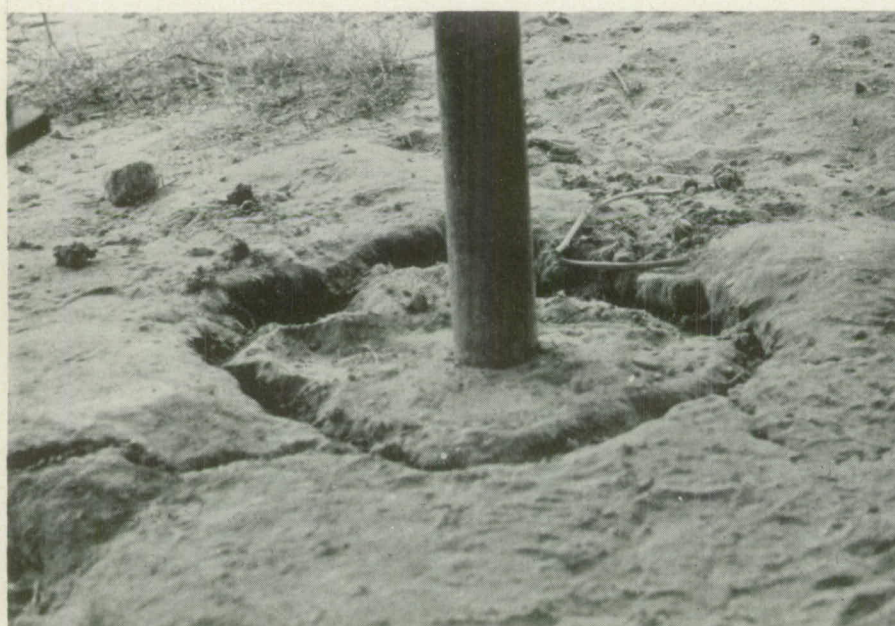
houses in danger and Camp 10 dormitory buildings suffered disturbances of the ground supports' such as in Fig. 11.

Figure 11. Disturbed foundation pile of residence in Panguna indicates considerable movement during earthquake.

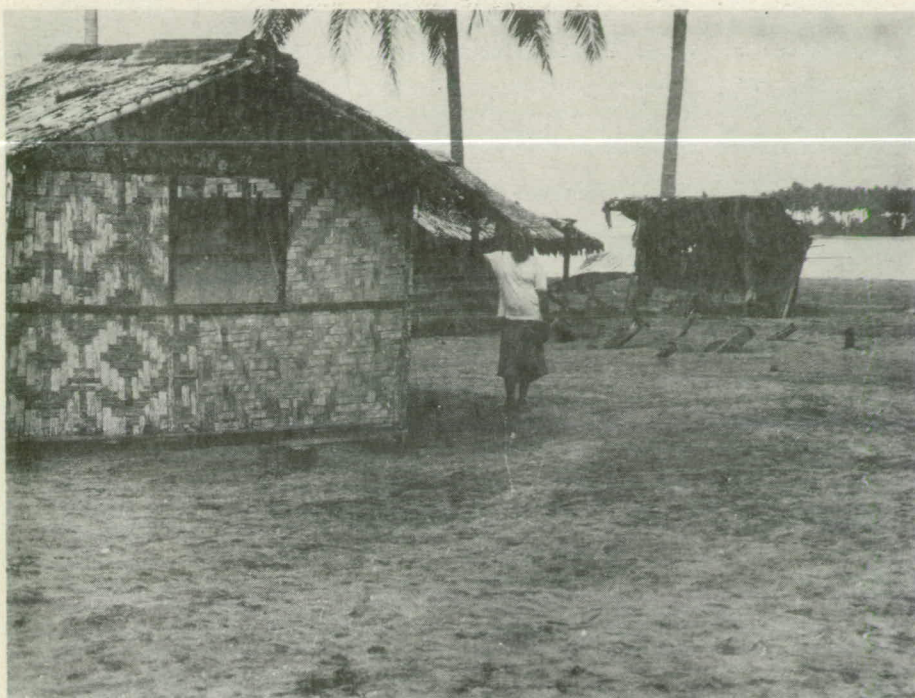
Figure 12. Village house removed from stumps (in centre of picture) by tsunami, Torokina.

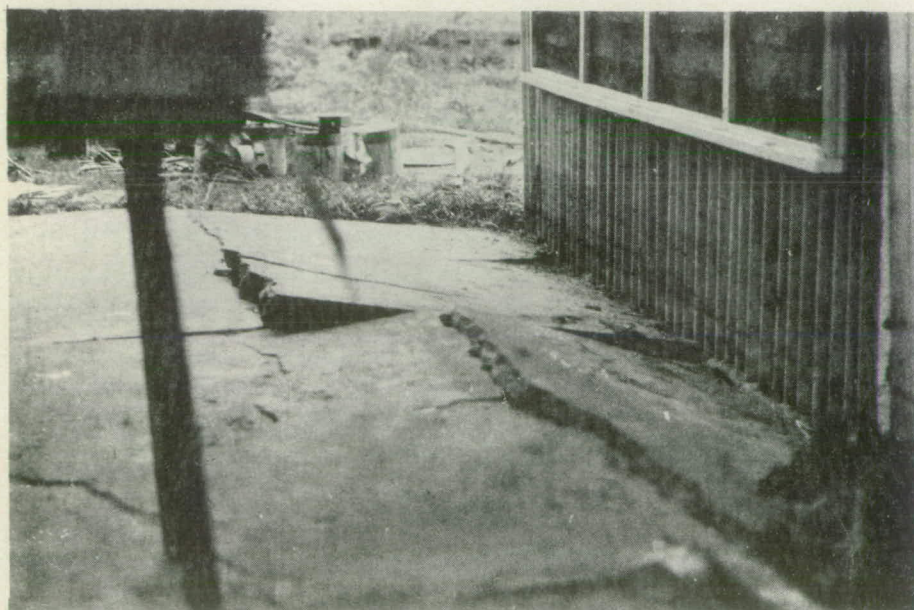
Figure 13. Subsidence of building containing heavy machinery, and tsunami strandlines on walls, P & T power house, Torokina.

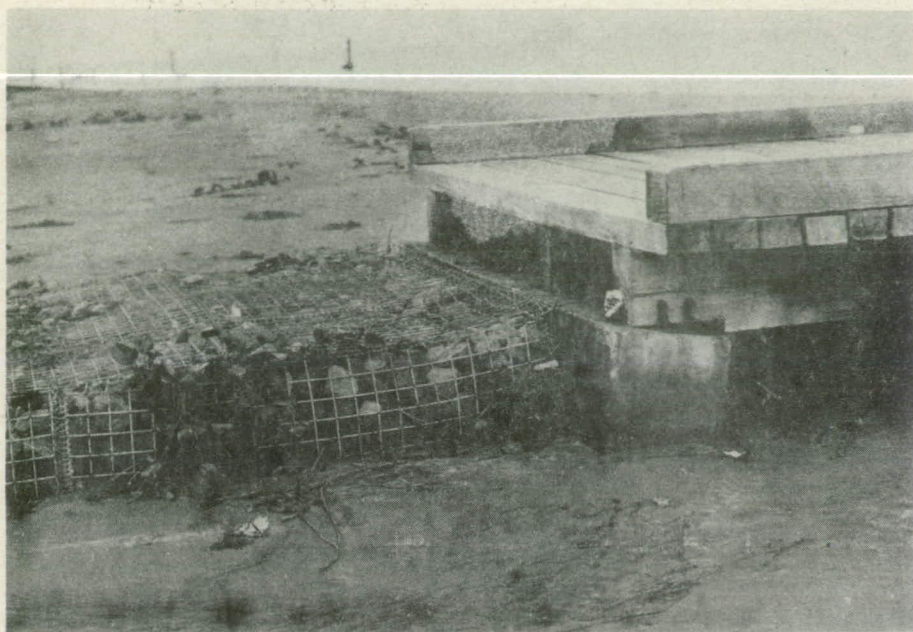
built up naturally since World War II - i.e., the coast was inland from the station some 30 years ago. Some typical effects of the tsunami and earthquakes are shown in Figures 14 and 15.

Figure 14. Wharf at Torokina. Eight piles similar to that in the foreground and about 14 m long were tilted seaward  $15^{\circ}$  from the vertical as a result of shaking and liquefaction.

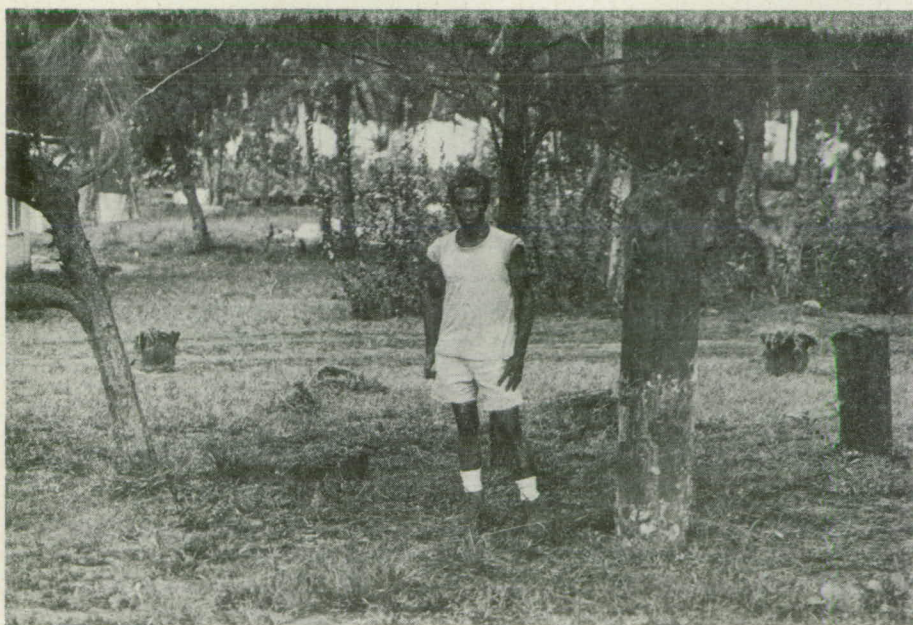
Buildings subsided, probably during the main earthquake, before the tsunami. However, further subsidence occurred during strong aftershocks, notably those about 9.30 a.m. and 12.30 a.m. local time on 21 July. Engineering staff who had flown in to repair the station reported that during the second aftershock the tower base appeared to sway horizontally back and forth over an estimated range of 400 mm, and liquefaction of the ground was apparent. Liquefaction was also indicated by the movement of the wharf piles (driven down to a depth of about 14 m), which were tilted out towards the sea at an angle of about  $10-15^{\circ}$  from the vertical (Fig. 14); and by the fact that heavy objects tended to sink and light objects such as buried empty petrol drums rose out of the ground. Startling effect of the liquefaction associated with the largest aftershock was the emergence of old buried piles of a discarded World War II landing wharf (Fig. 15).

Figure 15. Old wharf piles at Torokina extruded by the effects of liquefaction caused by aftershocks. The tops of the piles were formerly below ground level, as indicated by the grass and plants growing on them.
