# BUREAU OF MINERAL RESOURCES, GEOLOGY AND GEOPHYSICS

RECORD 1977/59

GEOLOGICAL AND GEOPHYSICAL INVESTIGATIONS OF SITES FOR MAJOR  
BUILDINGS, CANBERRA CITY, PARKES, AND CAMPBELL, ACT  
1974-5

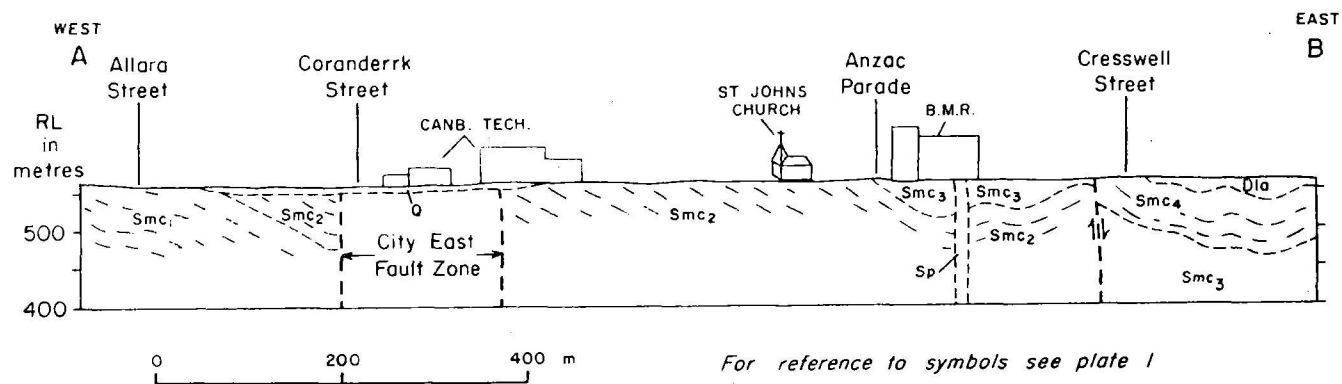
Fig.2 Diagrammatic geological cross-section along Constitution Avenue

The Canberra Group rocks have been mapped as four units in Plate 1. Relations between the rock units are shown in the diagrammatic geological section (Fig. 2). The lowest rock unit Smc<sub>1</sub> is the City Hill Shale (Opik, 1958) which underlies the eastern slopes of City Hill. The rock is typically blue-grey or green-grey slaty mudstone, and fresh rock generally occurs within about 2 m of the surface. The drill holes at Section 11, adjacent to City Hill, are in the unit. Limestone has been reported in this unit at a locality south of Commonwealth Park now covered by Lake Burley Griffin,

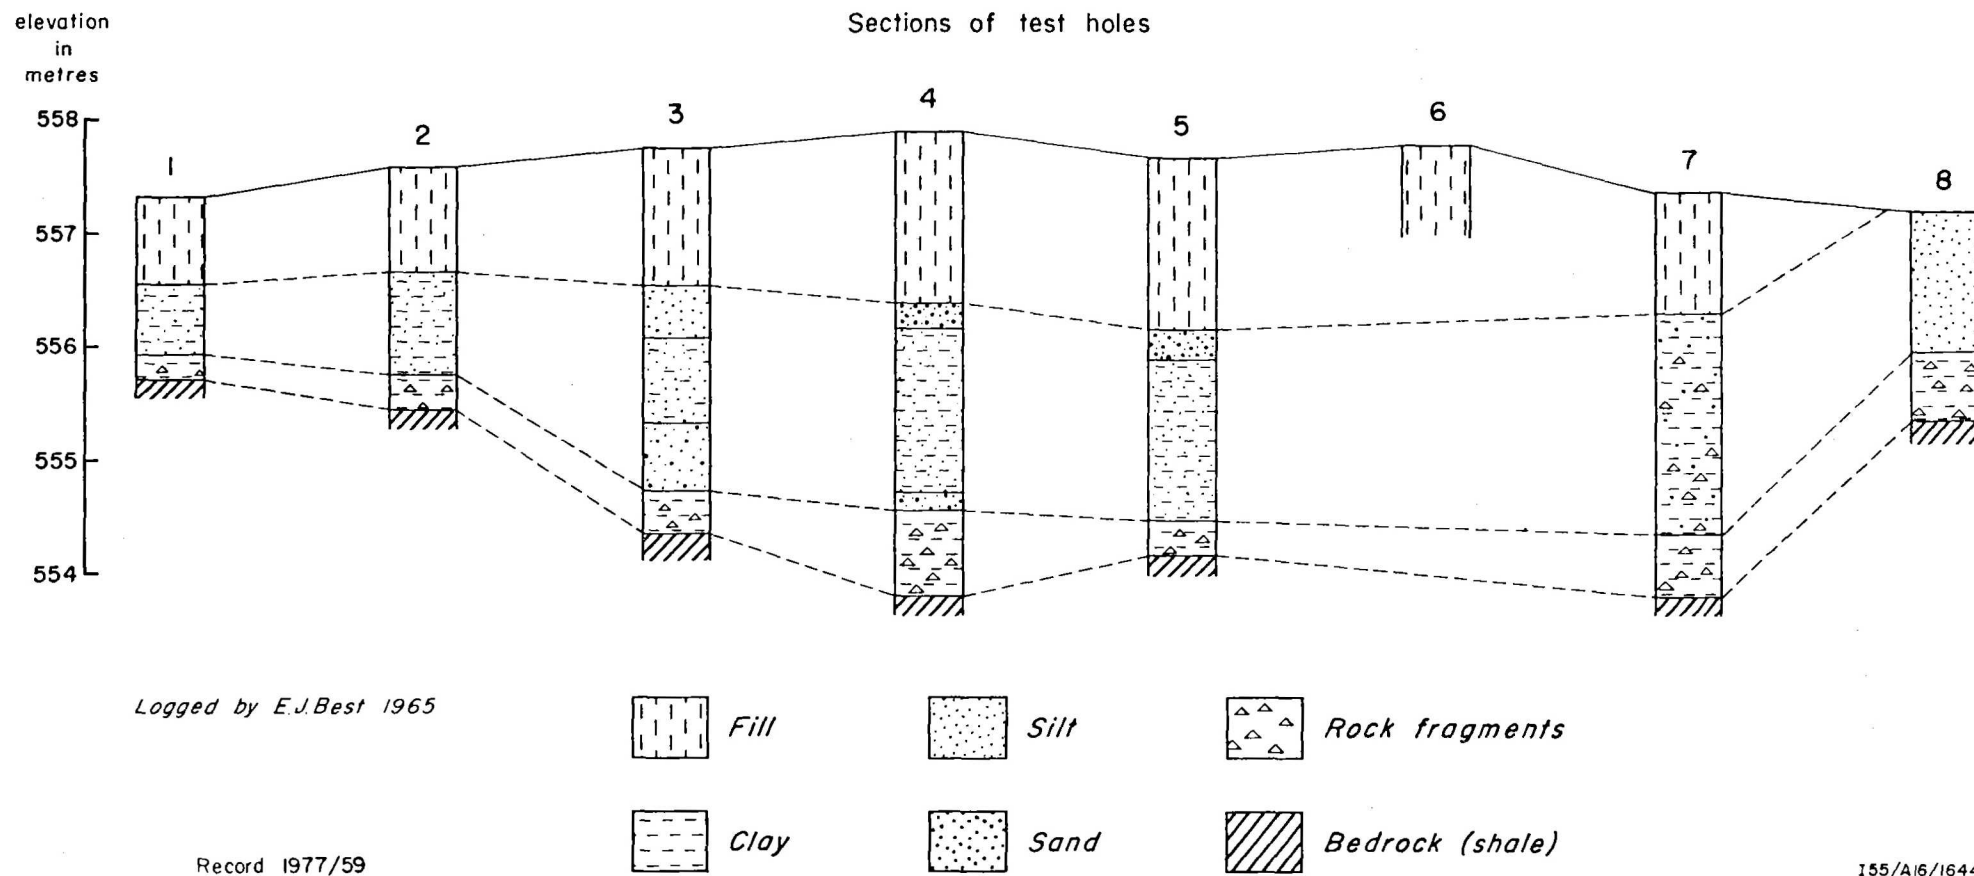
Fig. 4 Alluvial cross-section, Olympic Pool, Canberra

Filled ground has not been shown on the geological map, but occurs in places throughout the area. A depth of 1.5 m of fill was proved by augering near the Olympic Swimming Pool (Fig. 4). The top 0.9 m in drill hole 12 east of the BMR building is probably fill associated with landfill material in an erosion gully that crossed Section 4 towards the RSL National Headquarters.

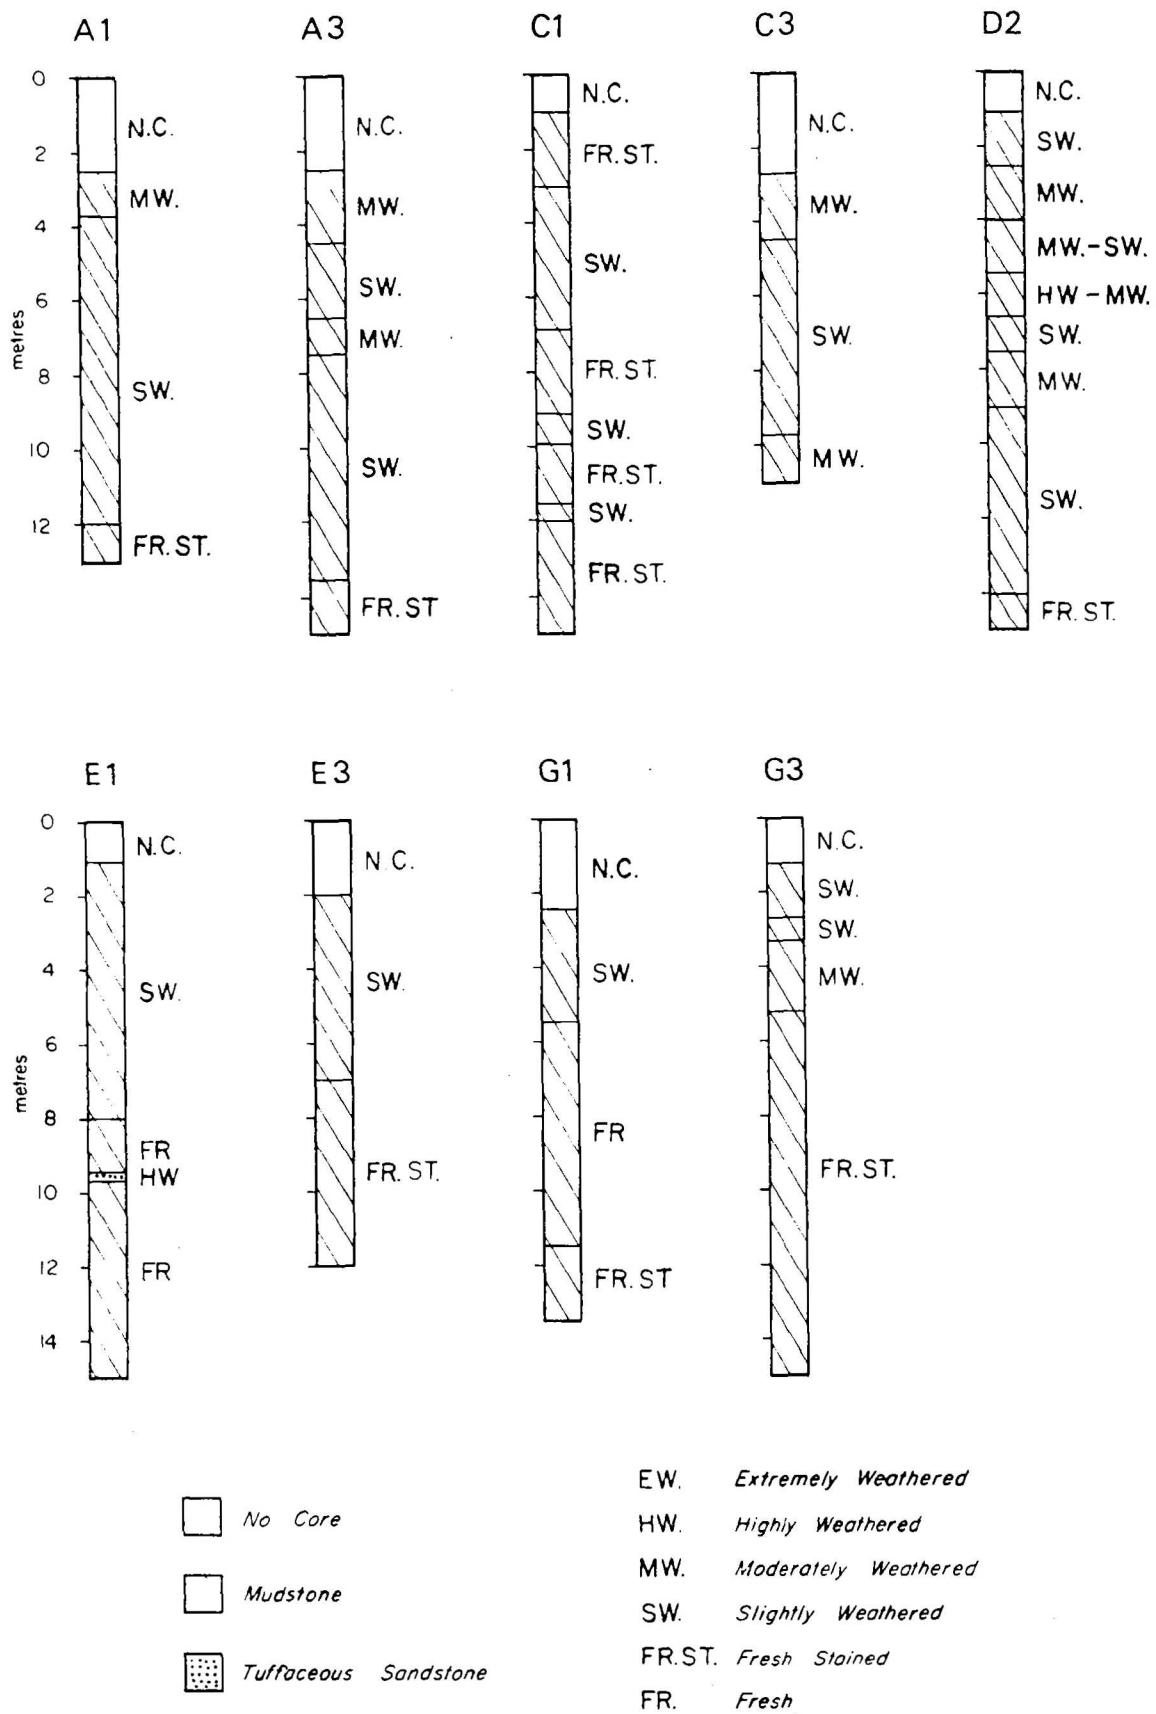
Fig. 5. Logs of drill holes, Section II, Canberra City, August 1974

The investigation proved hard fresh calcareous mudstone at shallow depths on City Hill with an increasing depth of weathering towards Glebe Park which is traversed by the City East fault zone.

| Site | Depth to sound foundation (m) | | Depth to which rock is rippable (m) | |
|---|---|---|---|---|
| Section 11 | 1.1 | 2.7 | 1.1 | 4.6 |

These three alternative sites are all suitable for a large building. A good deal of blasting would be required in an excavation on the Section 11 site. The western site on Section 41 would have more uniform foundation conditions than the eastern site.

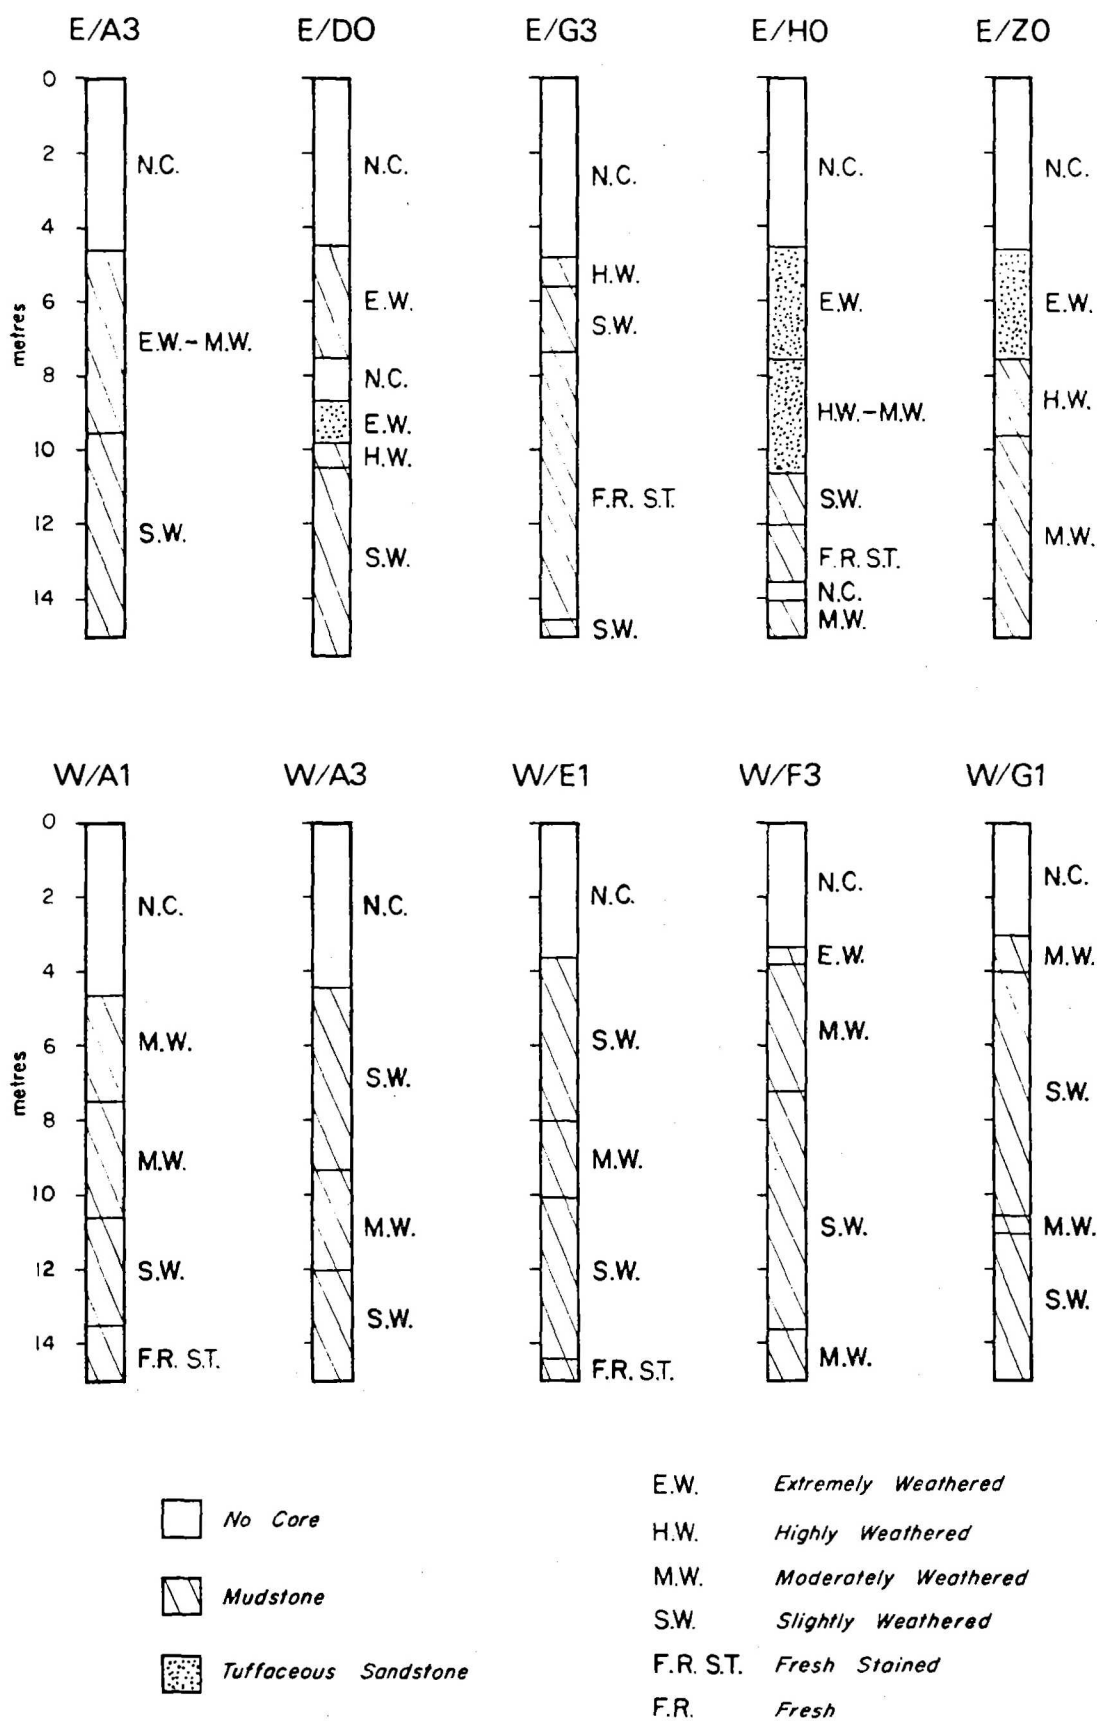
Fig. 6 Logs of drill holes, Section 41, Canberra City, August 1974

| Site | Depth to sound foundation (m) | | Depth to which rock is rippable (m) | |
|---|---|---|---|---|
| Section 41 (west) | 4.2 | 5.4 | 4.2 | 9.4 |
| Section 41 (east) | 4.6 | 10.6 | 7.4 | 15.0 |

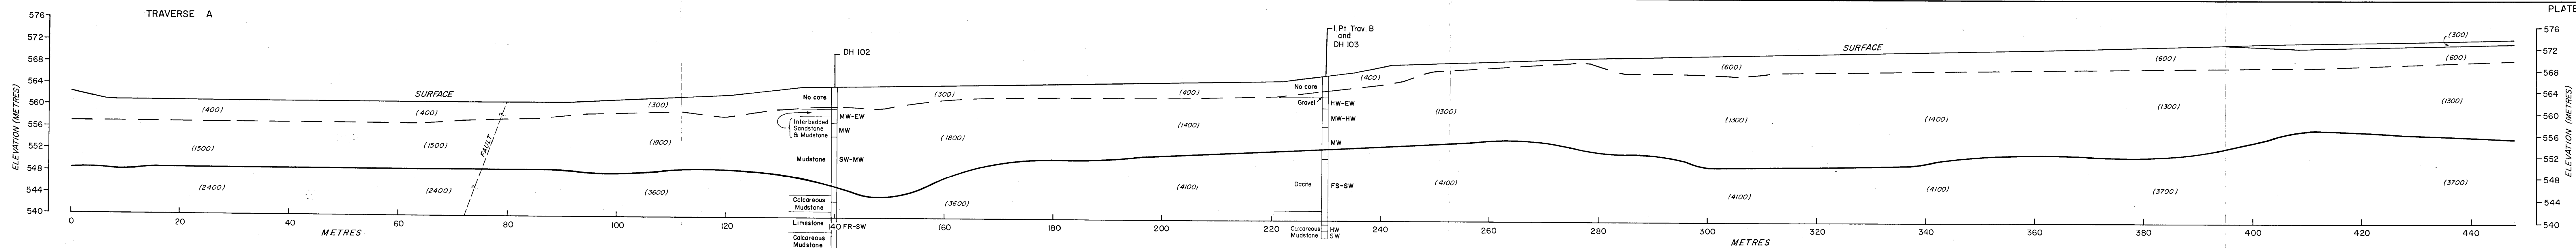
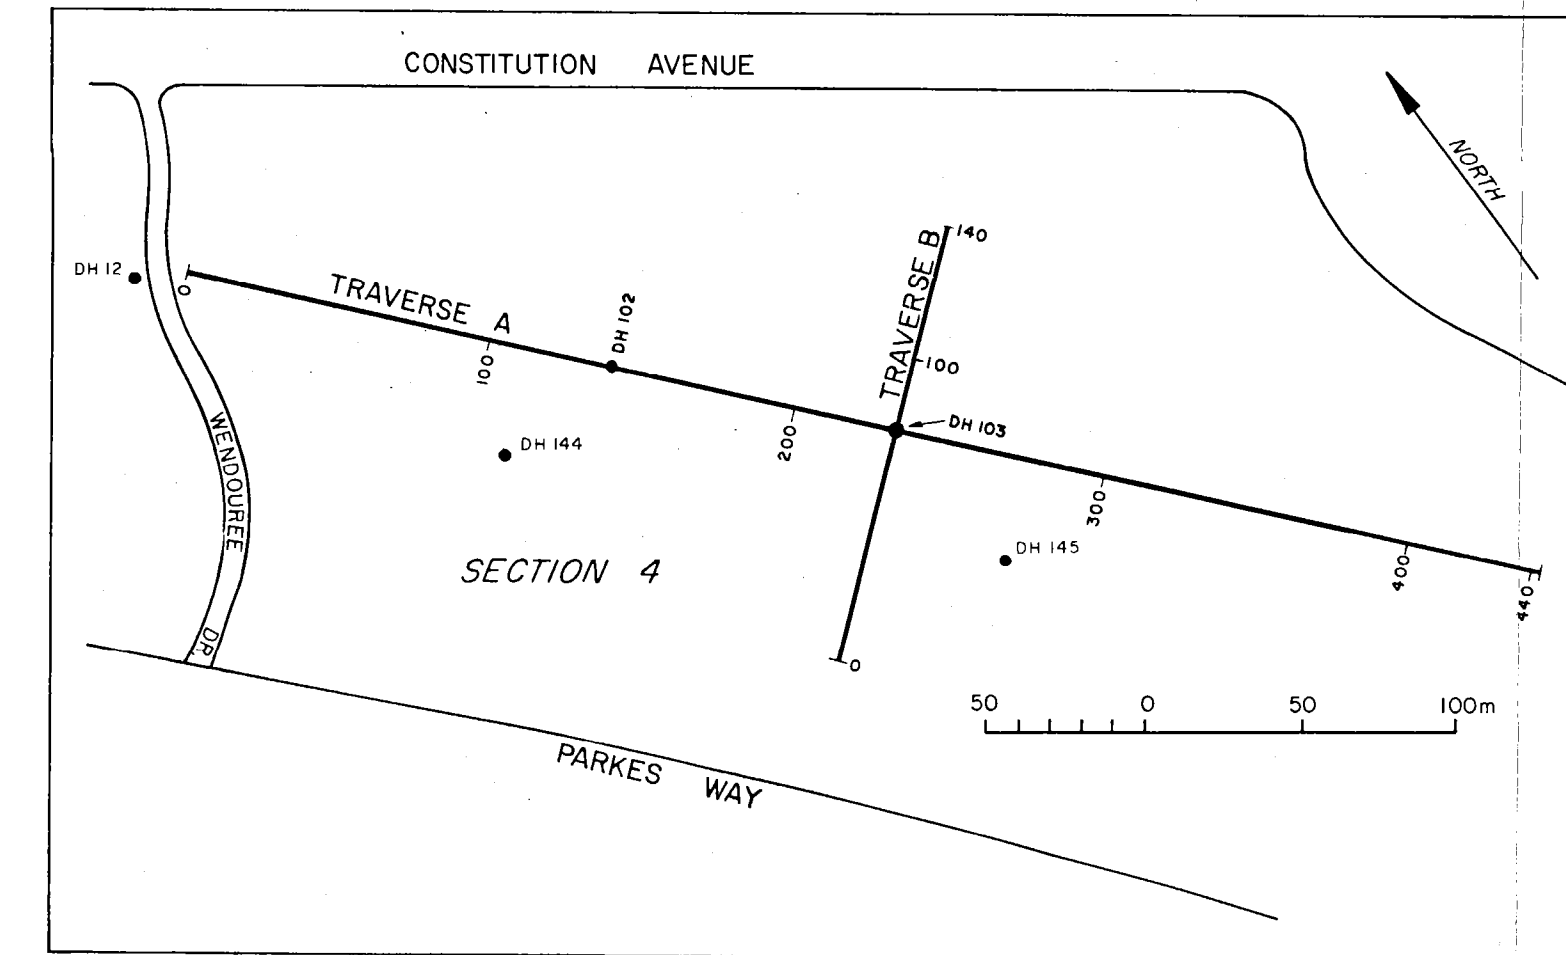
SECTION 4, PARKES  
SEISMIC CROSS-SECTIONS

At this site several metres of fill and alluvium overlie irregularly weathered rocks of varying lithology including dacite, mudstone, and tuffaceous sandstone. There is some limestone but at considerable depth, and at least one fault passes through the section. Foundation depths are expected to average about 8 m, but could be variable and a foundation investigation will be required for any major building.

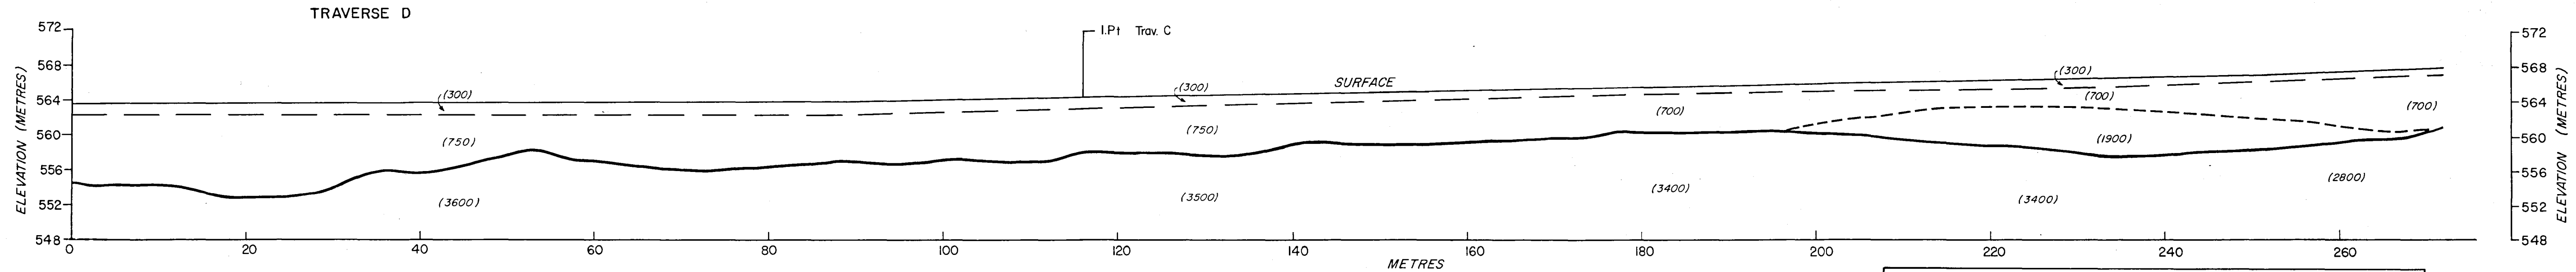
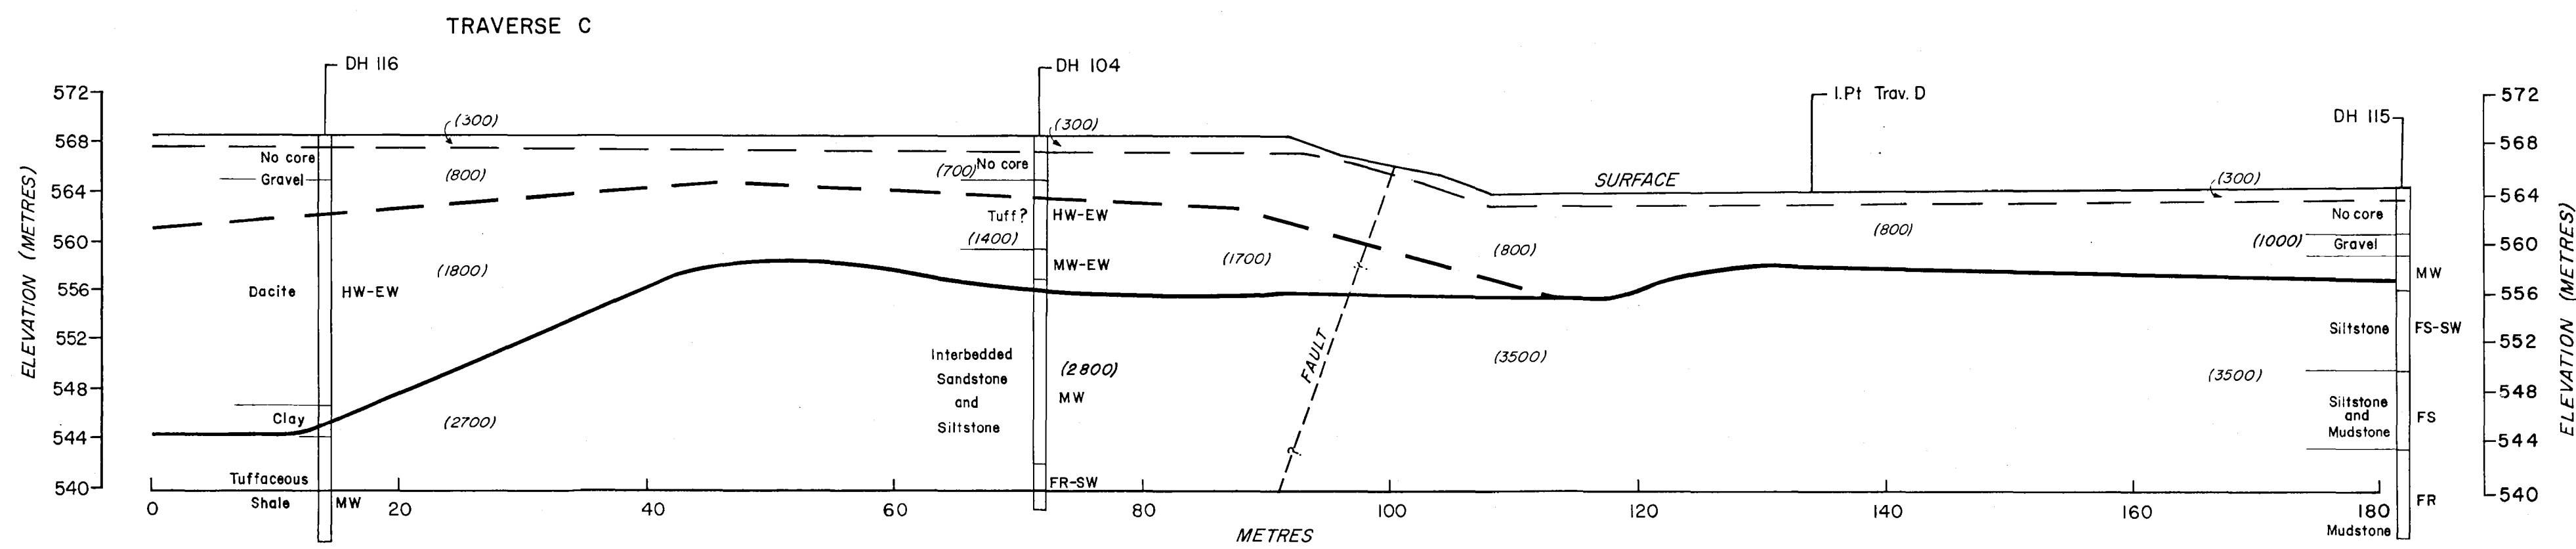
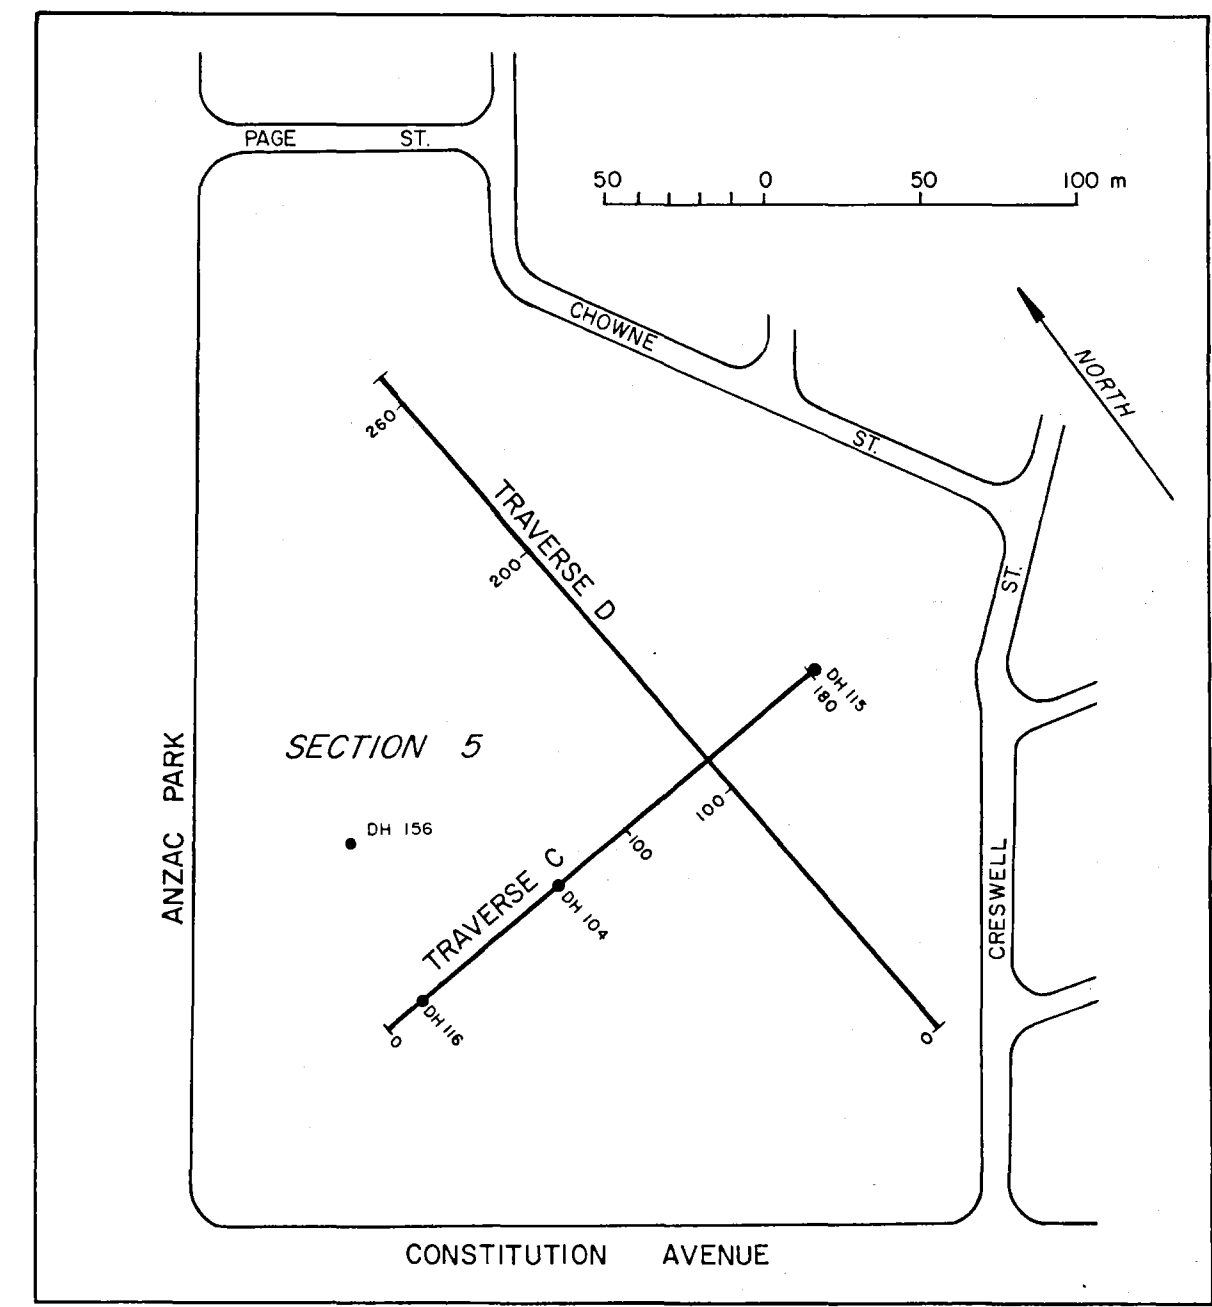
SECTION 5, CAMPBELL  
SEISMIC CROSS-SECTIONS

At this site, alluvial gravel several metres thick overlies weathered dacite, shale, siltstone, and sandstone. Deep weathering in the dacite on the west side could present difficulties for foundations, although over most of the site large buildings could be founded on moderately weathered rock at 5-8 m. Artesian water was encountered at a depth of 25 m in drill hole 115; the water flowed at the surface at about 20 l/minute.

A pre-existing earth dam in the southeast of the section has been filled with spoil.
