BMR Record 1979/84

OBSERVATIONS ON GEOLOGY, SOILS, AND GROUNDWATER
RELEVANT TO PAVEMENT FAILURE IN CANBERRA, 1979

E.G. Wilson

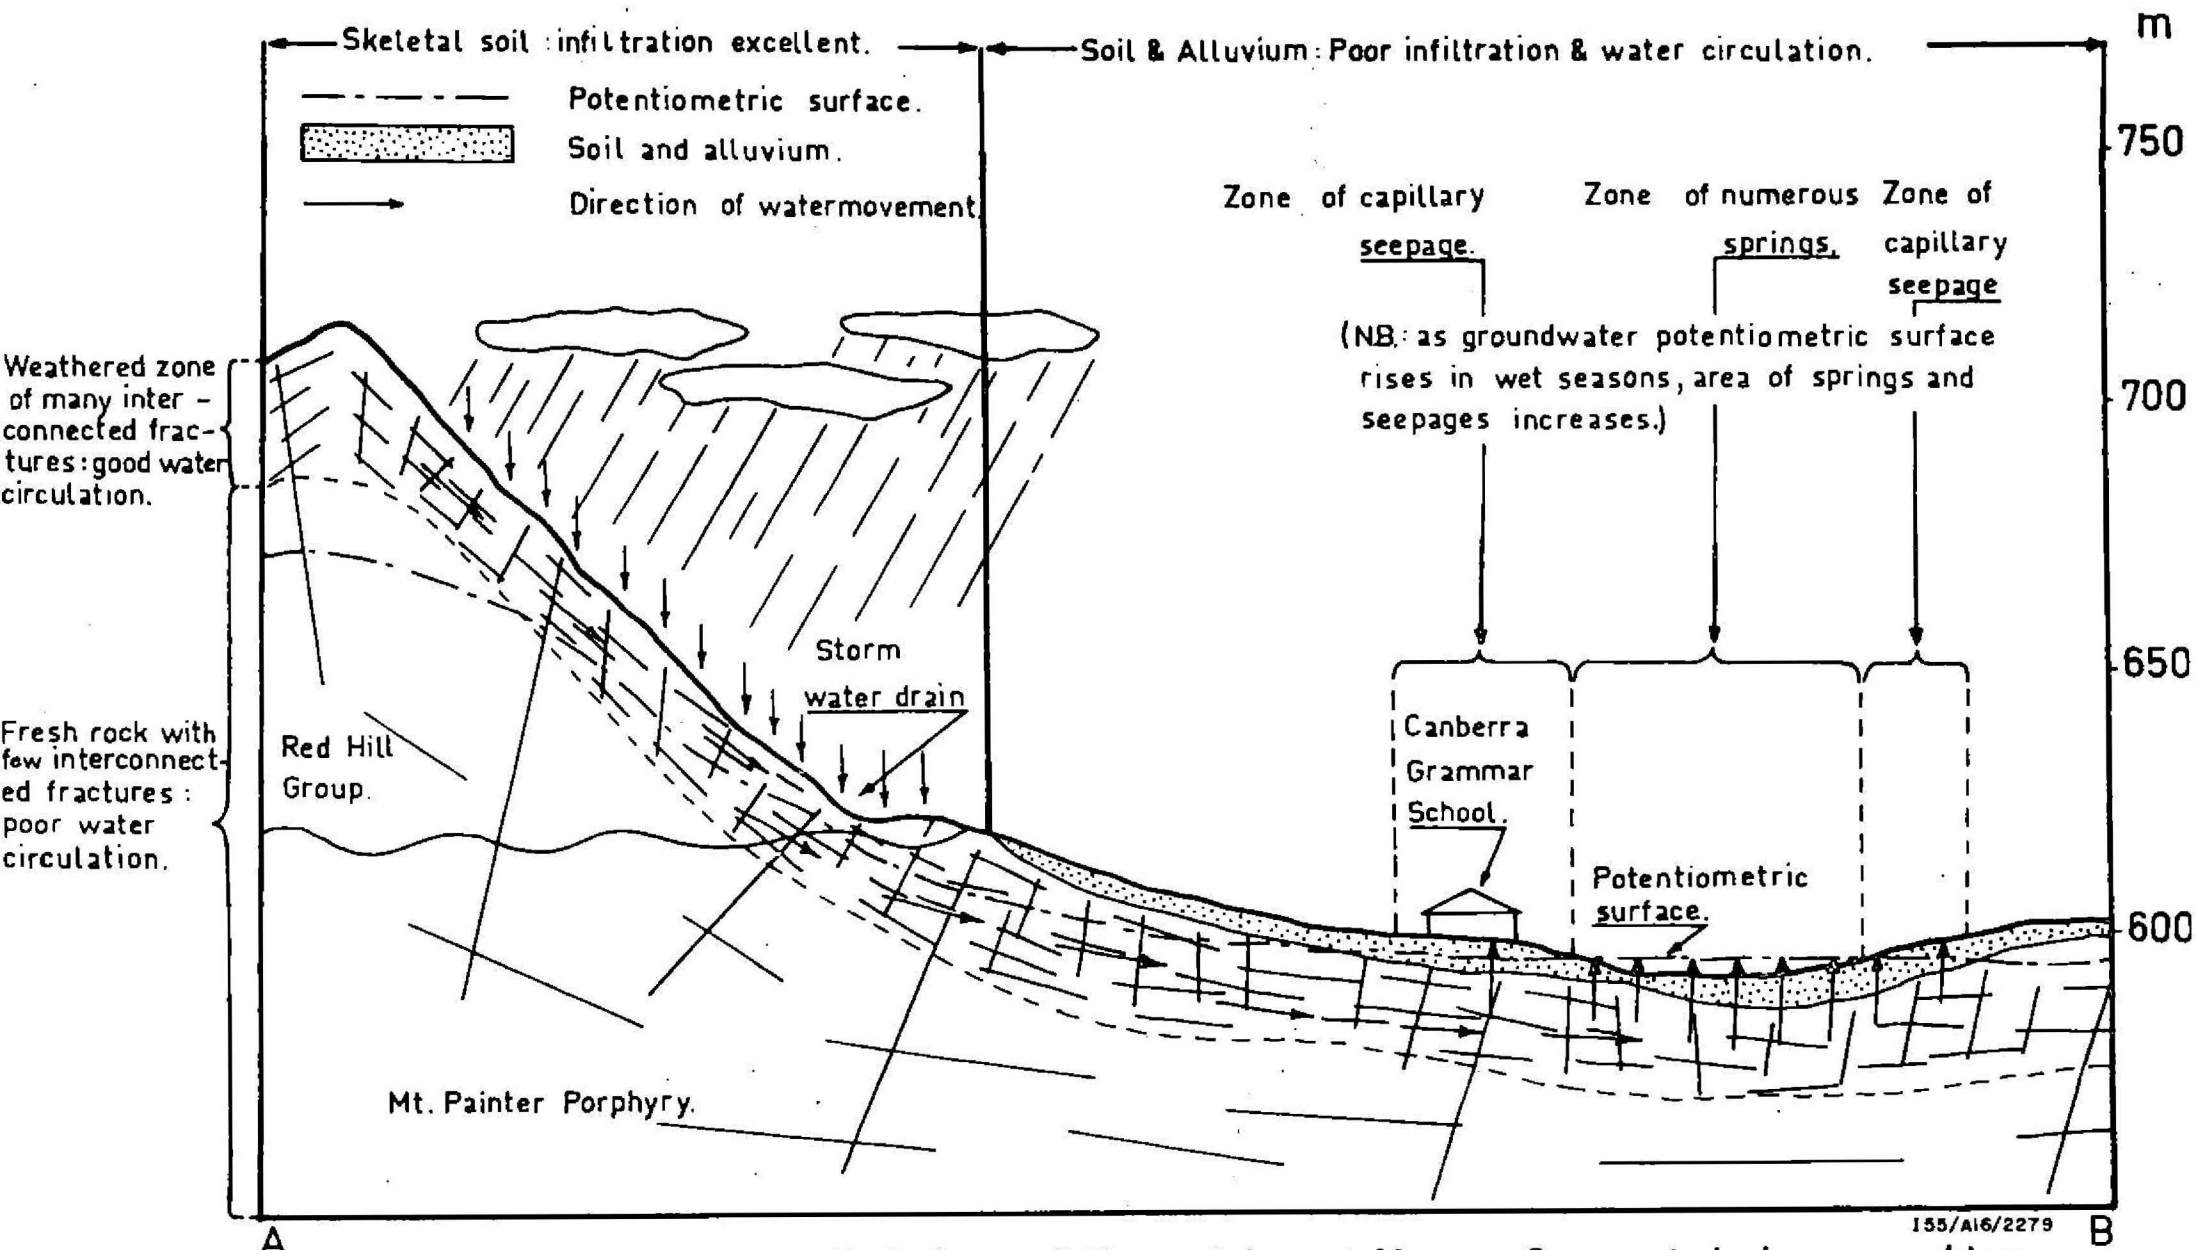
FIG: 4

Horizontal scale: 1:10,000 Hydrology of the catchment, Monaro Crescent drainage problem

The potentiometric surface of a number of such underlying aquifers has been found to be near or above ground level (Fig. 4). At Monaro Crescent, Red Hill, the potentiometric surface of the fractured volcanic rock aquifer measured in bore 424 is generally 3 m above the ground (Saltet & Hohnen, 1965). At Yarralumla Sportsground (bore 82) the potentiometric surface is rarely more than 1 m below the surface (Jacobson & Schuett, 1975). Other observation bores at which the potentiometric surface is generally within 1 m of the surface are bore 87 near the BMR building, and bores 36 and 356 near Coranderrk Street, Reid, (near pavement test site 19). In all these locations the high moisture content will be maintained until the potentiometric surface is lowered.

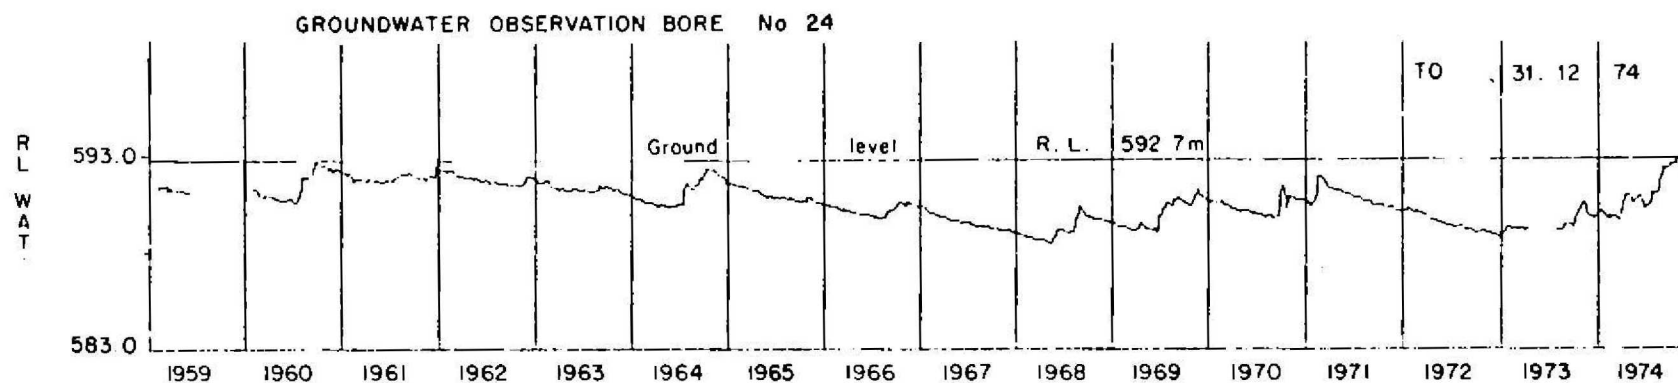
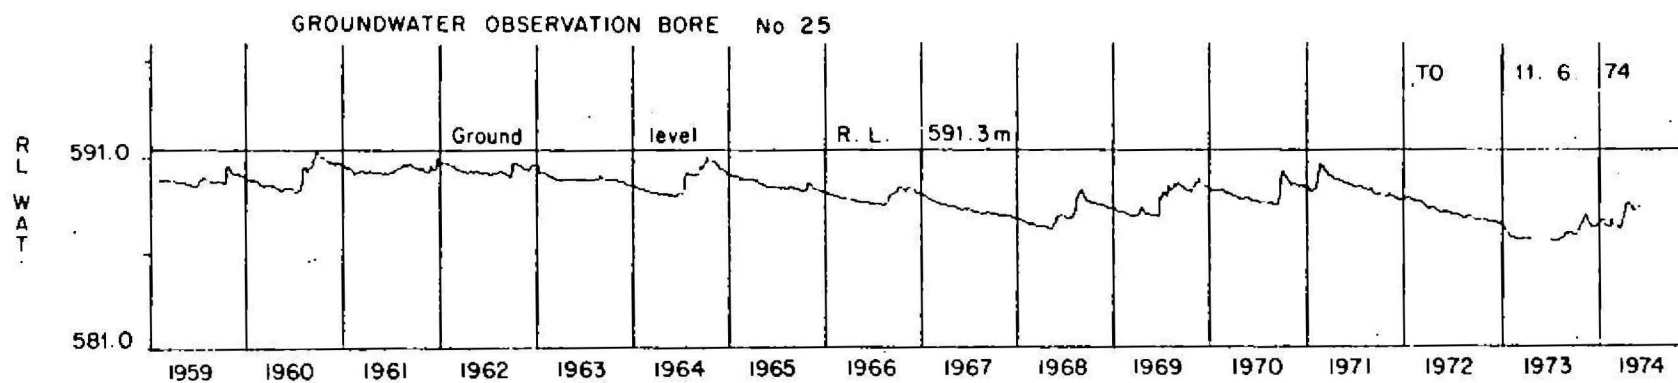
Fig. 5 Groundwater levels, Observation Bores 24 and 25
RECORD 1979/84

As the invert levels of main drains are generally too high to intercept permeable material, pumping has been found to be the only means of improving drainage. Pumping has been successful in lowering the potentiometric surface at Torres Street, Red Hill since 1959, and the effect is monitored by observing water-levels in nearby observation bores (Hohnen, 1977).

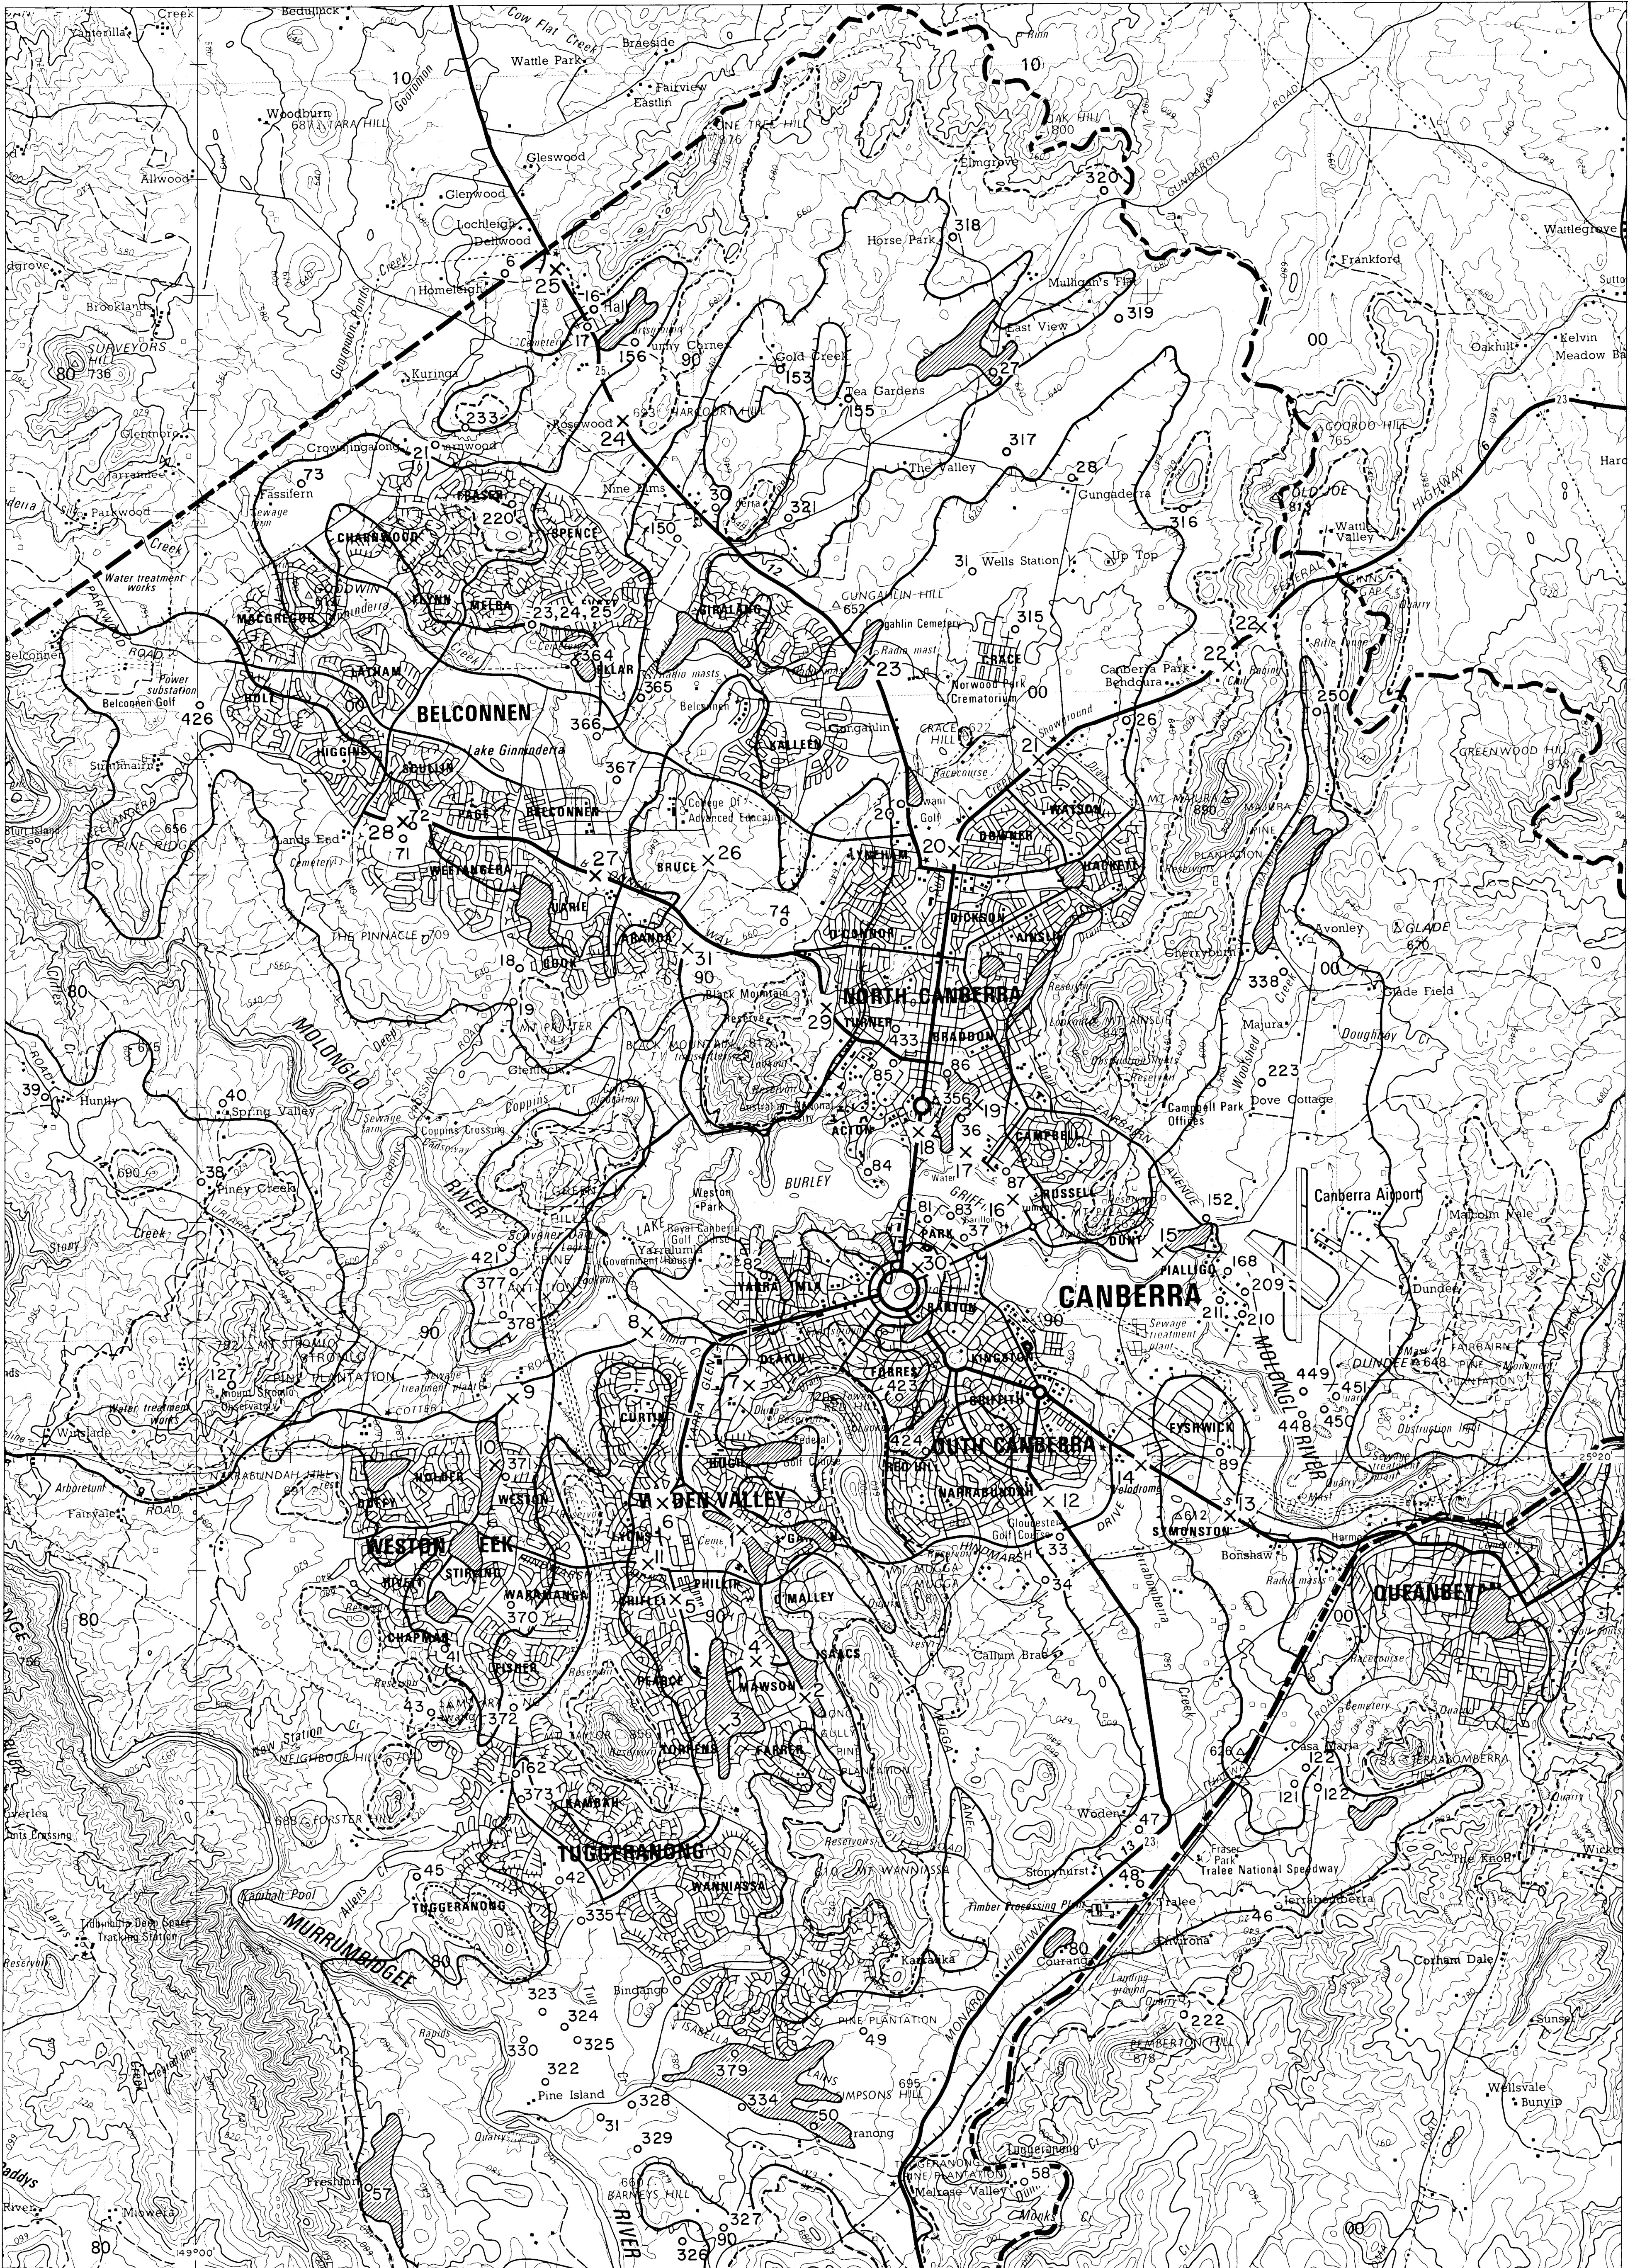
Hydrogeological data relevant to pavement failure in Canberra

The pavement test sites nominated by DHC (Plate 1) were visited and a table was prepared setting out information concerning geology, soils, groundwater conditions, and possible contributory factors to road subgrade failure at each site (Appendix 1).

Superficial sediments are widely distributed below the change of slope, which is at an elevation of about 670 m around the major hills, and the built-up area of Canberra is below the change of slope (Plate 1).

The Bureau has investigated poor soil drainage conditions at the following locations during the last 20 years, and at all of them the problem was associated with a high potentiometric surface causing the overlying soils to become saturated (see Plate 1).
