Record 1980/28

INVESTIGATION OF A SOIL DRAINAGE PROBLEM AT COOK PRIMARY

SCHOOL, ACT

P.D. HOHNEN

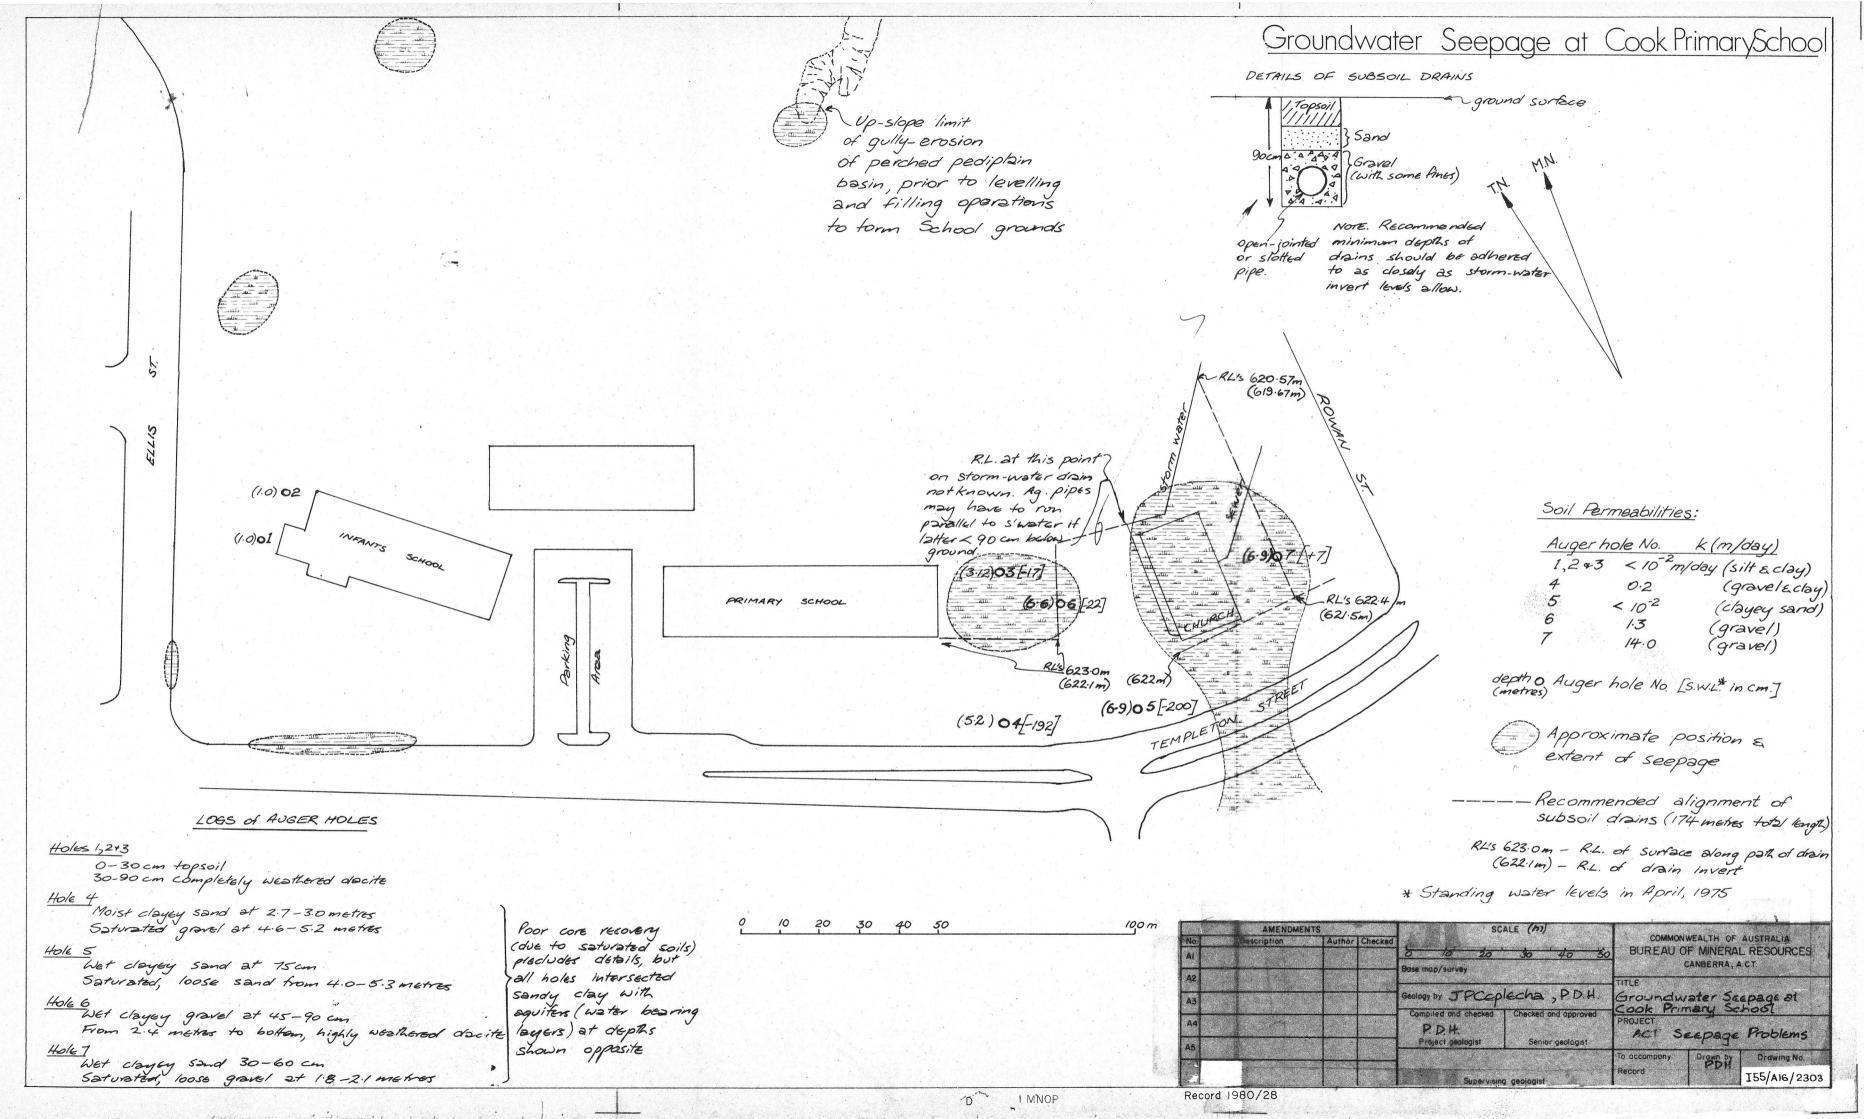
Foundations for the southern side of one of the school buildings were excavated below the natural groundsurface, and the batter slope between the school and Templetion Street is partly on fill materials (Fig. 2).

- 1. Highly permeable colluvial fan and basin deposits, which are the transport medium for shallow drainage or interflow in the higher parts of Cook, have been intersected by the cut-and-fill processes of landscaping operations during the construction of Cook Primary School. This has allowed seepage from the colluvium, of water that was previously confined beneath low-permeability clay soils (Fig. 2).
