BMR RECORD 1980/41

GROUNDWATER POLLUTION BY PETROL

AT THE NRMA BUILDING,

BRADDON, ACT

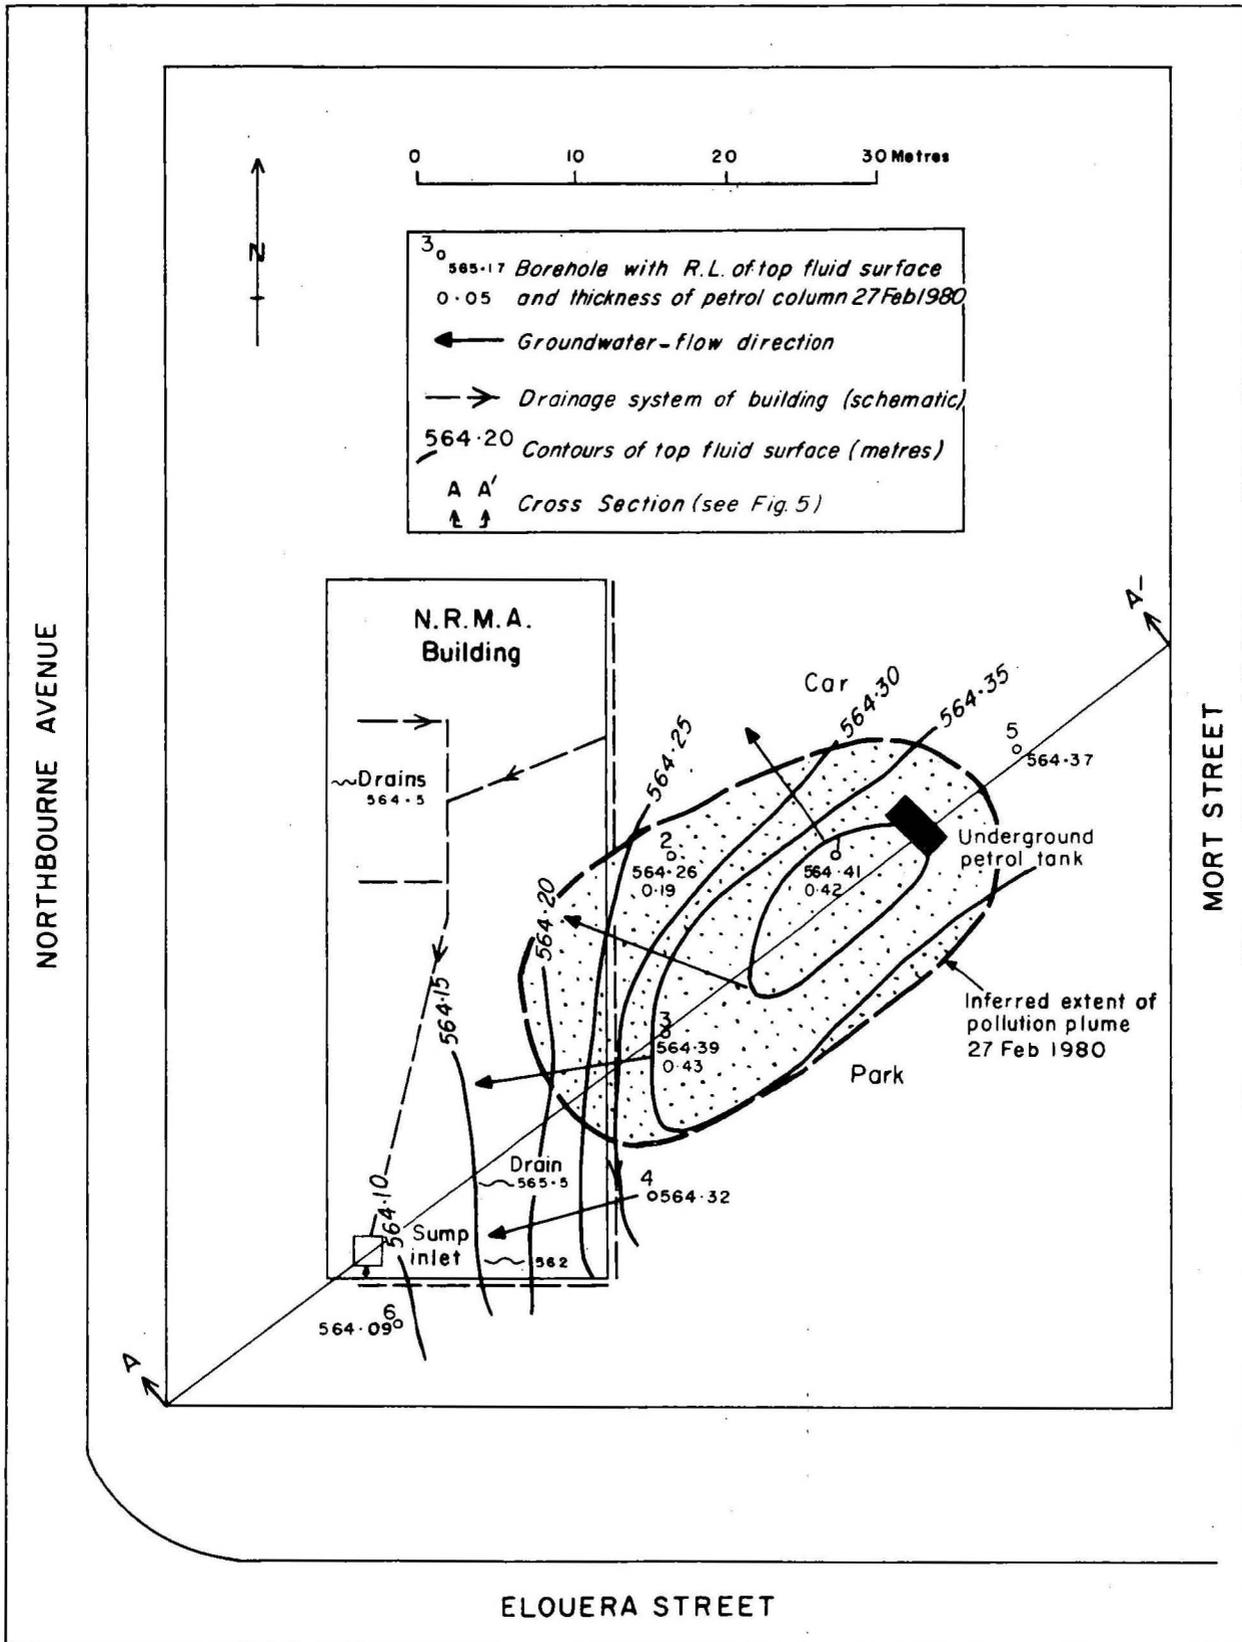
Figure 3 PETROL POLLUTION PLUME at the N.R.M.A. Building, Braddon, A.C.T.,

The pollution plume is believed to be continuous between the bores that contain measurable quantities of petrol, and probably extends for some distance laterally beyond these. The inferred extent of the pollution plume in February 1980 was about 300 m² (Fig. 3). The total volume of petrol-saturated rock was estimated as about 200 m³. On the assumption that one percent of the rock is voids - pores, fractures, and solution cavities - which contain petrol, then the total amount of petrol in the plume was about 2000 litres. However, as limestone is present the porosity could be greater than one percent, and the volume of petrol could be considerably greater.

The inferred extent of the pollution plume includes the site of the underground petrol tank in the NRMA car park (Fig. 3), and this tank and its fittings were considered the most likely source of petrol. In-situ tests by the Inspector of Flammable Liquids, Department of the Capital Territory, did not show any leakage. The tank was excavated on 9 November 1979, and petrol was observed in the sand surrounding it.

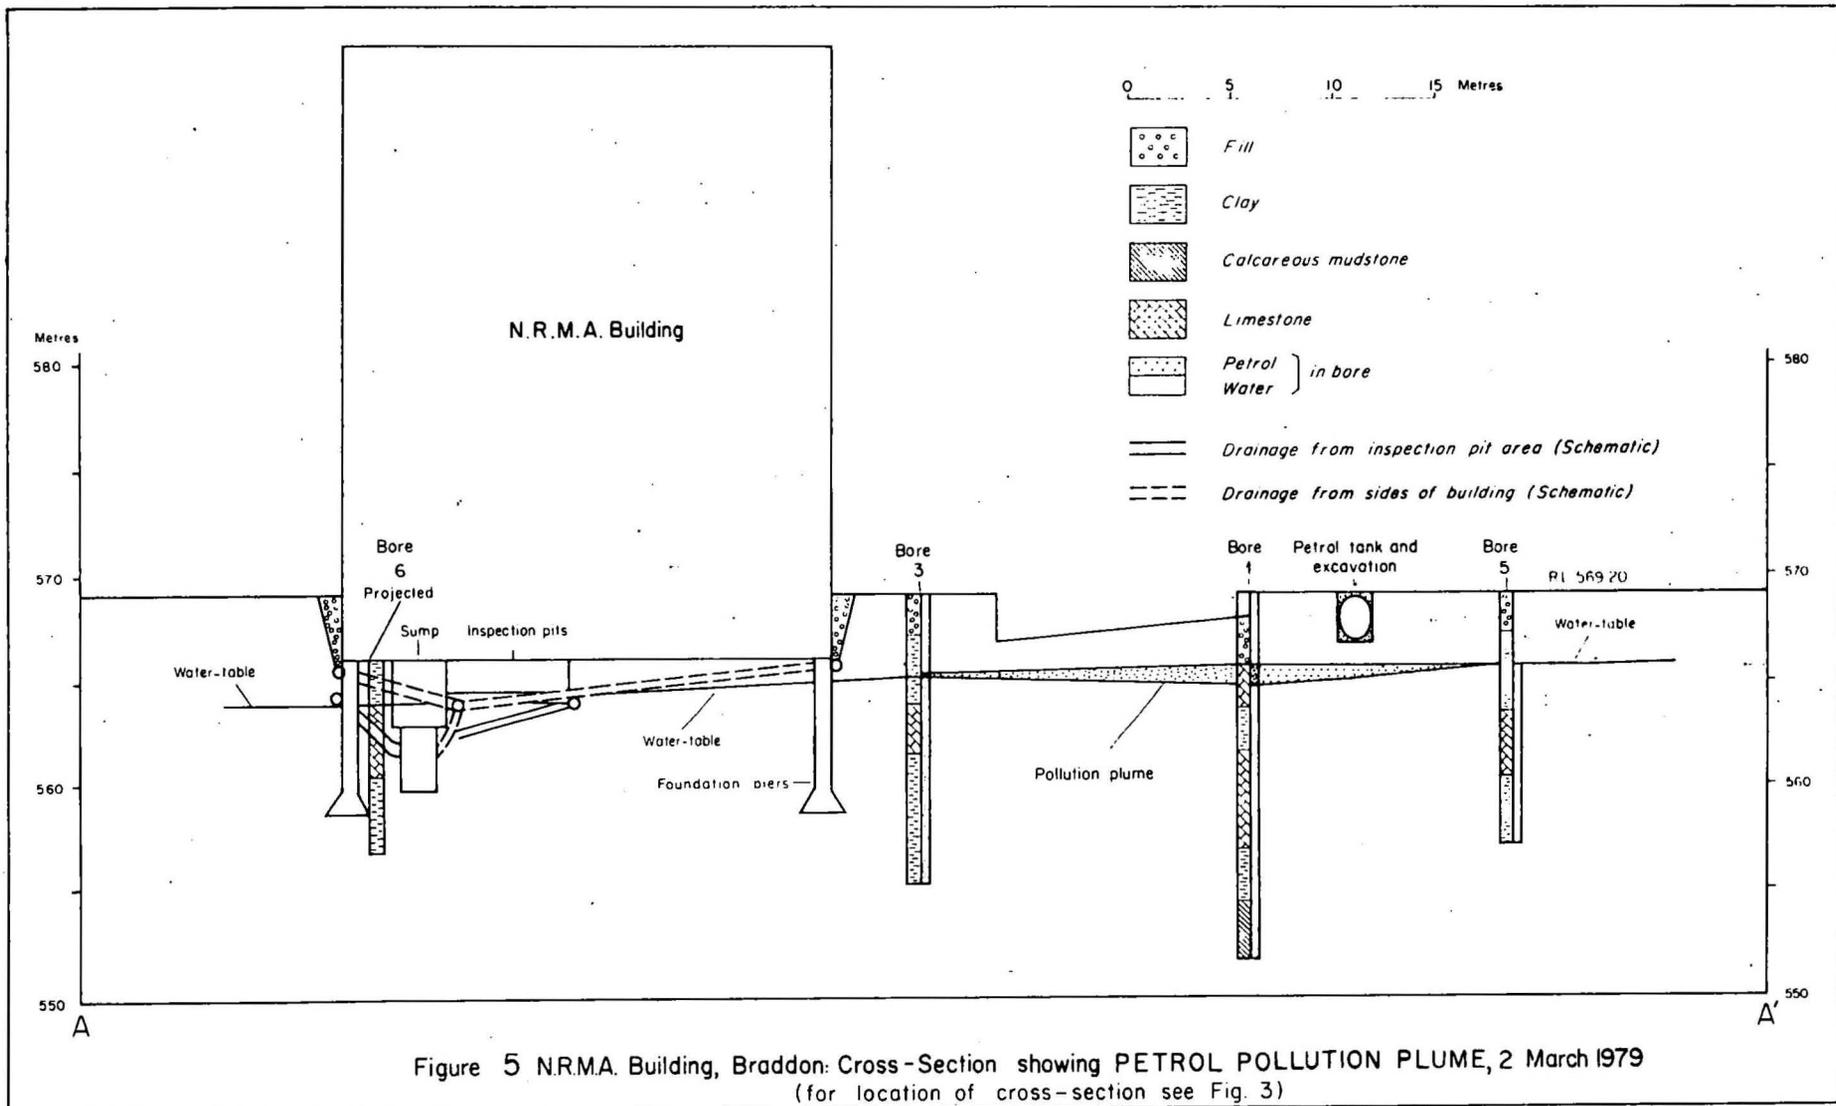
A cross-section through the building (Fig. 5) shows that the water-table is, at times of high rainfall and considerable groundwater recharge, close to the level of the foundation drains which surround the building and drain into the sump.

Figure 5 shows that on 2 March 1979 the water-table and the petrol floating on top of it were just below the level of the foundation drains along the east side of the NRMA building. It is likely that a rise in the water-table brought petrol into the drains and thence into the sump on three occasions in September 1978. It is not known to have occurred since, possibly because 1979 was a dry year and groundwater-levels have remained low; however, the ventilation installed in the sump in September 1978 to remove petrol fumes may also mean that the entry of petrol may not be detected. The entry of petrol into the sump is likely to recur

whenever groundwater recharge after heavy rain raises the water-table along the east side of the building so that water, and in some places petrol, enters the drain. The hazard will remain, and continuous ventilation must be maintained in those areas of the building likely to be affected by petrol vapour.

An appropriate ventilation system should operate in the sump of the NRMA Building whenever petrol is likely to enter it. However, as it is doubtful that such events can be reliably predicted, consideration should be given to a continuous ventilation system that could be monitored for serviceability at all times. A review of the ventilation of the basement should be made to assess its effectiveness whenever petrol as well as water is present in the open parts of the drains.

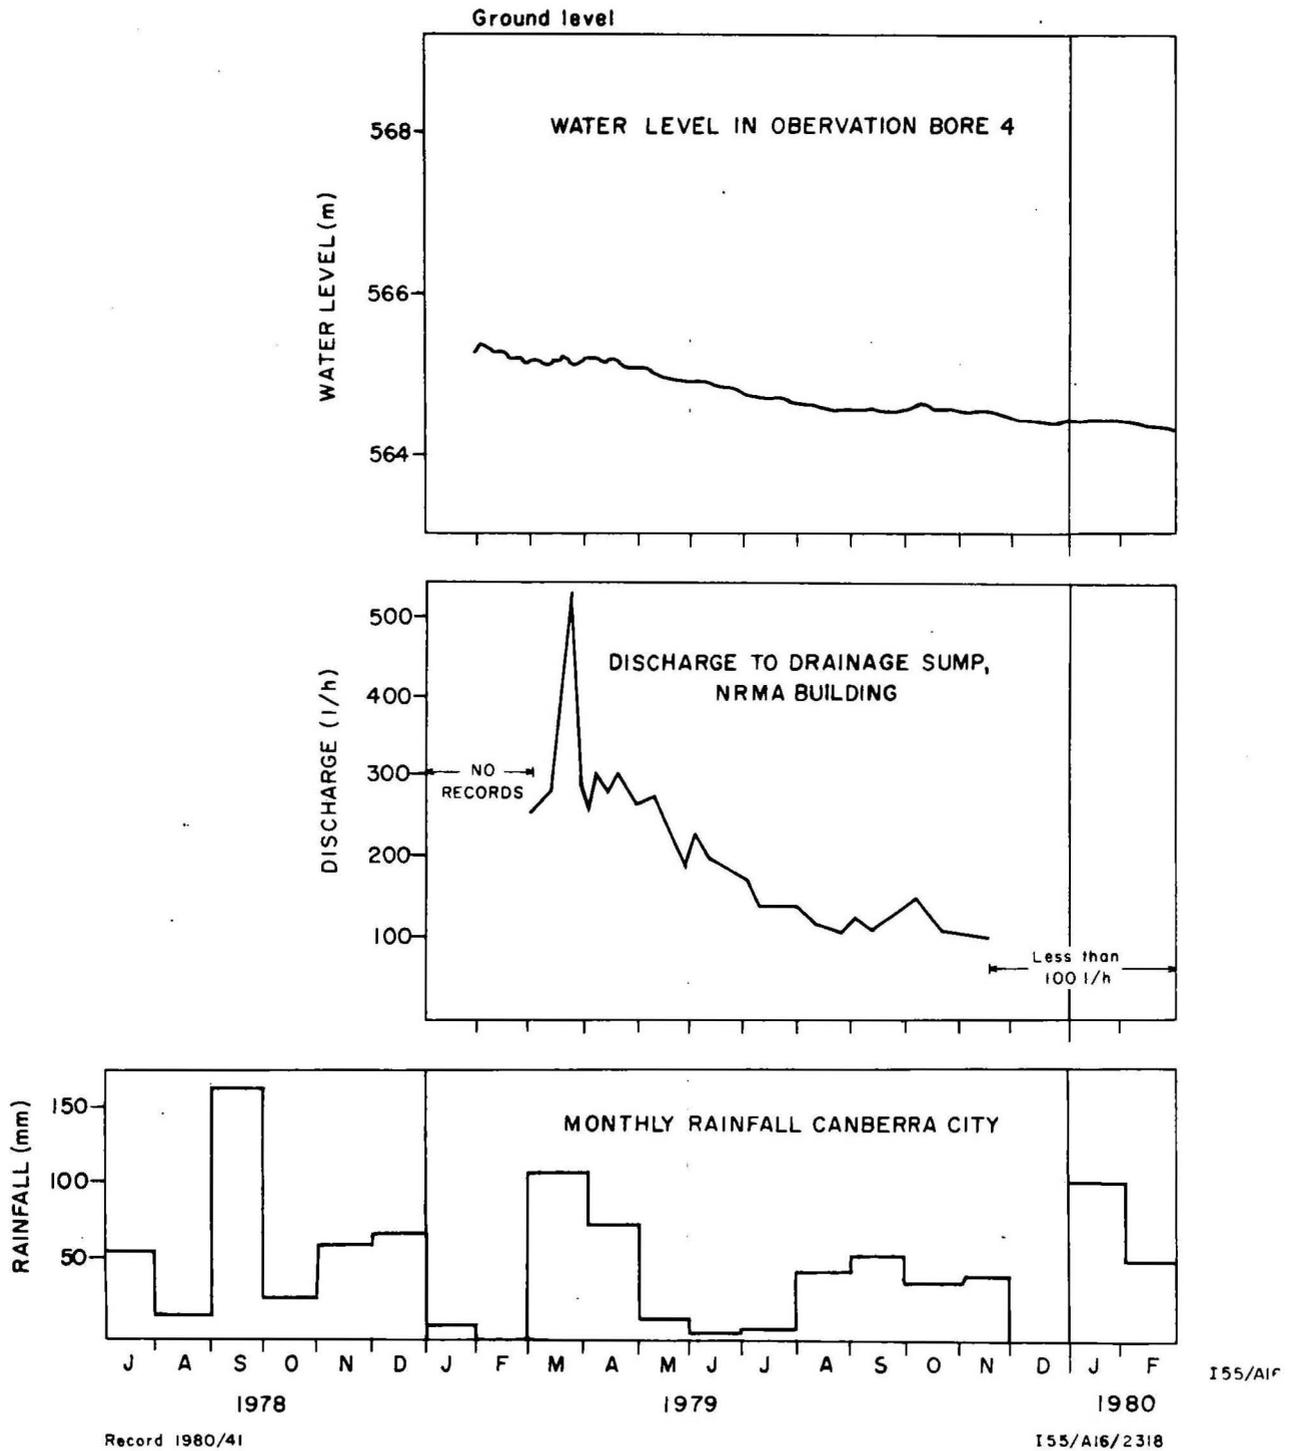
Figure 6 Rainfall, sump discharge, and groundwater-level

At the NRMA Building, groundwater was encountered in all six drillholes. The water-table is 4-5 m below ground surface and slopes gently to the west. Water-table fluctuations in monitoring bores have ranged up to about 1 m during one year of measurement to the end of February 1980, and have generally declined during this year (Figs. 6 and 7).

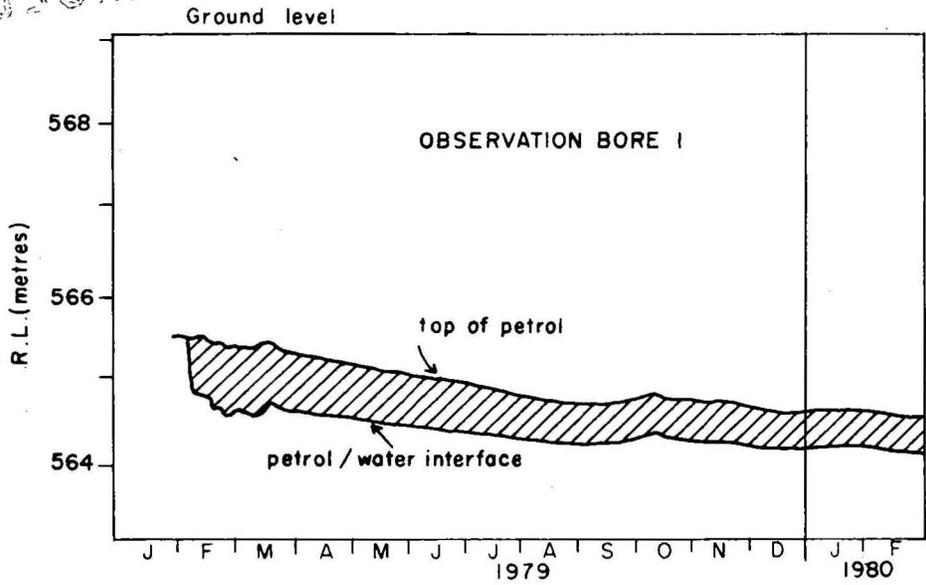
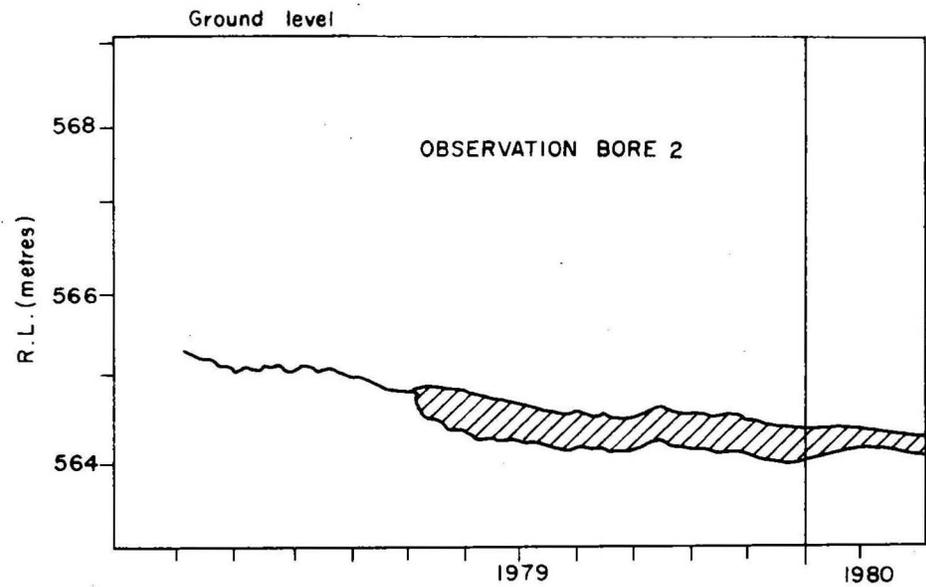
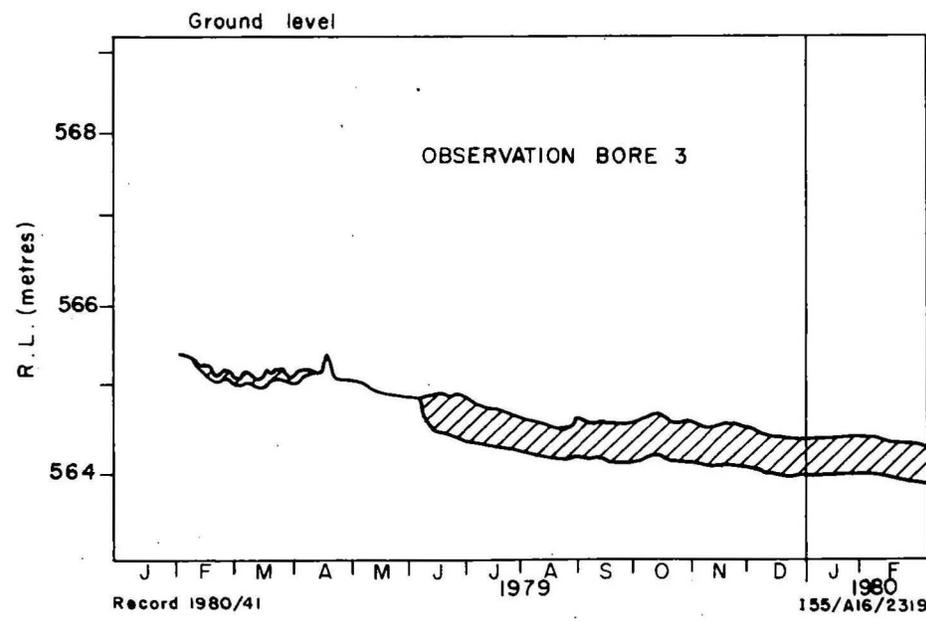
Figure 7 Petrol and groundwater-levels in observation bores N. R. M. A. building

Petrol has been observed on top of the water-table in three of the observation bores; petrol and water-levels in these three bores are shown in Figure 7. Petrol was first observed in bore 1 soon after drilling, and since then the column of petrol has ranged in thickness from 0.42 m to 0.84 m. In Bore 2, petrol vapours were observed during drilling, but petrol was not measured in the bore until June 1979; the thickness of the column of petrol has since ranged from 0.19 m to 0.53 m. Bore 3 contained only a few centimetres of petrol until June 1979, when the column thickened; it has since ranged from 0.36 m to 0.49 m thick.

The decline in petrol thickness in bores 1 and 2 (Fig. 7) probably indicates that the plume is spreading out from a source that is no longer active; however, traces of petrol have not yet been detected in bores 4, 5 and 6.
