BUREAU OF MINERAL RESOURCES, GEOLOGY AND GEOPHYSICS

REPORT 215

PRELIMINARY REPORT ON THE CADOUX EARTHQUAKE,
WESTERN AUSTRALIA, 2 JUNE 1979

P.J. GREGSON & E.P. PAULL

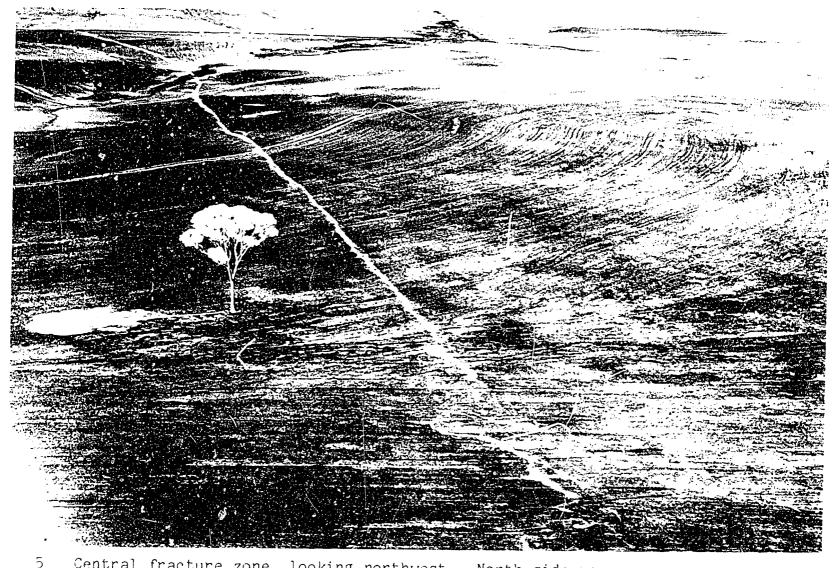
Central fracture zone, looking northwest. North side up 5 approximately 50 cm.

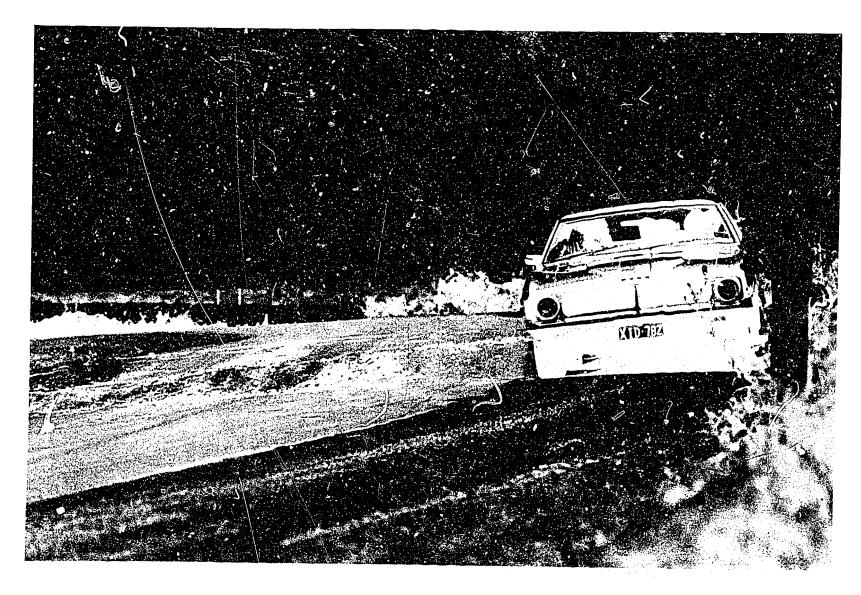
7 Southern fracture zone looking south along main road 1.0 km north of Cadoux.

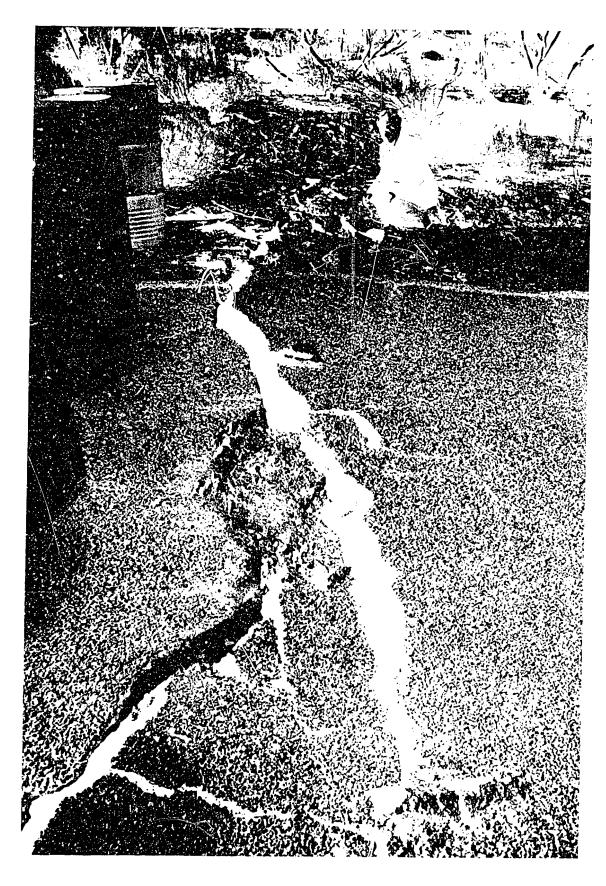
8 Central fracture zone looking west across main road 3.2 km north of Cadoux.

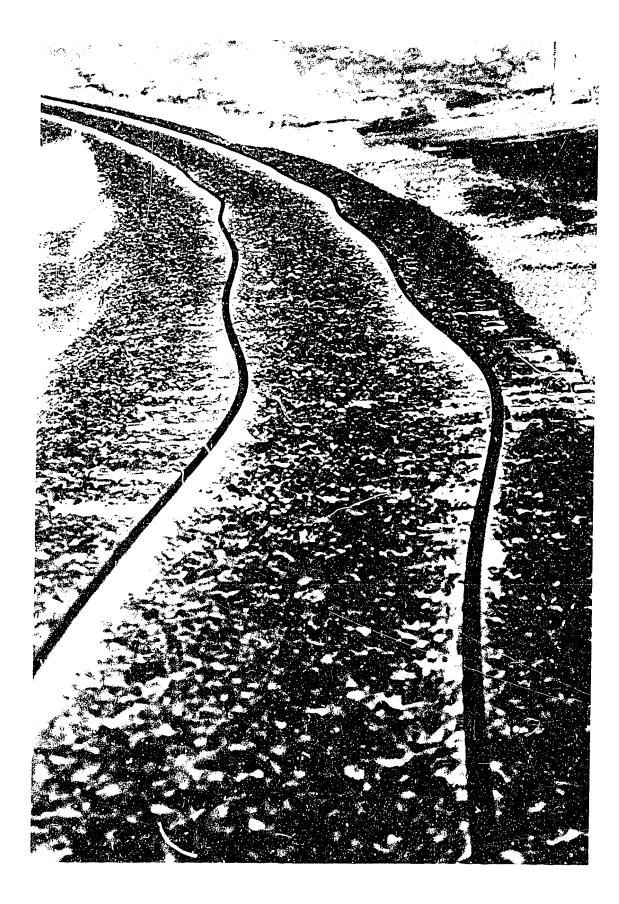
9 Railway (gauge 1.07 m), 1.0 km north of Cadoux.

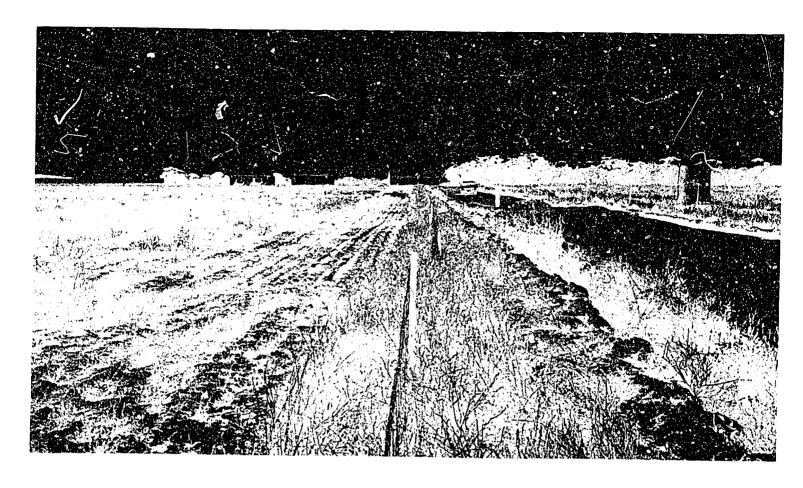
10 Fence displacement 4.0 km south of Cadoux, looking south.
Note fence crosses scarp twice.

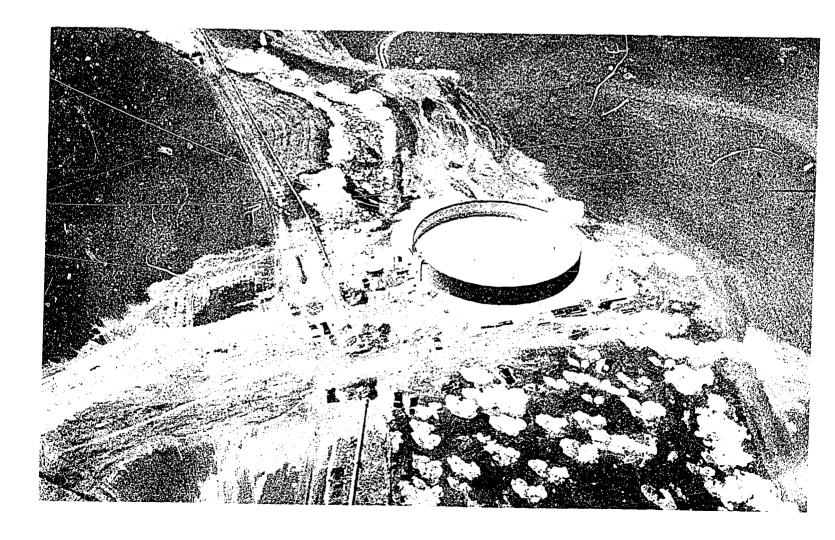
The major structure damaged was a nine-million litre concrete water tank (Fig. 11) valued at \$250 000. The tank moved 0.45 m off its base in a northerly direction, releasing all the water. At this stage it is not known whether or not the tank can be repaired. Uninsured buildings, and damage to public buildings, will raise the above figures considerably.

11 Nine million litre water tank close to northern fracture zone after water escaped.

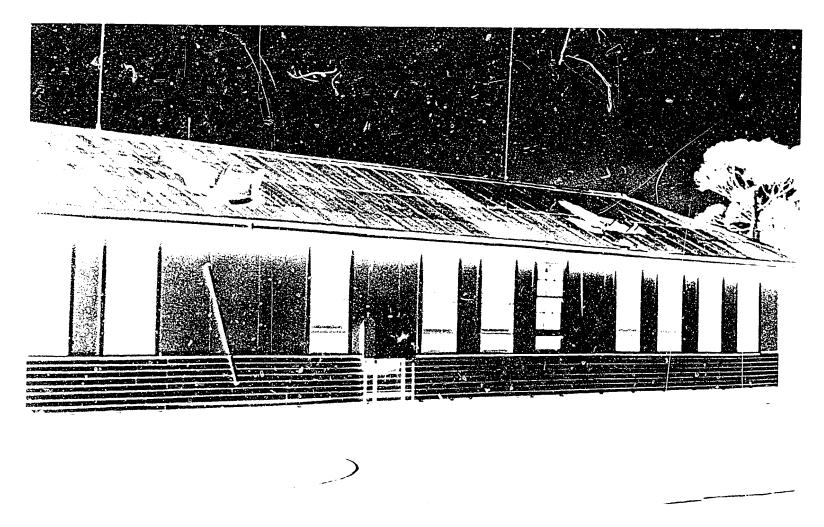
There were several examples of damage which could have been avoided by appropriate design and construction. Figure 15 shows the damage caused by two brick chimneys which fell through the roof of the timber-framed school house. This could have caused serious injury had the school been occupied at the time.

15 Damage to school house. Brick chimneys fallen through iron roof.

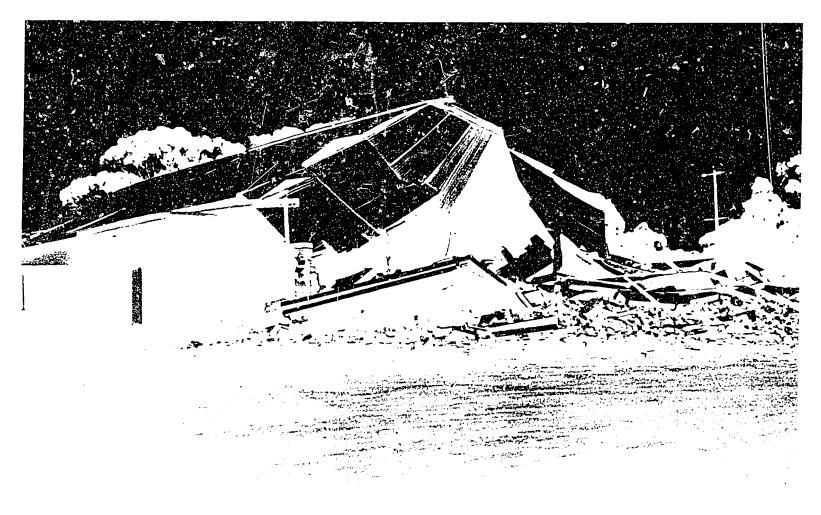
16 Damage to public hall. Collapse of brick front.

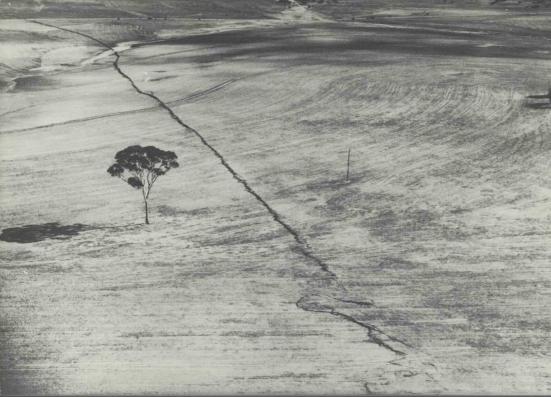
Southern fracture zone, looking west. West side up near area of maximum displacement. (Reproduced by permission of West Australian Newspapers Ltd)

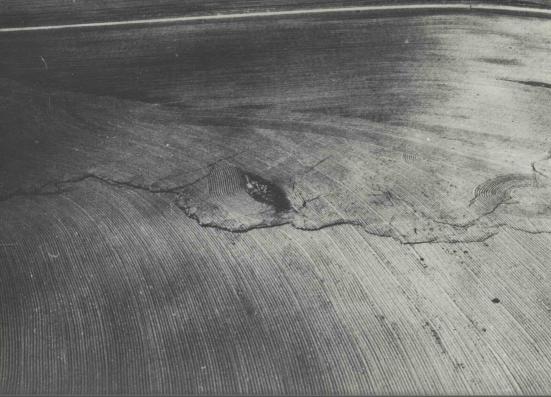
Southern fracture zone looking south along main road 1.0 km north of Cadoux. (Reproduced by permission of West Australian Newspapers Ltd)

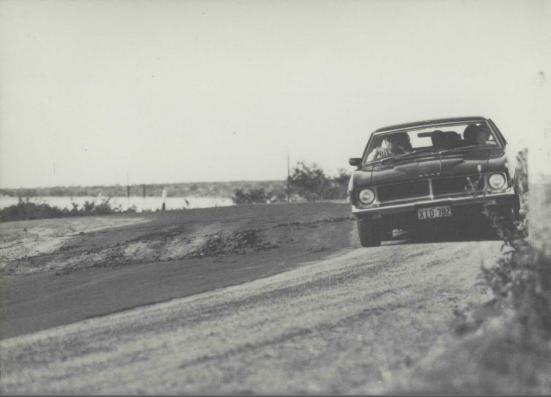
Central fracture zone looking west across main road 3.2 km north of Cadoux. (Reproduced by permission of West Australian Newspapers Ltd)

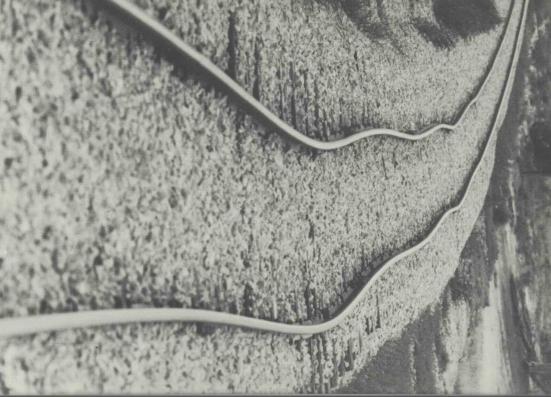
Fence displacement 4.0 km south of Cadoux, looking south. Note fence crosses scarp twice.

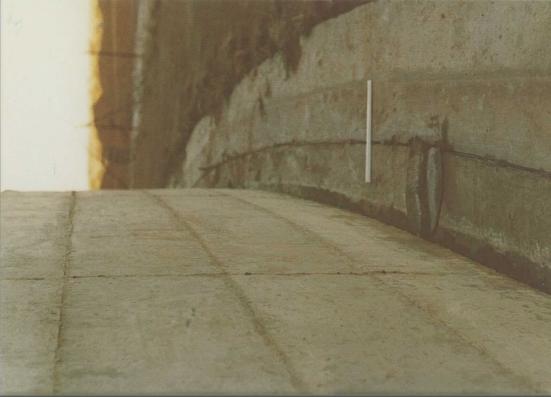
Damage to cement brick house, adjacent to northern fracture zone. (Reproduced by permission of West Australian Newspapers Ltd)

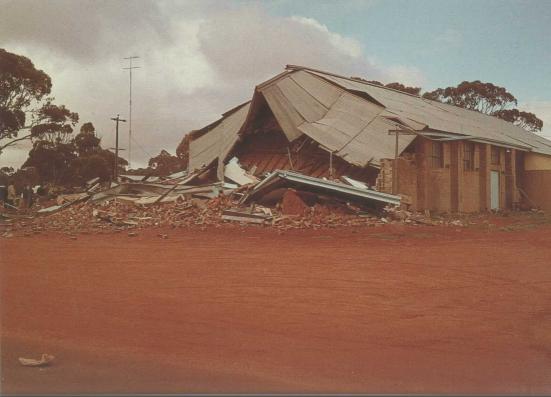
Damage to club house. Collapse of roof after brick wall support collapsed.
