BUREAU OF MINERAL RESOURCES, GEOLOGY AND GEOPHYSICS

RECORD 1981/42

Report on pyritic aggregate and the
cause of warping in concrete paving
flags, Parkes Place,
Canberra, A.C.T.

A.D. Haldane

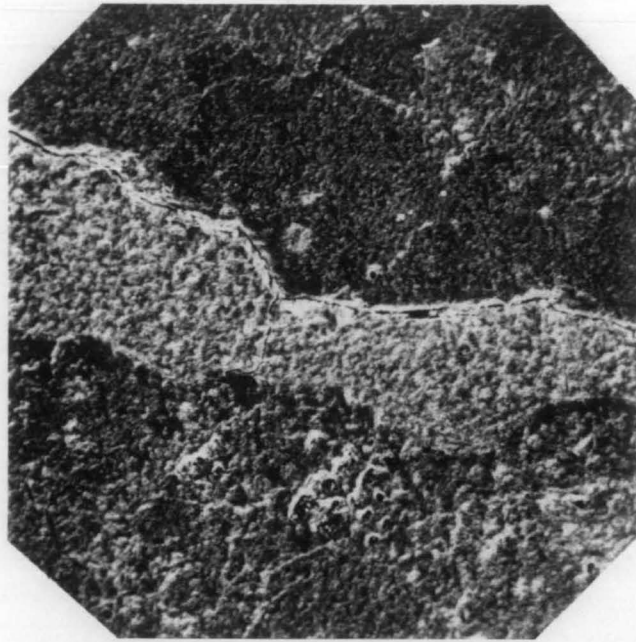
Fig 1(a) Fracture line, in paving flag along cement matrix (light grey)- aggregate (dark grey) boundary. Magnification 47X.

Figures 1(a & b), 2(a-c), and 3(a-d) contribute a series of scanning electron micrographs taken to illustrate vesicle and fracture filling found in the paving flags. The body of the flags exhibits a network of microscopic cracks filled with ettringite (Fig. 1). These cracks occur in the cement matrix and along aggregate grain boundaries. Spherical voids, filled to various degrees of completeness with well-developed ettringite crystals, occur throughout (Figs 2 & 3). Other inclusions are a felted mass of ettringite, unidentified crystals and remnants of other material. An examination of the base of a piece of paving flag showed a thin skin approximately 1 mm thick of soft, white, altered cement matrix. X-ray diffraction analysis of this material and the adjacent grey cement matrix gave the following approximate composition:

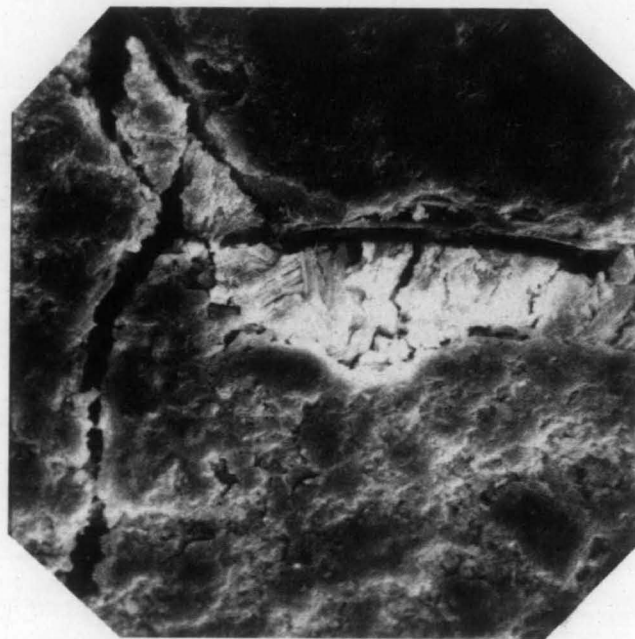
Fig 1(b) Central section of fracture in fig 1(a) showing filling of fracture by ettringite crystals. Magnification 470X.

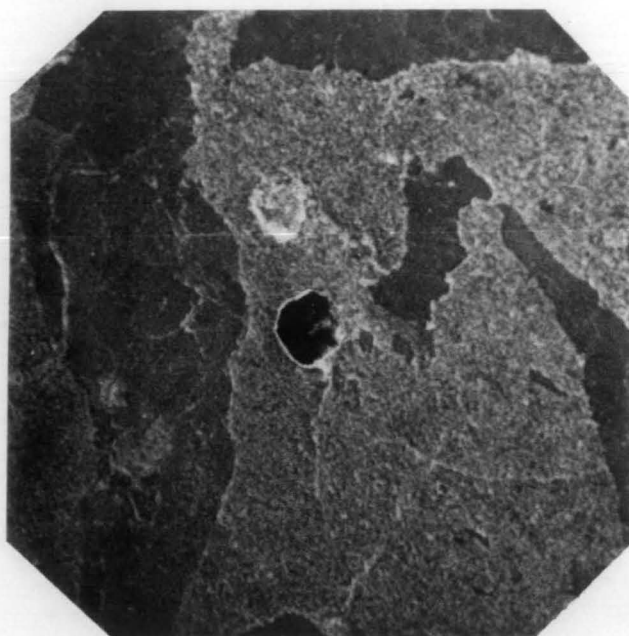
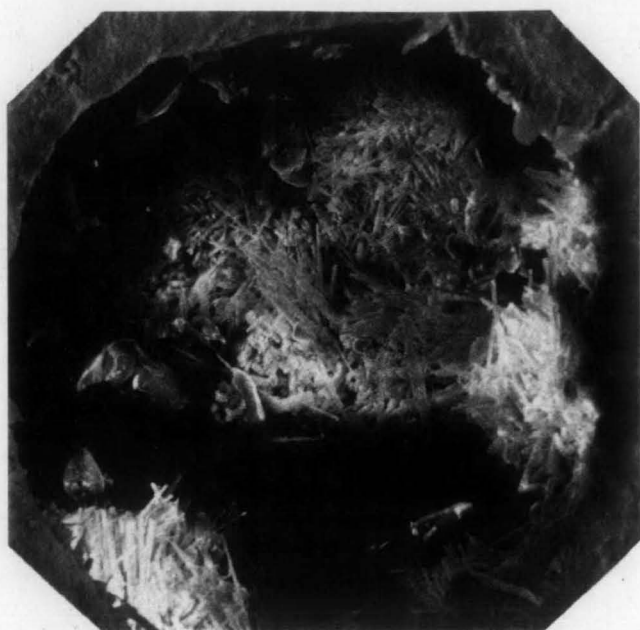
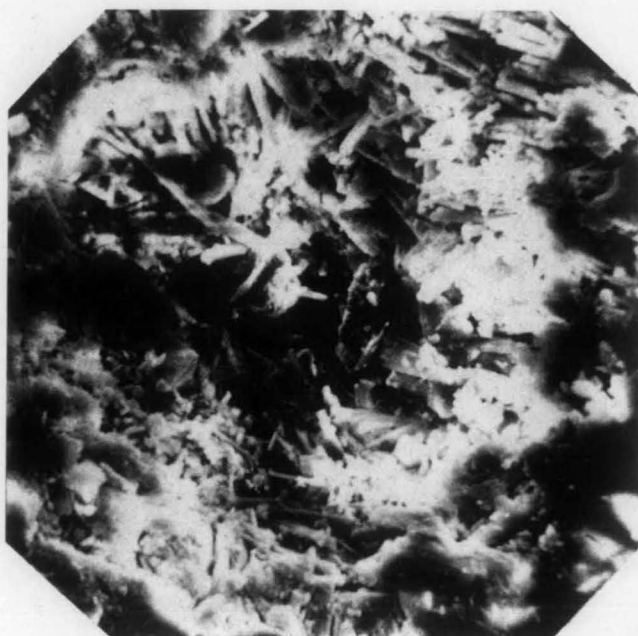
Fig 2 (a) Paving flag showing filled vesicle (white) and partially-filled vesicle (black) in cement matrix (light grey). Aggregate is dark grey. Magnification 20 X.
 (b) Ettringite crystals in partially-filled vesicle visible in fig 2(a). Magnification 200 X.
 (c) Dense mass of ettringite crystals in filled vesicle visible in fig 2(a). Magnification 430 X.

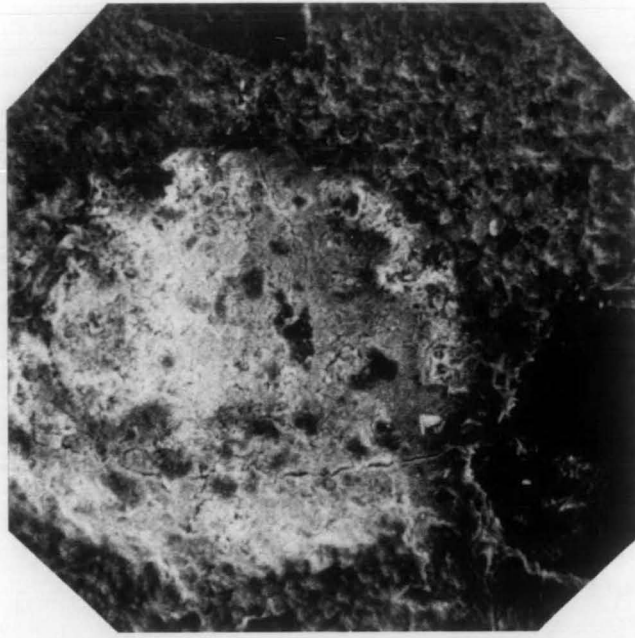
Fig 3(a) Paving flag showing filled vesicle (white) in cement matrix (light grey). Magnification 80X.

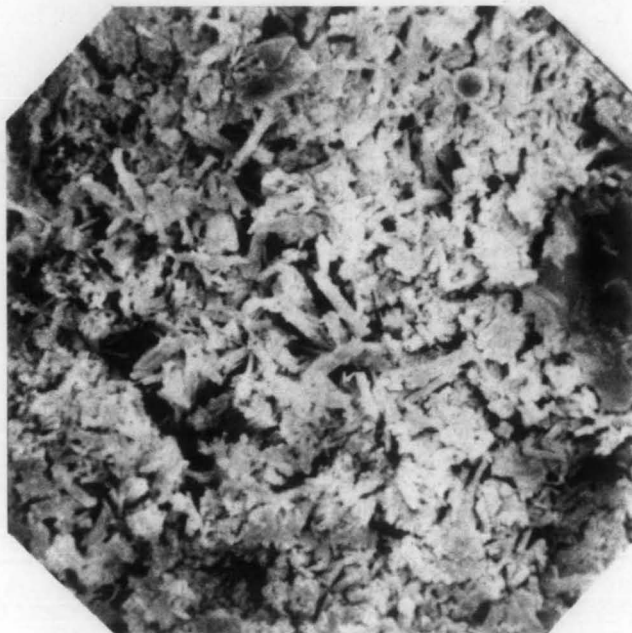
Fig 3(b) Central area of fig 3(a) showing filled vesicle (white) in cement matrix (light grey). Magnification 80X.

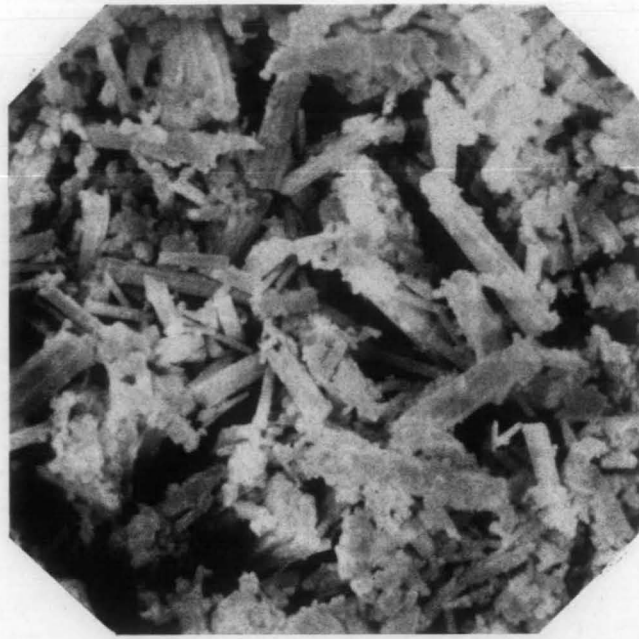
Fig 3(c). Central area of fig 3(b). Magnification 2000 X

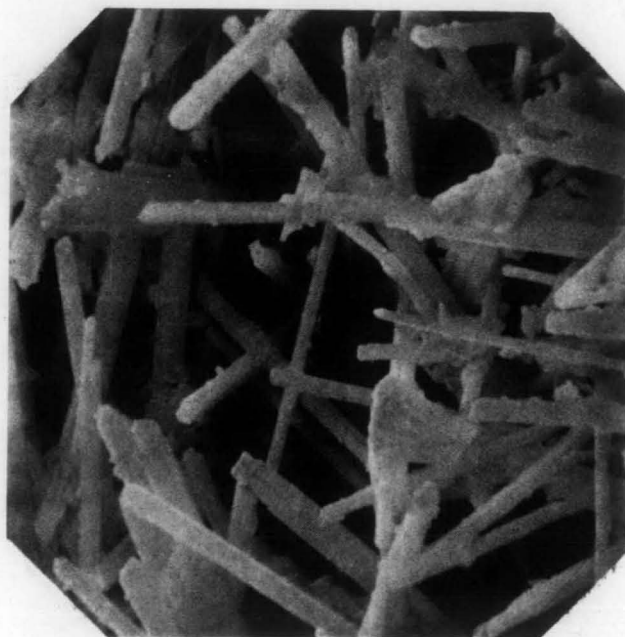
Fig 3(d) Partially filled vesicle in fig 3(a) (black area, lower right hand corner of 3(a)) showing detail of ettringite crystals. Note generally larger crystals than in filled vesicle (fig 3(c)) and absence of cement particles. Magnification 2000 X.
