A REGIONAL REVIEW OF COASTAL HAZARDS ALONG THE SOUTH WEST COAST OF WESTERN AUSTRALIA

Minerals and Geohazards Division
Perth Cities Project

**This report was produced as a part
of the graduate traineeship program**

**Geoscience Australia
April – June 2002**

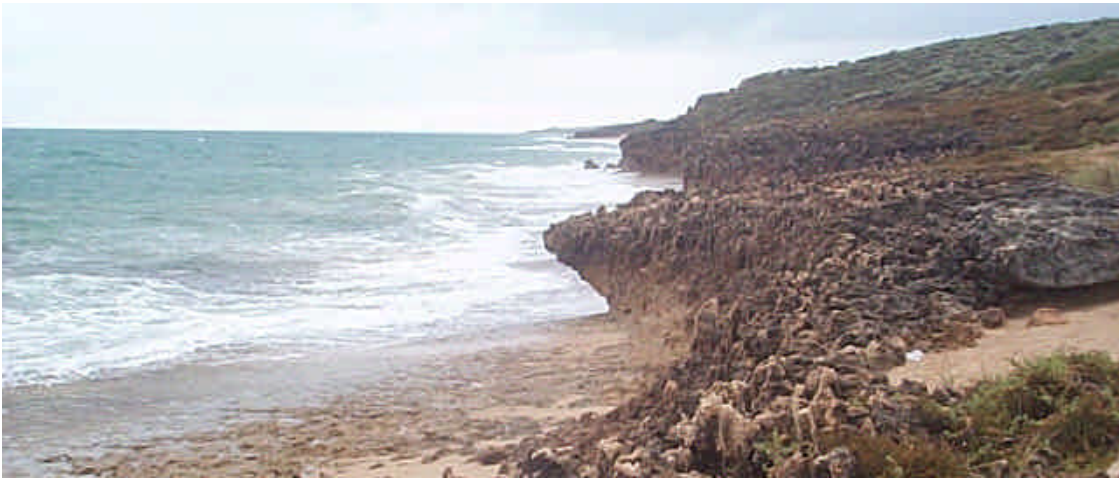
Figure 2.4 Wave action at the base of this cliff has initiated the development of an overhang.

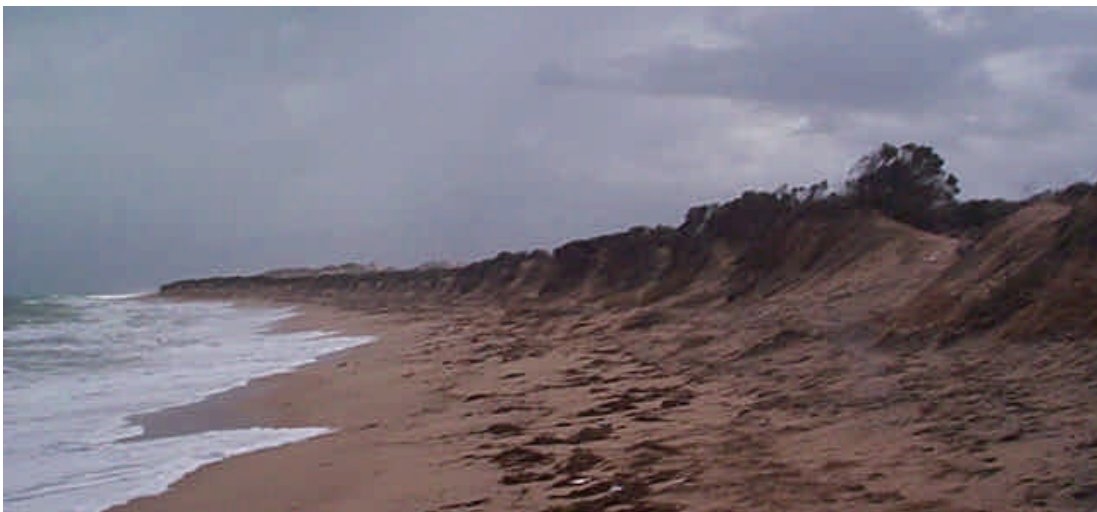
Erosion of dunal systems can occur through several processes. The first agent of dune erosion is that caused by wave action upon the seaward margin of a foredune (Figure 2.5). This natural process cuts into the base of the dune, increasing the angle of repose and exposing a crumbling cliff of sand. This process can dramatically increase the risk of collapse and is most common during winter storms.

Figure 2.5 The natural angle of repose for these dunes has been steepened to almost 90° due to erosion.

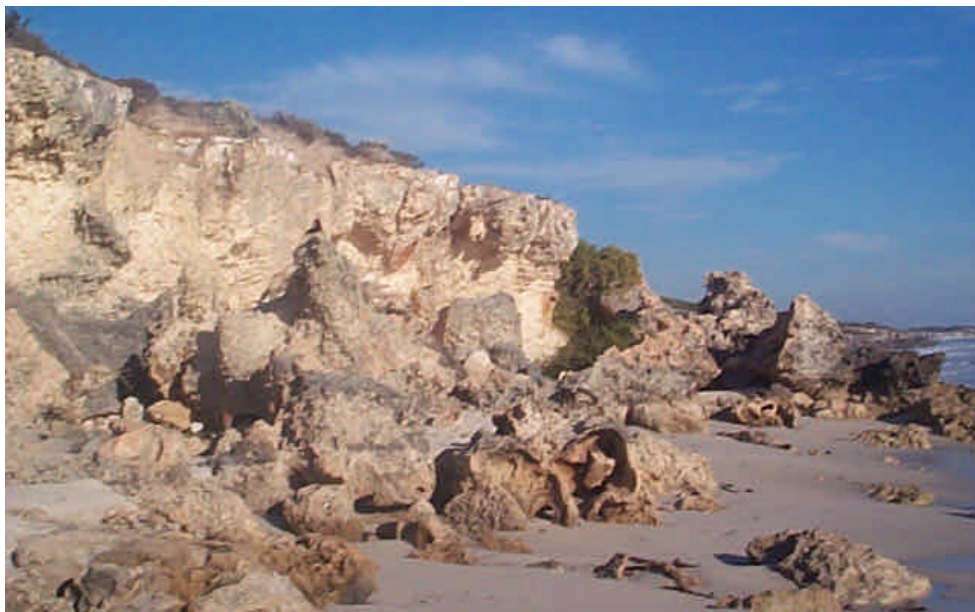
The most obvious feature pertaining to the cliff hazard, are the large limestone blocks that have separated from the parent body and fallen onto the beach (Figure 3.5). These limestone blocks can be up to 1m³ in dimension. The timing of collapse is not known, however in certain instances, variations in the colour of the exposed rock formations indicate recent fracture.

Figure 3.5 Large limestone blocks ($<1\text{m}^3$) have separated from the cliff and fallen on to the beach (Site 5).

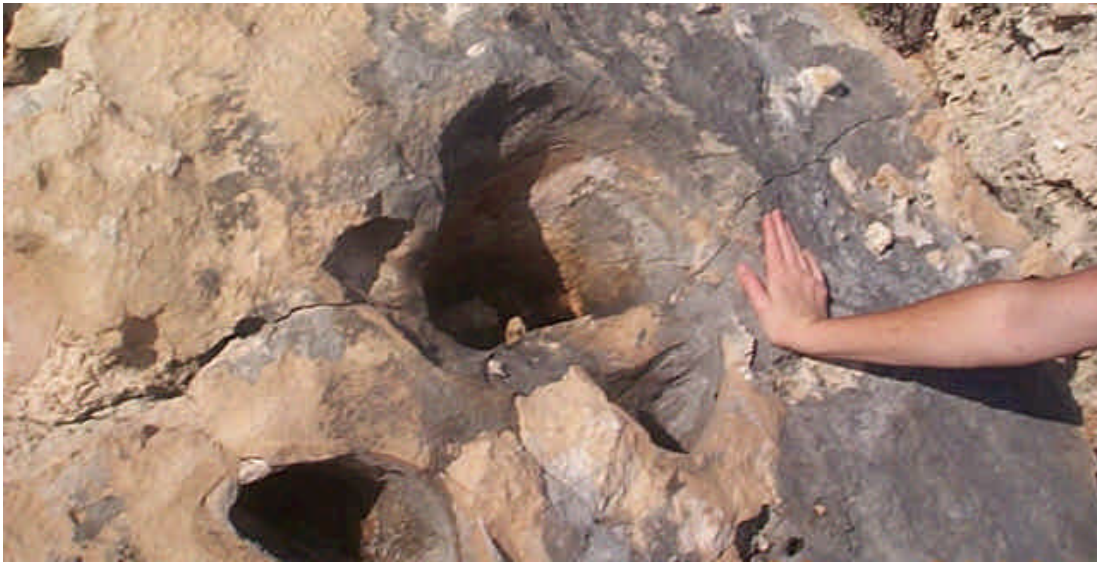
Other features seen within the limestone include cracks and fissures, along with solution piping. This piping was apparent at most sites, but was most noticeable at site 5 where the limestone was riddled with solution tubes up to 60 cm in diameter (Figure 3.6).

Figure 3.6 Solution piping is a common feature within the Tamala limestone. At site 5, these solution tubes were up to 60cm in diameter.

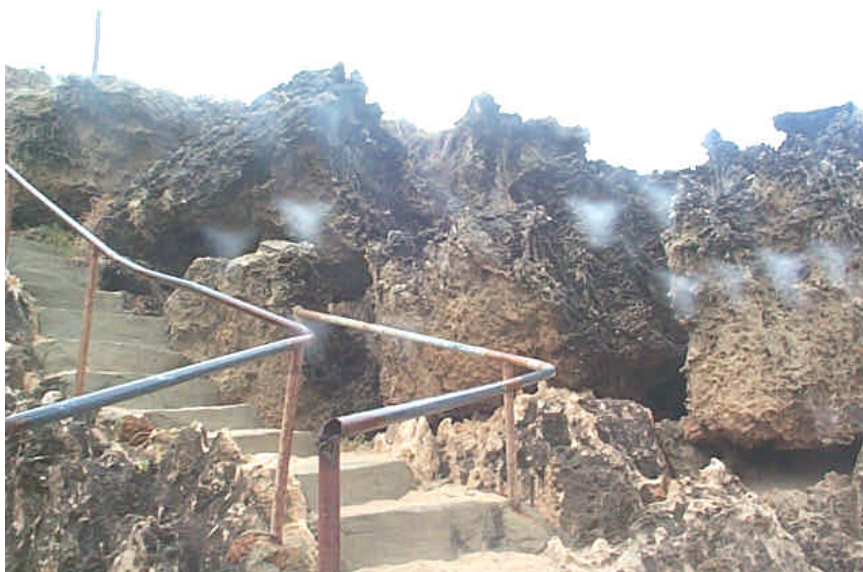
the cliff, and some of these are encroaching on to the public staircase that provides access to the beach (Figure 4.3). There did not appear to be any warning signs at this site, despite recommendations to do so in a draft safety audit for the City in 1997. It may be possible however, that these signs have been removed or are still in the process of being developed.

Figure 4.3 Limestone blocks encroaching on to a stair way that provides the public with beach access.

Loose or unstable blocks of limestone are extremely hazardous in frequently used areas. Removing loosened blocks or rolling them down the slope using mechanical equipment such as a backhoe bucket can reduce the risk of rockfall. This remedial method has been suggested for several localities by geotechnical consultants.

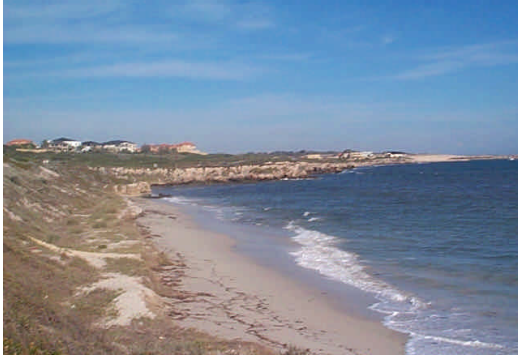
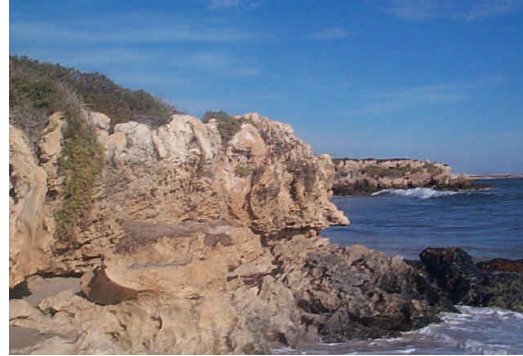
Site number: 4
Location: Quinns Rock Beach
GPS: 0376504 / 6494237
Geological unit: Tamala Limestone (LS1)

Description: There is a very narrow (<10m wide) sandy beach, backed by low (~5 m) dunes. At the southern end of the beach, vertical limestone cliffs approx. 3-4 m tall

form a series of headlands along coast. Access to the cliff areas is limited as they front straight on to the water. There is evidence of wave undercutting and the development of small overhangs. There are several large ($>1\text{m}^3$) blocks of limestone scattered around the base of the limestone which provide evidence for collapse. There is a large sign at the top of the car park warning visitors that this is a rock fall risk area.

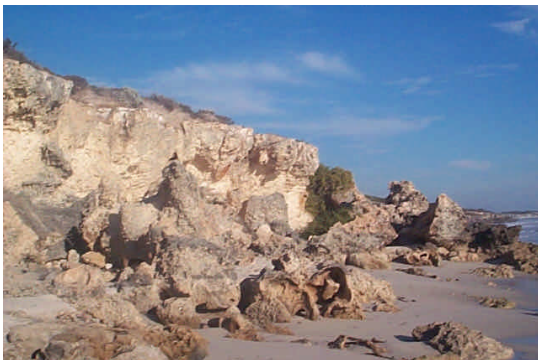
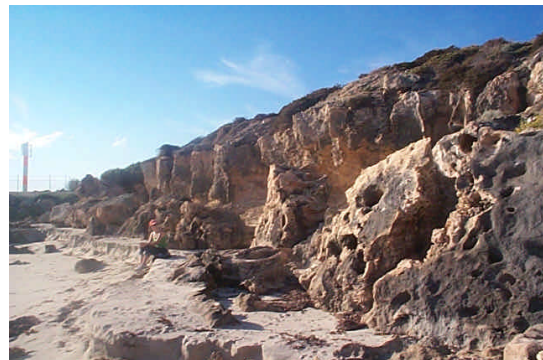
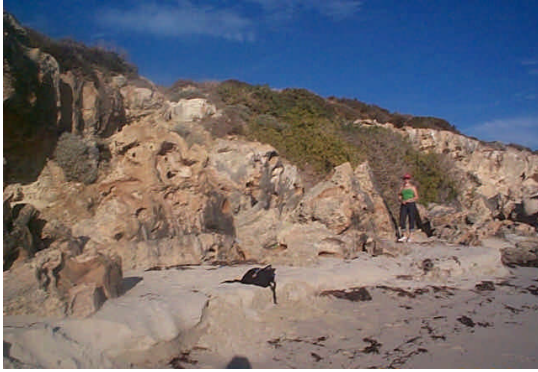
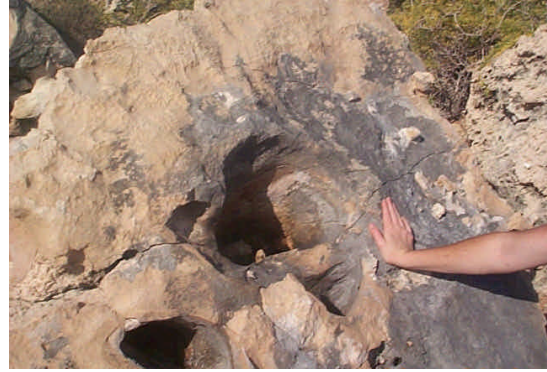
Site number: 5

Description: This site is characterised by a small sandy beach backed by highly weathered limestone cliffs (~5 m tall). The beach is littered with very large ($1\text{--}2\text{ m}^3$) blocks of limestone derived from collapse. The cliff face appears to be quite fresh in a number of places which is evidence for recent topples. The limestone is extremely porous exhibiting large solution tubes $<60\text{ cm}$ in diameter. A fence has been erected part way around this area, but does not surround it, making the beach easily accessible. There are no warning signs in the immediate vicinity identifying the cliff as a hazard.

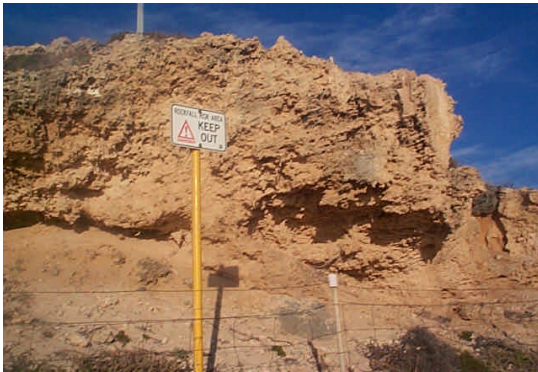
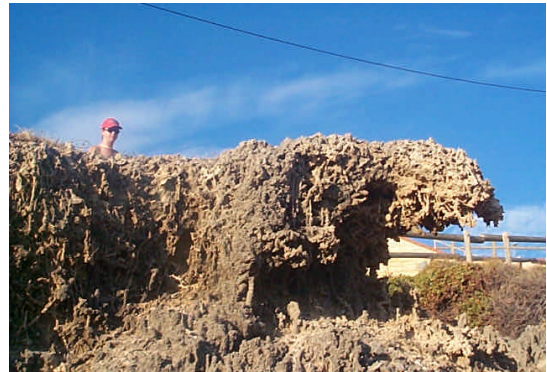
Site number: 6

Description: Some of the limestone cliffs within this area appear to have crumbling rock faces. Pitting caused by dissolution is evident in some outcrops, along with overhang development and loosened blocks of limestone. Calcified root structures can be seen quite clearly in one outcrop, and is an excellent example of the Zone of Roots. Fences have been erected around dangerous areas and warning signs are displayed.

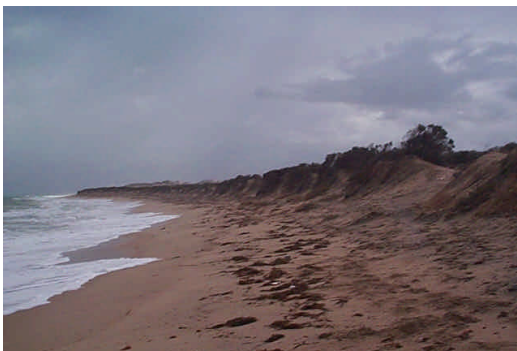
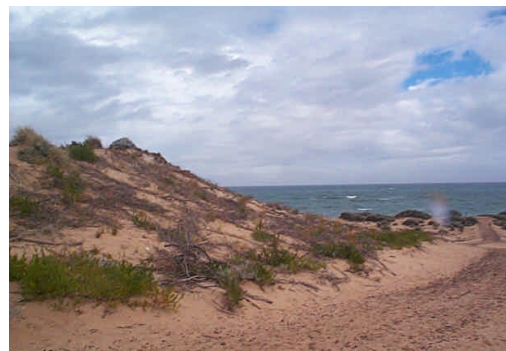
Site number: 14
Location: Tims Thickett Road
GPS: 0370112 / 6386302
Geological unit: Safety Bay Sand, S1 backed by S2

Description: The foredunes along this narrow beach are 4-5 m high and front on to the waters edge. Their angle of repose is around 70-80°, giving them a cliff like appearance, which is most likely caused by wave erosion. The dune systems backing the beach are extremely large reaching heights well over 20 m. There is evidence of de-vegetation and blowout formation, however these are being remedied through the use of brushing.

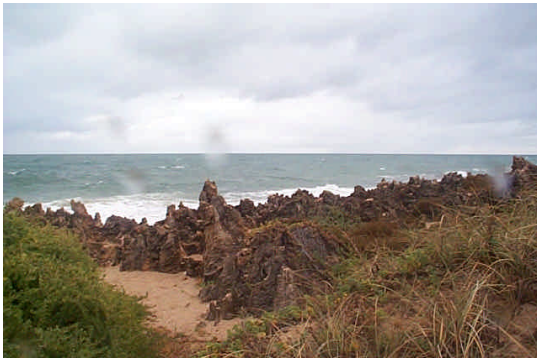
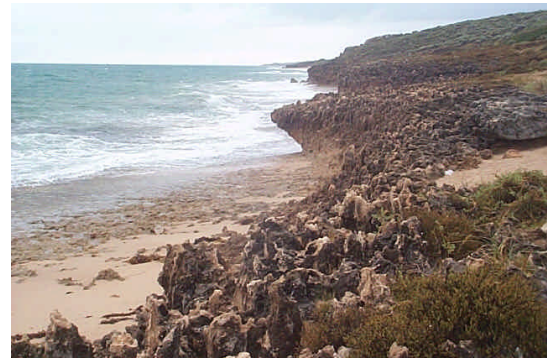
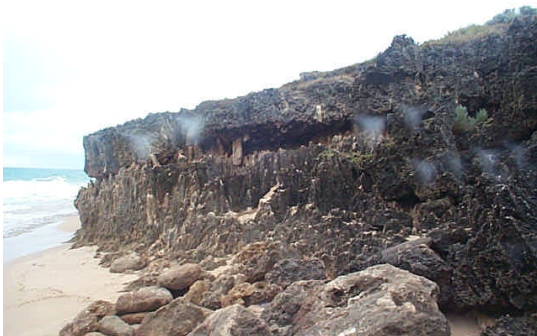
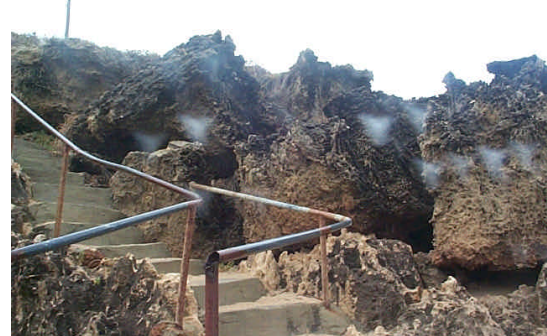
Site number: 15
Location: Gretel Drive, 2km North of Falcon Bay
GPS: 0374892 / 6395996
Geological unit: Tamala Limestone (LS1)

Description: The limestone outcrop in this location is part of a natural headland (< 3-4m high). The limestone fronts directly onto the water with some narrow areas of beach at the base of the cliffs. Weathering features are highly developed at this site, with rock surfaces being extremely jagged and porous. There is clear evidence of undercutting and the development of overhangs, as well as fractures and piping in the rock. Large sections of rock have separated from the parent rock and lay scattered around the base of the cliffs. There are also large separated rocks (> 1m³) encroaching on to the staircase that provides access to the beach. There are no signs erected at this site warning the public about the condition of the limestone or the risk of rockfall.

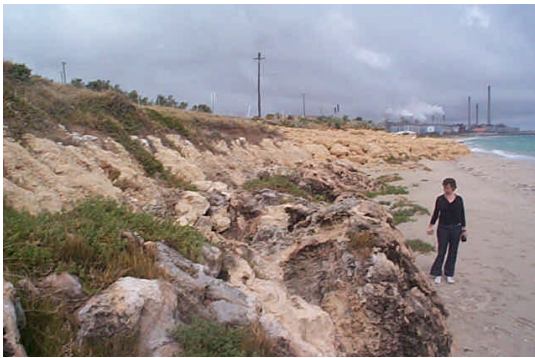
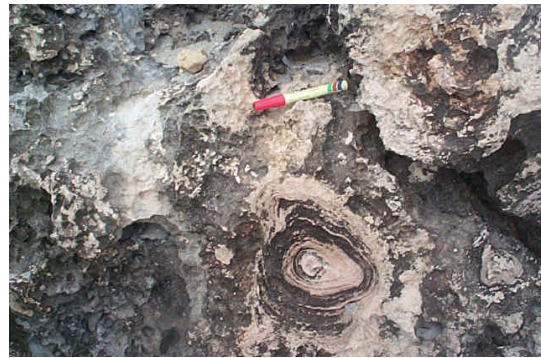
Description: Challenger beach is a flat and narrow sandy beach backed by < 4 m high limestone cliffs. At the base of the cliff there are numerous blocks of limestone ranging in size up to 2 m³. There does not appear to be any major overhang development or cave formation. A 'rockfall risk' sign has been erected at the top of the beach.

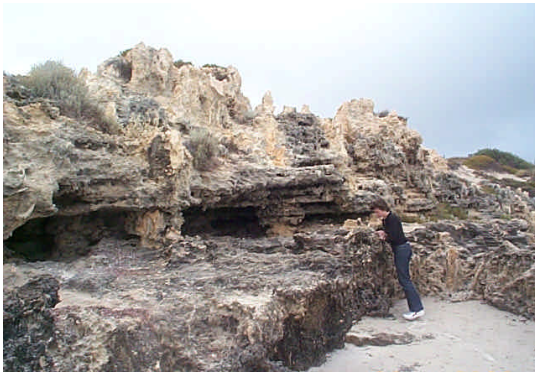
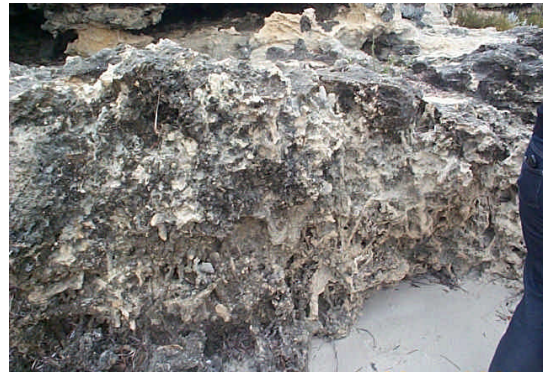
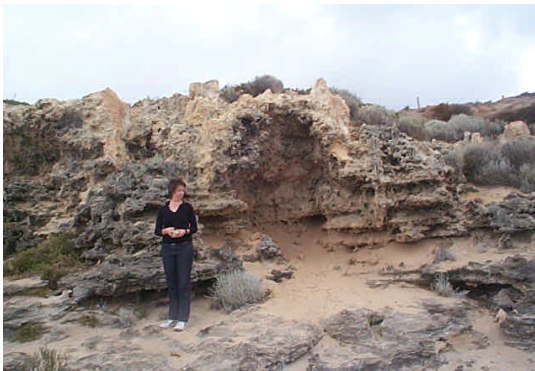
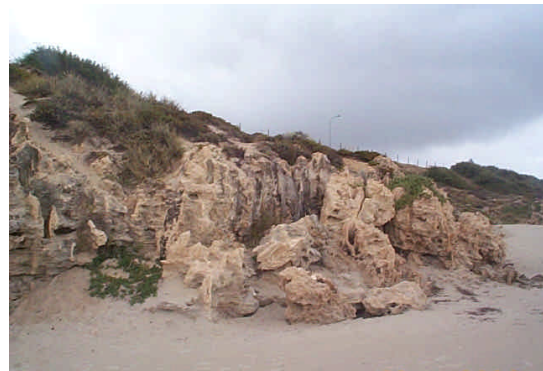
Site number: 18
Location: South Cottesloe Beach
GPS: 0382113 / 6458087
Geological unit: Tamala Limestone (LS1)

entrance to the beach outlining prohibited activities and general warnings. The risk of rock fall is one of these warnings.
