The 30TH September 2009 West Sumatra Earthquake

Padang Region Damage Survey

2010/44

GEOSCIENCE AUSTRALIA
RECORD 2010/44

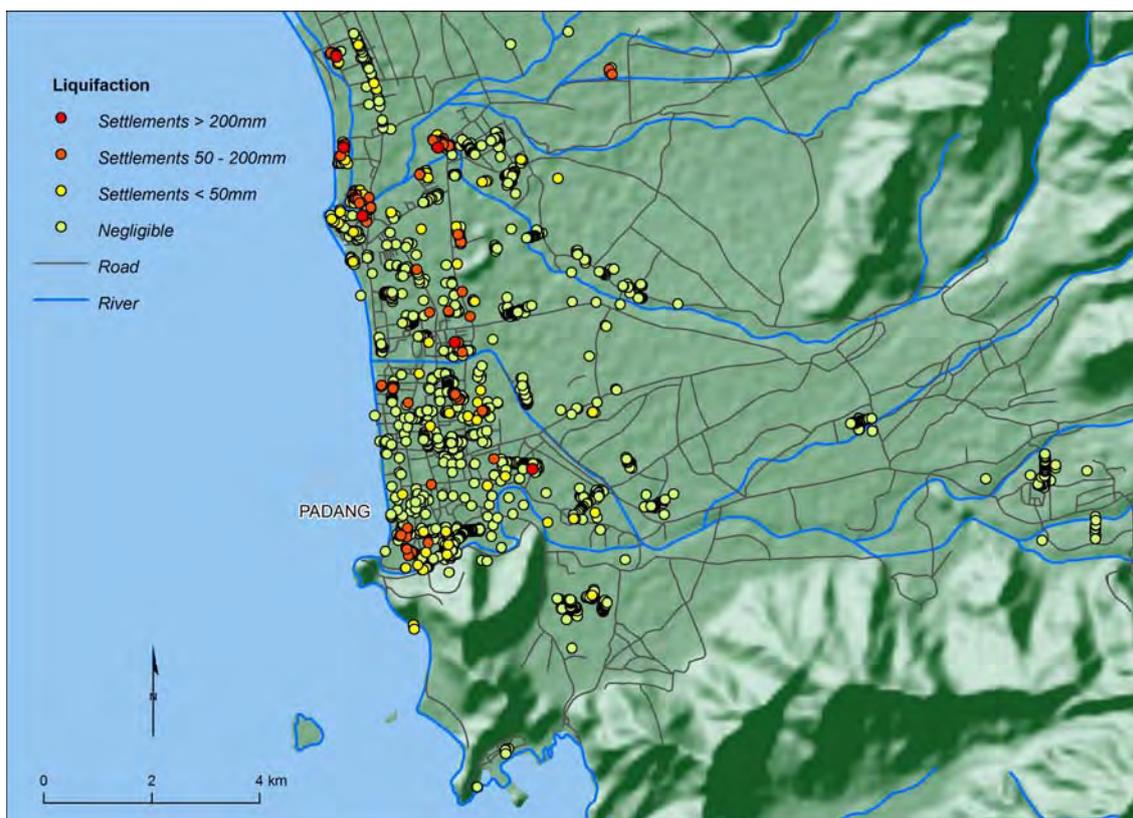
Extensive liquefaction was experienced across the coastal plain. Sand boils, settlement of building structures and lateral spreading were evident. Figure 3.4 shows the extent of liquefaction as identified by the field survey teams.

Figure 3.4: Locations of liquefaction occurrences as identified by field survey activity.

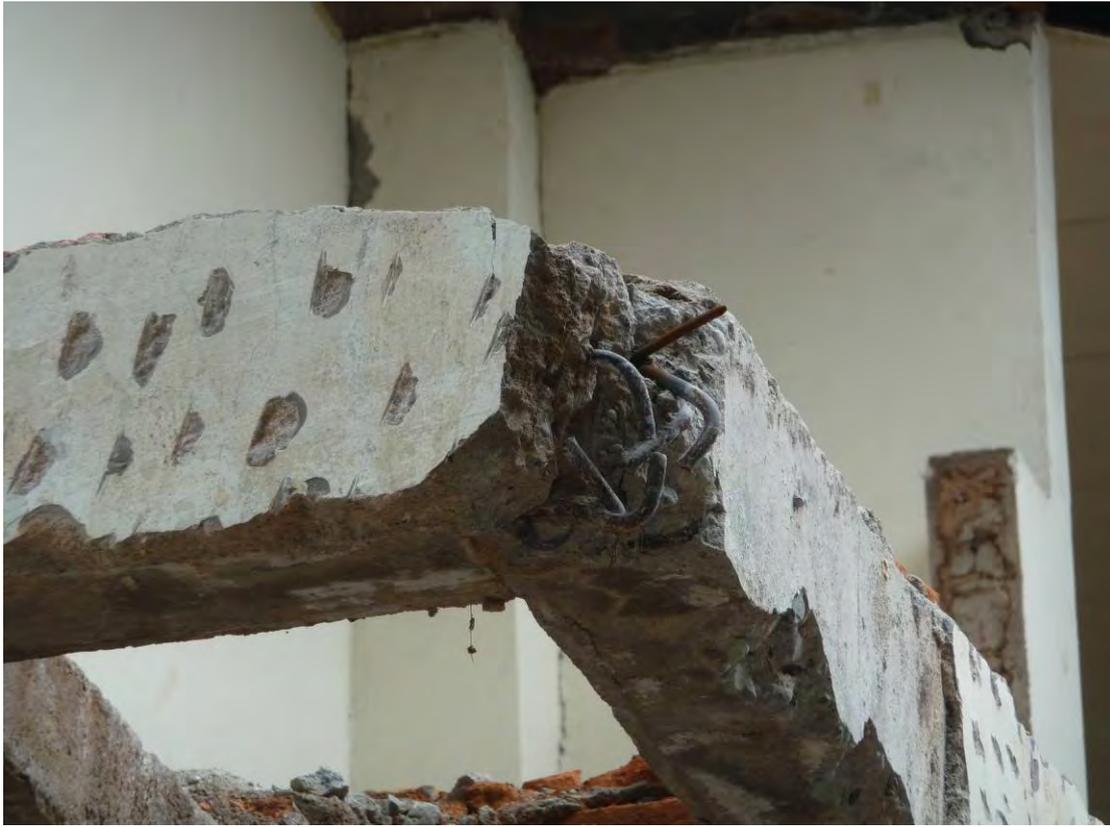
Figure 4 Poor reinforcement detailing

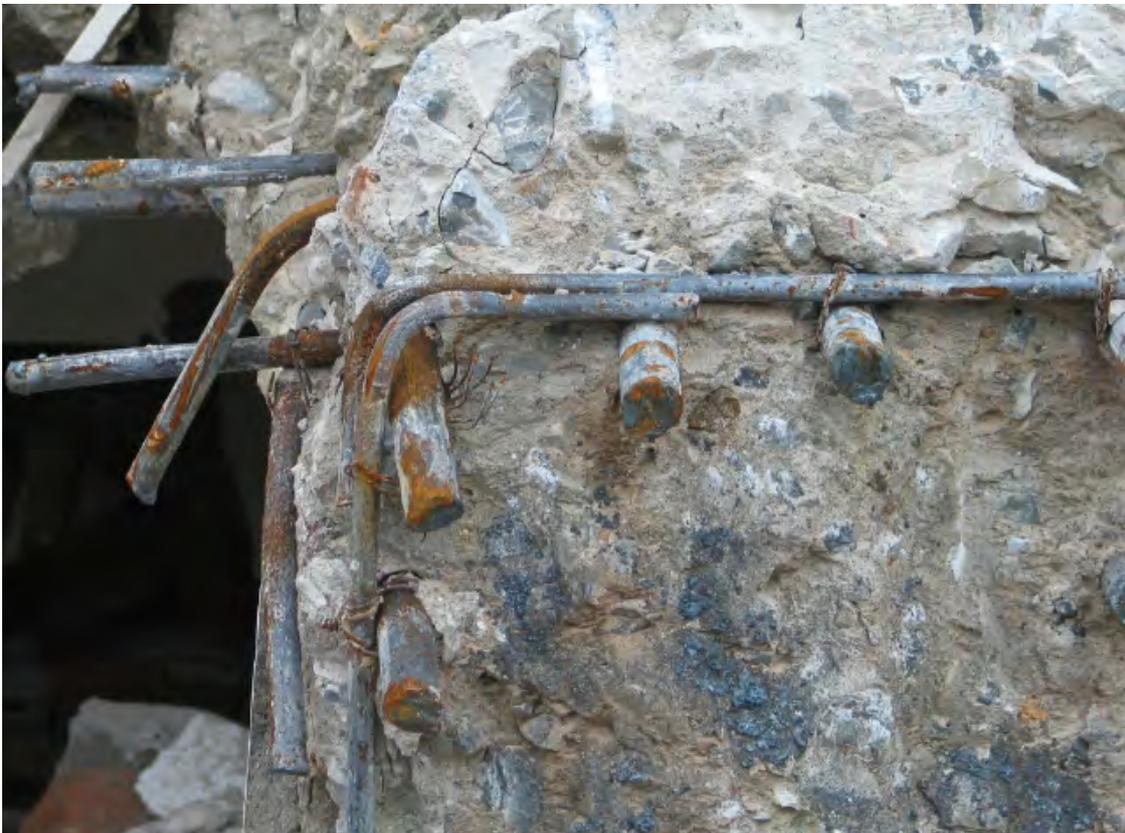
Figure 5 Poor reinforcement detailing

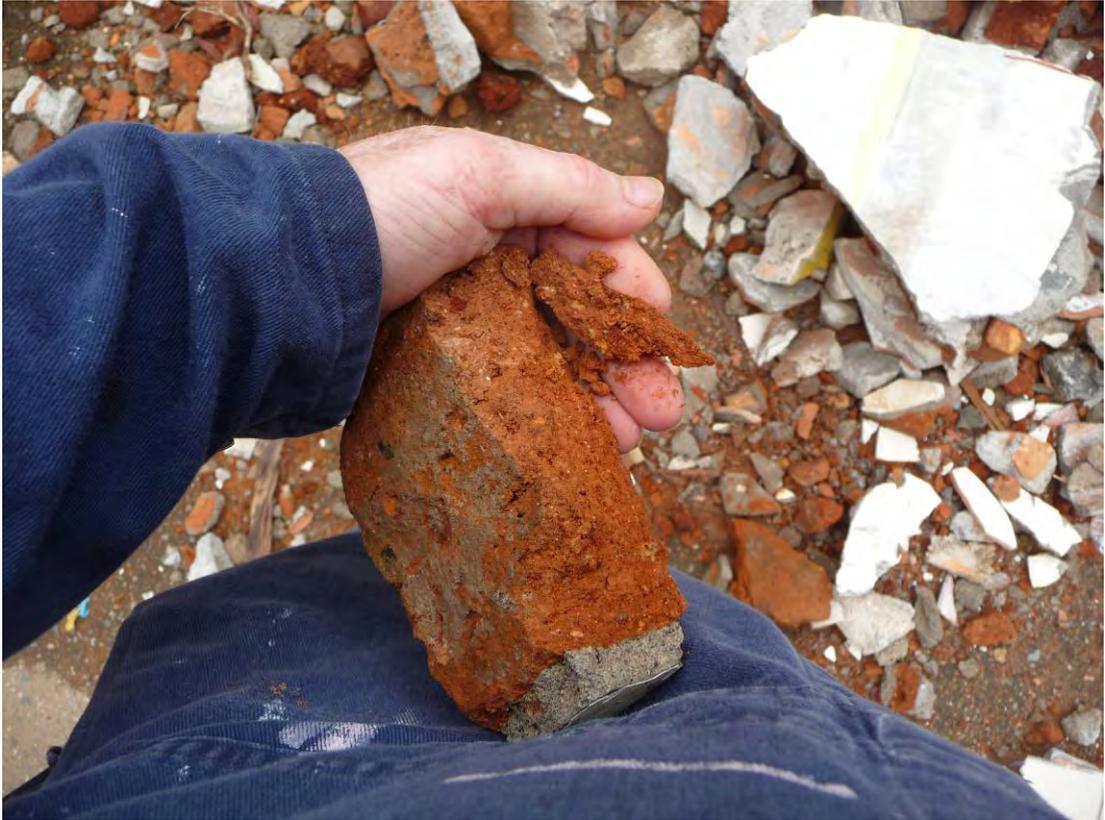
Figure 6 Soft bricks--Broken with fingers

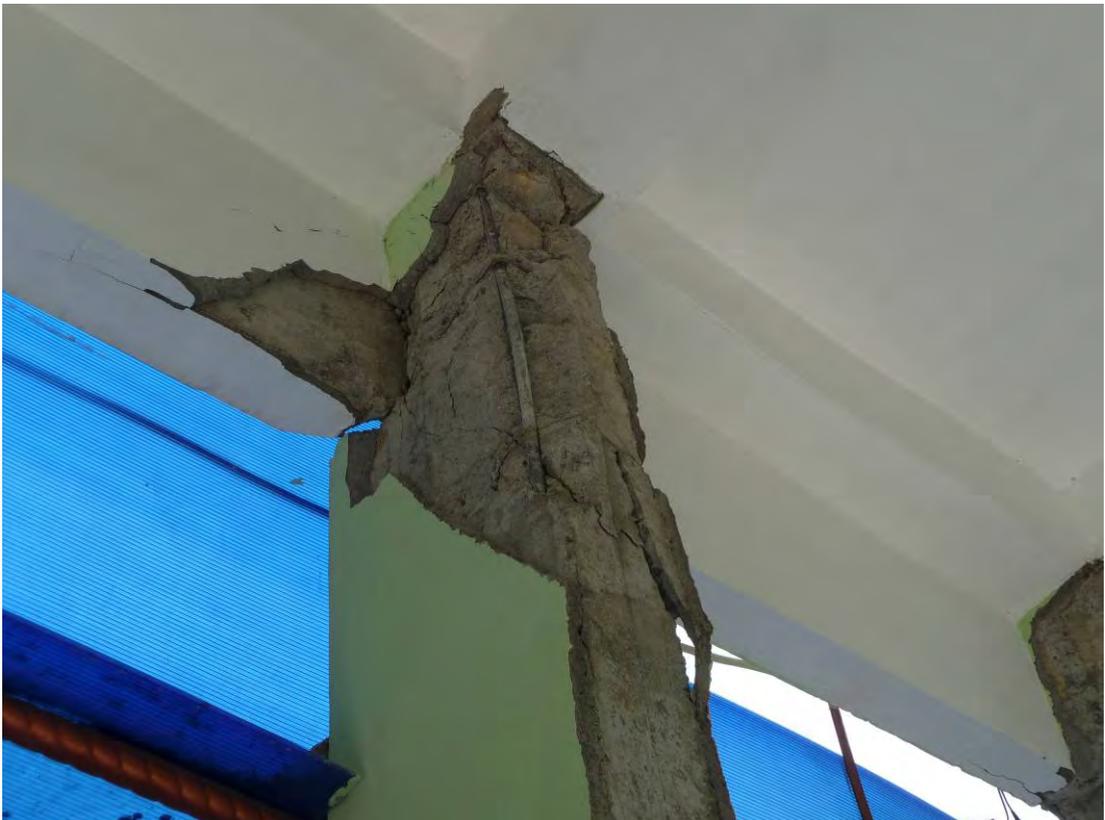
Figure 7 Missing ties in column/joint

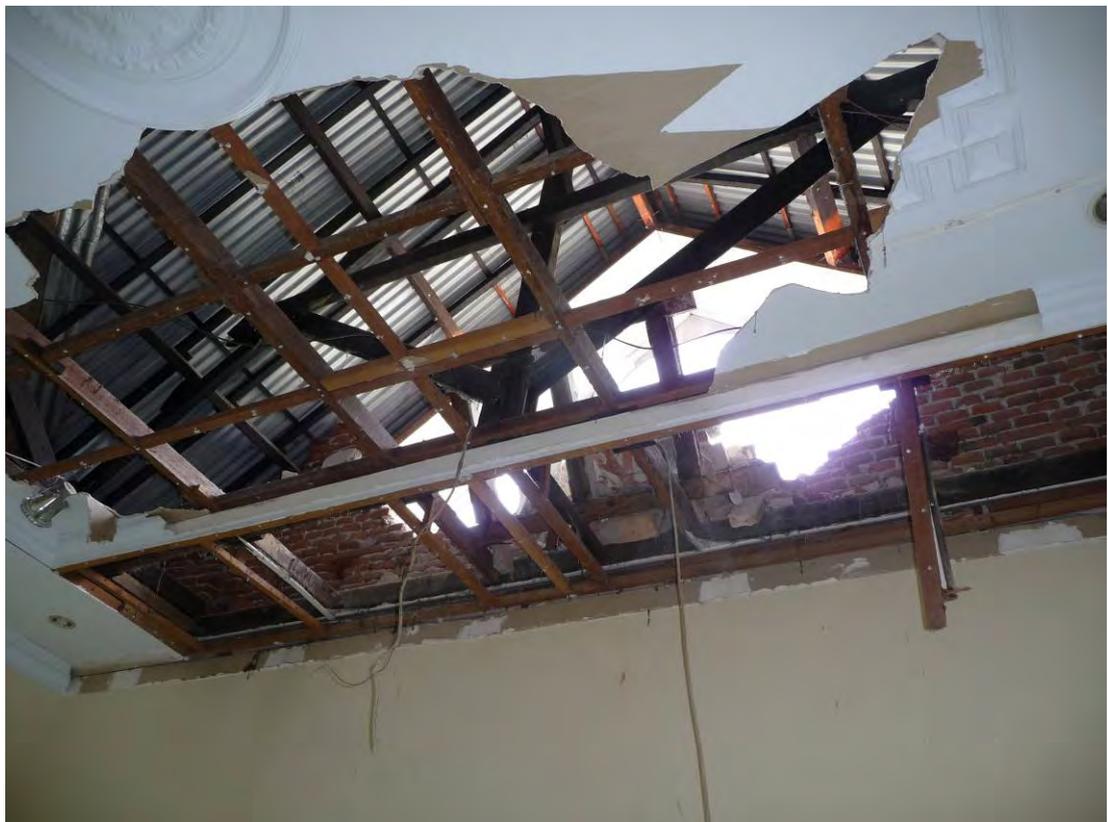
Figure 9 Failed Gable Wall

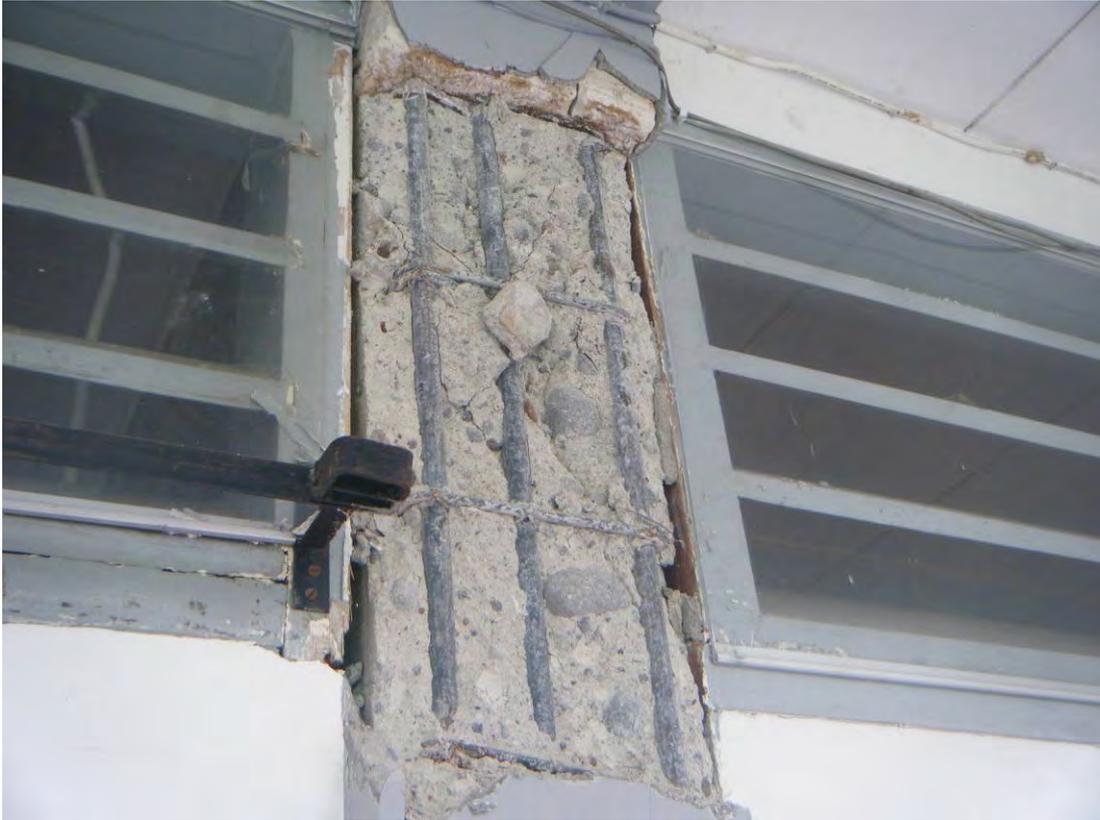
Figure 10 Poor aggregates/concrete

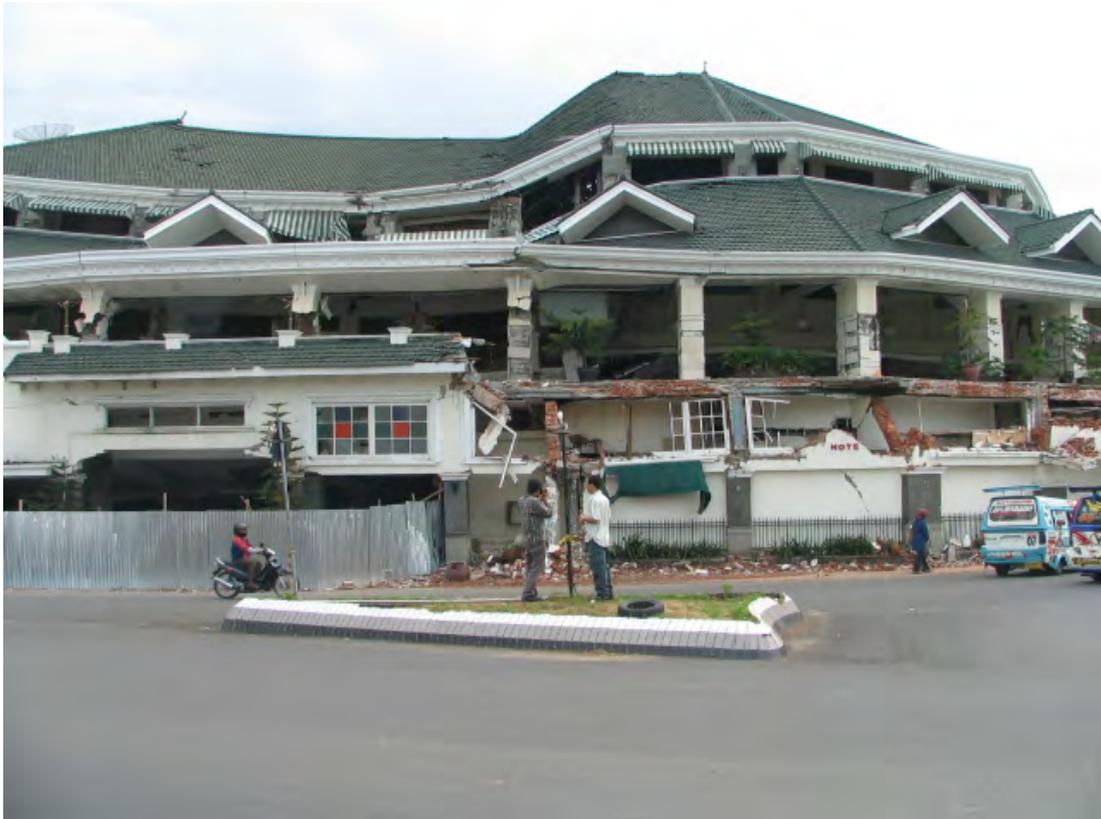
Figure 12 This was a 6 storey hotel

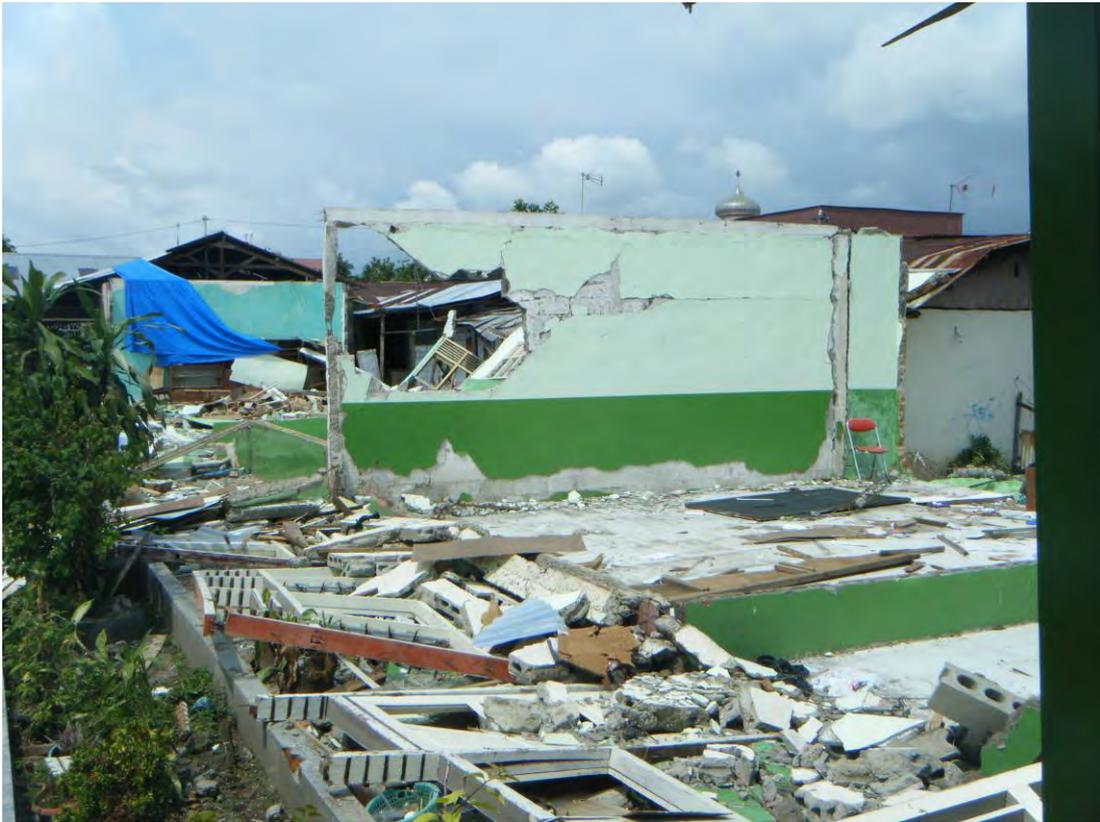
Figure 14 Collapsed school (single storey)

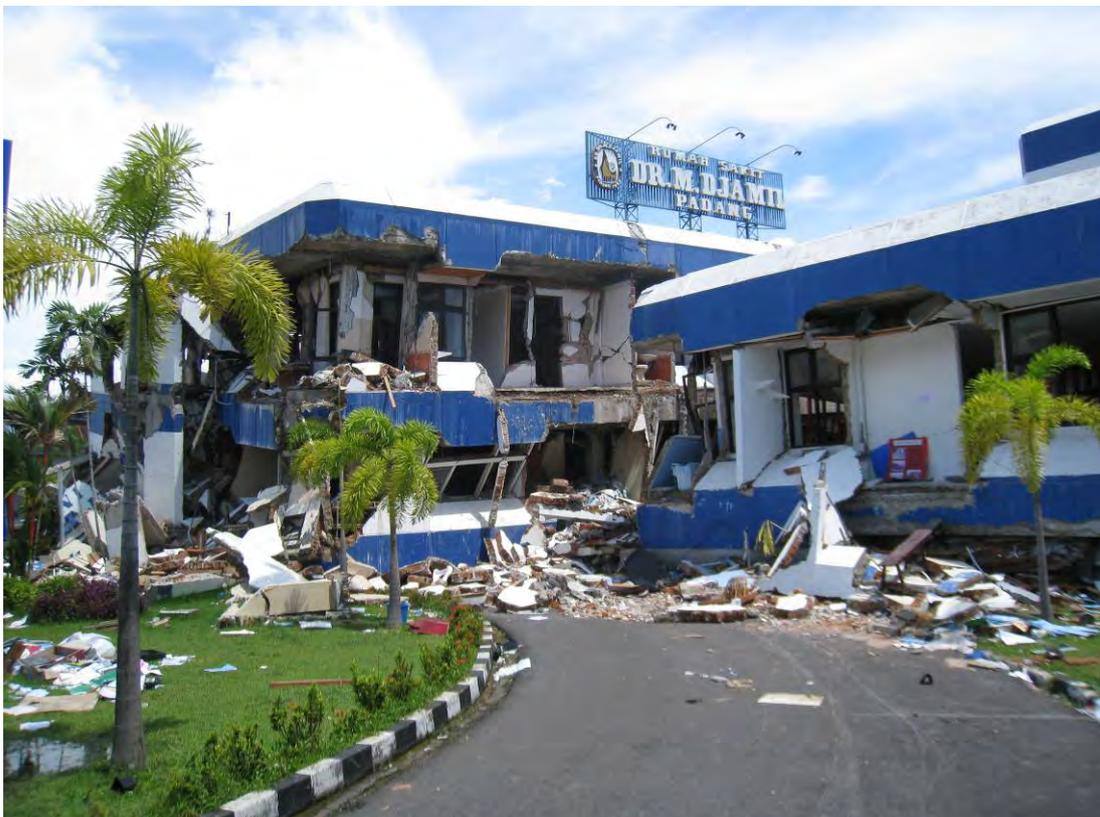
Figure 15 Collapsed Medical Facility

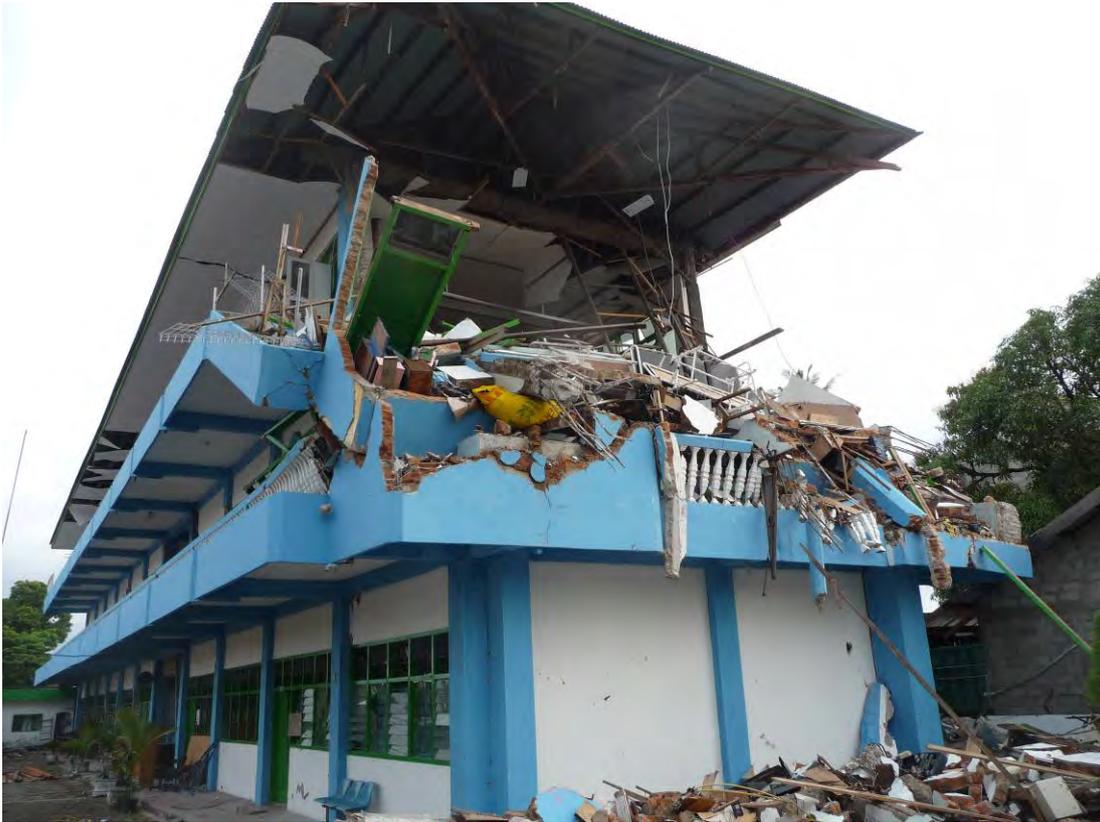
Figure 16 School abandoned

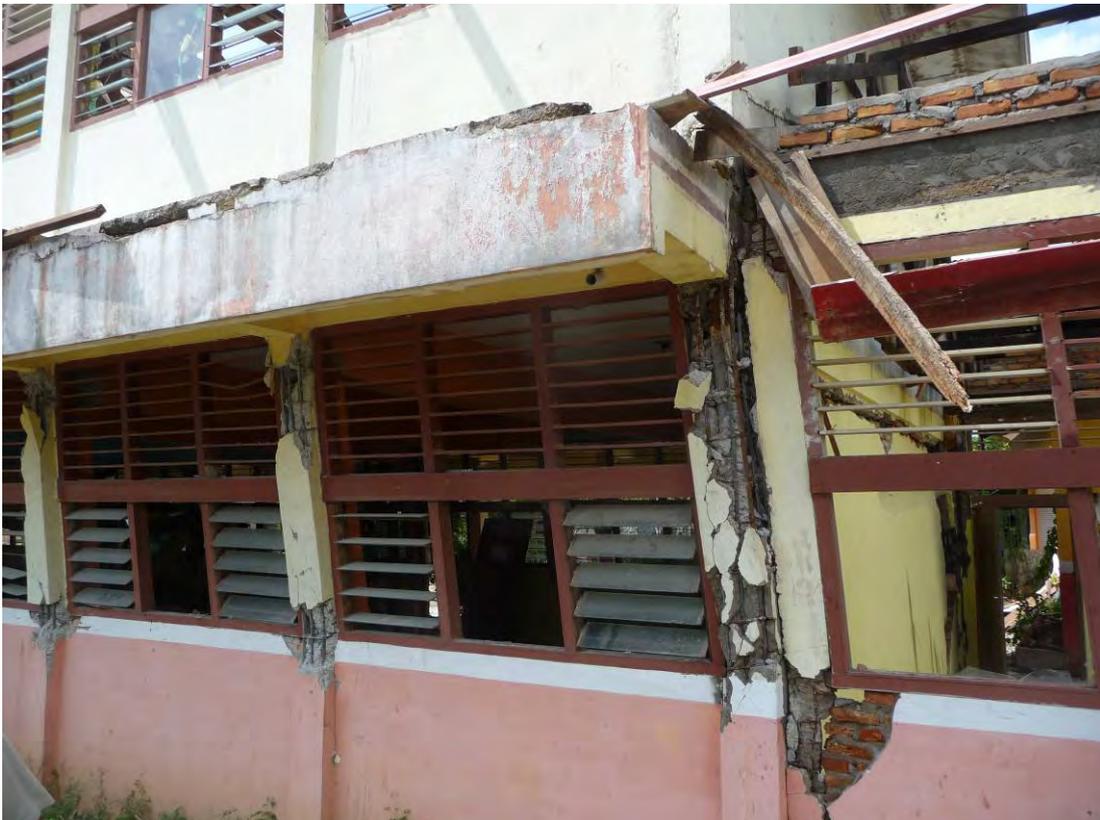
Figure 17 School very near collapse

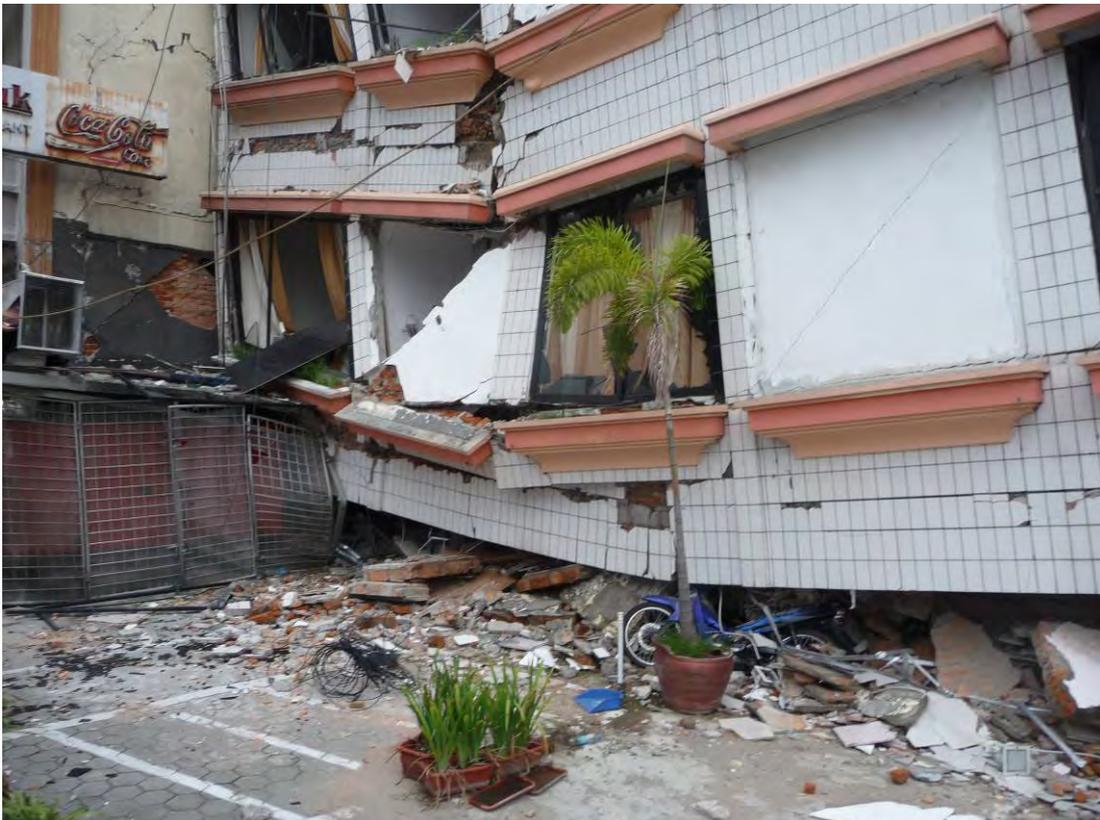
Figure 19 Soft Storey (commercial shop-front) Ground Floor Collapse

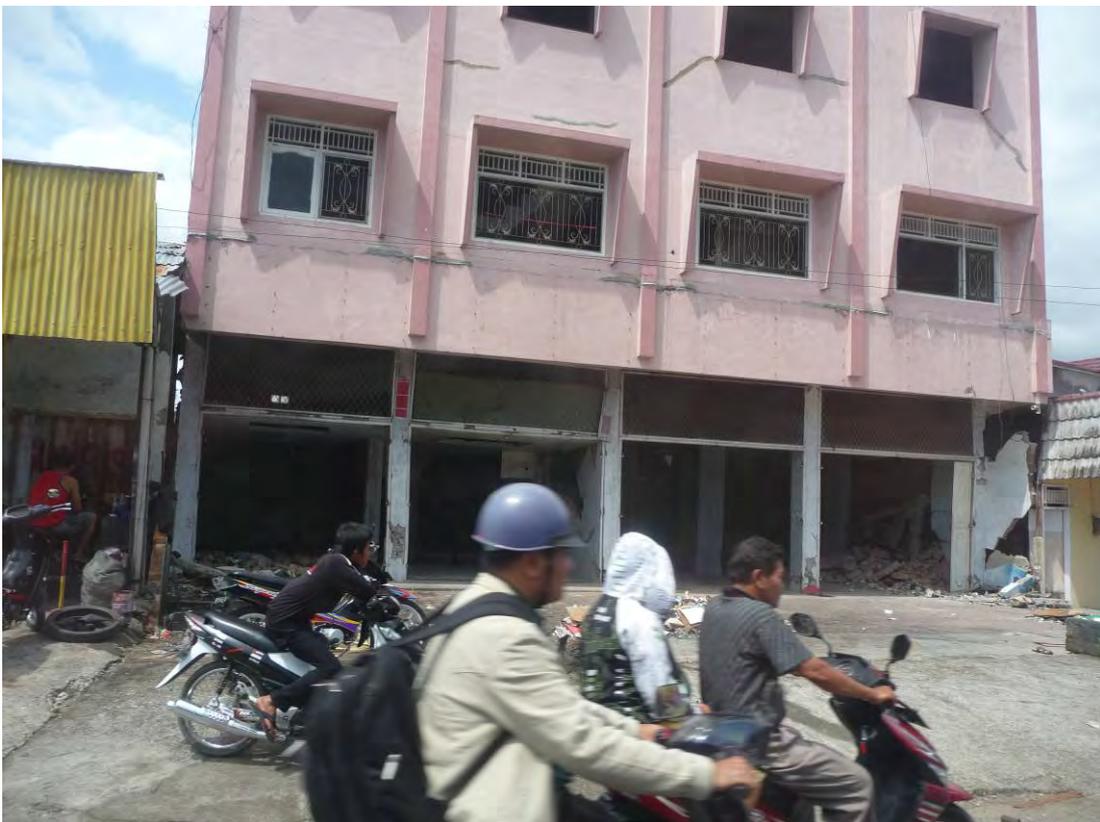
Figure 21 Another soft storey building near collapse

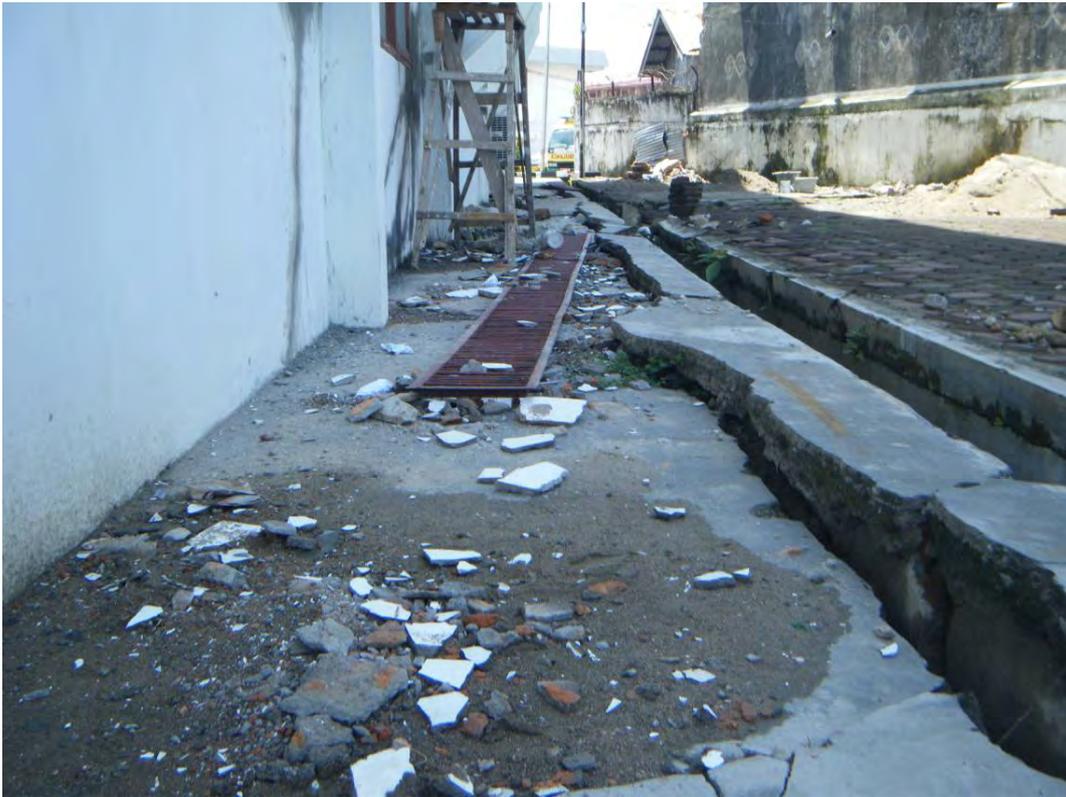
Figure 22 Settlement due to liquefaction (note sand forced up through cracks in concrete)

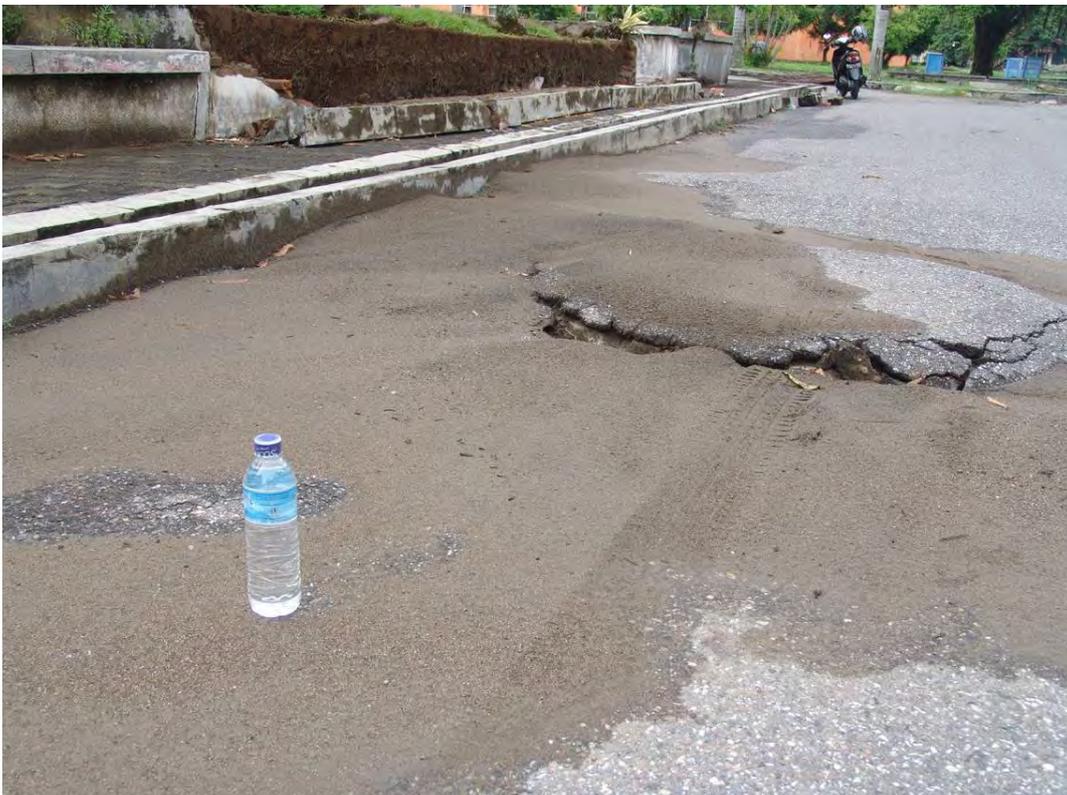
Figure 23 Sand brought to the surface due to liquefaction

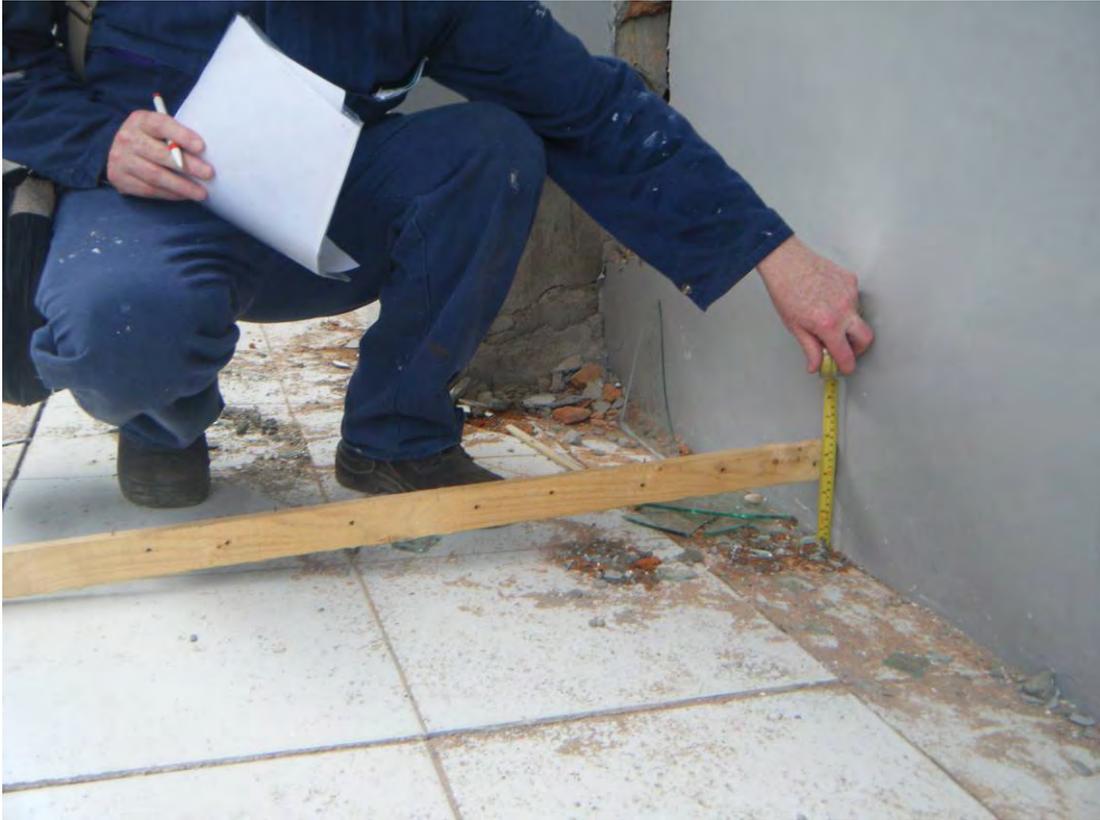
Figure 24 Liquefaction caused heavier buildings to sink
