PRELIMINARY REPORT ON ACCIDENT DURING ERECTION OF SEISMOLOGICAL  
OBSERVATORY AT MACQUARIE ISLAND

Report No. 1949/77

Geophysical Report No. 1949/4

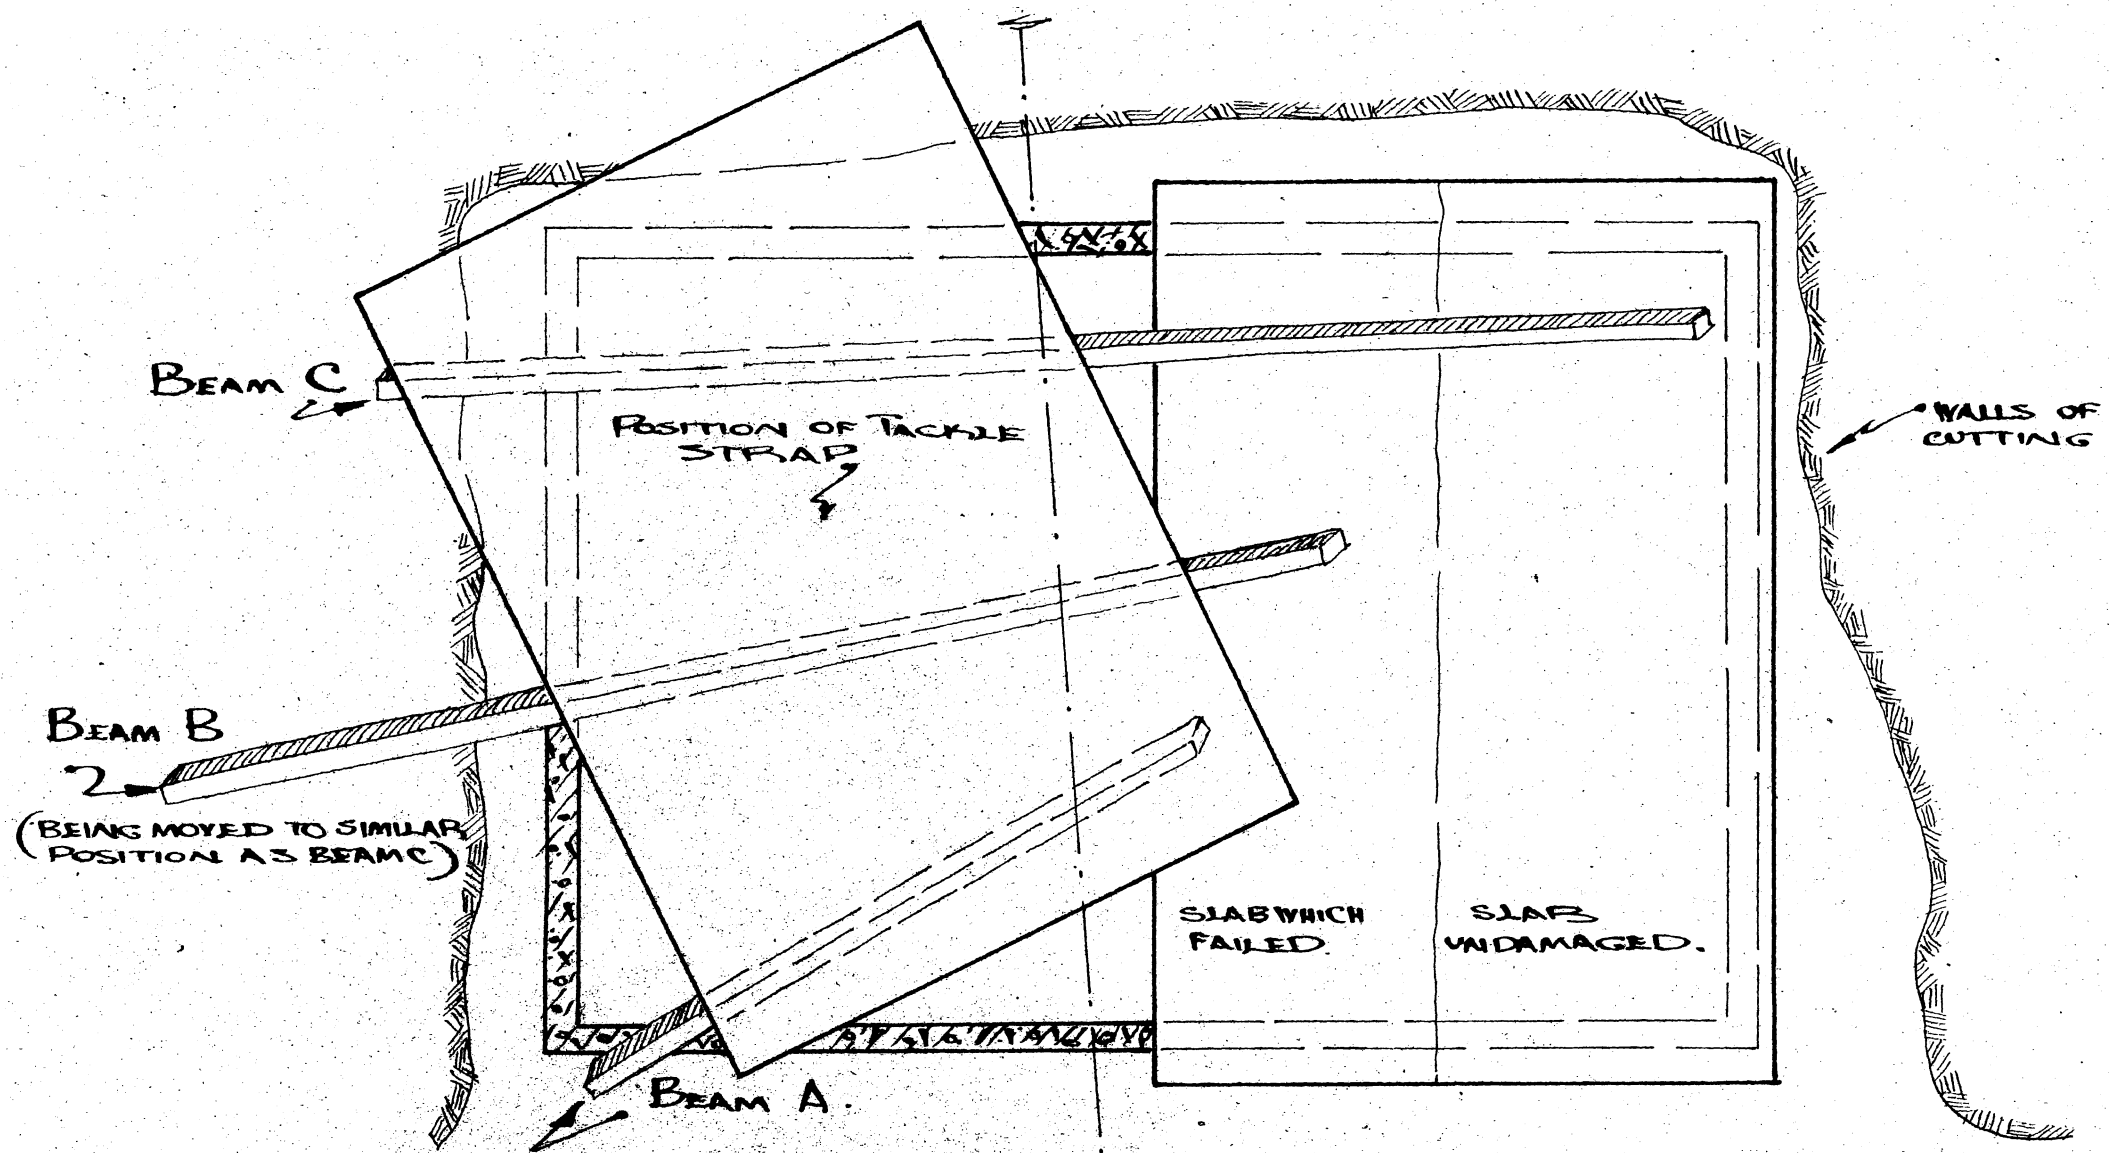
. DIAGRAM 1.  
. ACCIDENT REPORT, MACQUARIE

with comparative ease. The position is illustrated on the accompanying sketch for the critical time when the two smaller (2'6" x 8'8" and 2'2" x 8'8") sections had been satisfactorily placed in their respective positions.

While the third and last roof slab was being manoeuvred into position, as shown, it was supported by two 4" x 4" oregon pine beams by the tackle suspended from the flying fox, and by the inside roof slab already in position. A third 4" x 4" beam was being pushed under the slab to give it additional support and it was found necessary for three men of the Naval working party to stand on the slab temporarily for this purpose. The slab failed at this stage by breaking across the reinforcement. Failure was sudden and without previous warning as indicated by bending or the formation of cracks. Beams A and B then collapsed due to the failure of the slab, and the sudden impact then caused the failure of beam C and made the tackle slide away from the men holding it.

Mr. A. Hayter, RAN, and another man went down either above or alongside the large slab, and suffered no injury. The third man, A/B Dillan, RAN, however, was wedged between the slab, the front wall of the hut, and the concrete pier which fortunately had prevented the slab from falling further than it did.

The writer and the other members of the party inspected the fallen slab after the accident. Although the fracture was not easily accessible (and could therefore not be photographed) the inspection revealed that the 4" thick concrete slab with approximately 30% voids, weighing about 23 cwt., was reinforced in the 8'8" direction by wires set at about 3" centres. These wires appeared to be about 3/32" in diameter; more accurate values could undoubtedly be obtained from the Company if required.

Since the design carried out and submitted by Monocrete Pty. Ltd. included a flat roof, and since the Company was informed of the proposed location of the building at Macquarie Island, it is difficult to understand that the type of reinforcement used could have been designed adequately for the considerable wind and snow loads to be expected, quite apart from allowing for additional heavy stresses due to difficulties of transport and erection with limited equipment.

In view of these facts it is recommended that no attempt be made to recover and use the Monocrete roof slabs, but that the design be put in hand of an entirely different and adequate roof which should be erected during the next visit to the Island.
