REPORT No. 1949/25

GEOLOGICAL SERIES No. 10

DAM SITES ON THE LALOKI RIVER, PAPUA

M. A. CONDON, B.Sc.

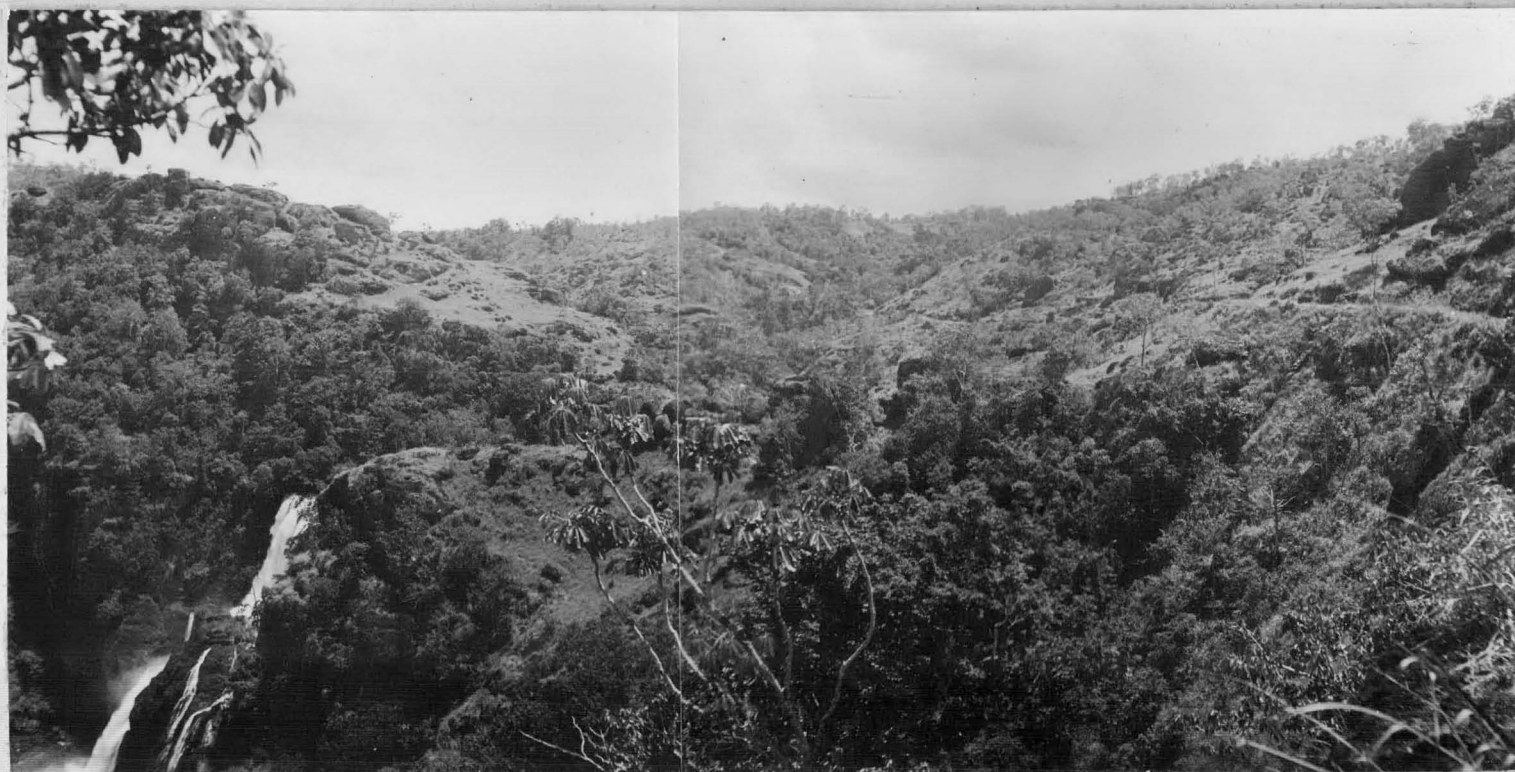
The valley profile at the site above Rouna Falls is mature. Solid agglomerate outcrops up either side of the valley and across the river bed. The mature valley upstream probably would provide a large storage if this were required.

The site above the falls has everything to recommend it - solid rock outcropping right across the valley, an open valley of low gradient upstream, a relatively small siltation rate. A high dam may produce seepage problems (through the vertical joints of the agglomerate) but these could be met by grouting. This site is so good that it should be reserved for a future maximum power development but, if required for immediate small-scale development, a small diversion weir could be constructed closer to the falls.

PHOTO I LALOKI VALLEY ABOVE ROUNA FALLS (LEFT)
 SHOWING MATURITY OF VALLEY.

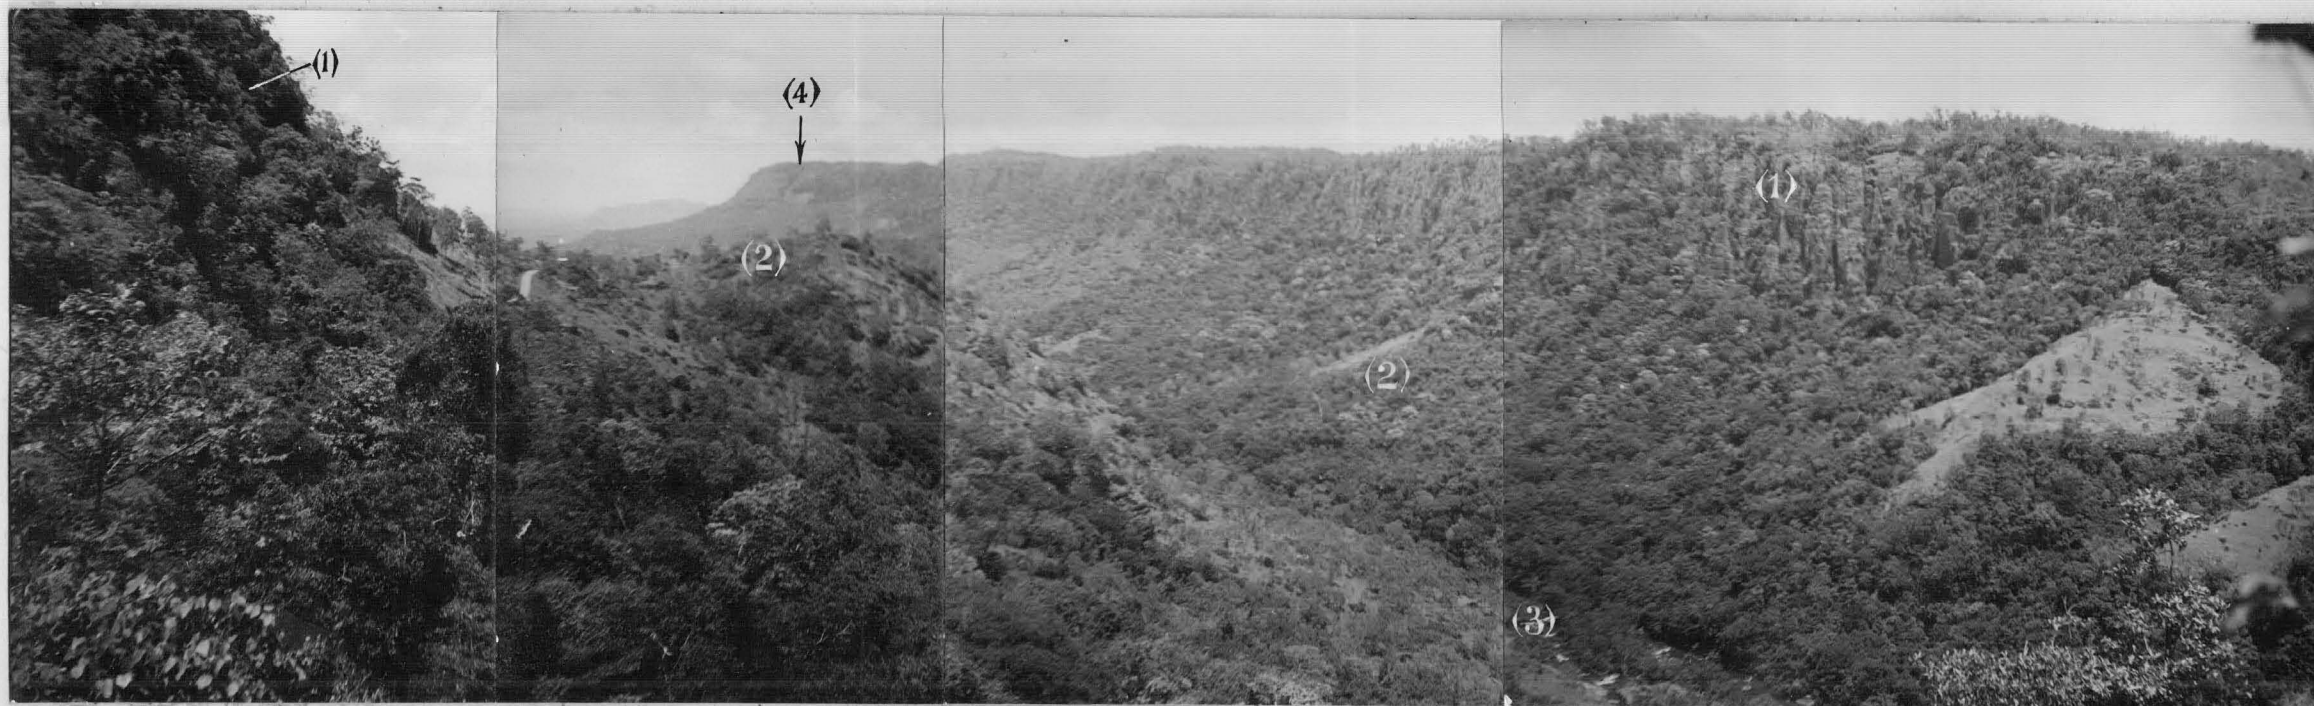
Dam Site at Point No.5: (See photo No.2)

This site is very similar in all respects to the site at Point 3, but farther upstream. The main landslip is from the left side of the valley. The road is cut into this slip. In the road cuttings the landslip material is seen to be very badly pulverized in places although other parts are very little changed except for tilting.

The very steep gorge section between point 5 and the falls is unstable and large slips are likely to occur. Such a slip would cause the filling of a dam at either of the downstream sites with sediment, and may cause structure damage to a dam at point 5.

PHOTO 2 LALOKI VALLEY LOOKING DOWNSTREAM FROM NEAR ROUNA FALLS.

- SHOWS
- (1) Steep slip faces
 - (2) Landslips
 - (3) Boulder-strewn bed
 - (4) Hombrom Bluff
