THE GEOLOGY OF THE COTTER RIVER VALLEY
WITH RELATION TO THE PROPOSED EXTENSION TO THE DAM.

REPORT NO. 1949/32

by W. B. Dallwitz

<u>PAGE</u>
SUMMARY	1
INTRODUCTION	1
DESCRIPTIVE GEOLOGY	2
ENGINEERING GEOLOGY	3
a. NORTHERN FAULT	3
b. SOUTHERN CRUSH ZONE	3
NOTES ON AGGREGATES	4
CONCLUSIONS	6

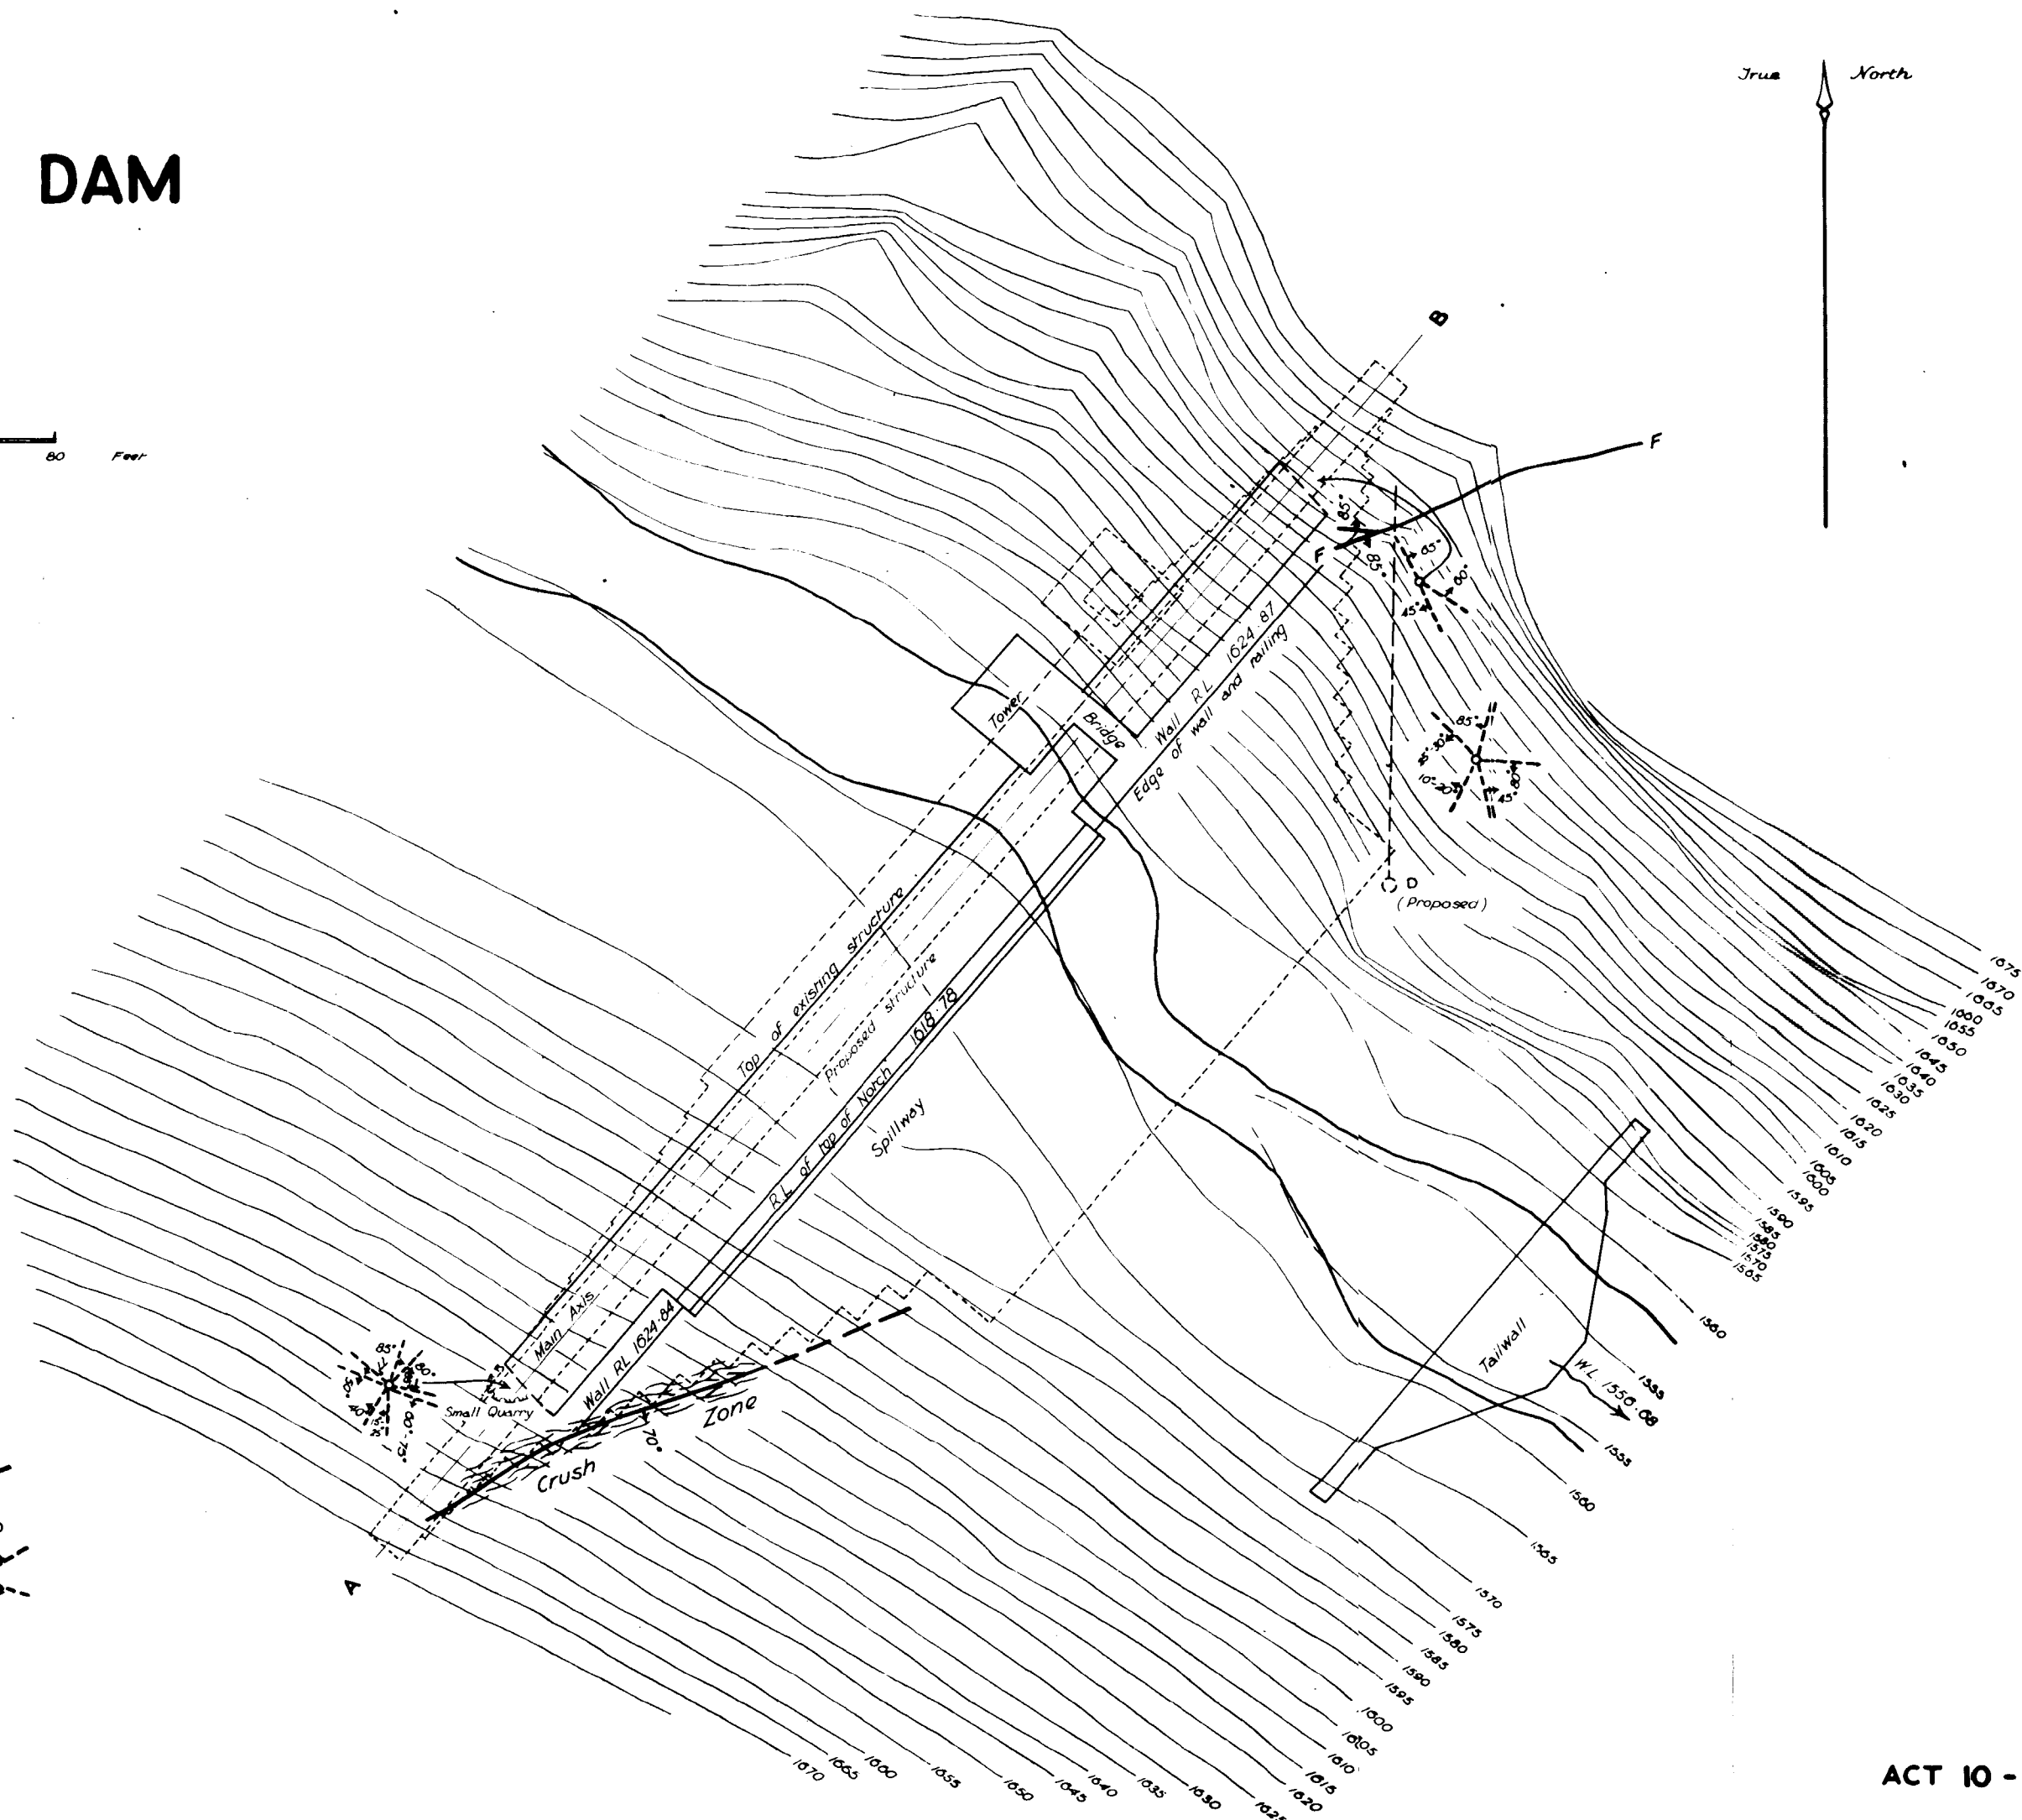
PLAN

The fault is exposed over a length of about 15 feet beginning from the top of the path on the left bank of the stream (see Plate 1). Its strike here is 70° , and dip 85° SSE. A minor fault branches off at a point about 8 feet from the south western end (as exposed) of the main one; its dip is 85° N. Gouge in the main fault reaches a maximum thickness of 1 foot. The small gully trending NNE from near the top of the path is due to the fault's extending in that direction; a slight change in strike to 80° was noted there. The rock in the gully is fairly heavily weathered, whereas the outcrops on either side of it are solid and more or less fresh at the surface.

On the south side of the dam a crush zone about 10 feet wide is exposed (see Plate 1). This zone strikes 70° , dips 70° SE and follows rather closely the base of the apron down the side of the gully. The rock in a small quarry on the northern side of the crush zone just above the level of the wall is solid and fresh, whereas that in the crush zone itself is rather friable, deeply weathered and strongly iron-stained, generally much more so than that near the northern fault. Actual movement in the crush zone was probably small; however the rocks there were moderately squeezed and are traversed by irregular, semi-parallel surfaces of movement whose spatial concentration and individual intensity diminish outwards from the centre of the zone. A large amount of scree and soil lies on the slope above the dam, making it impossible to trace the crush zone more than about 40 feet (plan distance) uphill from the end of the wall; however, for constructional purposes, it is safe to assume that it will continue for at least another 100 feet towards the south west.

However, if the dam is raised, it is not unlikely that the additional head would cause water to seep through the fault. It is suggested, therefore, that a horizontal or slightly upwardly directed hole be drilled due north through the fault from a position near the base of the apron (see Plate 1). Flow from this hole would show seasonal variation, of course, and would not, unless an indicator is placed in the reservoir, show whether water is escaping from the storage basin; however, if there is any (additional) escape of water due to increased hydrostatic head after the wall is raised, this would easily be made apparent. If leakage is found, the rock in the vicinity of the fault could then be grouted.

The weathered rock in the crush zone is so friable that a deep excavation will have to be made before anything like fresh rock can be expected. It is suggested, then, that the crush zone and neighbouring rocks be tested by excavating down to rock which will be solid enough for bedding the foundations, part of which will be within the crush zone over

a plan length of about 70 feet if the wall is raised 40 feet (see Plates 1 and 2).

Grouting will almost certainly be necessary even if the concrete is laid on fresh rock, because the surfaces of movement will still be present in the crush zone at depth, and they will very probably allow escape of water even under a comparatively small head.

As the crush zone, if not adequately treated, may well impart structural weakness to the whole wall and cause loss of water as well, it is recommended that it be closely investigated, not only by excavation but by drilling also, if this should be considered to be advantageous as the work goes on. If this investigation is sufficiently thorough and provision is made against any source of weakness that may be revealed, there is, at present, no discernible reason why the proposed additions to the dam should not be successfully completed, provided also that the concrete in the present dam is sound enough to bear the additional strains that will be placed upon it.

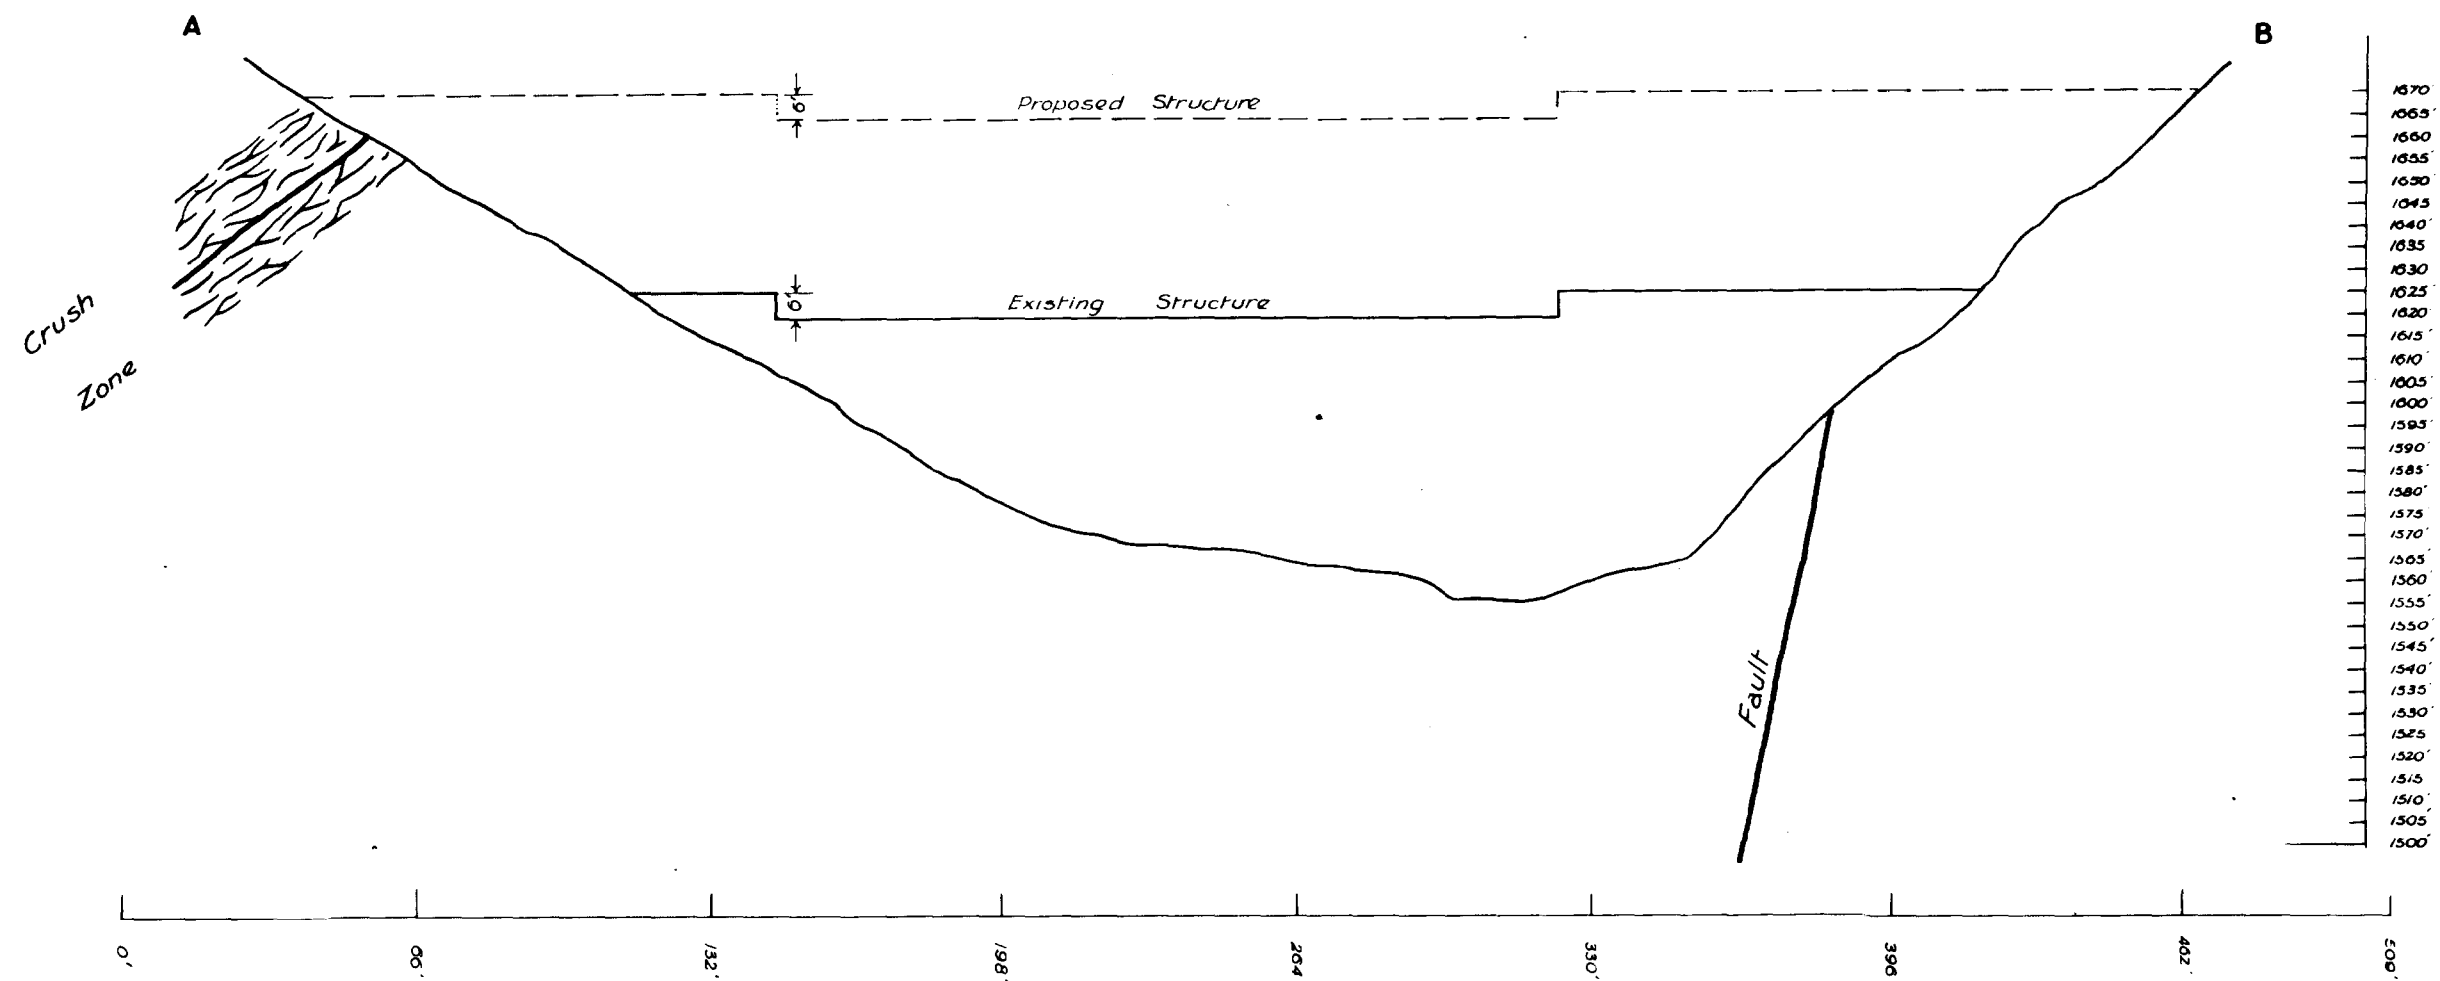
SECTION ALONG MAIN AXIS LOOKING UPSTREAM

The fault will not interfere with the new structural work, because the wall will be placed to the north of it, where the rock is fresh and solid. (See Plates 1 and 2).
