DEPARTMENT OF SUPPLY AND SHIPPING.  
BUREAU OF MINERAL RESOURCES  
GEOLOGY AND GEOPHYSICS.

REPORT No. 1948/54  
Geol. Ser. No. 20.

GEOLOGICAL REPORT ON DAM SITES 4 MILES NORTH-EAST  
OF TENNANT CREEK, NORTHERN TERRITORY.

September, 1948.

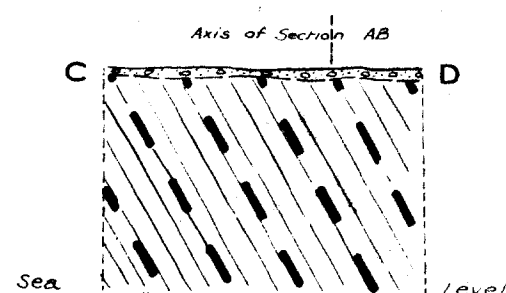
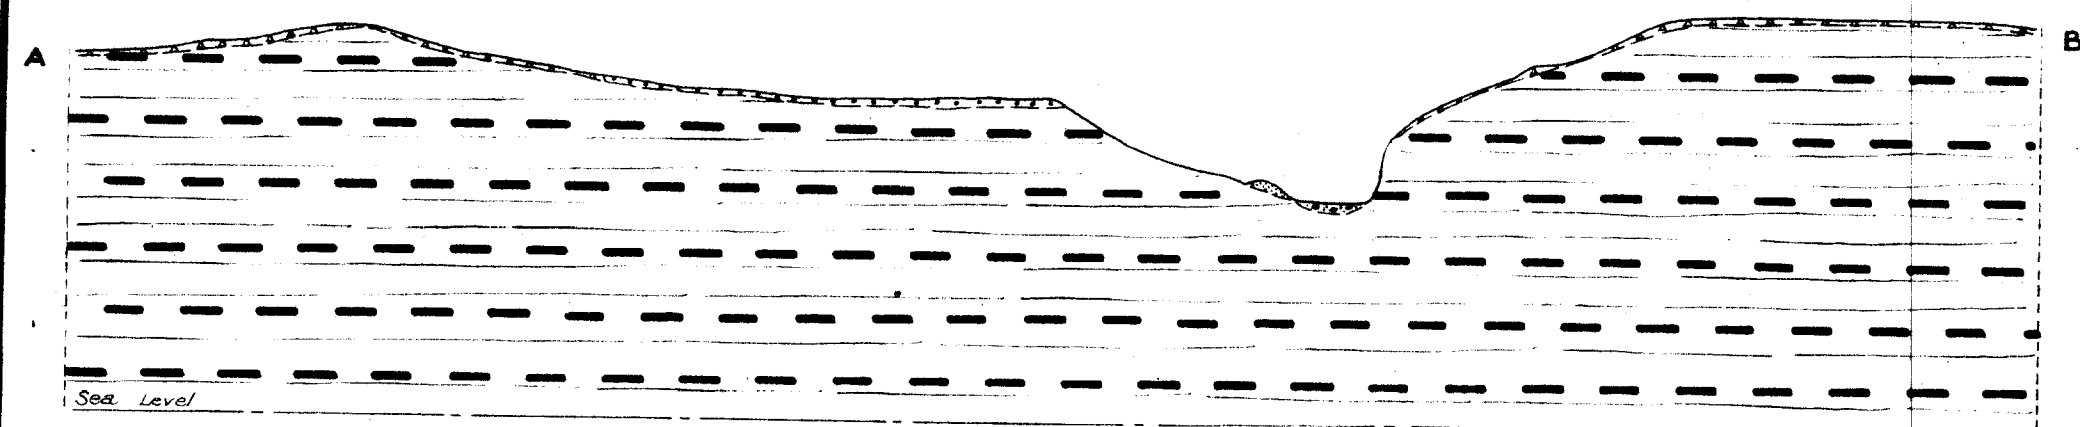
## SECTIONS AB, CD

A dam at Site 1, to impound the maximum depth of water (up to the 95 foot contour shown on Plate I), would be approximately 40 feet high, and the maximum length of the wall would be about 315 feet. The long axis of the dam would lie parallel to the strike of the slates which dip downstream at approximately 60 degrees. (See Sections A-B and C-D Plate I).

In the section exposed in the east bank of the stream at Site 1, the slates contain several massive bands which consist of partly silicified slate and lenses of porphyry. Typical exposures are shown in Figure 3, with finely bedded slate on the right, and a massive band in the left centre. The essential difference between the two rock types can be seen in Figure 4, which shows slate with fracture cleavage on the left and massive, partly silicified slate and porphyry on the right, separated by a small strike fault. Many of the contacts between beds of different competence are marked by strike faults.

However, the massive bands are relatively narrow - up to 20 feet wide - and may prove to be irregular along the strike. These rocks can provide suitable foundations for a rock-fill dam as far as strength is concerned. It may be possible to imbed the concrete membrane in one of the massive bands, although, due to the narrowness of the band and its dip to the north, the concrete core would have to follow a slight curve, convex downstream, to keep within the same band.

However, some leakage problems would be likely because the foundations of the dam would be relatively shallow. Although the slates should form a tight formation at depth, bedding and fracture planes, particularly the strike faults, are likely to conduct water for some distance immediately below the surface. Risk of leakage would arise from the possibility that water under head, would travel down fractures or down the dip of the slates and pass beneath the concrete membranes.

Minor leakage might occur at the western end of the dam, along bedding and fracture planes which traverse the narrow ridge forming the western abutments.

It would be wise to anticipate such leakage by grouting below the concrete membrane, particularly in the vicinity of the stream bed, where the hydro-static head of the water would be greatest.

If further investigations on Site 1 are intended, costans, at rightangles to the proposed wall, should be sunk to bed-rock on the slopes on both sides of the stream. (See Plate I). These exposures should indicate whether or not the massive beds, found in the creek, persist along the strike of the slates.

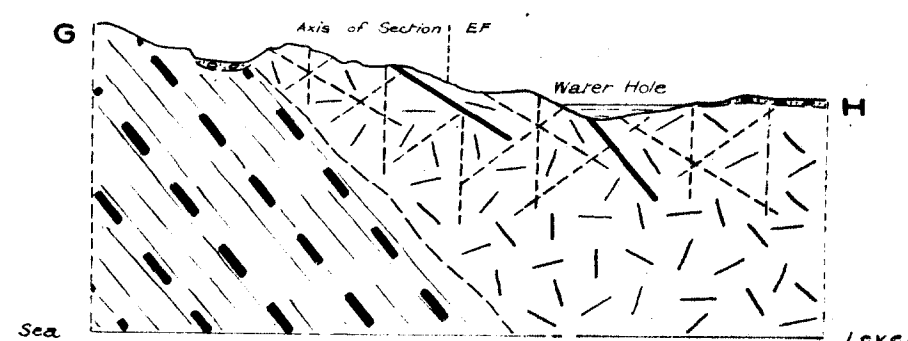
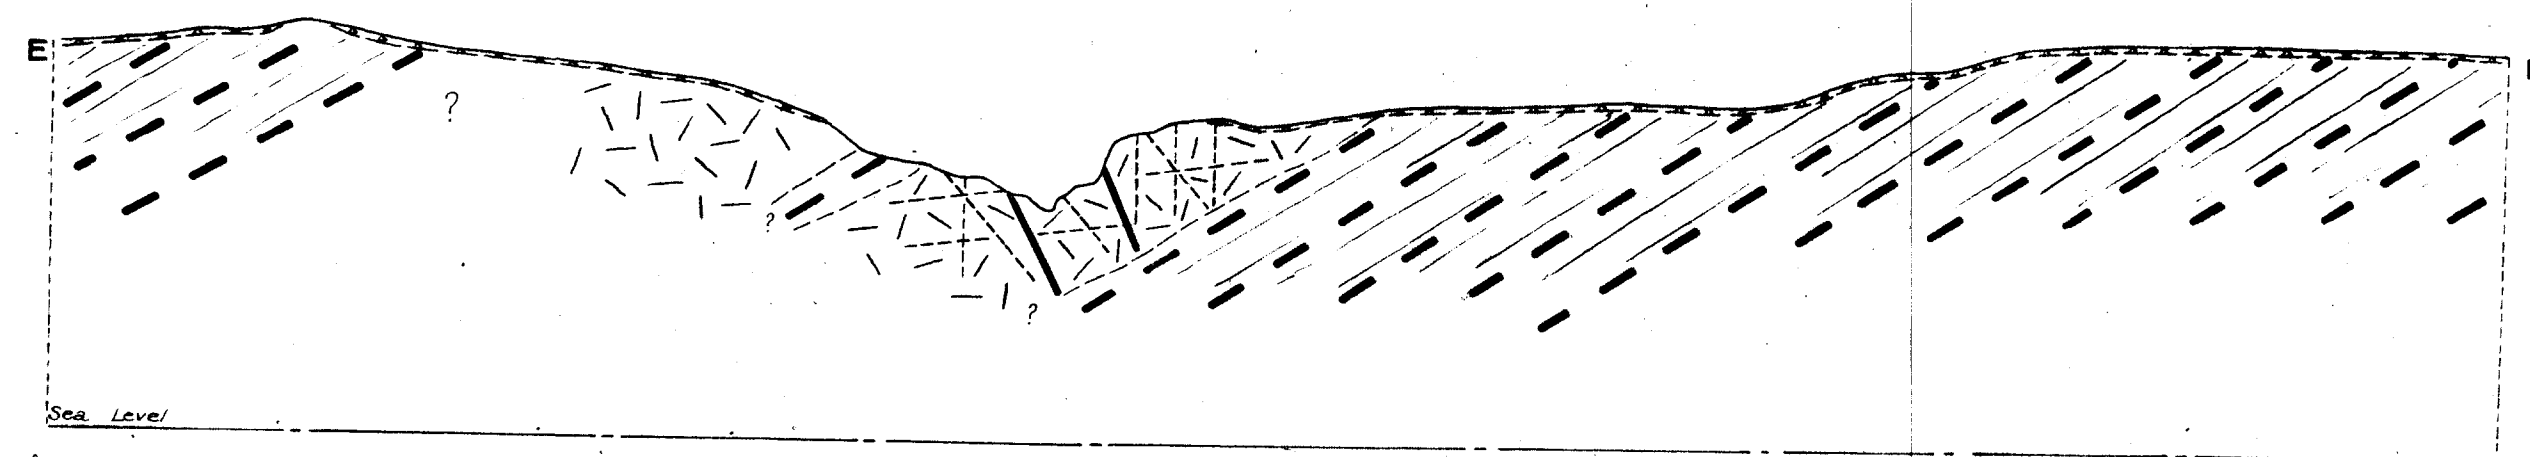
## SECTIONS EF, GH

The position of Dam Site 2 is approximately 500 feet upstream from Site 1. The best position for the dam cannot be decided without costaning, but a retaining wall constructed along Section E-F, on Plate I, to impound water up to the 95 foot contour, as at Site 1, would be approximately 370 feet long and about 40 feet above stream-level. The concrete membrane would lie in quartz porphyry in the western half of the dam site, but in slate in the eastern half. No difficulties are expected in procuring adequate foundation for the dam, or for the central core.

The quartz-porphyry, although sheared and altered, is still quite a strong rock, particularly in the outcrops in the creek bed, where partial silicification has caused a hard bar to form across the stream channel. Two faults or shears were mapped in the porphyry, and these may have to be grouted. The porphyry contains some inclusions of partly digested slate, but these are fairly hard and show no open contacts.

The apparent dip of joint planes has been shown in Sections E-F and G-H, although spacing of the planes is only diagrammatical. The joint pattern in the porphyry is shown to advantage in Figures 7 and 8. No leakage problems are expected in the porphyry although some grouting might be required along faults and flatly dipping joints. The relative tightness of this porphyry bar is indicated by the fact that it contained the only water-hole found in the creek in early June.

The slates in the eastern half of Section E-F strike approximately 95 degrees, and dip north at about 60 degrees, so that foundations constructed along the line of Section E-F would cross the bedding at an angle of 20 degrees with the dip in a downstream direction. This situation is similar to that pertaining at Site 1, and although the hydro-static head of water in this portion of the dam would not be great, some precautions should be taken if leakages were to be reduced to a minimum. The suggested positions of costeams to allow inspection of the slates in this section, are shown on Plate I.

Leakage from the western end of Site 2 should be negligible, particularly if the porphyry continues to the west.

In view of the fact that leakage should be kept to a minimum, it would be advisable to investigate the contacts of the porphyry on the eastern side of the stream. If the porphyry behaves as a normal sill, conforming with the strike of the slates, it should be possible to construct the concrete core wholly in porphyry by changing the direction of the dam as shown in Plate I.

The porphyry would provide adequately strong foundations with a minimum of work to reduce leakage. Furthermore, such a porphyry bar, although probably dipping with the sediments, should, to some extent, act as a cut-off wall, and reduce leakage arising from shallow circulation beneath the foundations of the dam. The suggested positions of costeams to trace the porphyry bar in the eastern side of the valley are shown in Plate I.
